Beddington Park Cottages

**Investigations before and during building work,
1982 - 1987**

John Phillips

Carshalton & District History & Archaeology Society
Occasional Paper 6

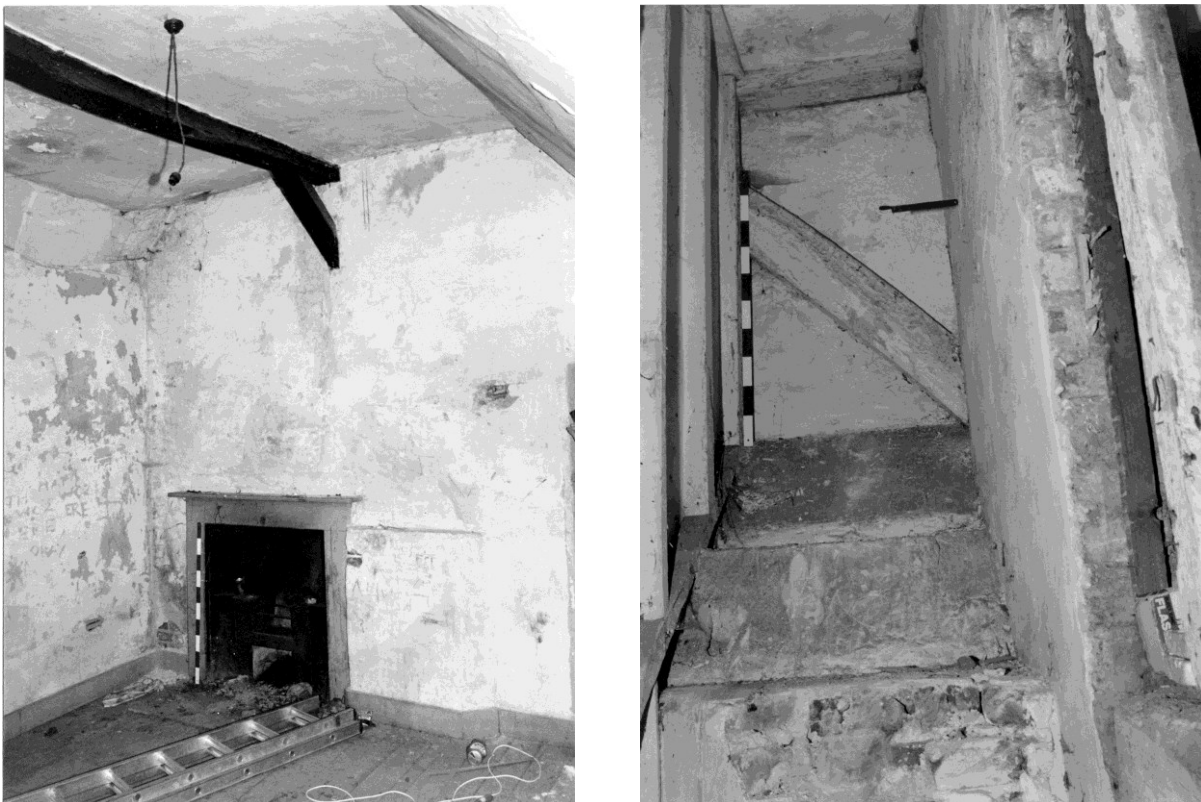
Figure 3. The crown post brace on the north side of truss 3. Seen on room 1-11 on the left and in the cubby hole at the south end of room 1-11 on the right. 1982.

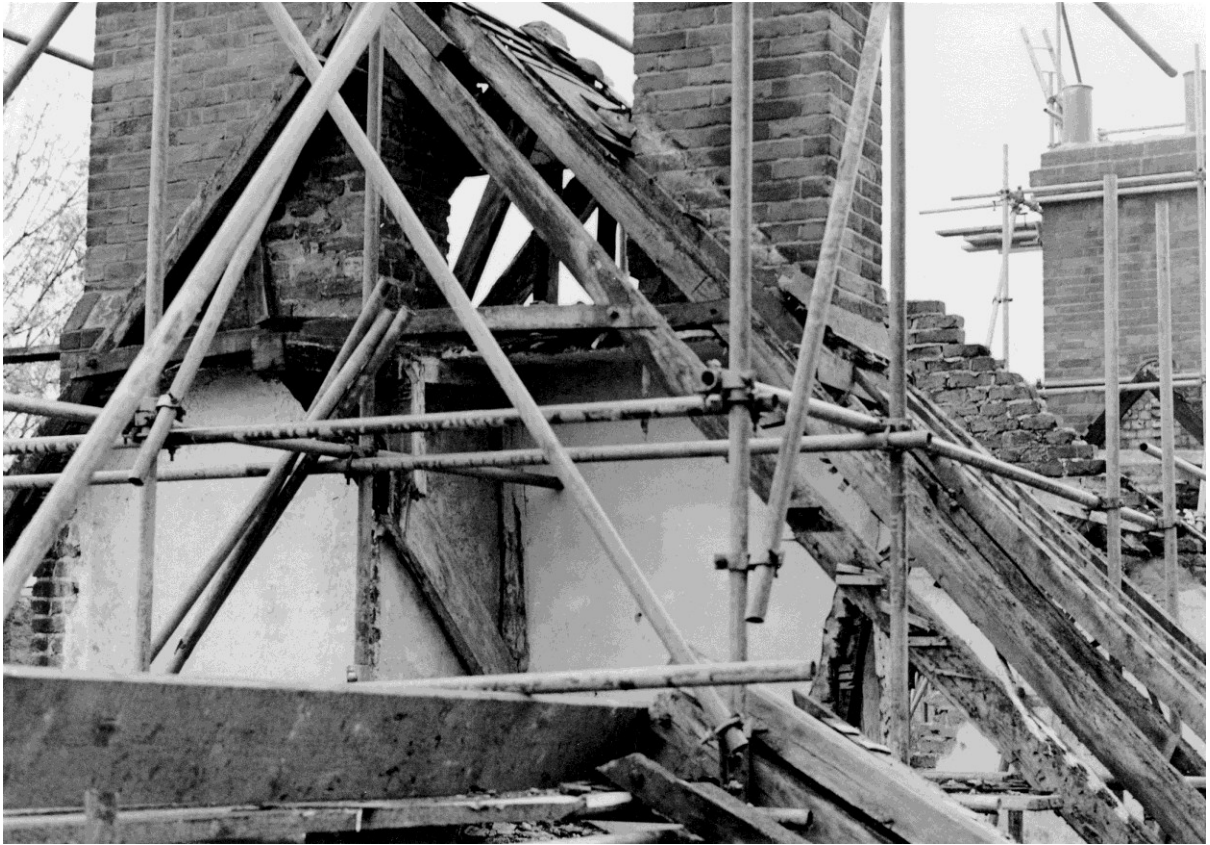
Figure 4. The sawn-through collar purlin and the brace to crown post 2 seen during conversion work in 1986-7. Looking approximately south.

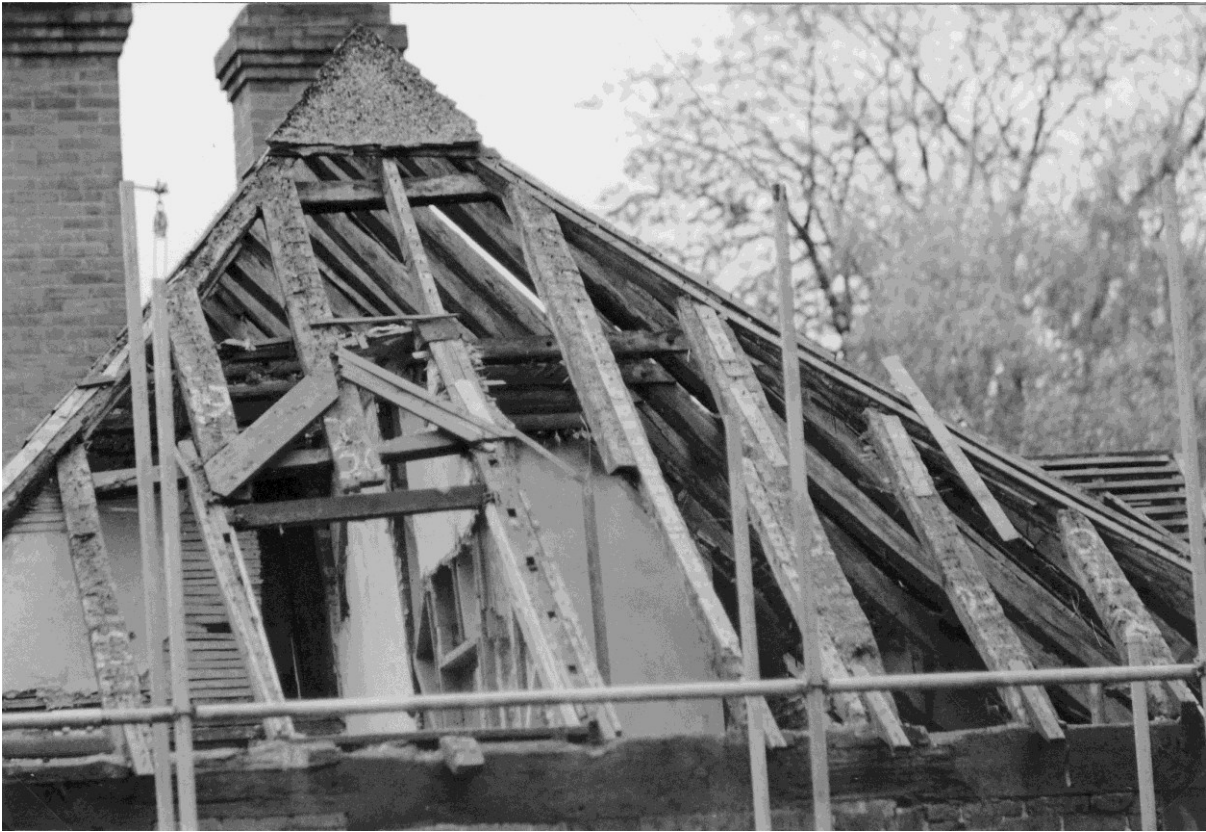
Figure 6. The hip on the north end of the cottages in 1986-7. Note the gap for a dormer window on the left and the cut rafter to the right of it, perhaps the site of an earlier dormer.

There was also evidence, in the form of cut rafters, for an earlier dormer in the north face of the roof lighting room 1-8 (see figure 6 above). The dormers presumably replaced two small blocked windows in the upper part of the west and north walls, which represent the earliest traceable lighting of the first floor (see sections 3.3.1 and 3.4).

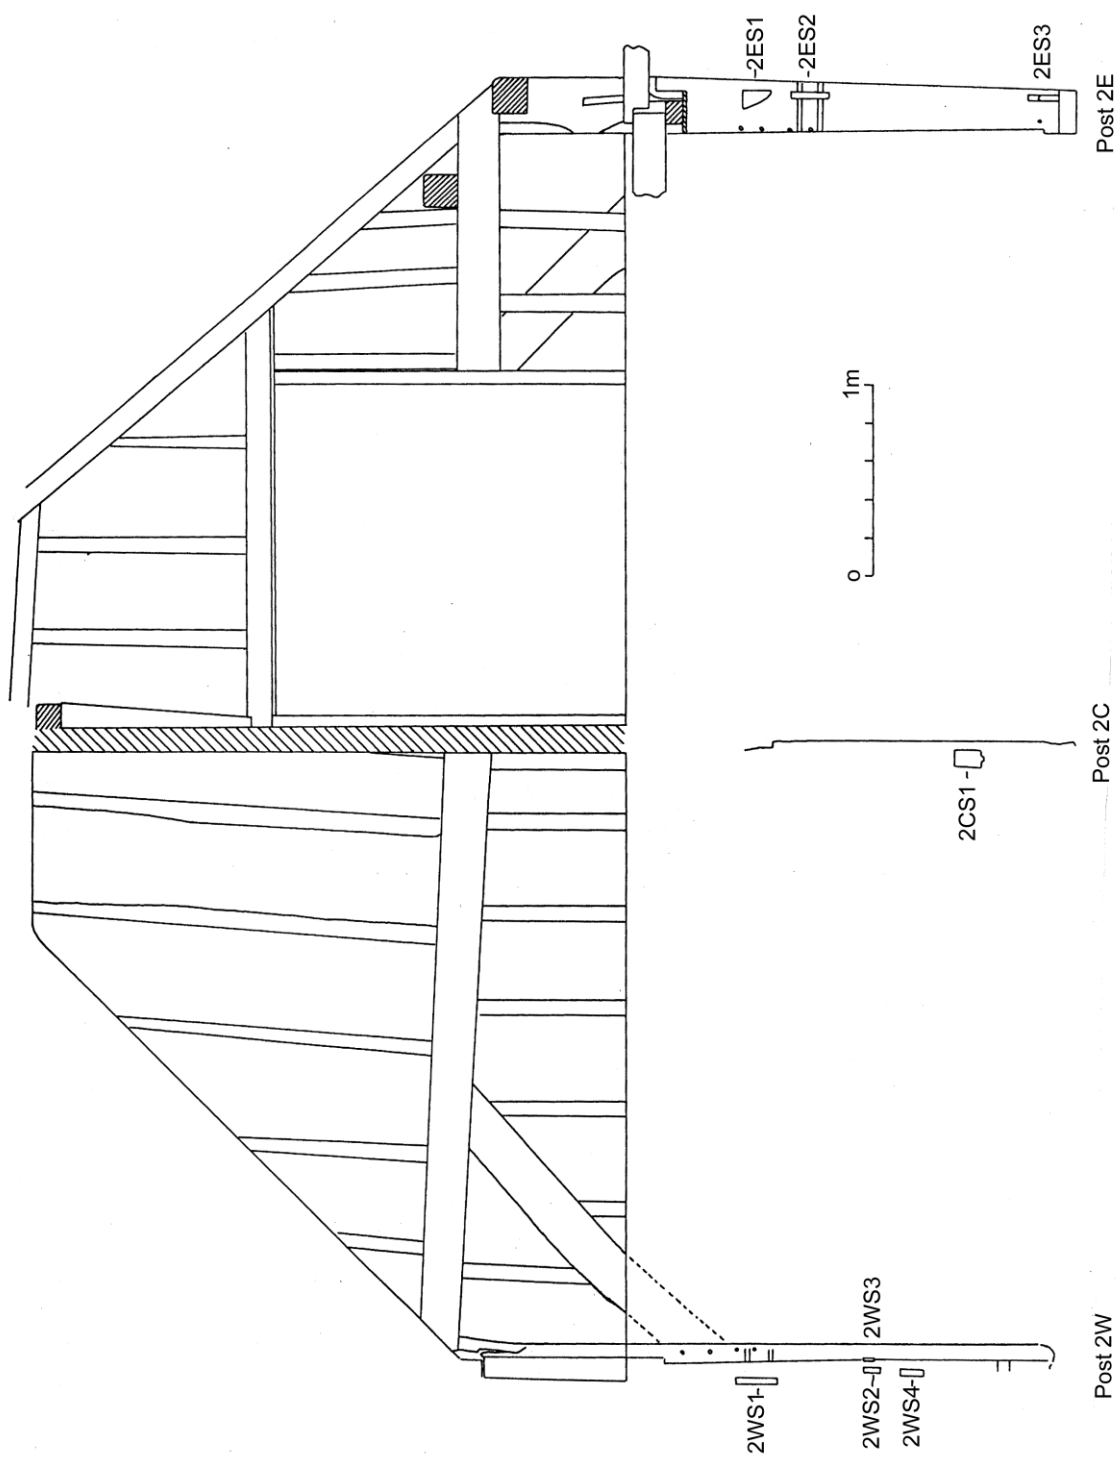
Figure 11. The south side of truss 2. Details of the ground floor walls are omitted. The west sides of posts 2W and 2C were hidden by brickwork. The top of post 2C had been destroyed by fire.

Post 2C had mortises on its north and south sides just below existing floor level but the upper part of the post had been destroyed by fire which had severely damaged the area around the joints, so that their size could no longer be determined. The exact distance between their tops and the bottom of the tie is also uncertain, but must have been similar to other posts. The joints differed from those on posts 1C and 3C, as they had plain rather than diminished haunches.

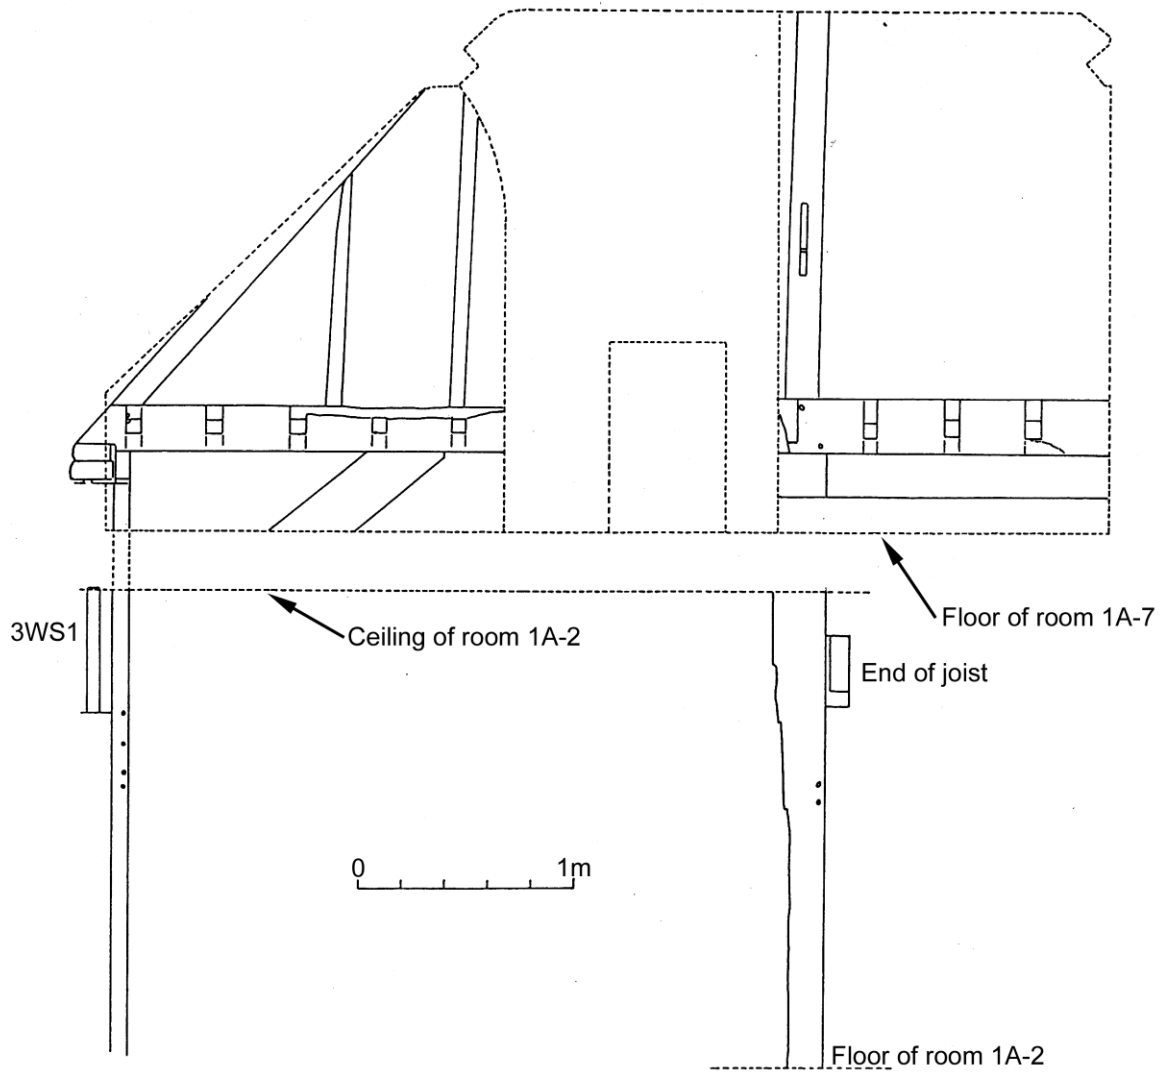
Figure 12. The south side of truss 3. Post 3E had gone. The chimney is not shown below the first floor.

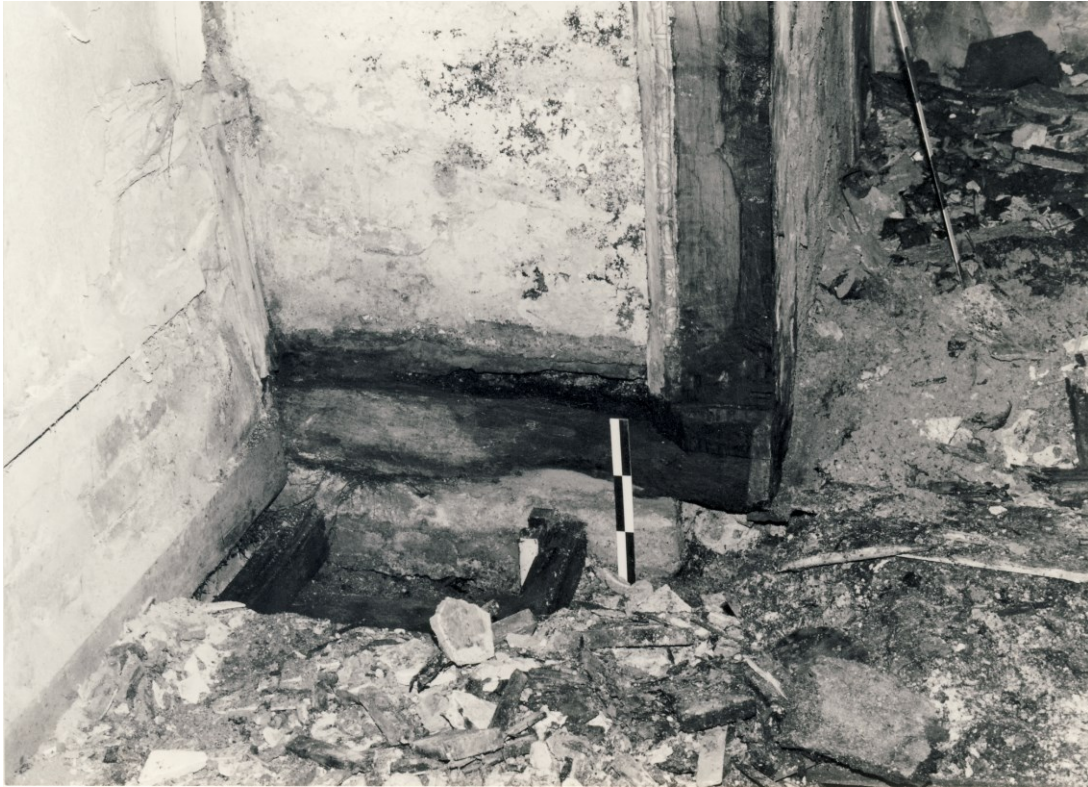
The sill beam, on which the wall posts would have rested, was very poorly preserved. The only section in good condition was located beneath post 2E (figures 16 and 17). Here the post had a height of 2.83m. There were traces of a sill about 2cm below the rotten bottom post 1W which had a surviving height of 3.1m and there was a short length of timber below post 1C which had a height of 2.92m. The bottoms of all the other posts were badly rotted but the wall posts had surviving lengths of 3.1m or more and 3W was 3.19m. The lengths of posts 2E and 1C are therefore anomalously short. It seems likely that the ground sill below post 2E was a later piece of under pinning. It rested on brickwork rather than chalk.

Figure 18. The bottom of post 2E showing a surviving section of ground sill resting on a brick foundation.

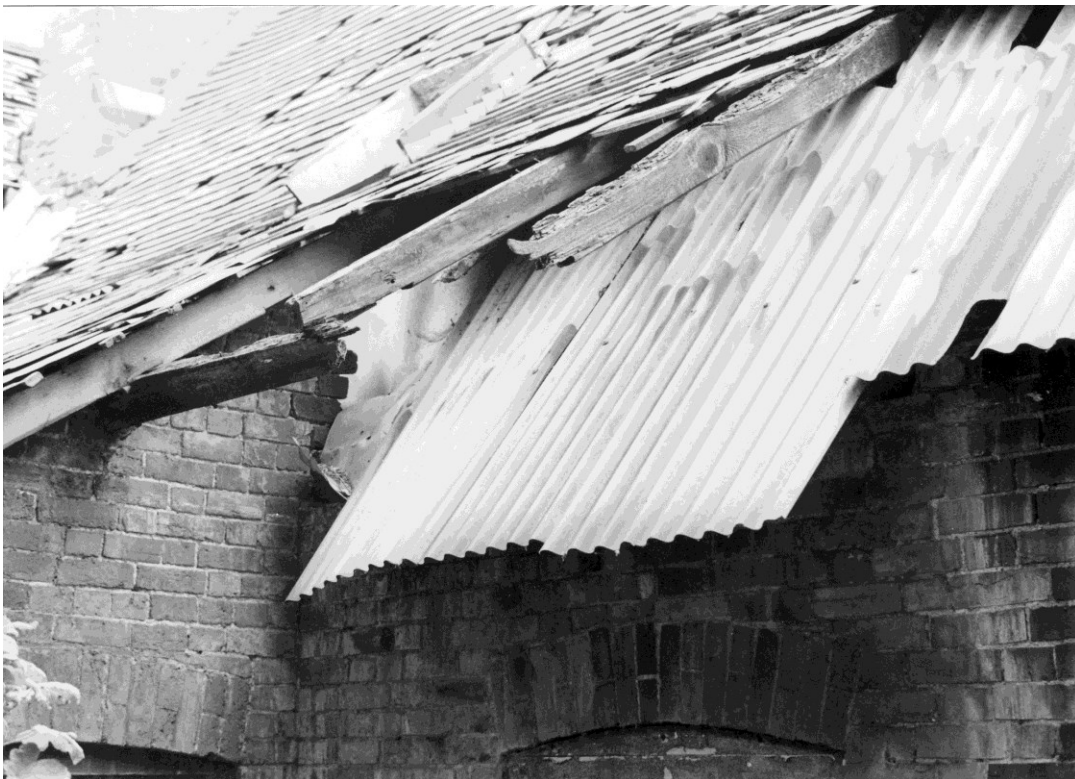
Figure 36 The east wall of room 1-4 with exterior wall or room 1-5 on the left. 1983. The corrugated iron appeared to have been inserted as a bodge repair to protect the head of the wall following the decay of the roof of the extension against the wall of room 1-4.

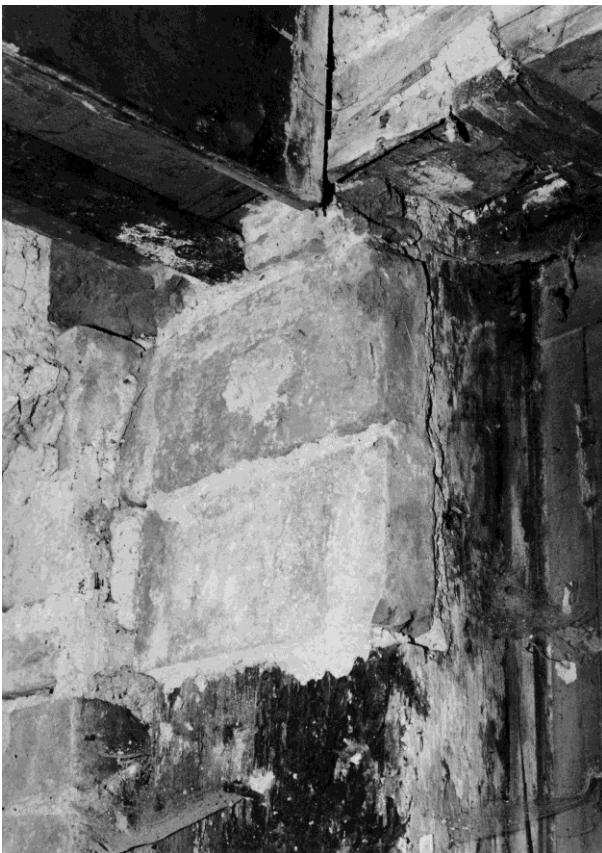
Figure 59 (left). The south side of post 1C below the first floor. Note the brick filled notch cut into the timber probably to hold a bridging joist below the level of the existing floor.

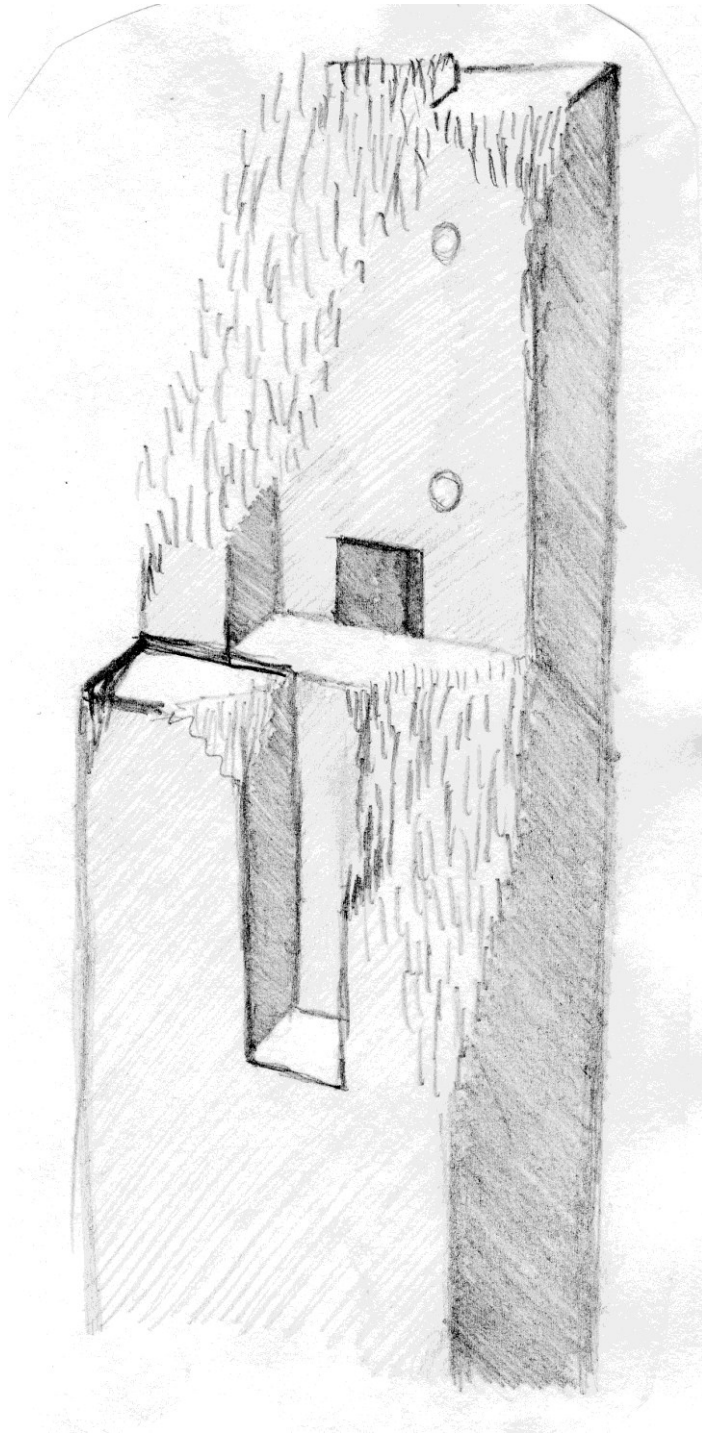
Figure 61. The top of the surviving part of post 2C after it had been damaged by fire. Looking southwest with the east face to the left. The east face had probably been cut away removing the side of a tenon for a south running timber. Not to scale.

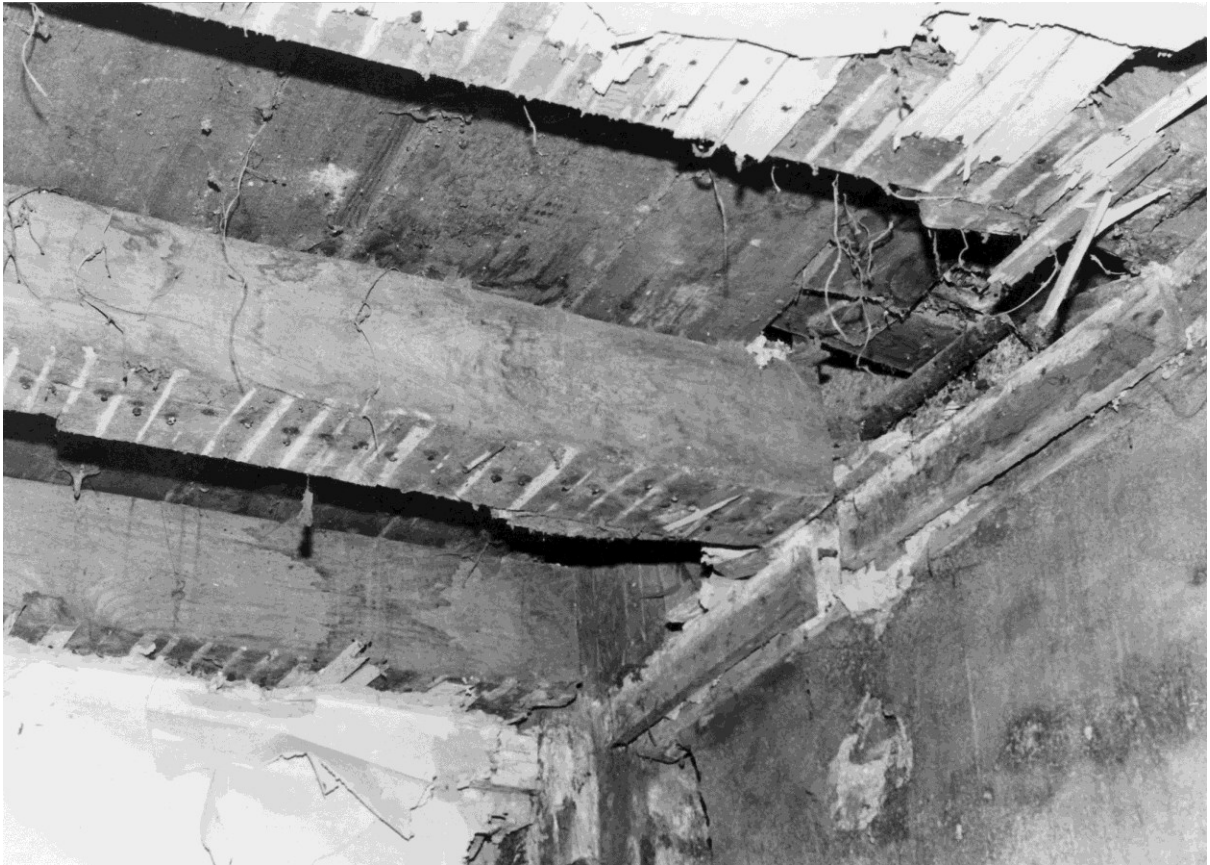
Figure 74. The ceiling at the southwest corner of room 1-6 showing the bodged repairs to fill the gap between the joists and the west wall.

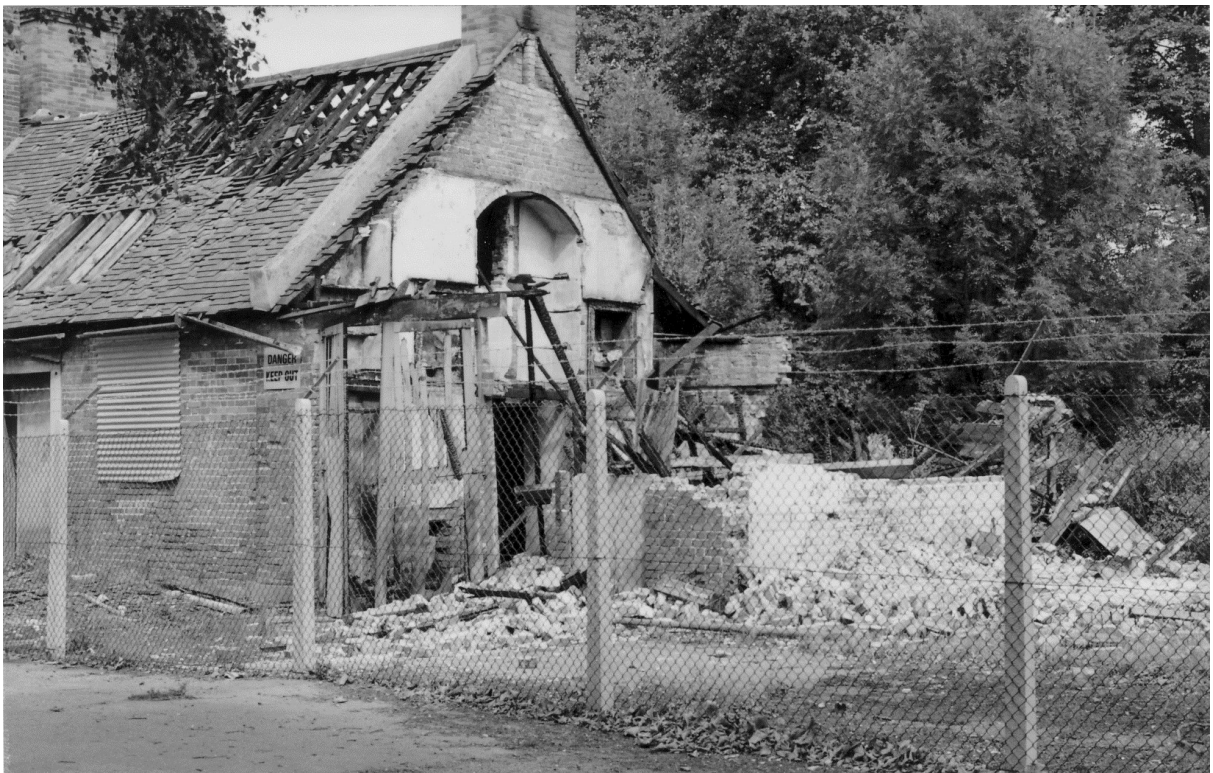
Figure 86. Cottage 2 shortly after being destroyed by fire. August 1982. Cottage 1B to the left.

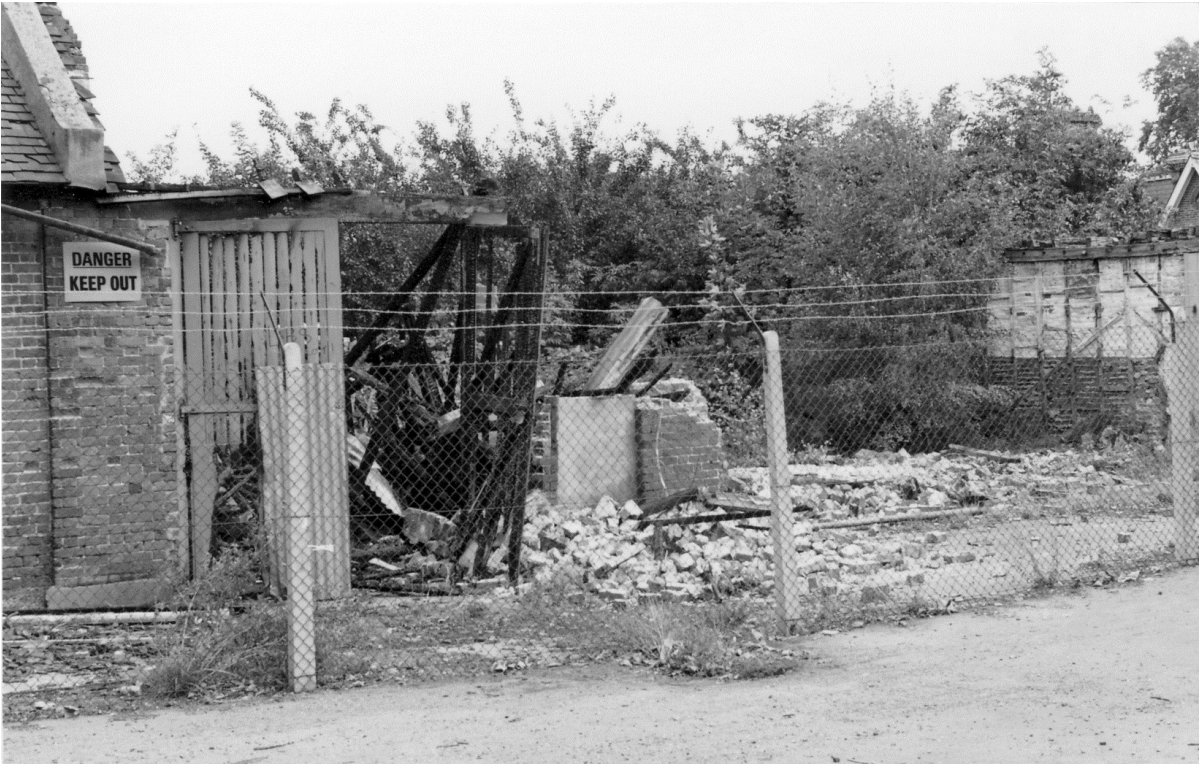
Figure 87. Cottage 2 shortly after being destroyed by fire. August 1982.
