The Dovecote at Carew Manor, Beddington

John Phillips

**Carshalton & District History & Archaeology Society
Occasional Paper 13**

Site address: Church Road, Wallington, Surrey
Grid reference: TQ 29544 65371
London Borough: Sutton
Listed building number: 1002017
Revised: 17 April 2020

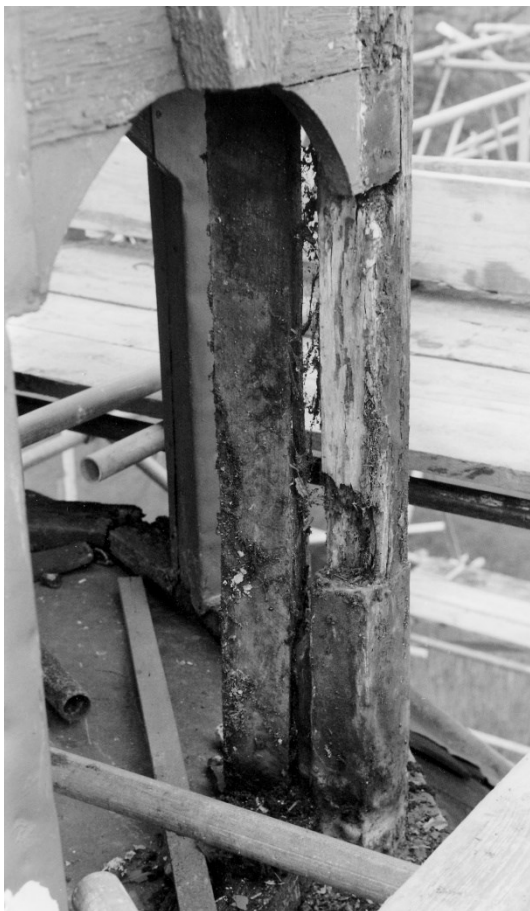
Figure 11. One of the columns supporting the turret roof. The lead has been removed, exposing the construction. It consisted of two pieces of timber with a gap between them.

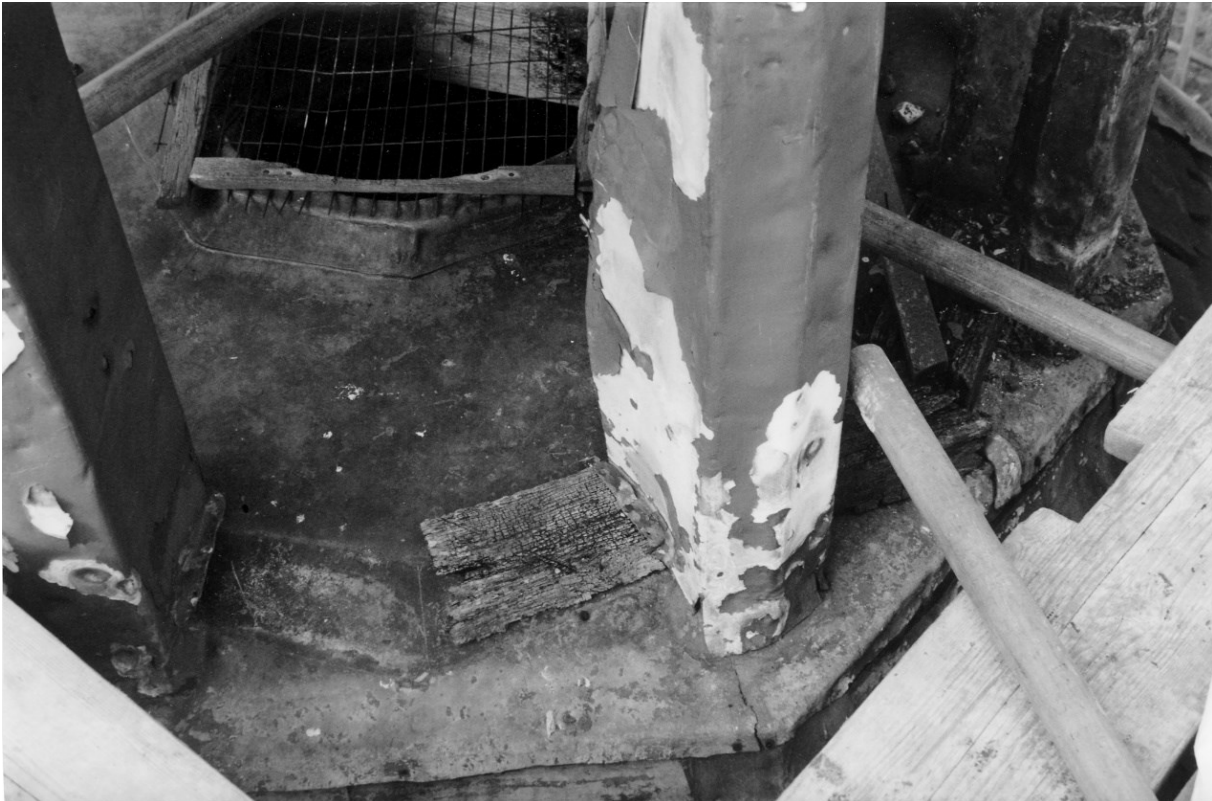
Figure 14. The base of the turret. The inner half of the column rested on a timber ring beam which in turn rested on lead capping at the top of the main roof.

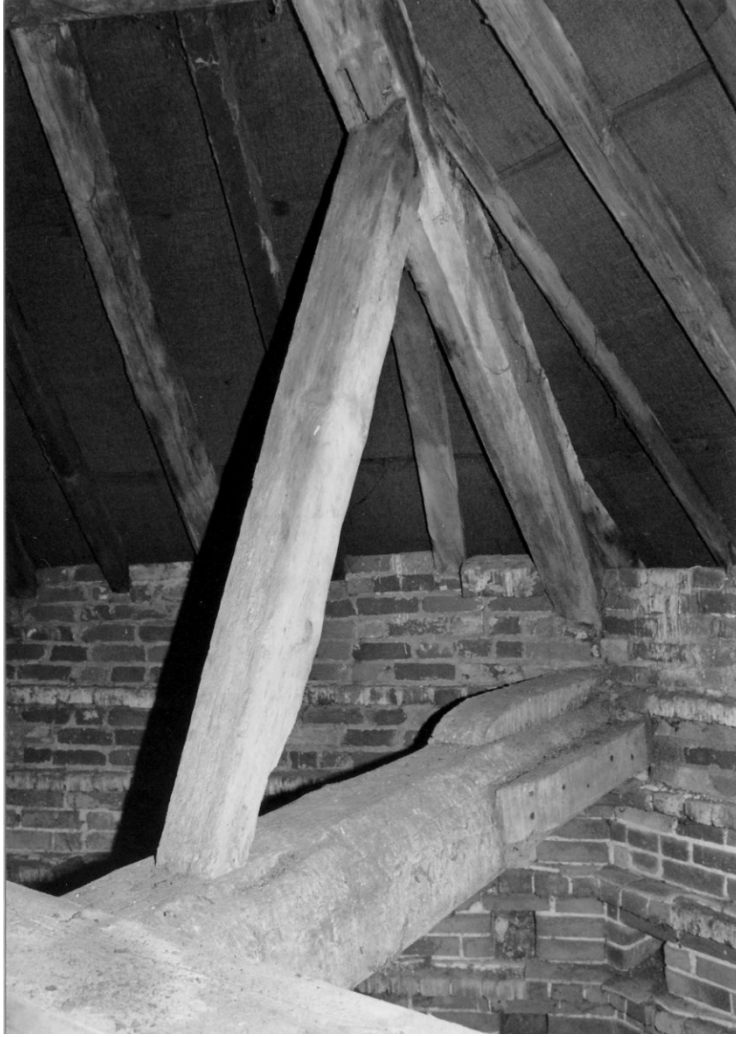
Figure 20. The east end of the main tie-beam at corner 2 showing the brace between it and the principal rafter. Note that the mortise on the underside of the rafter is for a wider brace. This was the brace which was in place before the 1997 repairs.

Tie-beam 2/6 was 37cm wide and 28cm high. The top was very eroded. Woodridge and Sciberras recorded a mortise 130mm long, 35mm wide and 125mm deep about 2.06m from corner 2. This must have been for an upward running brace which was missing at the time of their survey.²⁰

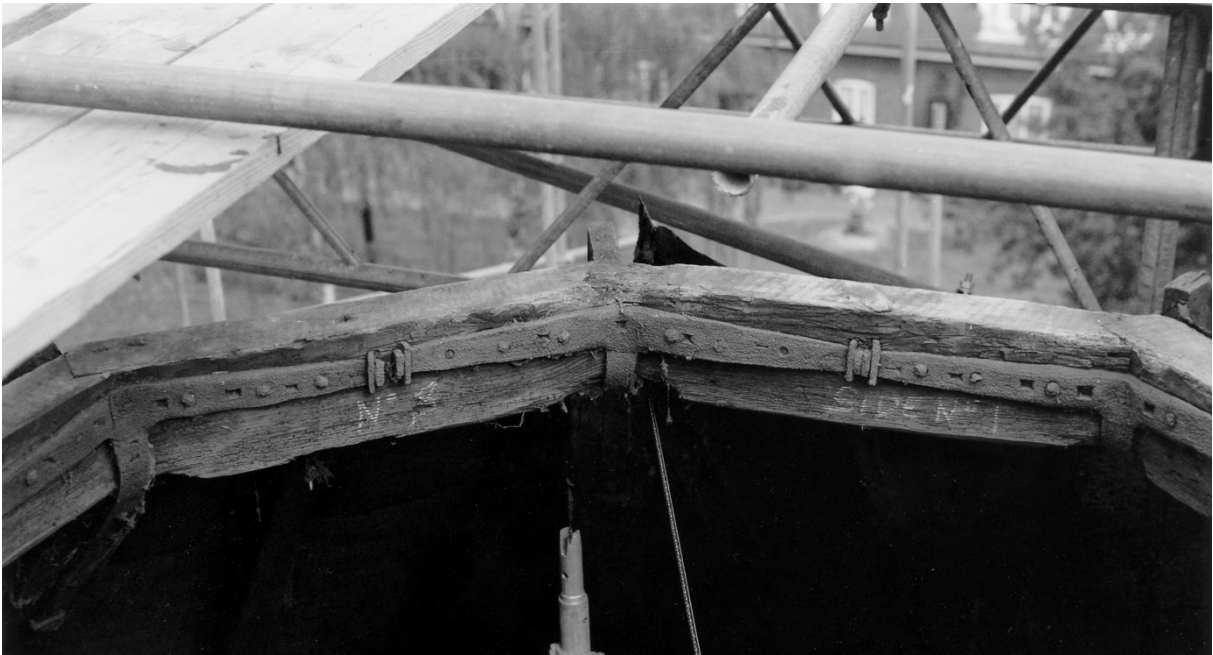
The apex of the roof was formed by an octagonal ring beam some of which was old and some more recent replacement. The older timbers appeared to have been joined by a simple notch although only the top of the joint could be seen. They were also connected with hand-forged T-shaped wrought iron ties which were secured by nails and also by staples driven in next to their raised ends. The descending parts of the Ts connected the ring to the top of the principal rafters where they were again secured with nails and staples. The older ties had square and rectangular fixing holes which were large towards the centre and narrowed towards the end (figures 21 to 23). These holes were generally empty and the ties were fixed with round nails driven through round holes. Several of the pieces of wood in the ring beam had been replaced with modern-looking timbers the ends of which were simply butted up against each other. Two of the ties also looked like replacements.

Figure 21. The ring beam at the apex of the roof showing the iron ties binding the structure together.

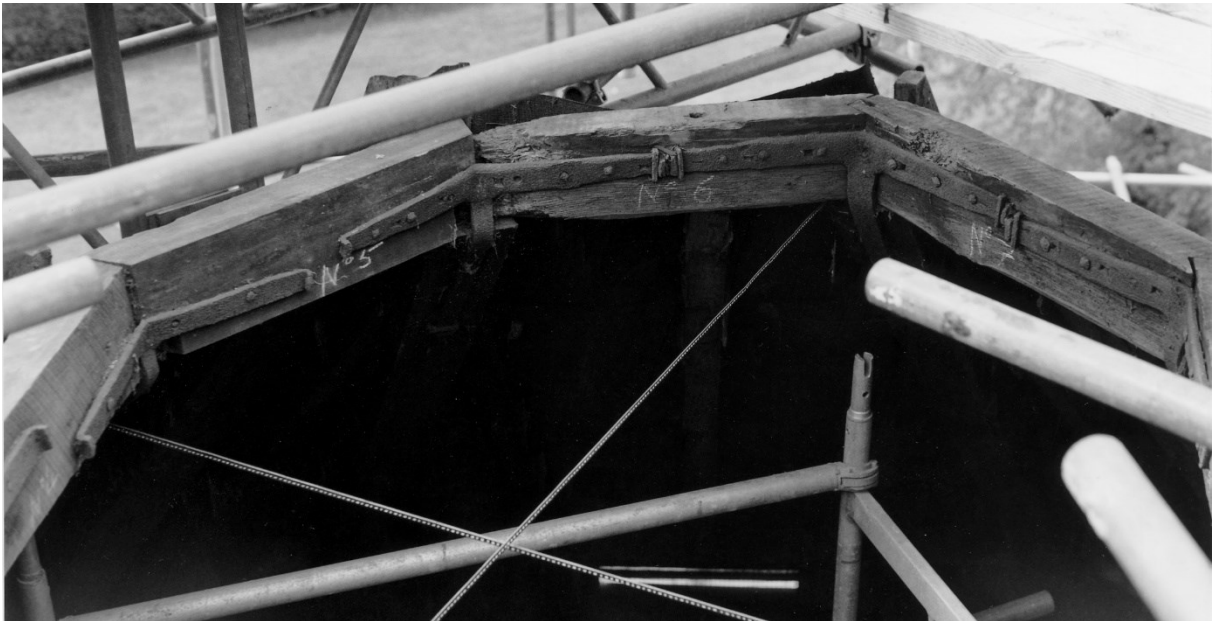
Figure 22. The ring beam showing the mixture of old and new timbers.

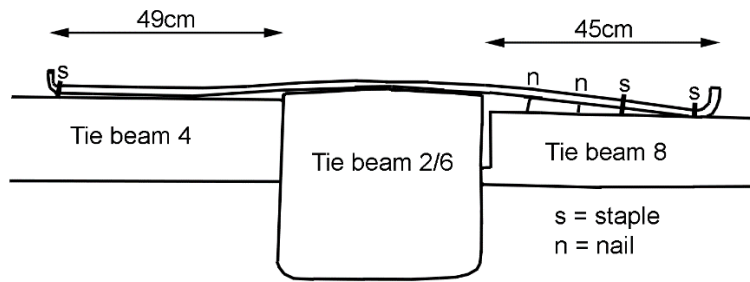
Figure 28. Sketch of the junction of beams 2/6, 4 and 8. An iron strap ran from beam 8 to 4 across the top of 2/6. The nails connecting the strap to beam 4 could not be seen properly and were not recorded.

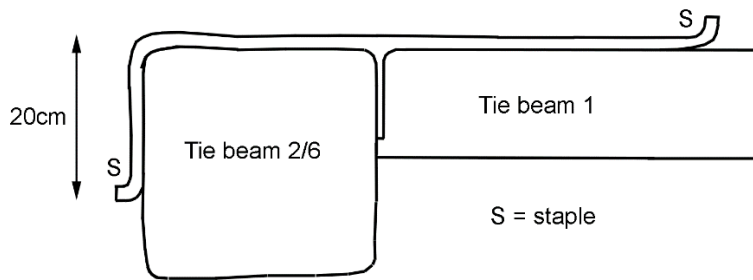
Figure 29. Sketch of the junction of tie-beams 2/6 and 1. The iron strap has been cut into the side of 2/6 to accommodate the curve of the metal.

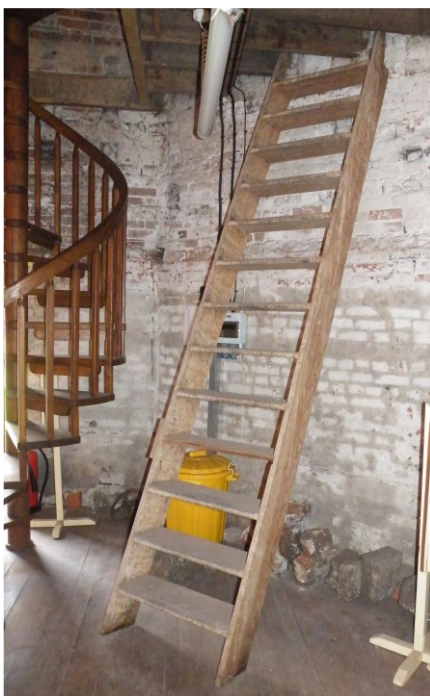
Figure 52. The first floor was accessed by this straight ladder which was replaced with the existing spiral staircase in August 1990 when the building was adapted for public opening. The steps are now preserved in the dovecote.
