Carshalton & District History & Archaeology Society

Local History Note 14

The structure of the Stone Court Mansion House, Carshalton and the water level in Carshalton Lower Pond

John Phillips

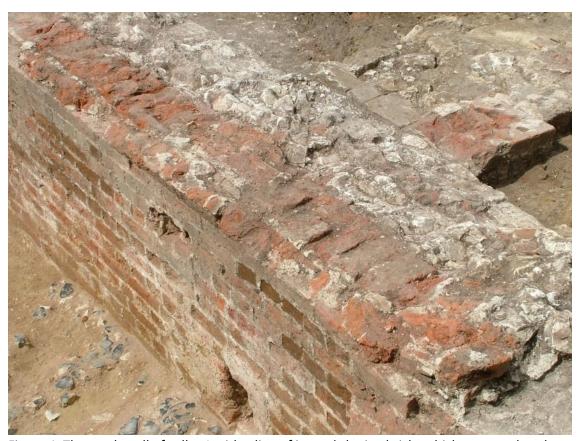
There was a short course of bricks set at an angle on the top of the north wall which suggested that the cellar had originally been vaulted.

Figure 4. The north wall of cellar 1 with a line of inward sloping bricks which suggest that the cellars had originally been vaulted.

The elevations show semi-basement windows for the cellars, with two main and one subsidiary floor above. A line of inward-sloping brick along the inner side of the north wall suggests that cellar 1 was vaulted. The angle of the brick is consistent with a vault that was semi-circular or nearly so, rather than low and segmental. A high arch would be necessary to make sufficient space between it and the floor.

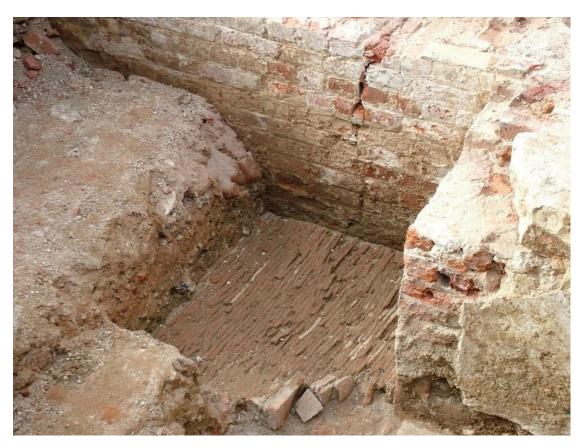
The foundations contained two cracks, which suggest that the building may have developed structural problems. One was in the north wall of cellar 4 (figure 14) and the other was in the south end of the east wall of the south porch (figure 23 and 24). The cause of these is unclear although an obvious possibility is subsidence into an area of soft ground.

Figure 14. Cellar 4 looking northwest.

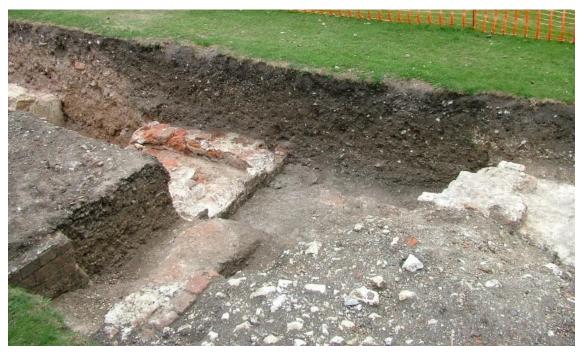
The south wall of cellar 4 was also the outside wall of the house. The excavated section had been badly damaged by a large pit which had been dug after the house was demolished. The visible parts of the wall were brick.

Figure 20. The south end of the trench with the outer south wall centre left. The innermost of the three walls forming the porch can be seen bottom left. The junction between the outer south wall and the porch had been largely destroyed by the excavation of a large pit, the dark fill of which is visible in the section.

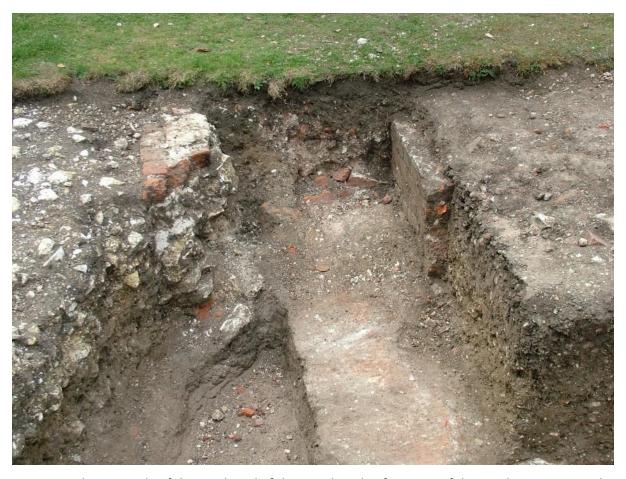
Figure 21. The west side of the south end of the trench with a fragment of the porch structure on the left and the south wall of the house on the right. Both are truncated by the large pit in the foreground.

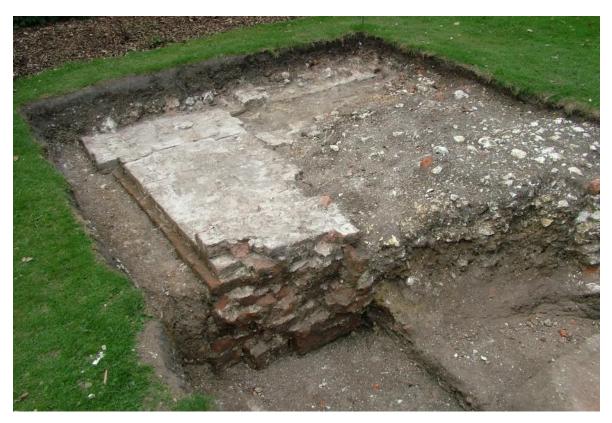
Figure 23. The south end of the trench showing the east wall of the porch. Note the crack in the south end and the two thinner walls at right angles.

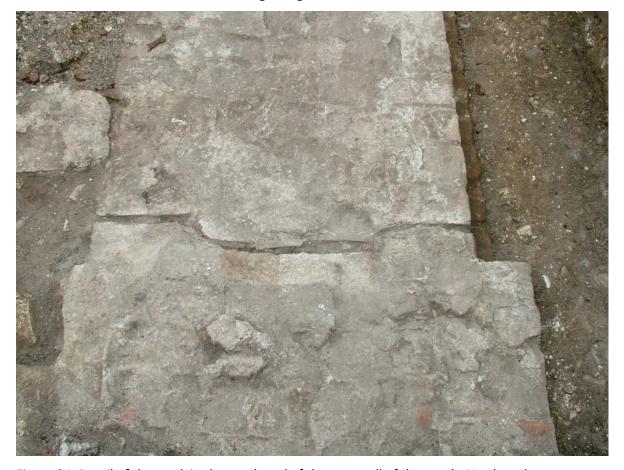
Figure 24. Detail of the crack in the south end of the east wall of the porch. North at the top.

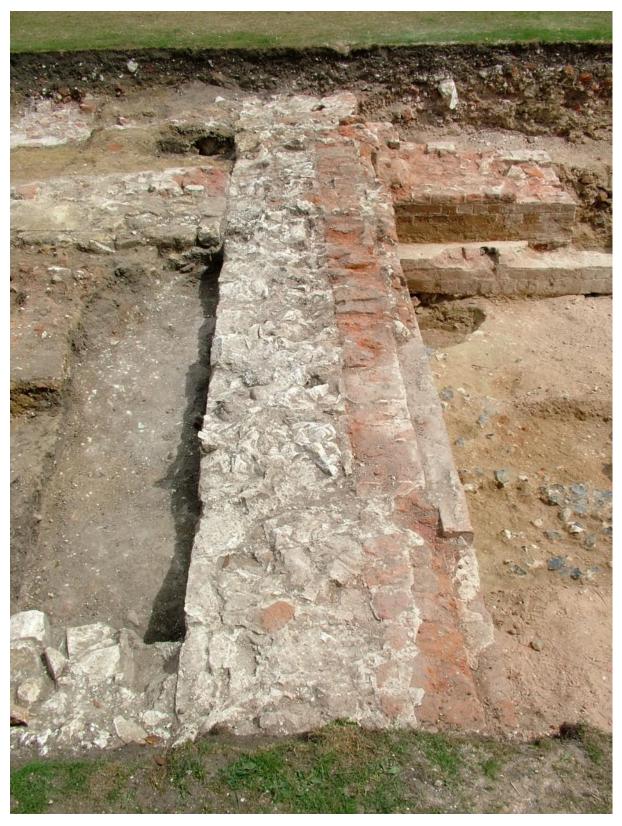
The northern outer wall of the house was of brick on the south side and stone on the north. It is possible that the stonework was the reused remnant of an earlier building, although it did include a few brick fragments (figure 25). A small sondage excavated against the north wall exposed the junction between an east-west and north-south wall (figure 30). This probably belonged to an earlier building, but too little was exposed to understand its context.

Figure 25. The north outer wall of the house looking east.
