**The Garden at Carew Manor, Beddington:
An interim report on investigations 1979-2005**

John Phillips and Nicholas Burnett

Carshalton & District History & Archaeology
Society
Occasional Paper 1
2008

Carew Manor, Church Road, Beddington SM6 7NH
TQ 295 653

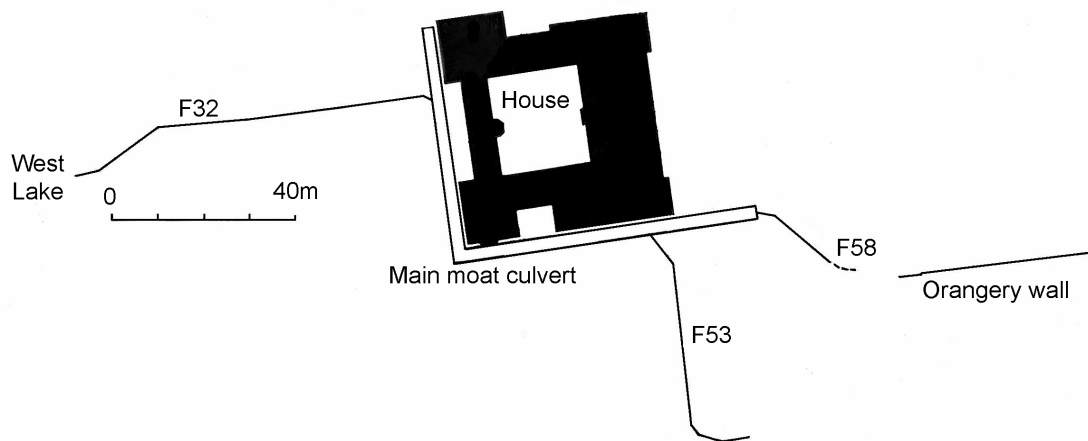
Figure 2. The main moat culvert and side culverts F32, F53 and F58. (From the Chelsea Speleological Society survey).

Culvert F58 ran into the east end of the southern moat culvert. It is brick arched and is 0.86 m wide and 0.48 m high.³ The Chelsea Speleological Society Survey shows that the culvert turns southeast. It then runs in a straight line to an abrupt drop in roof level 19.8 m from the entrance (figure 4). Photos of the roof drop show that the next section is also brick vaulted. The bricks look eighteenth or nineteenth century and have limescale and a black deposit on them. The culvert then bends towards the east. The culvert was crawled by Roger Browne in 1999. He found that the floor is covered with soft mud and that the brick often had a white deposit on it, presumably limescale.

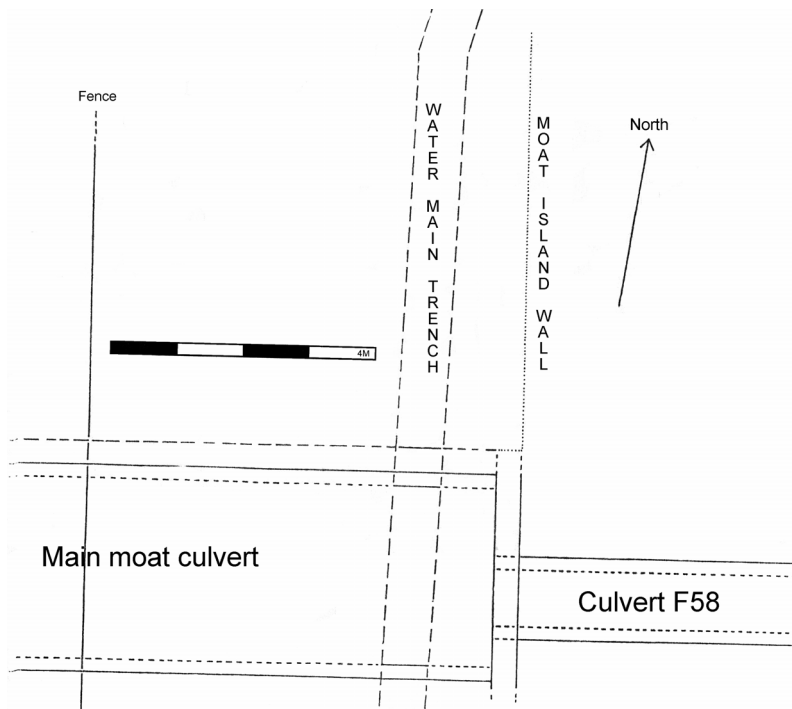
Figure 3: the junction main moat culvert and feeder culvert F58 and the south-east corner of the moat island. From a plan by Clive Orton, 1979.

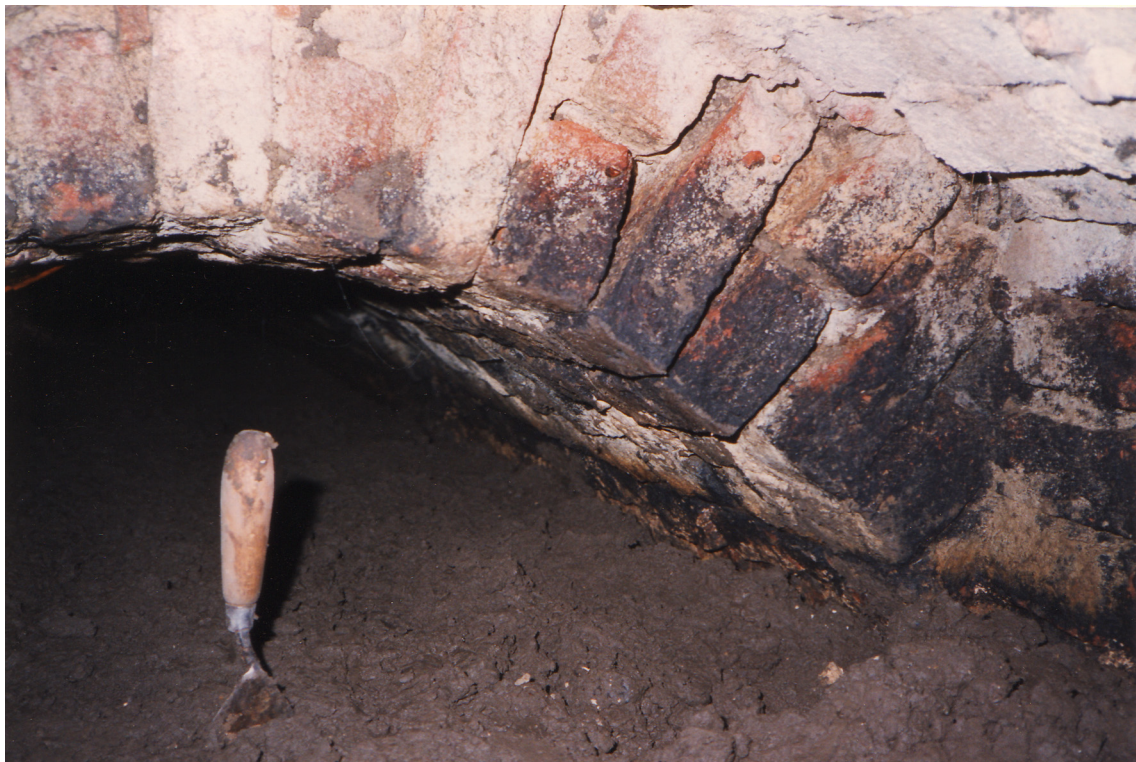
Figure 4. The drop in the roof of culvert F58. (Photo Roger Browne.)

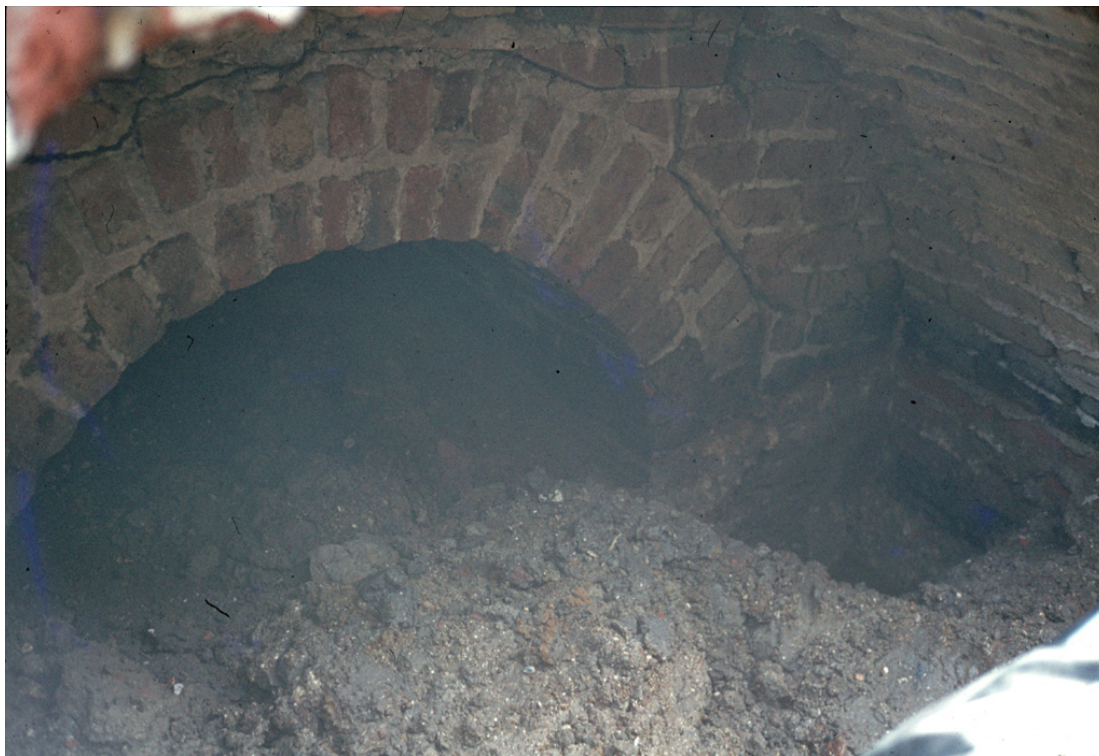
Figure 5. Culvert F58 entering the east end of the main south moat culvert.

this wall. The end of the culvert and the wall (figure 5) were fairly neatly made although there is some peg tile packing at the top of the arch and some areas which have not been properly pointed so the mortar has spread over the brick. It seems likely that culvert F58 is earlier than the main culvert and that the wall was constructed to retain the fill of the east arm of the moat.

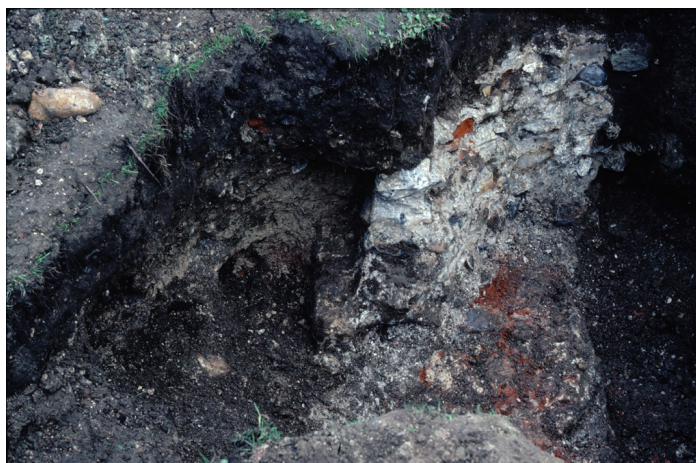
Figure 8. The wall in trench AA looking west.

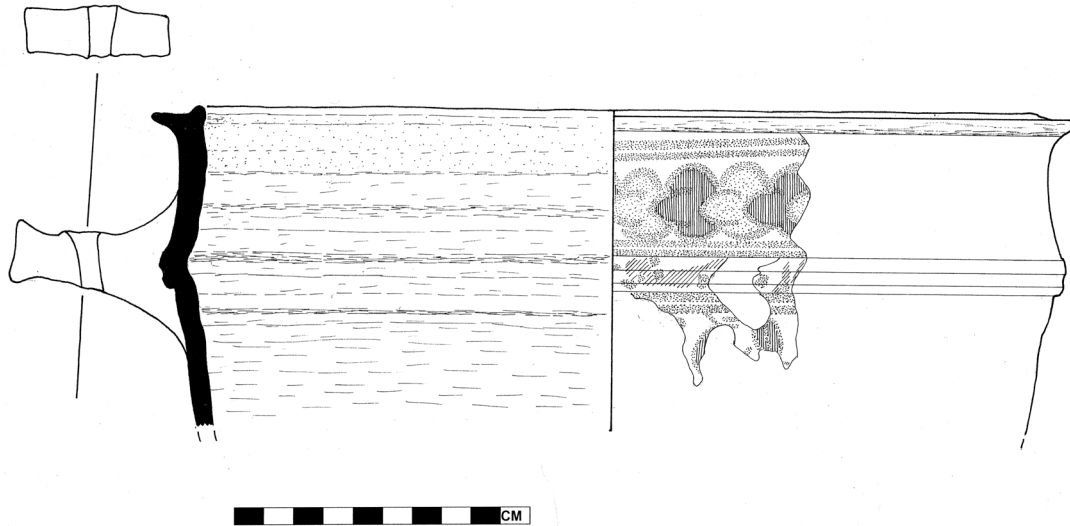
Figure 11: the tin glazed hanging flower pot above, drawn by Clive Orton, and photographed below

Workmen found part of a tin glazed pot in the lower part of the trench. It was originally about 280 mm in diameter with a flat rectangular handle projecting from the side. The handle was pierced for suspension. The outside was decorated with blue, green, yellow and white tin glaze (figure 11). The form is unusual and may be part of a hanging flower pot. Tin glaze of this type was made in Antwerp or the south Netherlands in the late sixteenth and early seventeenth centuries but could equally have been a product of one of the two tin-glaze kilns that are known to have operated in Norwich and Aldgate, London in the sixteenth century.⁶

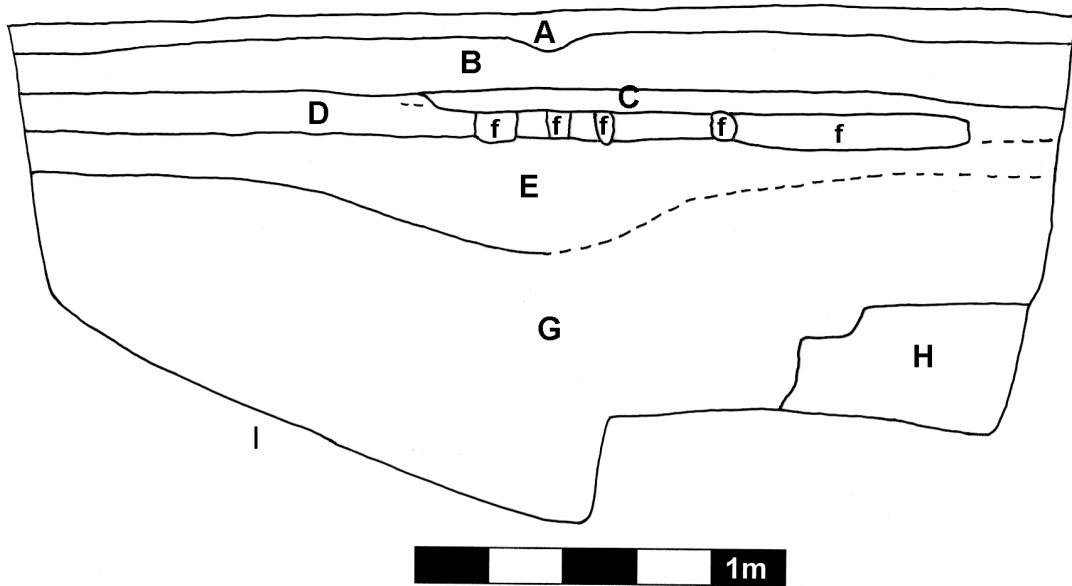
Figure 14. The north side of trench CI.

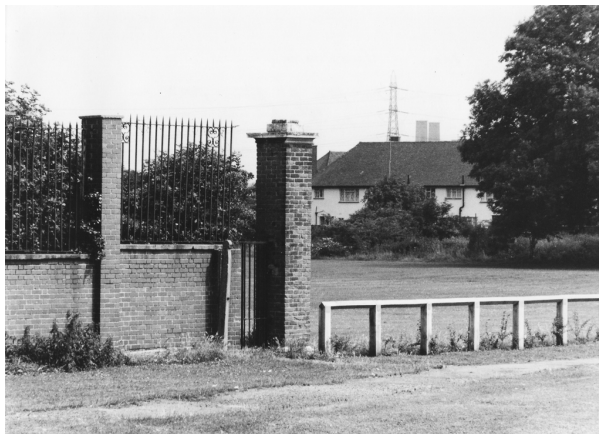
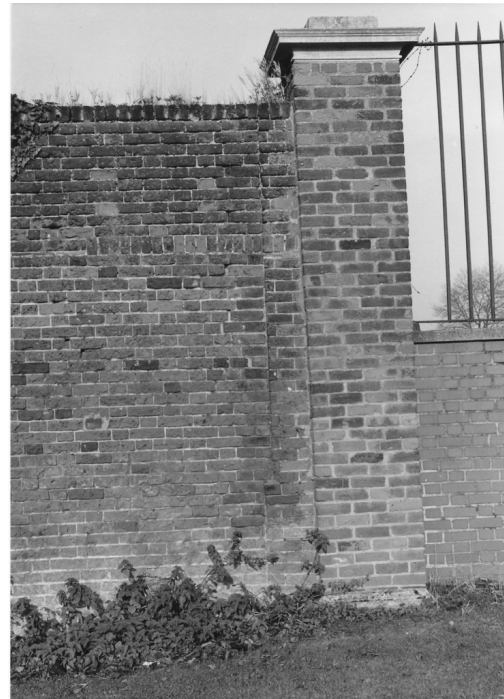
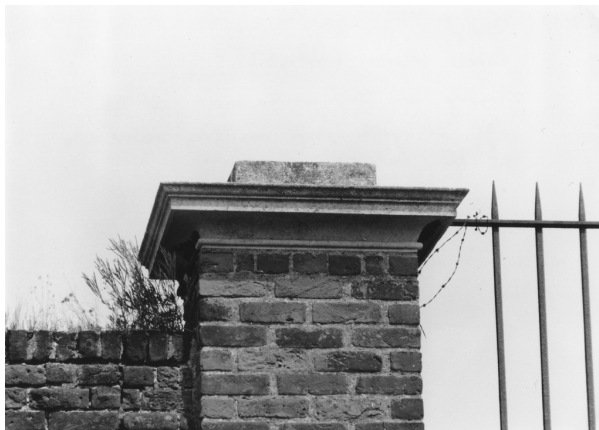
Figure 18. The north gates. Top left: the eastern pier, 1985. Above: the western pier, 1986. Bottom left, the capping on the western pier, 1985.

bases shown in figure 18. The caps have the bases for an urn or other finial. The gate has been replaced by a brick wall capped by railings which are clearly no older than the late nineteenth century. There was a bond break in the walls close to both piers suggesting that the gate had been inserted into an existing wall.

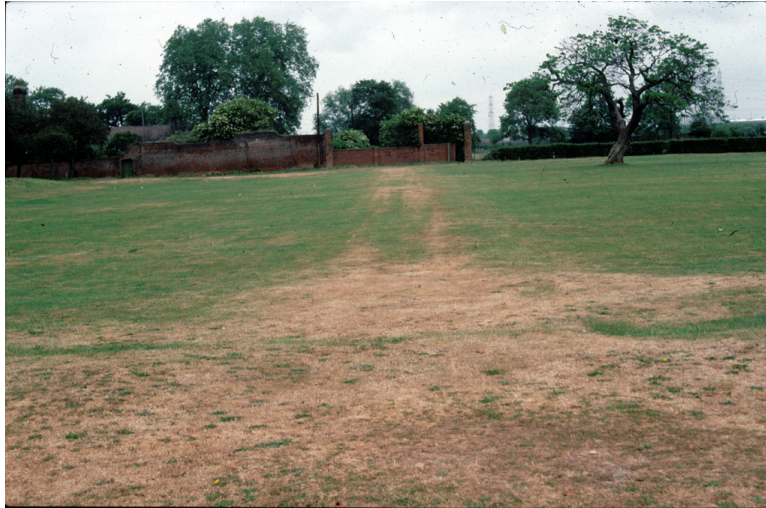
Figure 24. The cross drive burnt out on the east lawn. The site of the north gates in the background.

The northern and southern gates were connected by a north-south cross track. This is clearly marked on the 1820 enclosure award and subsequent maps down to 1956 (figures 63 and 24). The line is now marked by a clear ridge across the lawn which turns brown in dry weather. This appears to be a late resurfacing: probing the grass shows that the gravel is wider than the ridge.

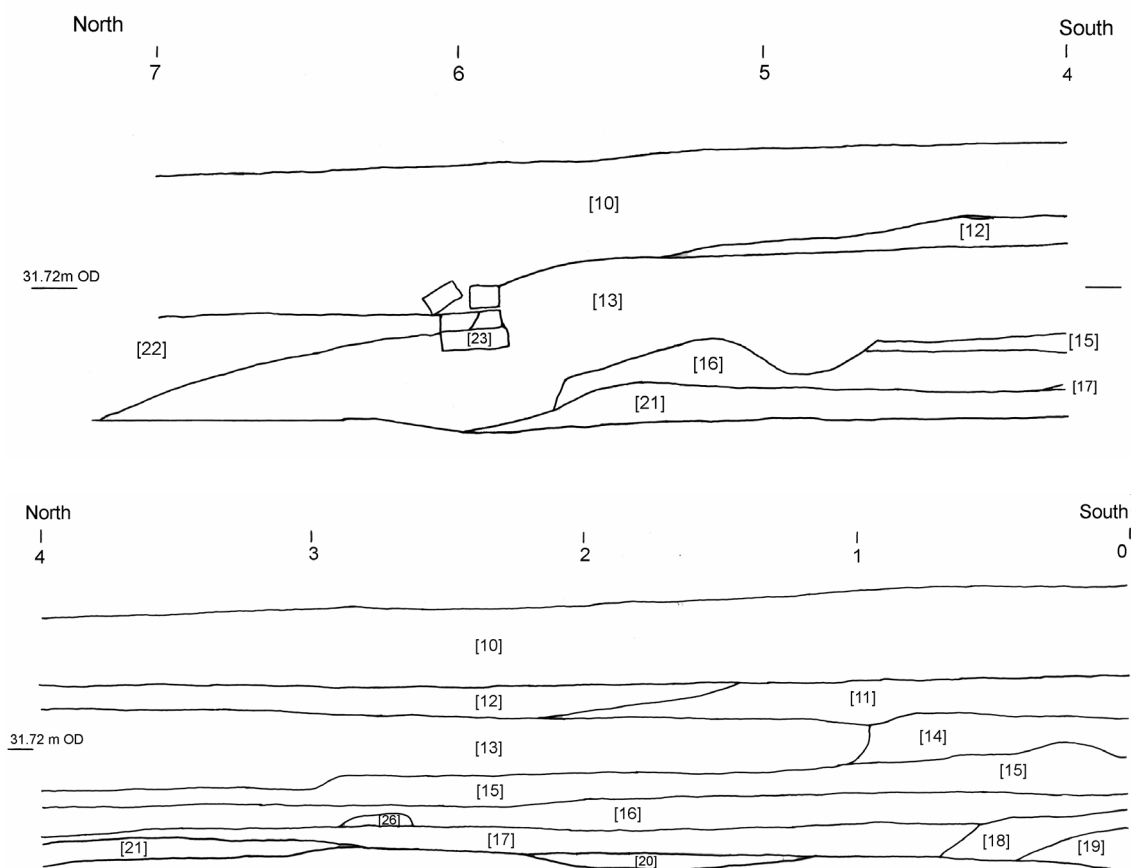
Figure 26. The east side of contractor's trench AJ. Northern part with wall of east lake above and southern part below. Scale along the top in metres.

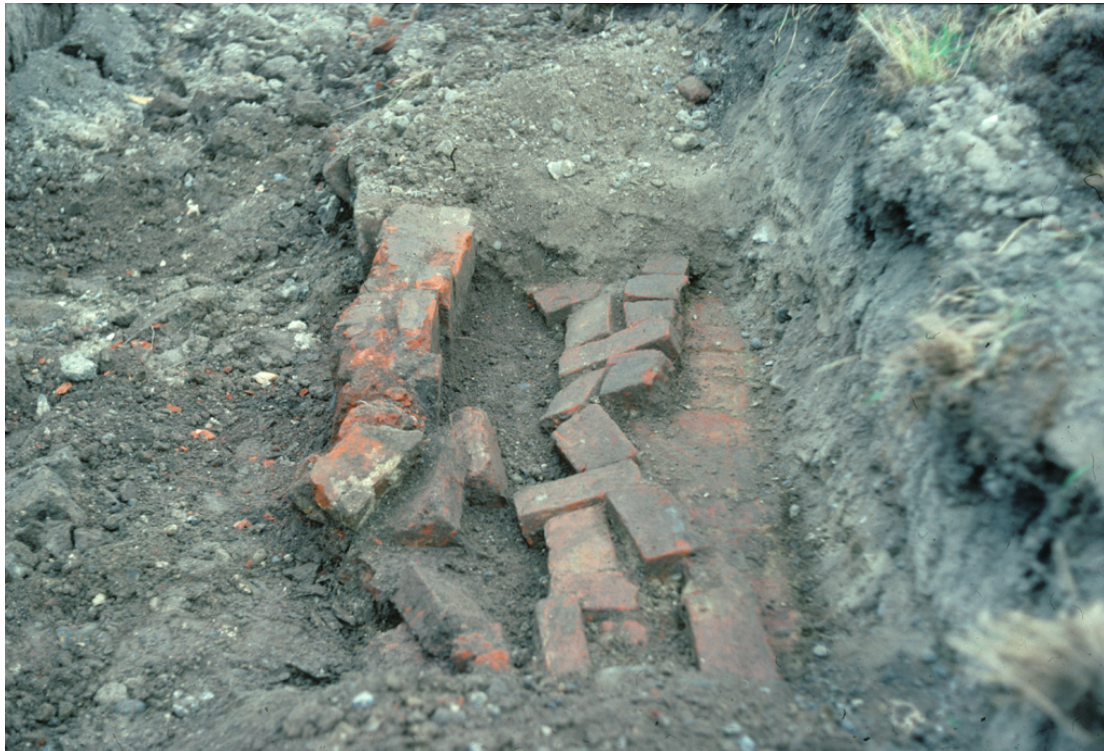
Figure 27. The southern lakeside wall exposed during flood alleviation work in 1990.

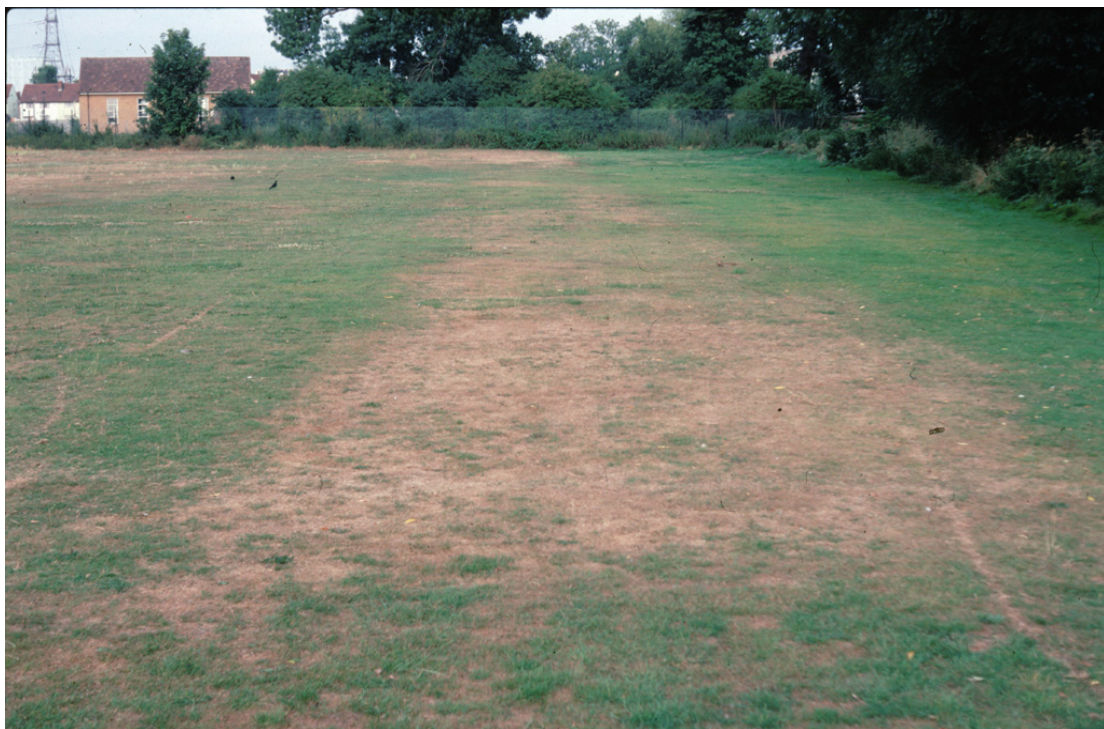
Figure 28. Scorch mark on the grass on the north side of the river probably marking the walk along the north side of the east lake, June 1989.

In June 1989 a very clear scorch mark appeared on the grass on the north side of the Wandle (figure 28). At the east end, close to the site of the former cascade, it was 17.5 m from the river.

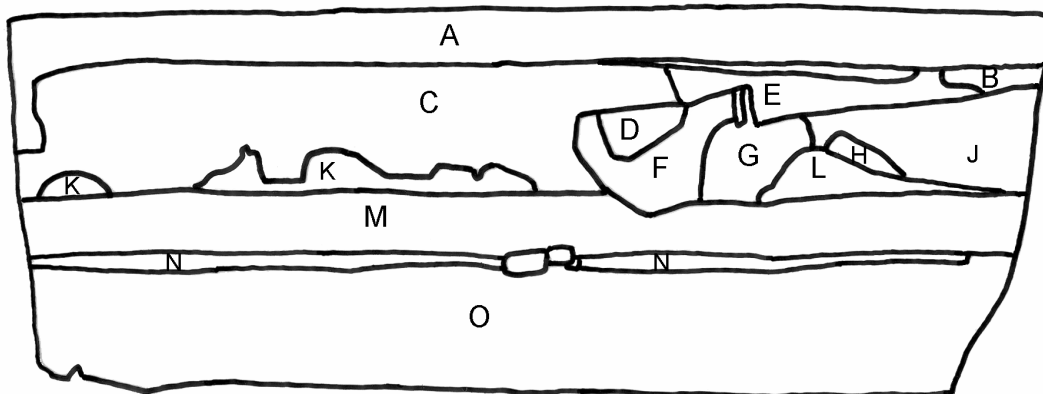
Figure 34. Section drawing of trench CM.

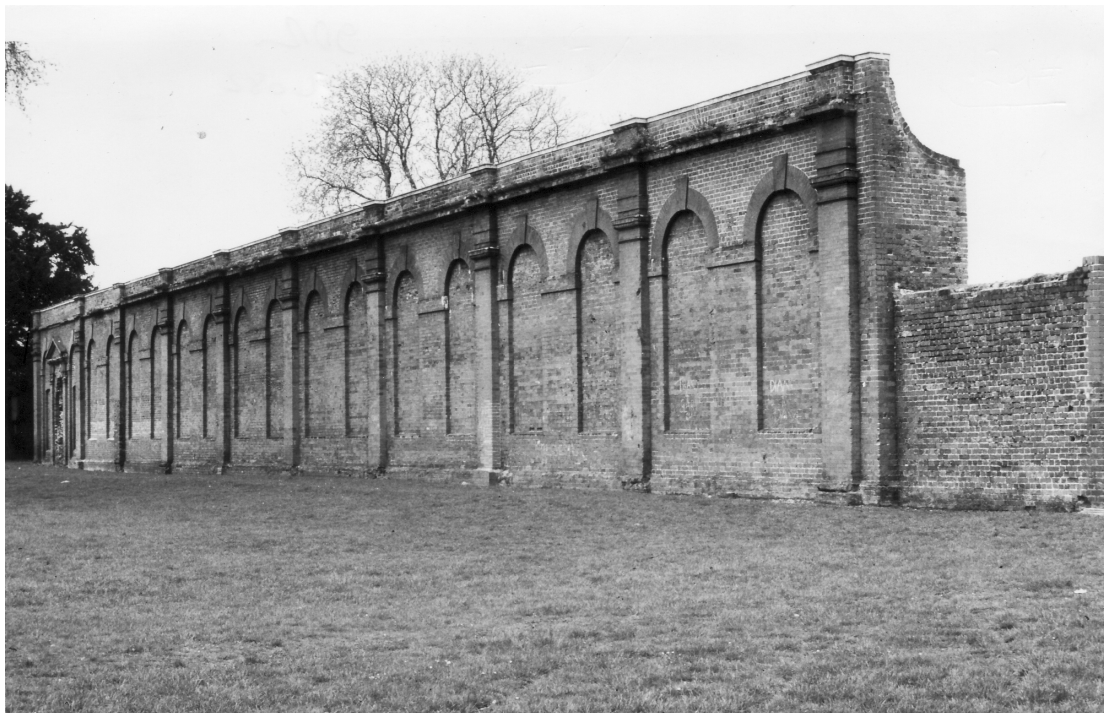
Figure 36. The north side of the Orangery wall from the west end.

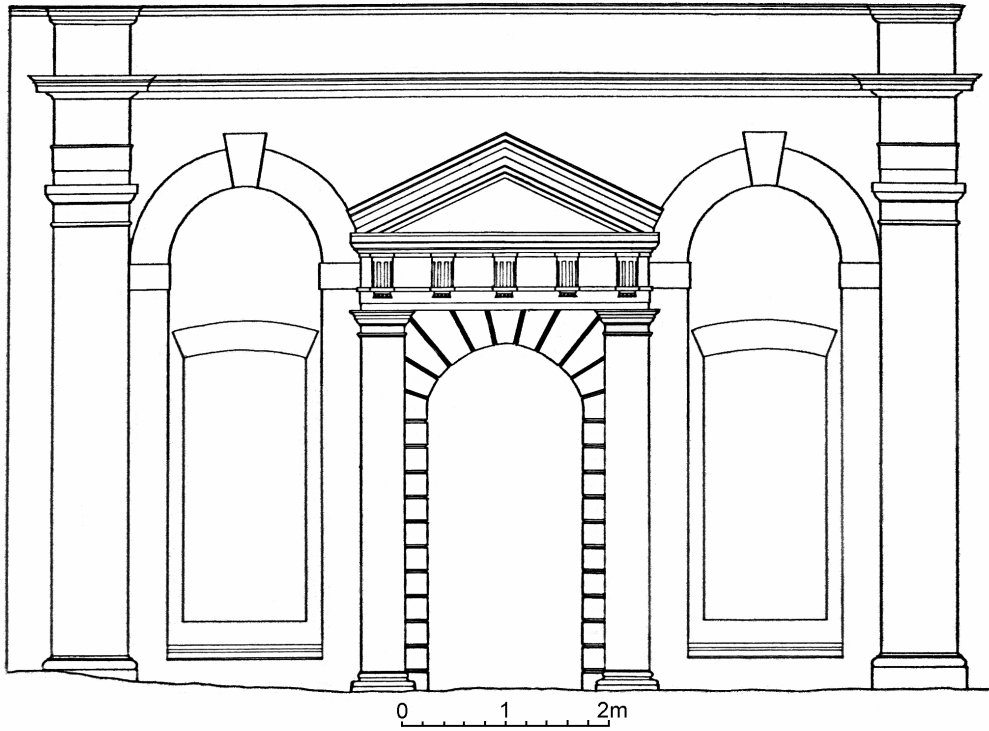
Figure 37. Reconstruction drawing of the Orangery wall bay 1.

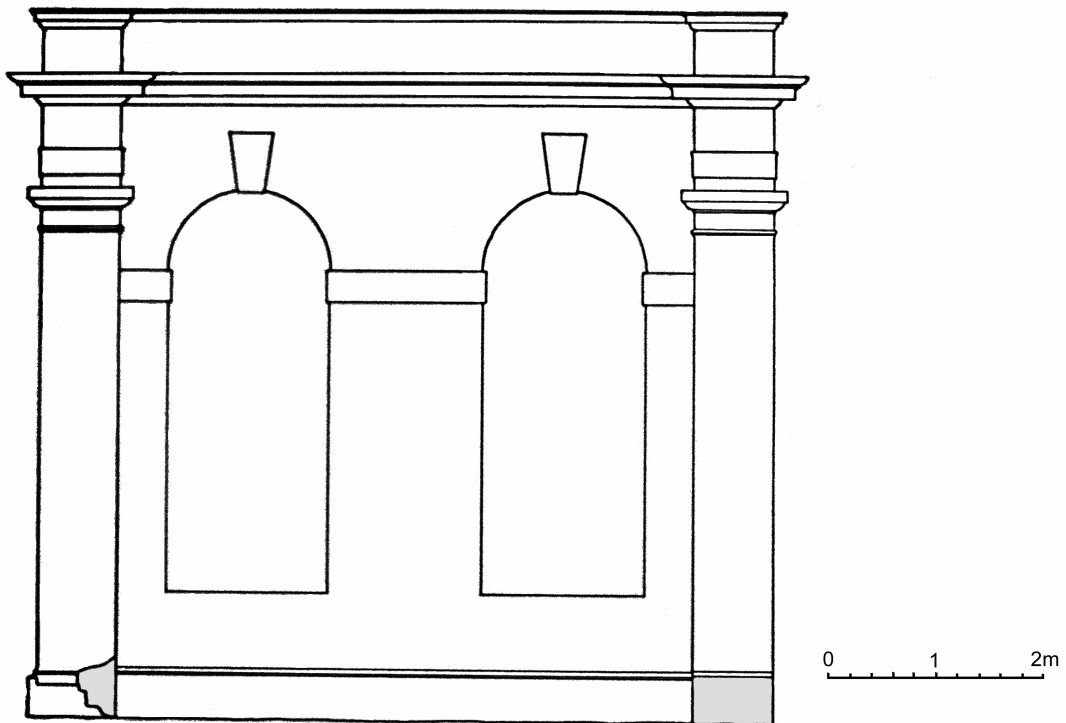
Figure 38: The Orangery wall bay 7. The grey areas are damage or poor repairs.

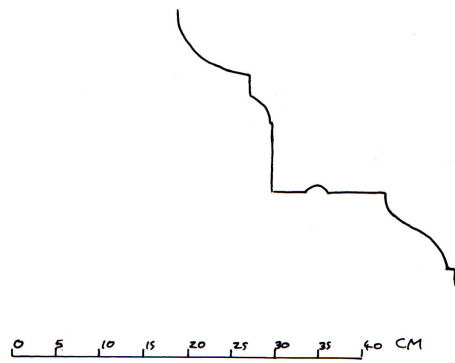
Figure 39. The Orangery wall bay 7, profile of the cornice.

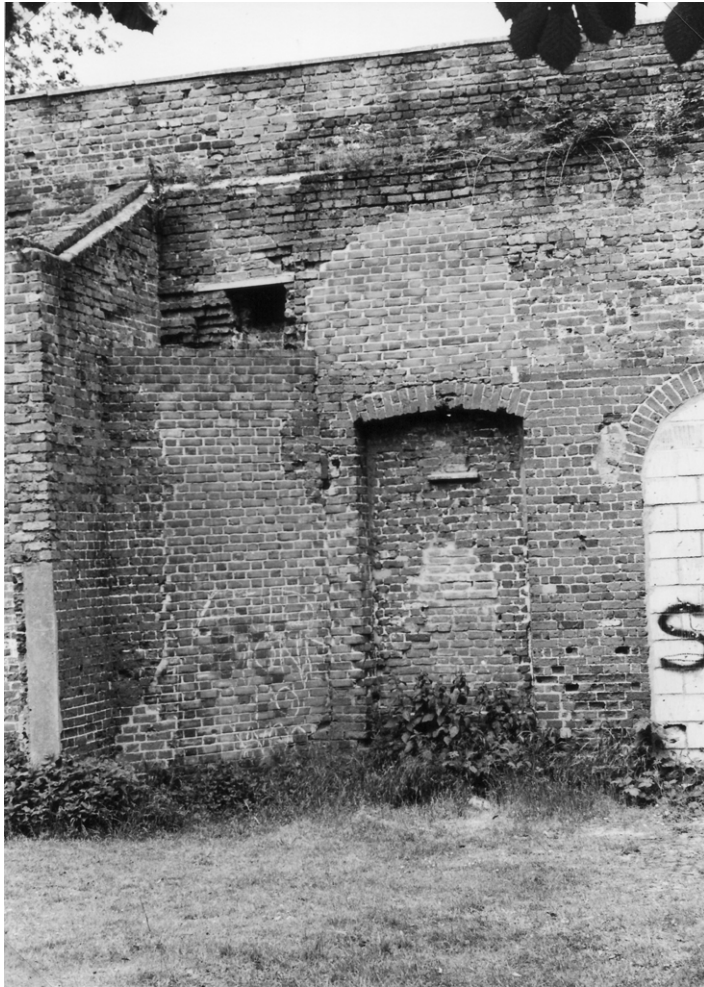
Figure 49. The fireplace and flue in the north-west corner of the building at the east end of the wall.

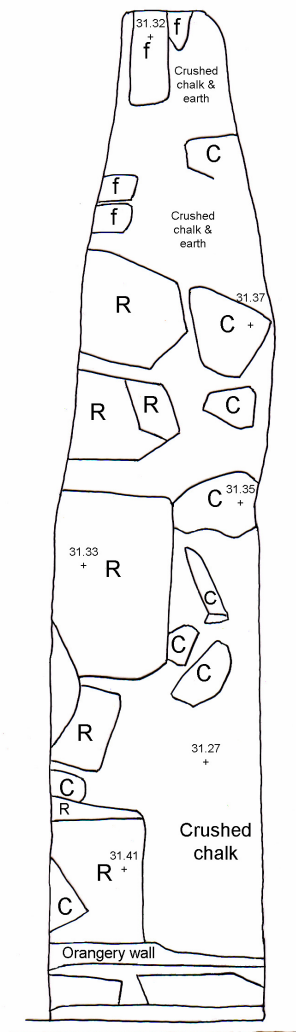
Figure 53. The stone on the bottom of trench CQ.
 C = chalk, f = flint, R = Reigate stone. Heights in m OD

When [CQ4] had been removed a line of stone blocks was exposed as shown in figure 53. There were five main blocks, all of Reigate stone, forming a line along the west side of the trench and a number of small pieces of Reigate stone and chalk to the west and north of them [CQ5]. The deposit around them consisted of crushed chalk and earth [CQ6]. Two pieces of white ware were found in [CQ4] close to the line of Reigate stone blocks. The first <1> was on the top of the second block from the Orangery wall. It was from the base angle of a pot with a distinctive pale pink fabric with pink quartz. There were splashes of yellow glaze on the base and sides which had gone green around the edges of bubbles and defects and there were also prominent throwing ridges on the interior. The sherd had been slightly burnt and there was some soot on the bottom but it had not been heated enough to damage the glaze. The second piece <2> was found immediately east of the third block and level with the top. It is a wall sherd. The fabric was similar to <1> and with a splash of yellow glaze but no sign of heating. The fabric and glaze appears to be identical with an alembic top found in trench CF. The fabric is locally uncommon and it seems likely that they all came from a set of distilling equipment.

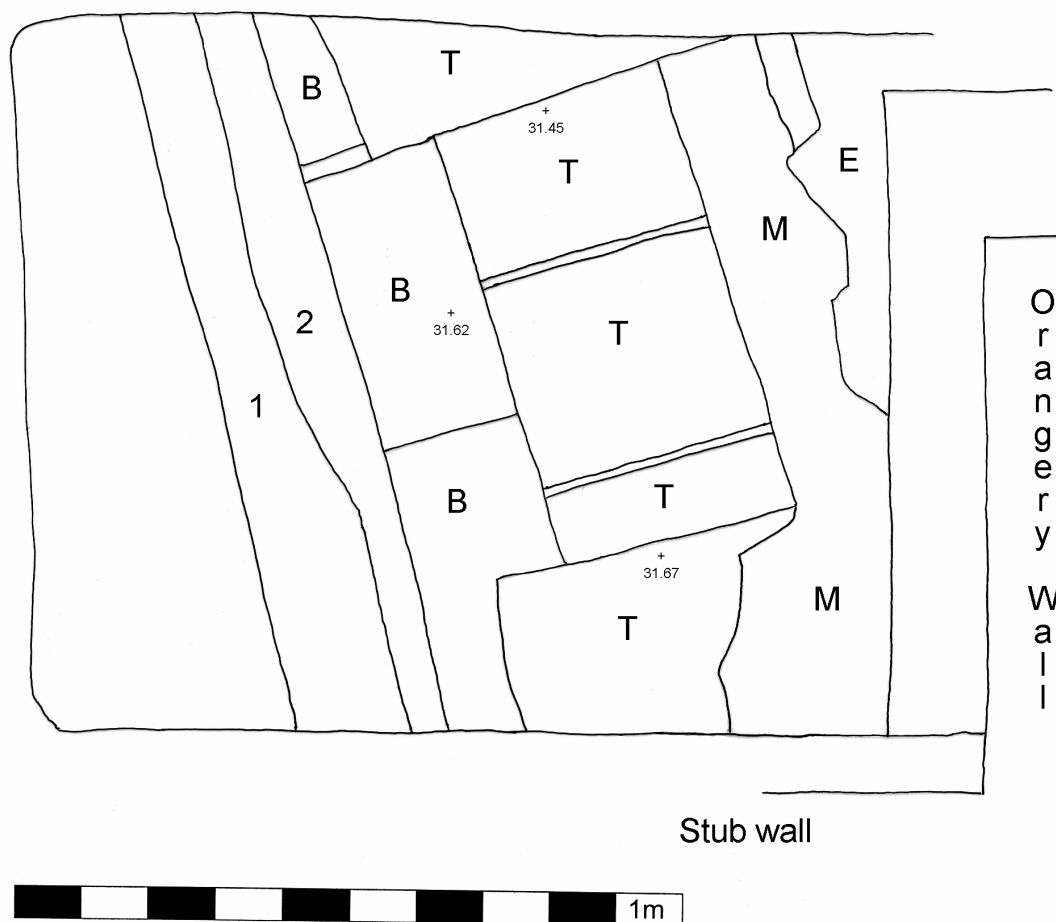
Figure 54. The top of the drain in trench CR.
 B = brick, E = earth, M = mortar, T = peg tile
 1 = Brown soil with occasional flecks of chalk
 2 = Slightly darker brown soil.
 Heights are in m OD. North at the top.

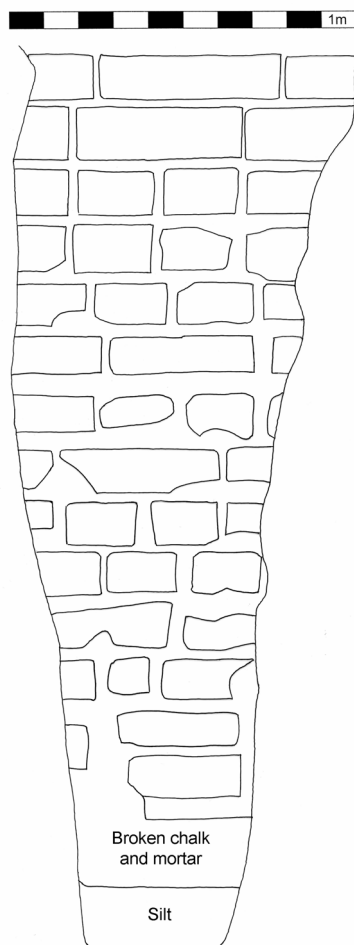
Figure 55. The foundations of the Orangery wall in trench CP.

The wall footings in trench CP are shown in figures 55 and 56. The wall foundation widened by an offset was at 32.04 m OD about two courses of brick below the surface. There were 12 courses of brick below this with a total height of 0.92 m. The foundation widened by a further four irregularly spaced offsets of varying width as shown in drawing 55. The brick rested on broken chalk and mortar at 31.12 m OD. This went down a further 0.11 m and rested on dark silt. The brickwork above the top of the offset was tuck pointed. There was no pointing below this and the bricks were carelessly laid.

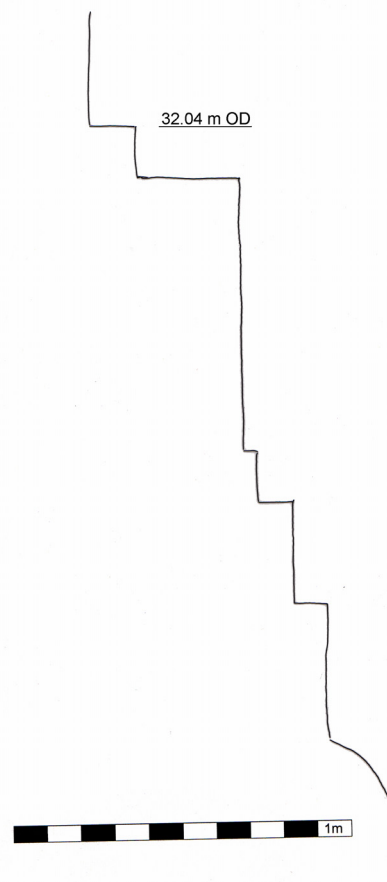
Figure 56. Section of the foundation of the Orangery wall in trench CP

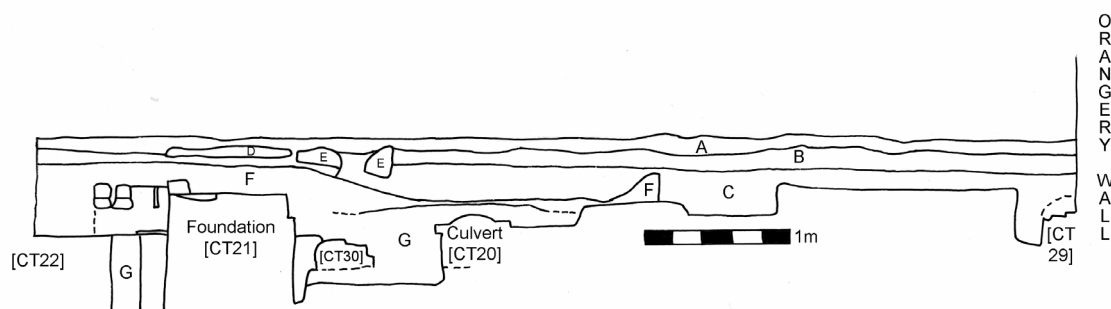
Figure 57. The west side of trench CT. A = Top soil; B = Soil; C = Soil; D = Ceramic building material; E = stone; F = Gravel; G = Dark silty soil.

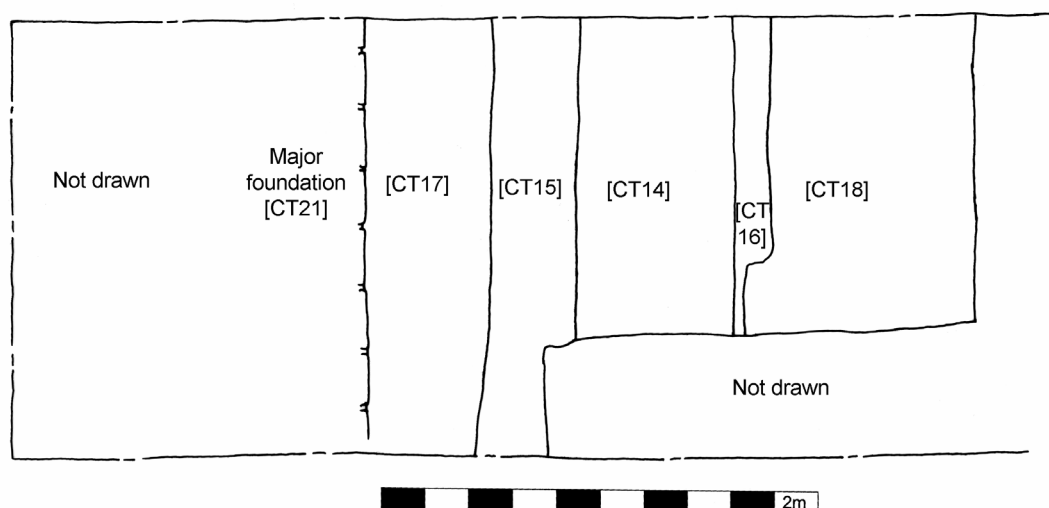
Figure 58. The deposits within the Orangery above the culvert [CT20] and the wall [CT30]. North to the right.

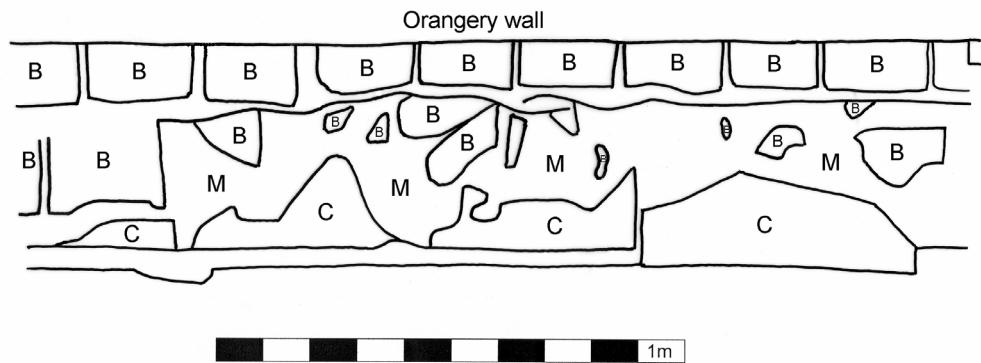
Figure 60. Plan of foundation [CT29] on the south side of the Orangery wall.
B = Brick; C = Chalk; M = Mortar.

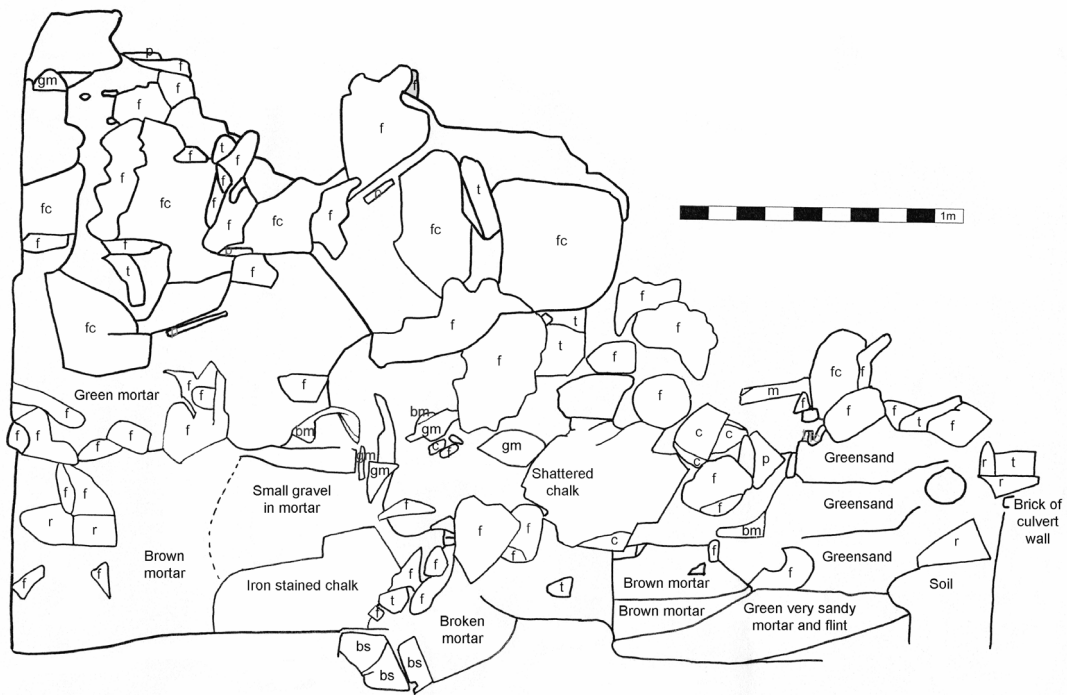
Figure 75. Drawing of the interior south wall.

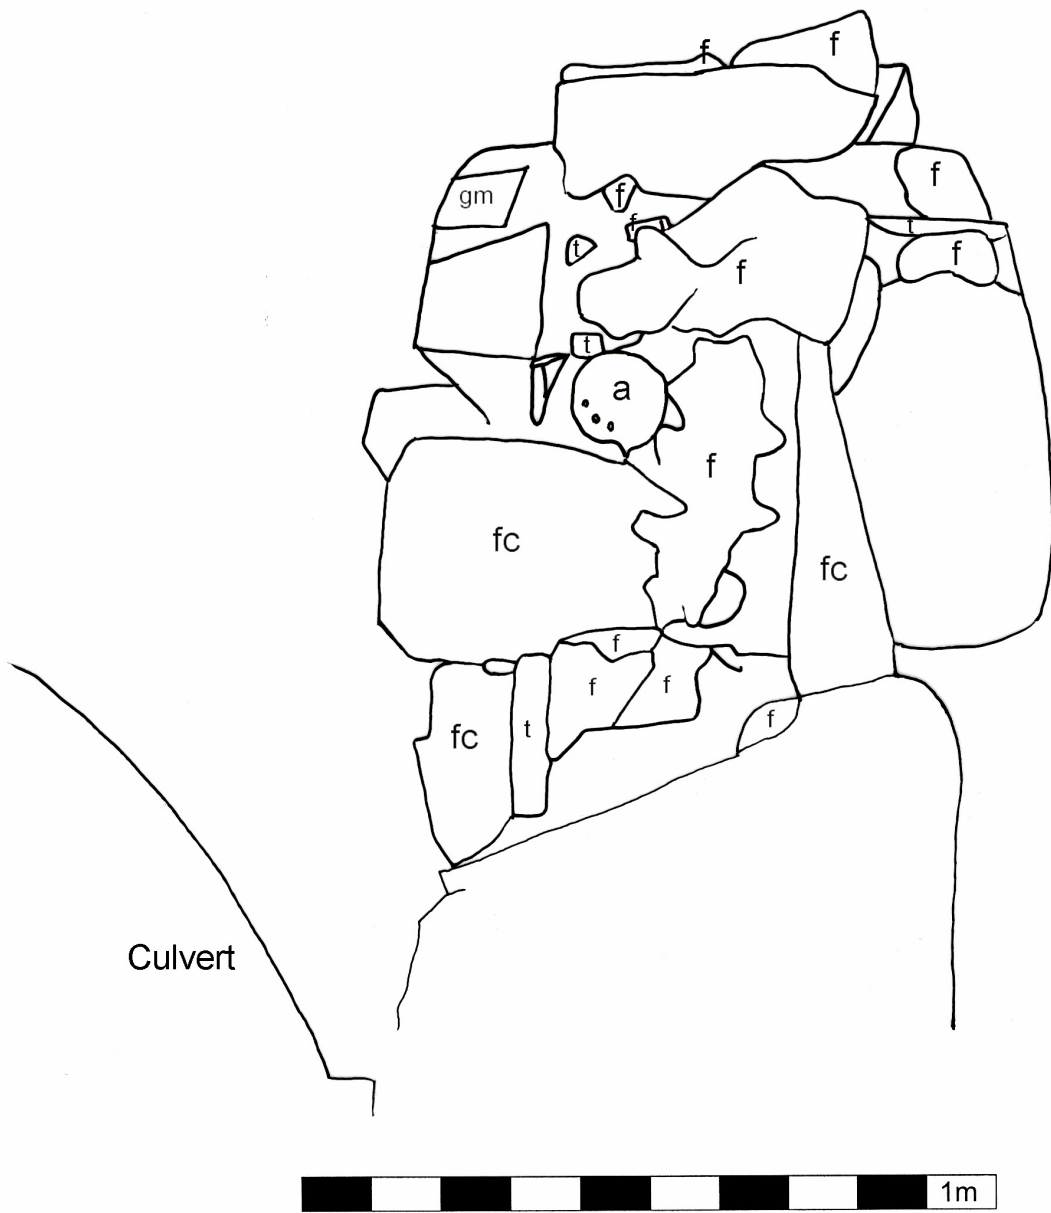
Figure 76. Drawing of the interior east wall.

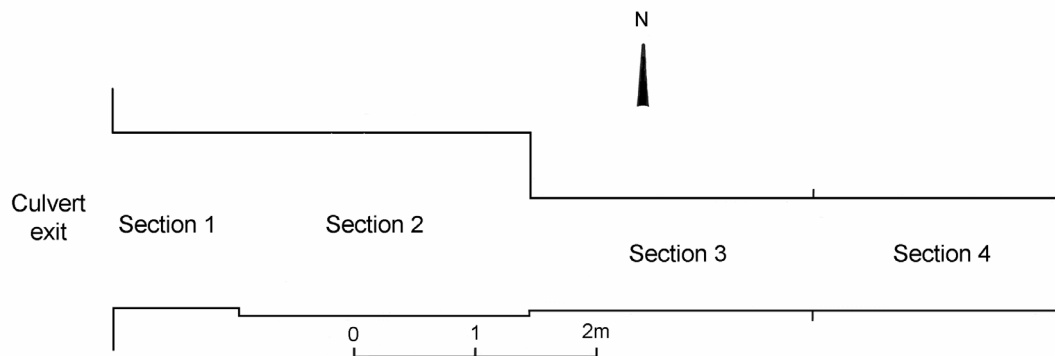
Figure 79. Plan of the culverts in trenches CU and CW.

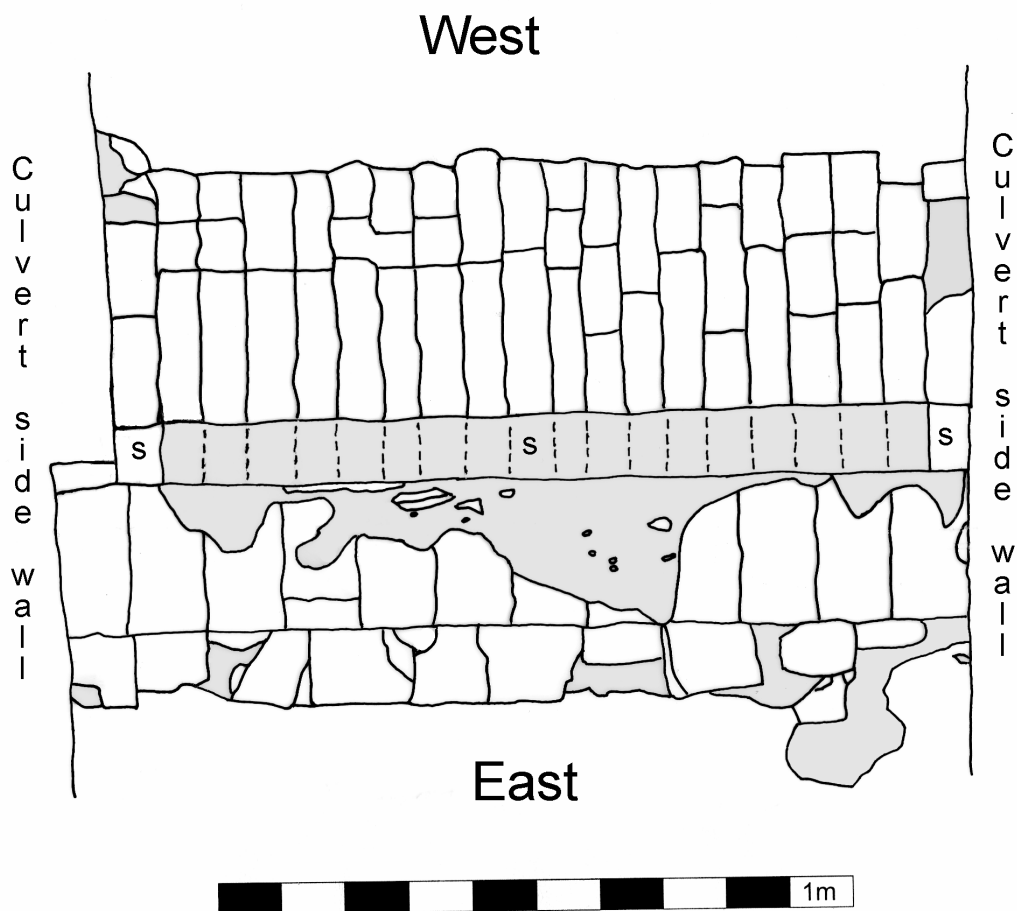
Figure 81. Plan of the slot in the floor at the beginning of culvert section 1. S S S = slot. Grey = mortar.

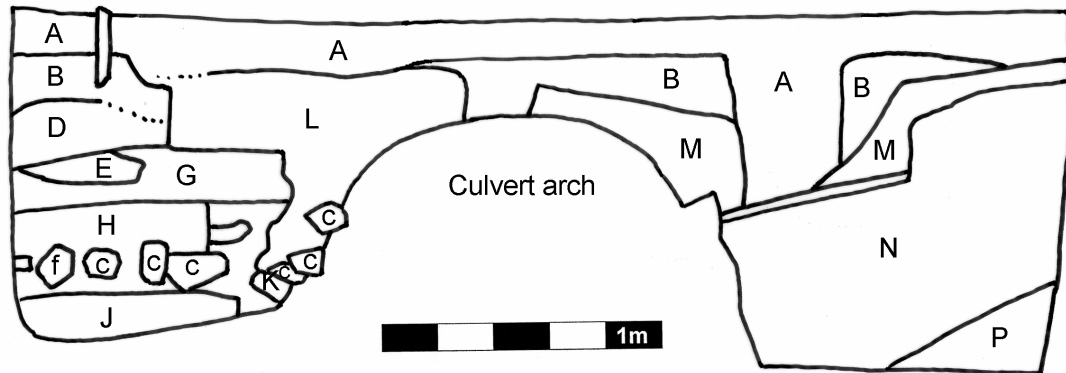
Figure 89: The east section of trench CW

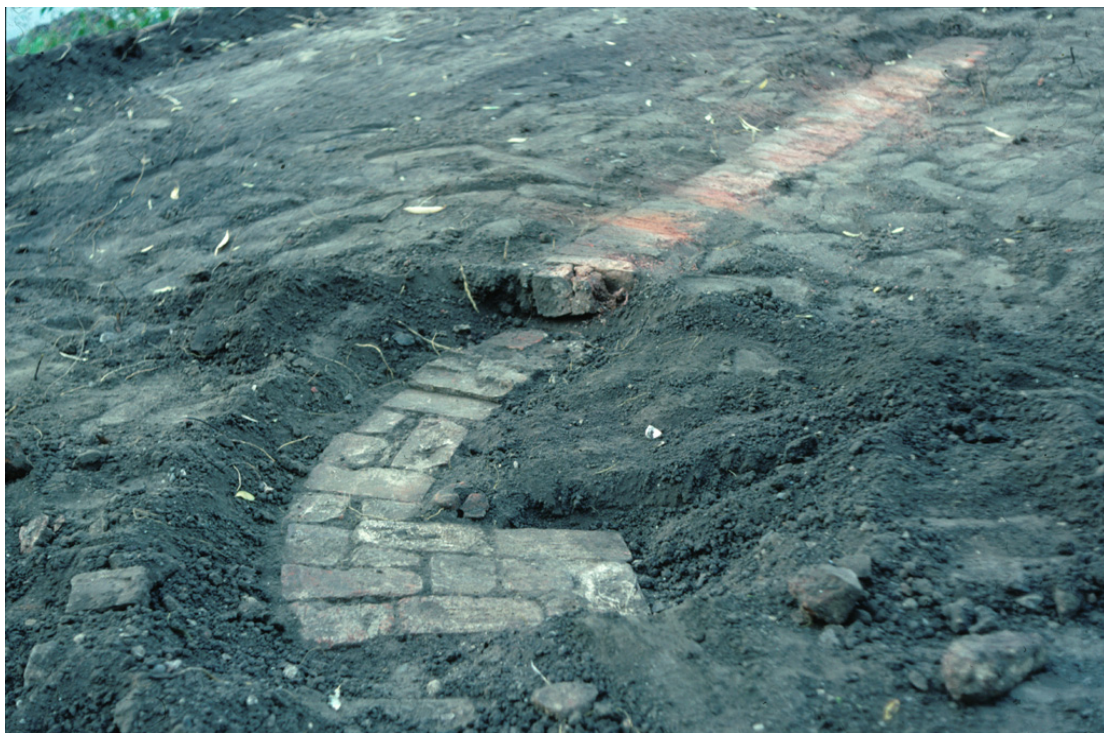
Figure 99. Foundation of a retaining wall on the east side of the channel at the exit from the east lake. Looking north-west during the flood alleviation work in 1990-1.
