# **The orangery at Carew Manor, Beddington**

A history of the orangery, a report on a survey of the wall in the 1980s and on excavations on the north and south sides in 1998 and 1999.

**John Phillips**

Carshalton & District History & Archaeology Society  
Occasional Paper Number 4  
2013

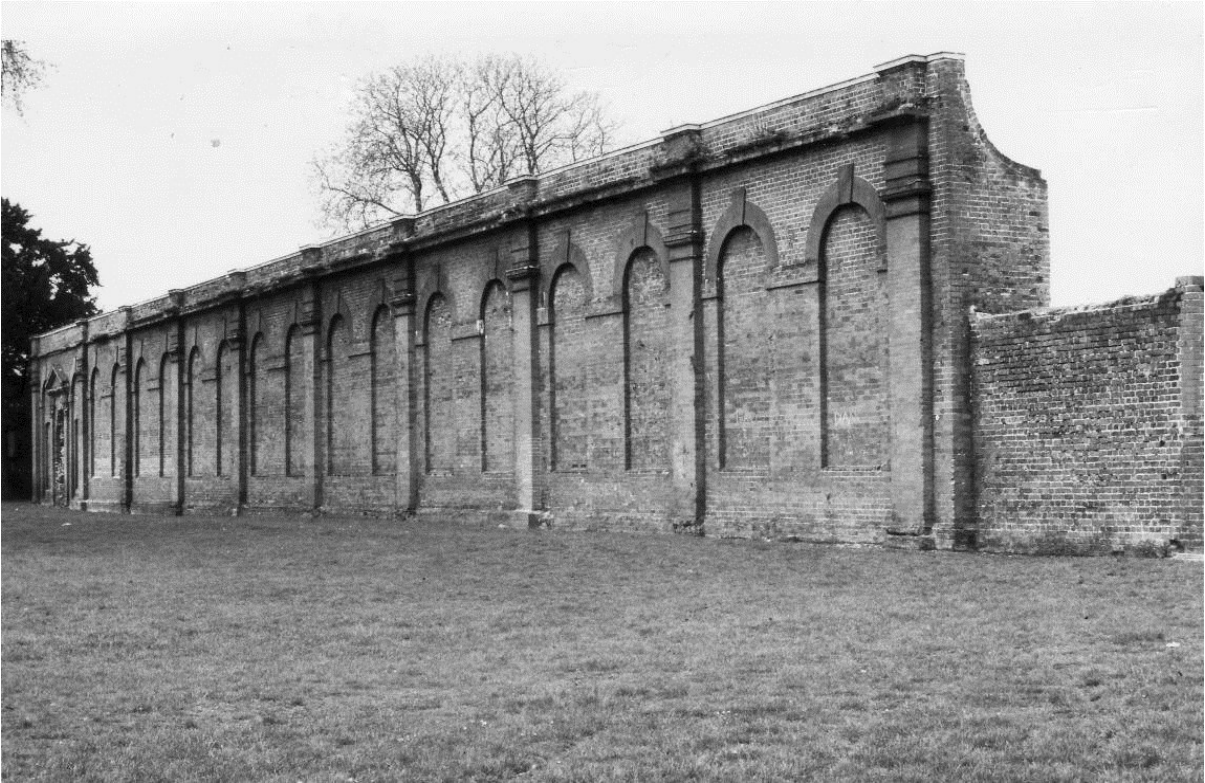
Figure 2. The north side of the orangery wall from the west end.

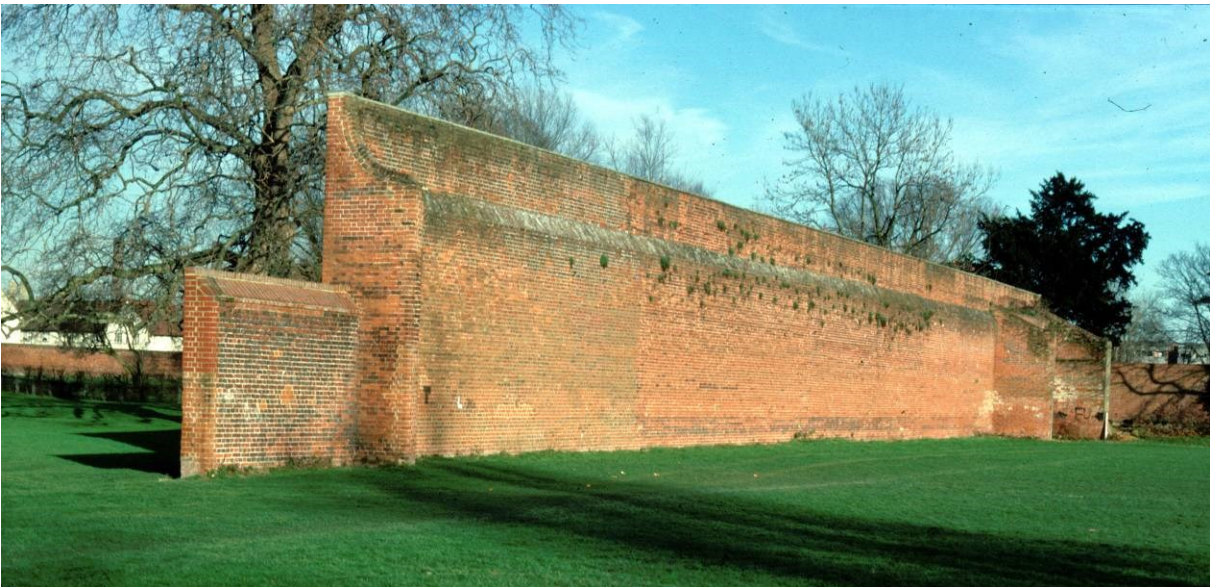
Figure 3. The south side of the orangery wall from the west end,

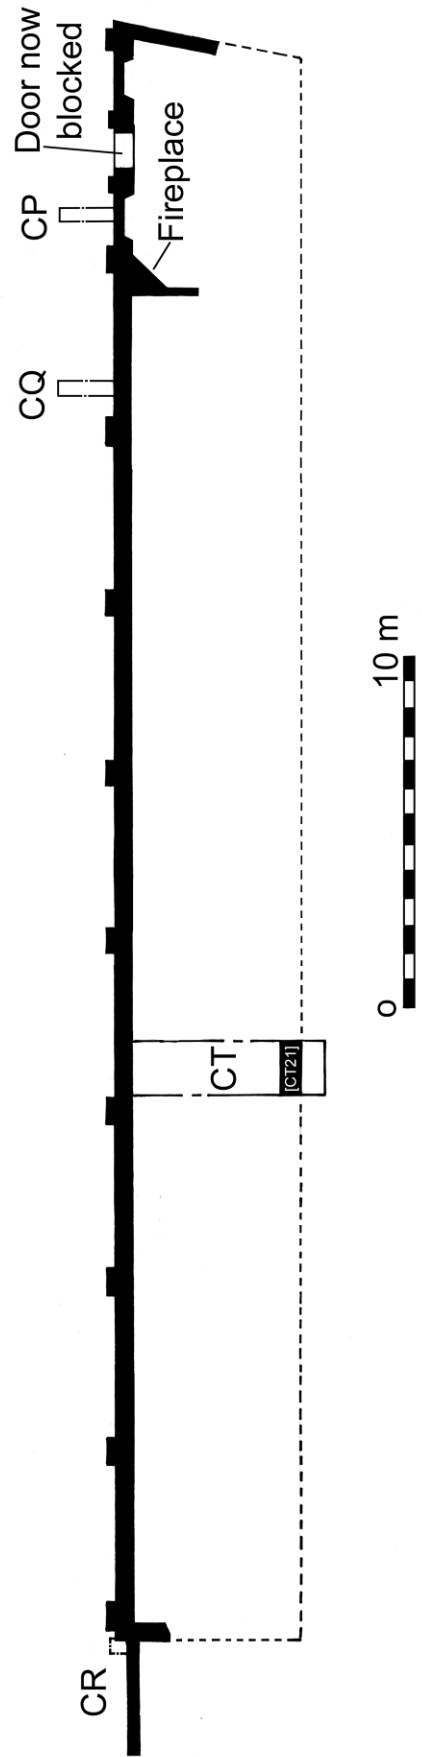
Figure 4. Plan of the wall showing the location of the trenches. North at the top.

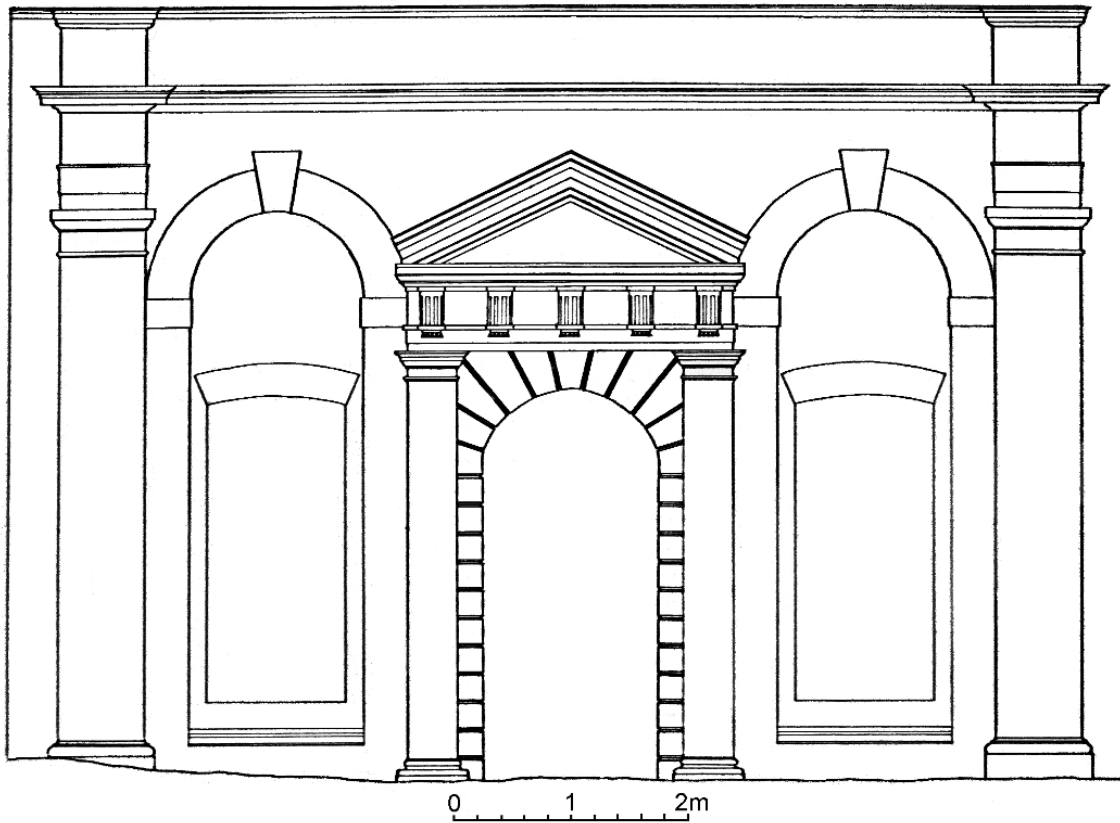
Figure 5. Reconstruction drawing of the orangery wall bay 1.

The whole wall is now in a poor condition but it was in a better state in the 1980s when it was drawn and the mouldings reconstructed on paper (figures 5-11).

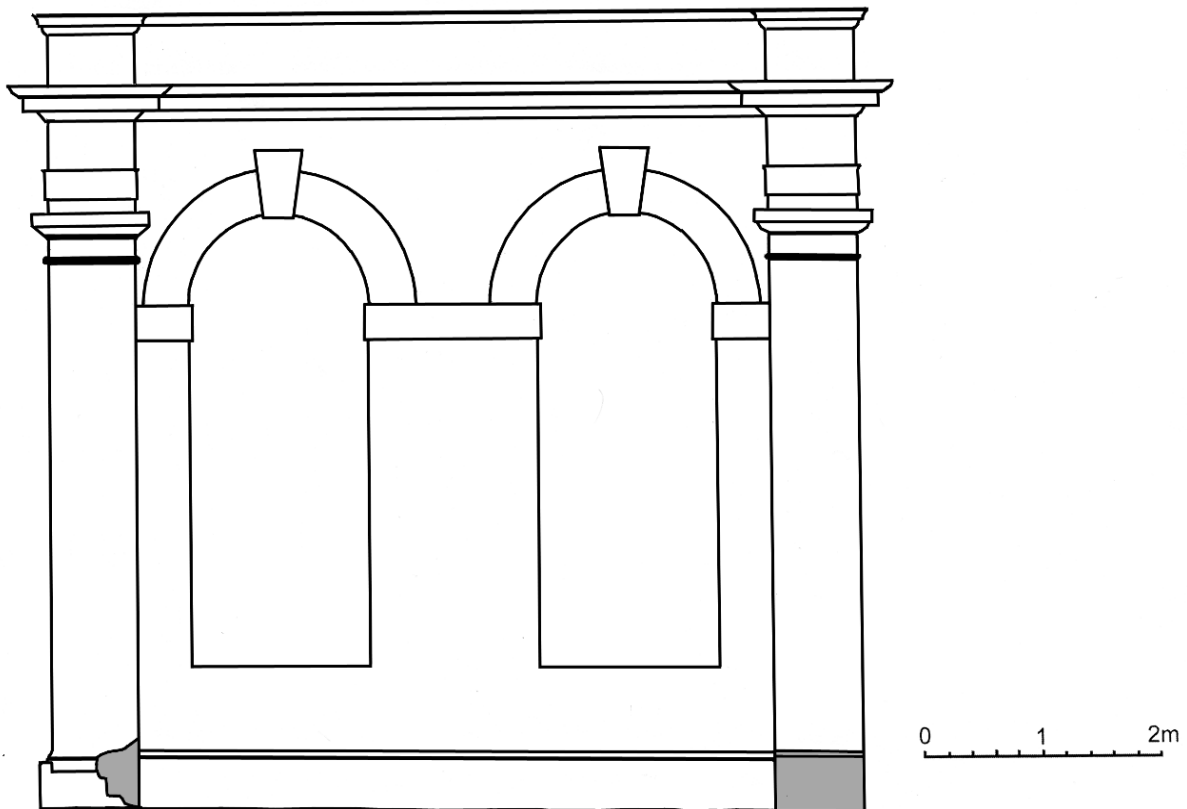
Figure 6. The orangery wall bay 7. The grey areas are damage or poor repairs.

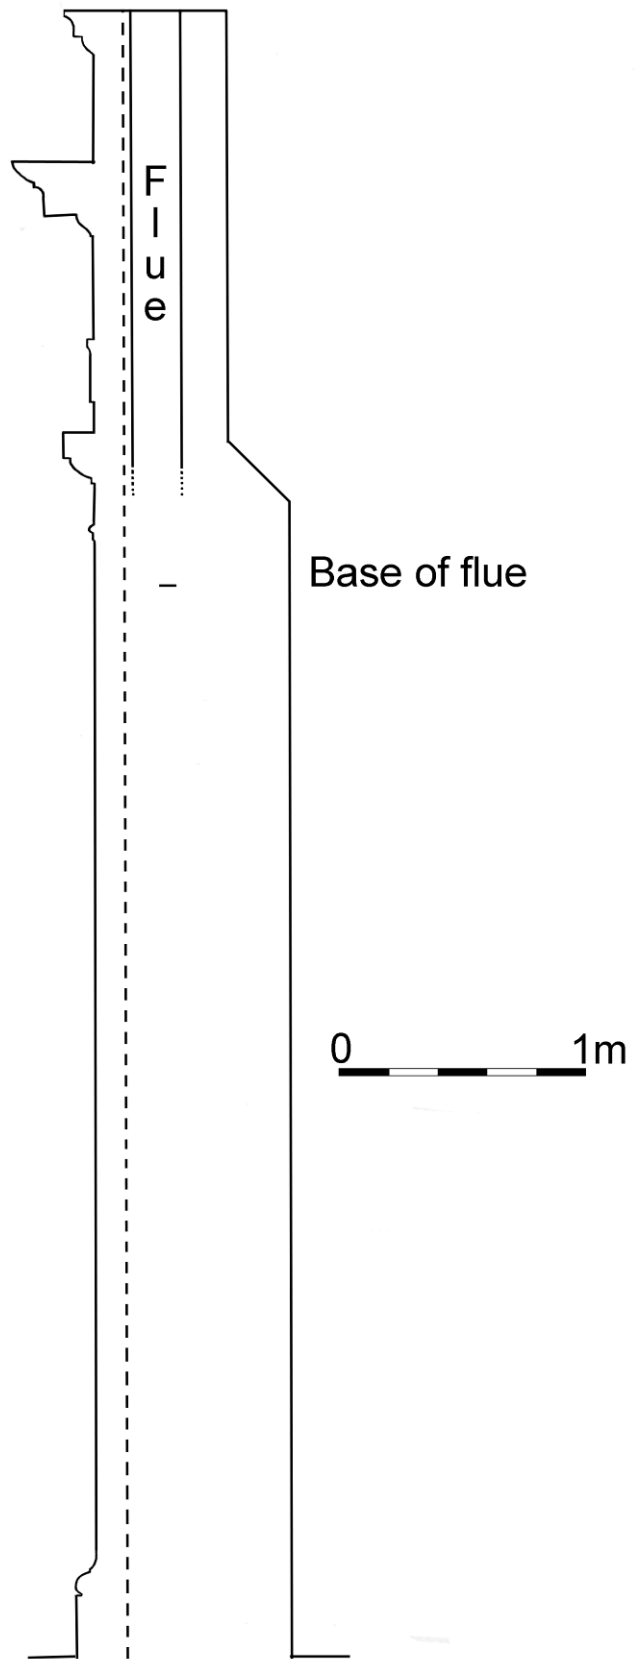
Figure 7. Section through the wall at the west-most pilaster.

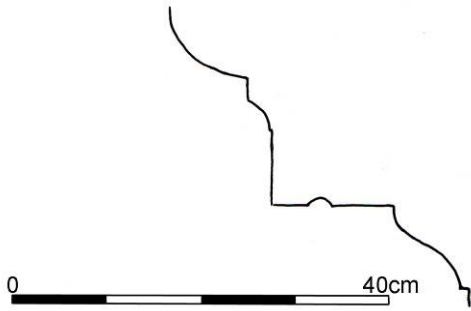
Figure 8. The orangery wall bay 7, profile of the cornice.

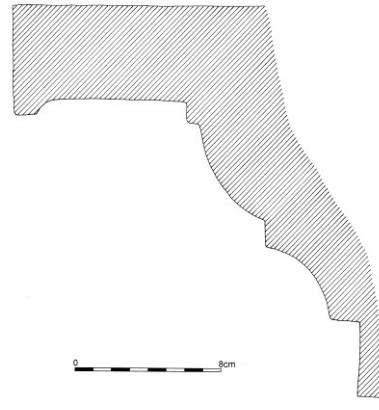
Figure 9. The orangery wall bay 1, The moulding on the bottom of the pediment over the door.

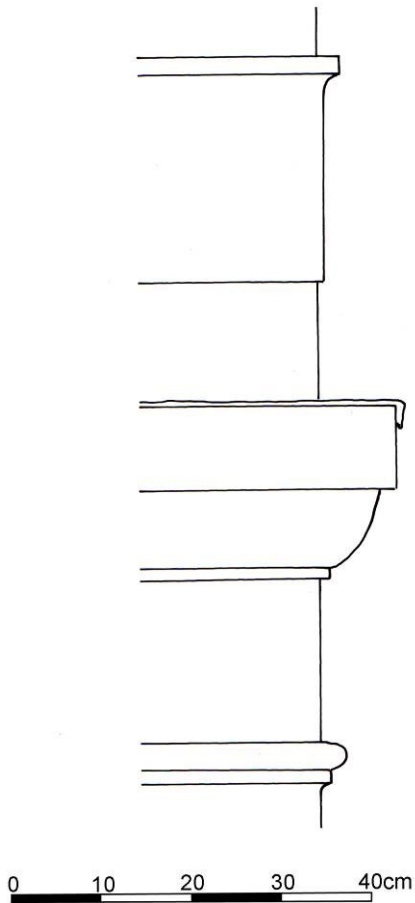
Figure 10. The orangery wall, capital moulding on pilaster 1.

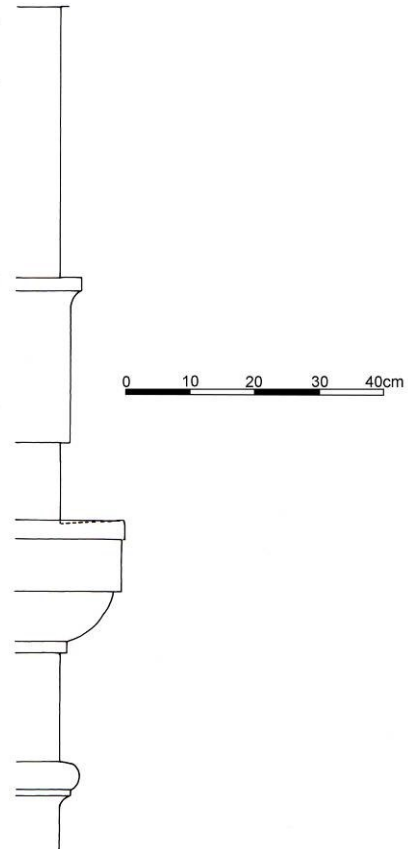
Figure 11. The orangery wall, the moulding at the top of pilaster 7.

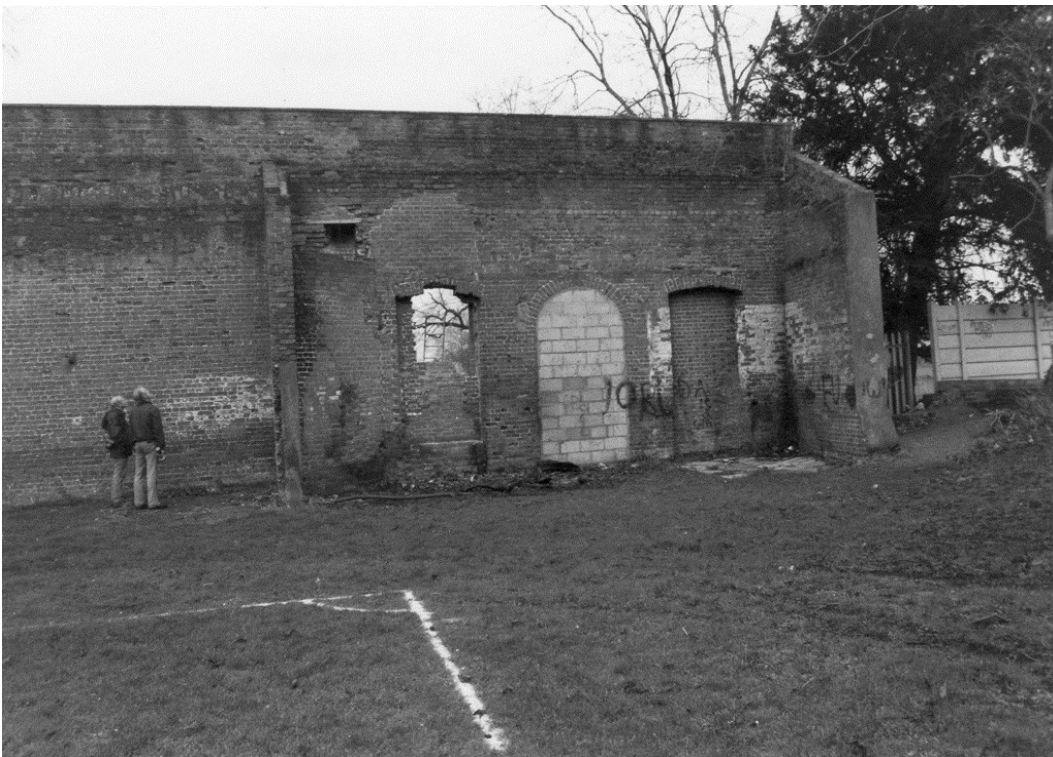
Figure 14. The south side of the east end of the wall on 10 January 1988. The blocking of the western window has been partly demolished.

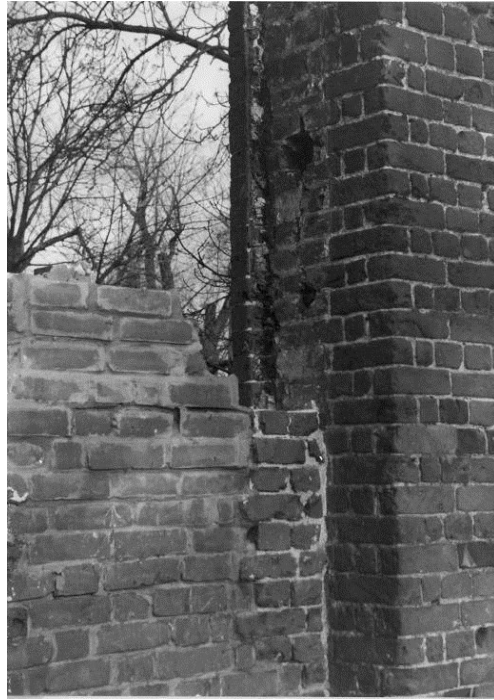
Figure 16. East side of the western window.

The western window on 10 January 1988 after the blocking had been removed by vandals.

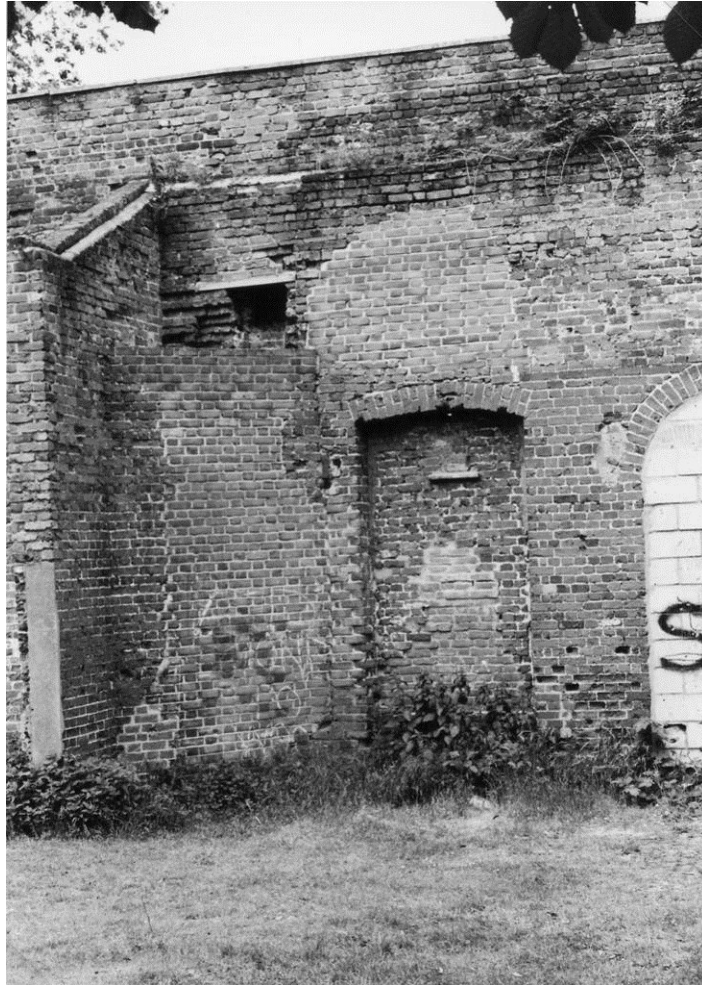
Figure 18. The fireplace and flue in the north-west corner of the building at the east end of the wall.

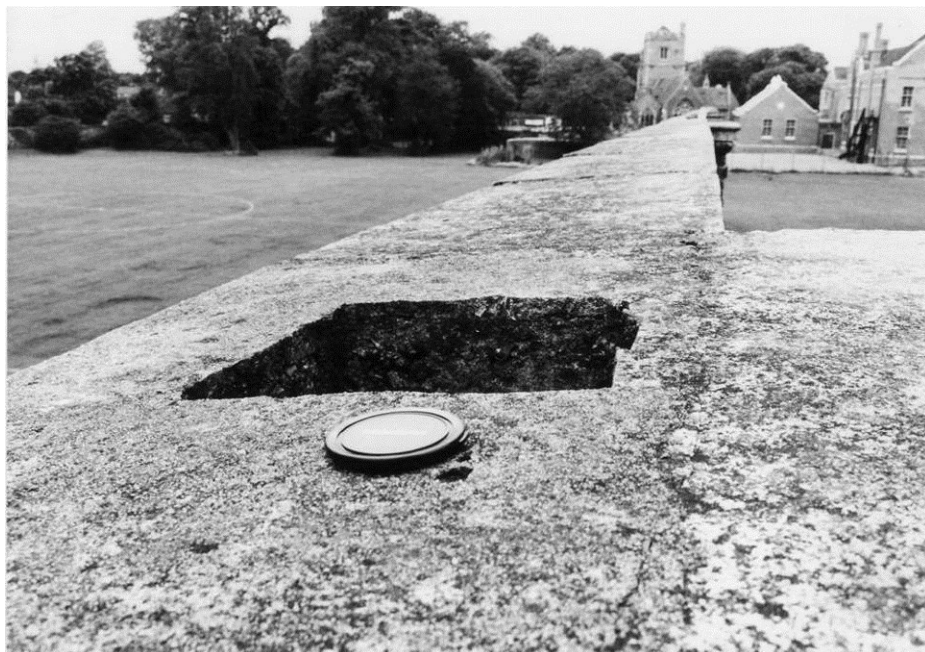
Figure 19. Looking west along the top of the orangery wall from the second pilaster, 1985. The flue in the foreground rises from the fireplace shown above.

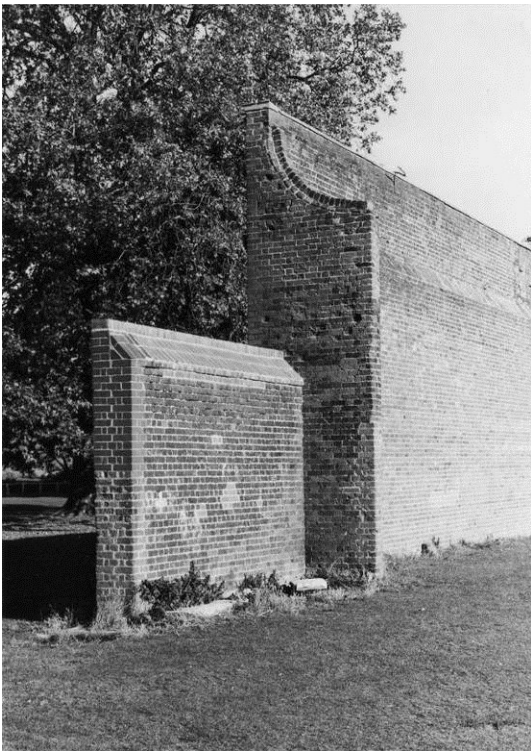
Figure 21. The west end of the orangery wall and the stub wall.

A short section of wall projects 4.23m from the western end of the orangery wall (figure 21). It is 0.47m thick and of brick laid in English bond. At the western end there is a Portland stone faced foundation for a pillar. The bricks have a median size close to those in the orangery wall. A late nineteenth or early twentieth century photo shows that it linked the orangery wall to an urn-topped stone-faced pier which supported a set of wrought iron railings and gates. The details of the gates and pier are entirely consistent with an early eighteenth century date.<sup>40</sup>

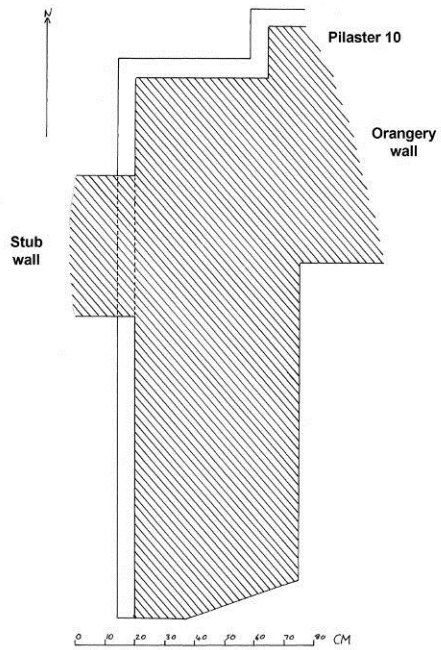
Figure 22. Plan of the west end of the orangery wall.

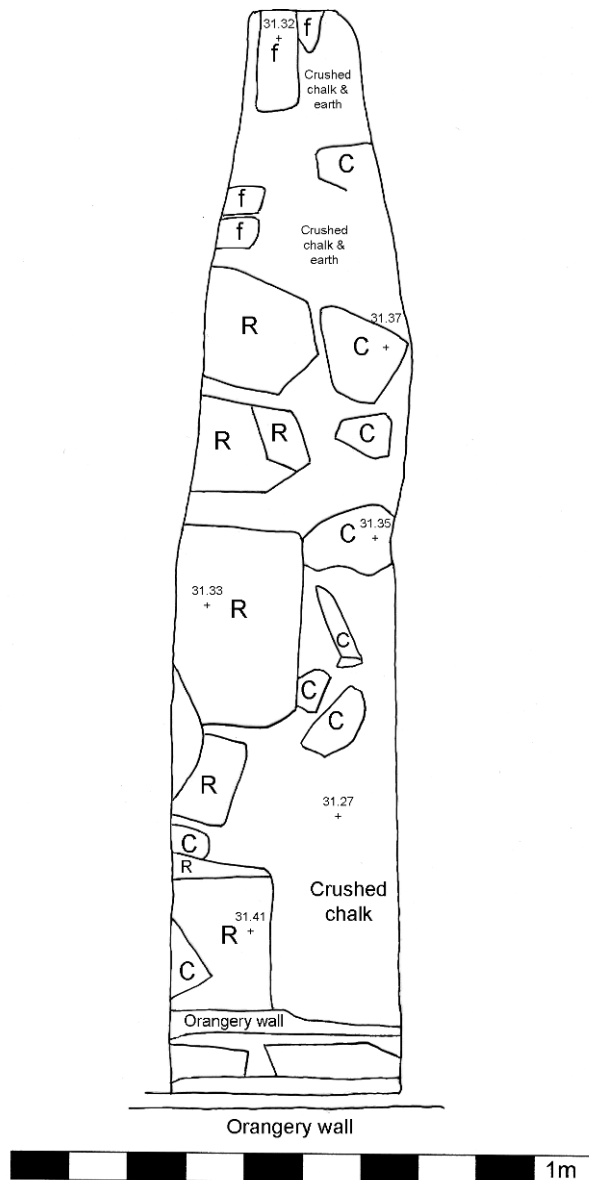
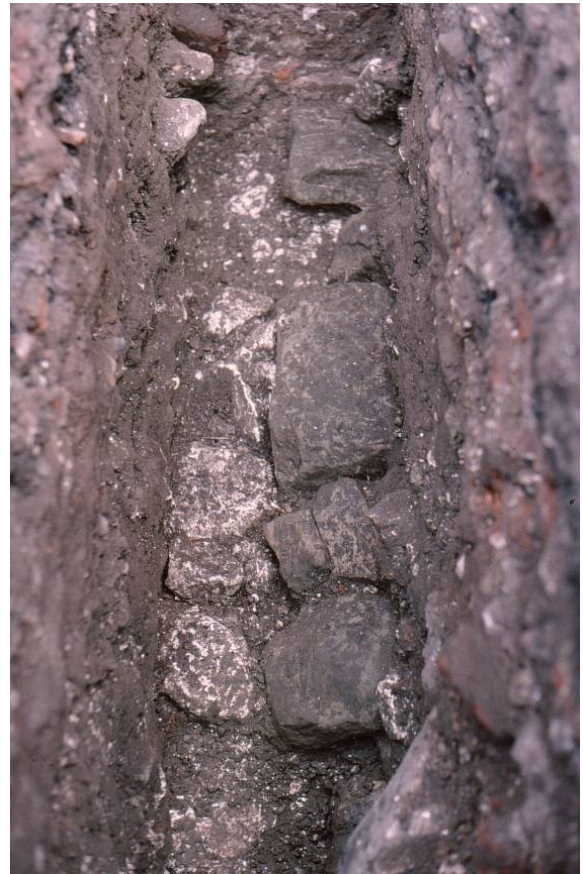
Figure 25. Reigate stone blocks [CQ6] and the top of layer [CQ7] as shown on the plan opposite. North at the top of the plan: south at the top of the photo.

When [CQ4] had been removed a line of stone blocks was exposed as shown in figure 25. There were five main blocks, all of Reigate stone, forming a line along the west side of the trench and a number of small pieces of Reigate stone and chalk to the west and north of them ([CQ6]). The deposit around them consisted of crushed chalk and earth ([CQ7]). Two pieces of white ware were found in [CQ4] close to the line of Reigate stone blocks.

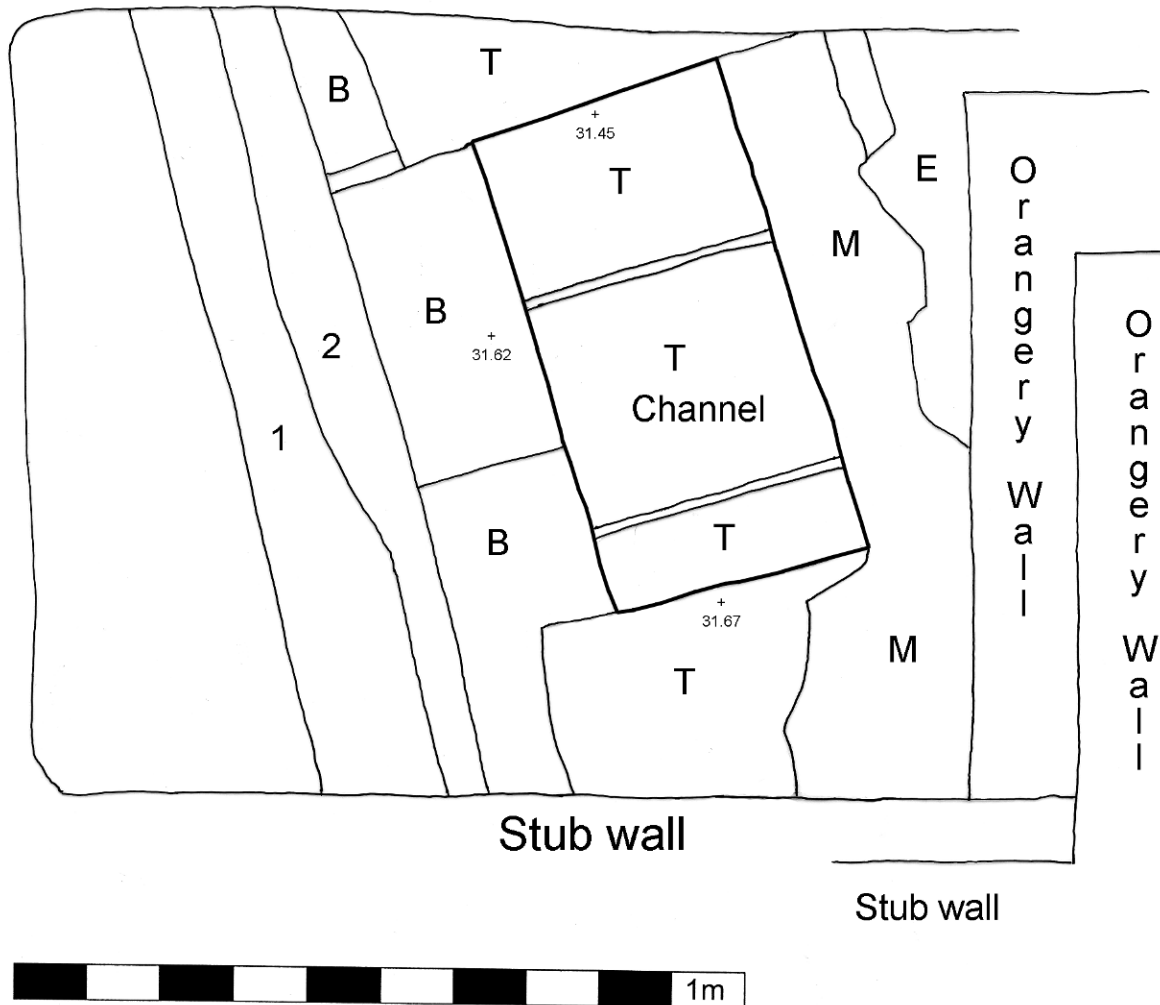
Figure 26. The brick and tile drain in trench CR with two tiles removed from the top exposing the channel.  
 B = Brick, E = earth, M = mortar; T = Peg tile.  
 M = Mortar.  
 1 = Brown soil with occasional flecks of chalk.  
 2 = Slightly darker brown soil.  
 North at the top.

The drain was aligned at an angle of about 18 degrees to the end of the orangery wall. The channel was inspected with a mirror. To the south it was blocked by an earth fall after about

0.5m. To the north the channel curved gently towards the east.<sup>42</sup> A tape was inserted to 3m and the channel curved out of sight beyond this. There was a thin layer of earth and scraps of chalk on the channel floor.

The trench exposed the foundations at the junction between the orangery wall and the stub wall which runs west from it with the intention of revealing the relationship between them (figures 26 and 27). The drain [CR3] passed under the stub wall. There were seven courses of brick above the drain and there was then an offset close to ground level.

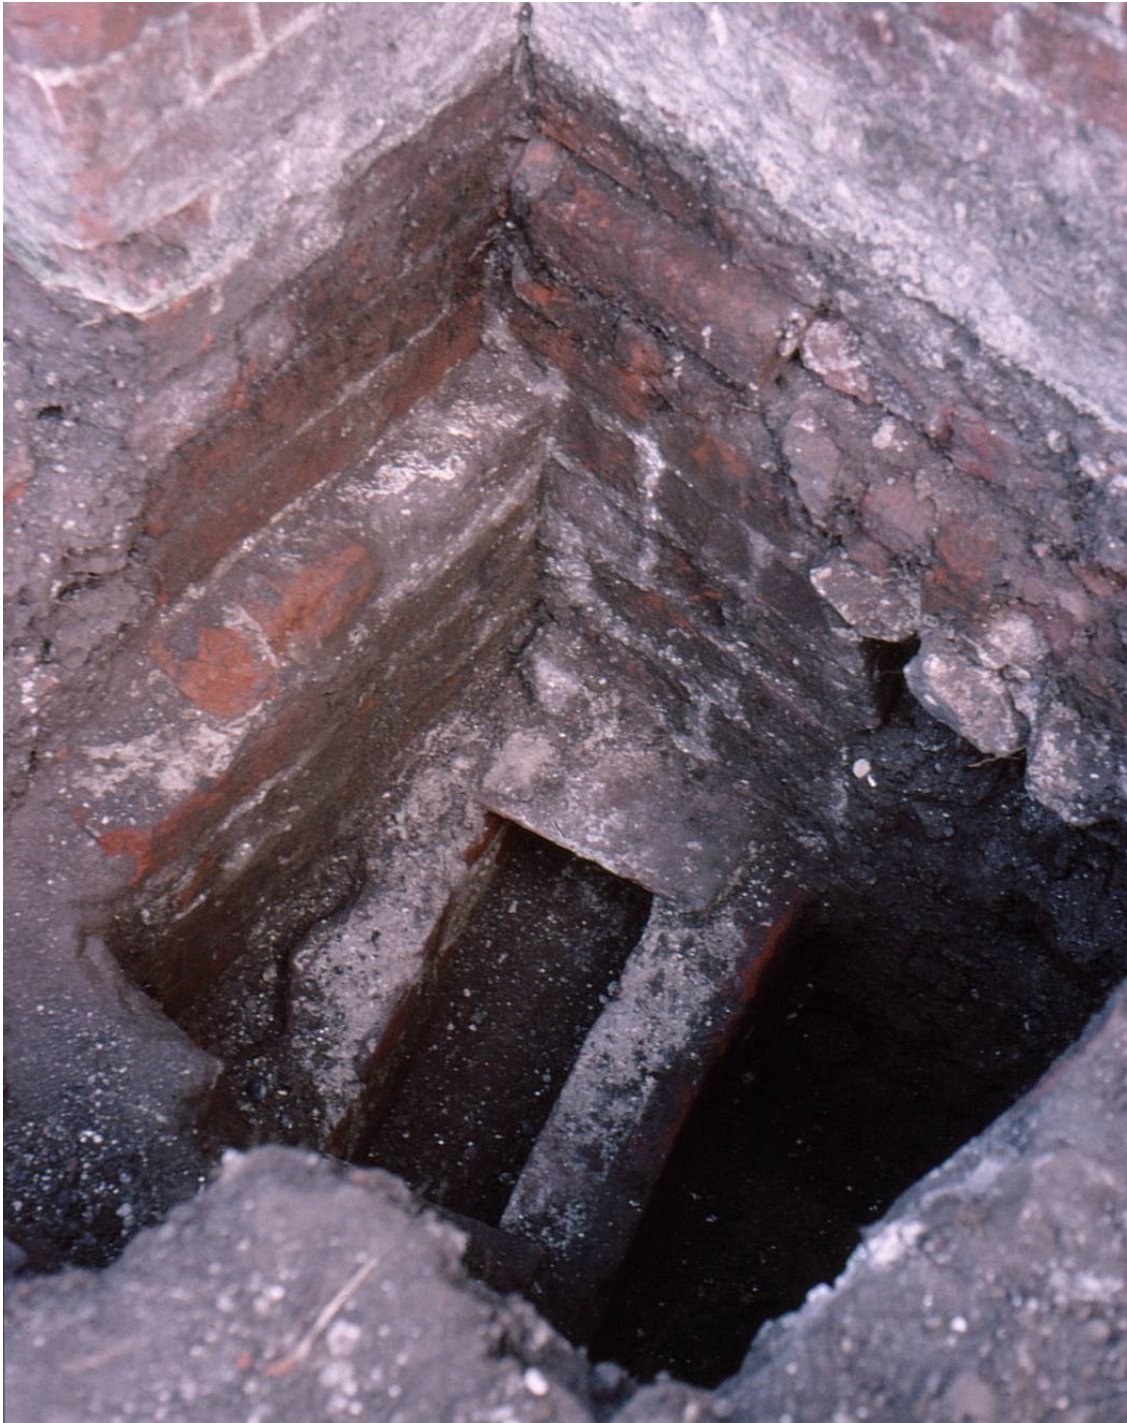
Figure 27. Trench CR with the drain. The end of the orangery wall on the left; the stub wall to the right.

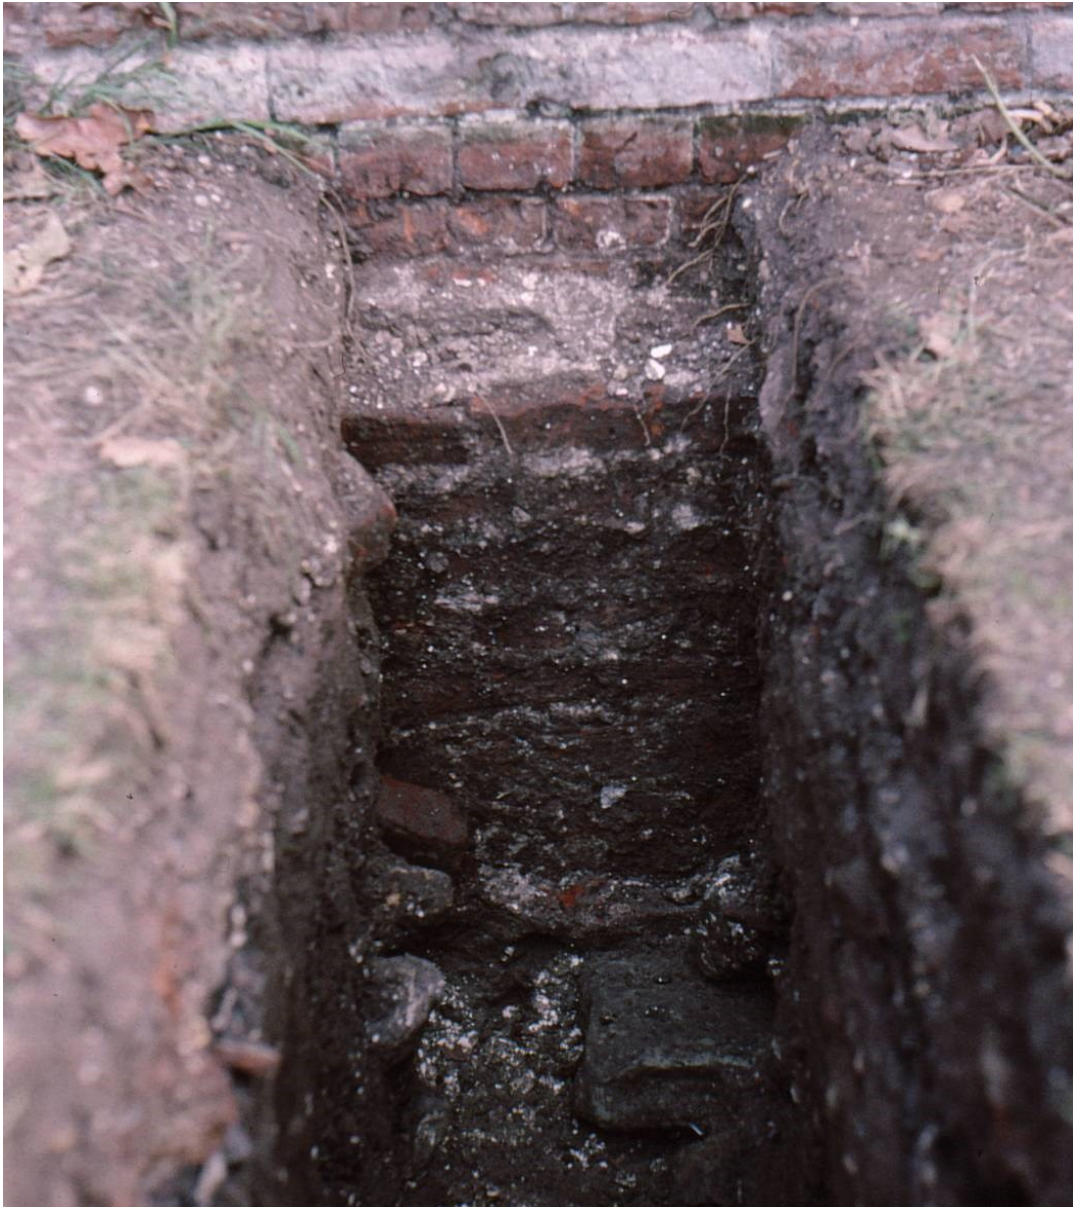
Figure 29. The footings of the orangery wall in trench CQ.

The foundation widened by an offset at 32.02m OD two courses below ground level (figure 29). There were mortar and brick impressions on the top of the offset which showed that it had originally been at least one course higher. There were seven courses of brick below the offset followed by a projecting course of mortar about half a brick thick. The top of this projection was at 31.43m OD and 0.59m below the first offset. The top of the crushed chalk layer [CQ6] was at 31.29m OD which was below the bottom of the foundation.

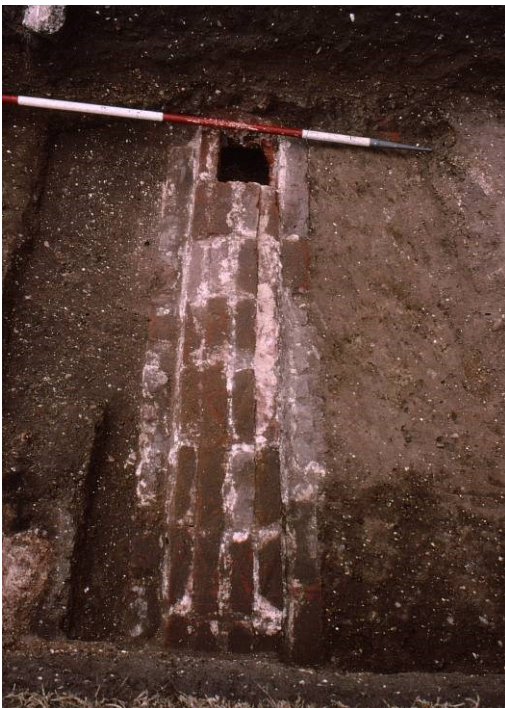
Above:  
Figure 44. Section of culvert [CT20].

The culvert was aligned east-west with its northern edge 3.84m from the south side of the orangery wall. A short section of the top was removed for internal inspection. The culvert had an internal width of 0.22m to 0.23m. The sides consisted of three courses of brick. The top course was stepped outwards to form a ledge to support the roof. This consisted of a very flat 'arch' of four bricks set on edge and laid lengthways along the culvert. The floor consisted of bricks laid flat across the culvert. The floor was at 31.75m OD and was covered with a thin layer of fine silt. The inside was examined with a mirror and a steel tape was run out to give some idea of distance. To the west the culvert started to bend gently to the north after about 3m. To the east the culvert appeared to be straight for the 6m to 8m it was possible to see. There were pieces of mortar hanging down from the joints between the bricks which showed that the 'vault' was constructed without any formwork.

The bricks were soft reds with clear diagonal hack stacking marks. The median thickness of ten measured bricks was 65mm (range 63 – 69mm). The mortar was grey-brown with large chalk inclusions very similar to the mortar in the core of foundation [CT30] immediately to the south.

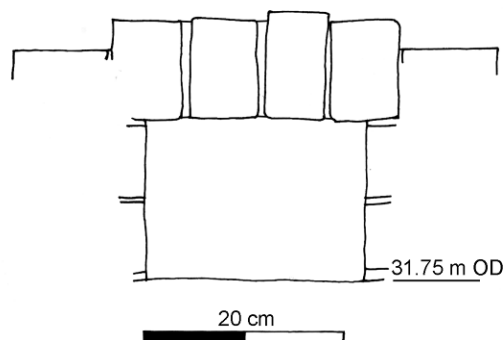
Left:  
Figure 45. The top of culvert [CT20] looking west.

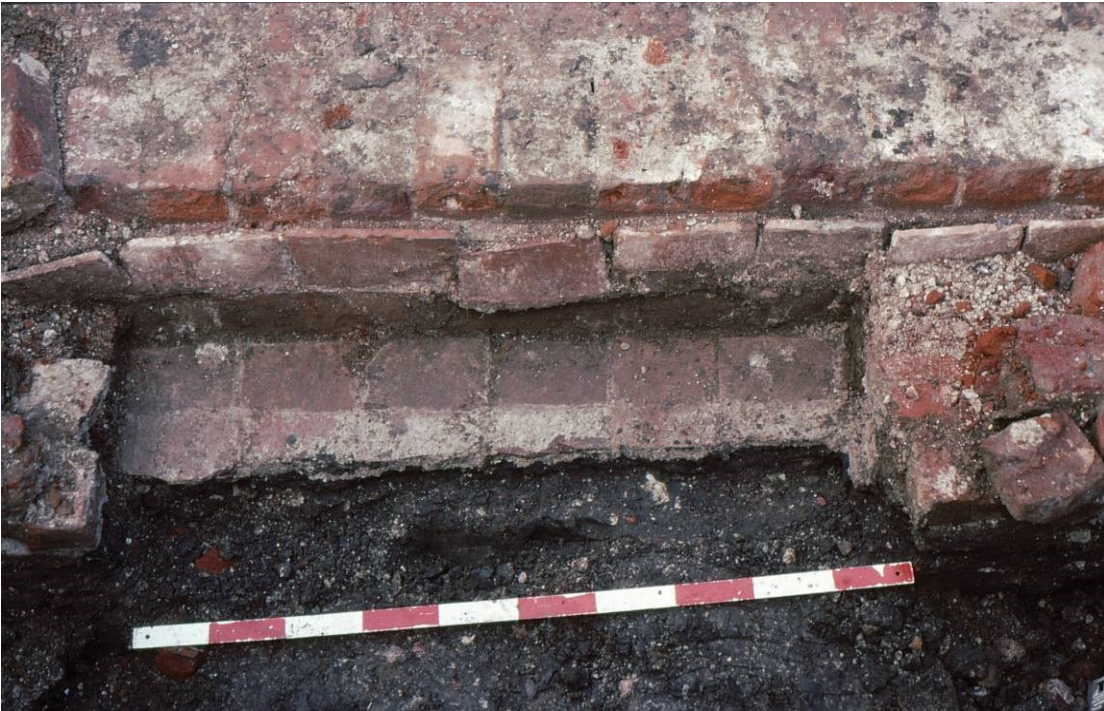
Figure 48. A section of foundation [CT22] has been removed to expose the peg tiles fixed to the south face of foundation [CT21].

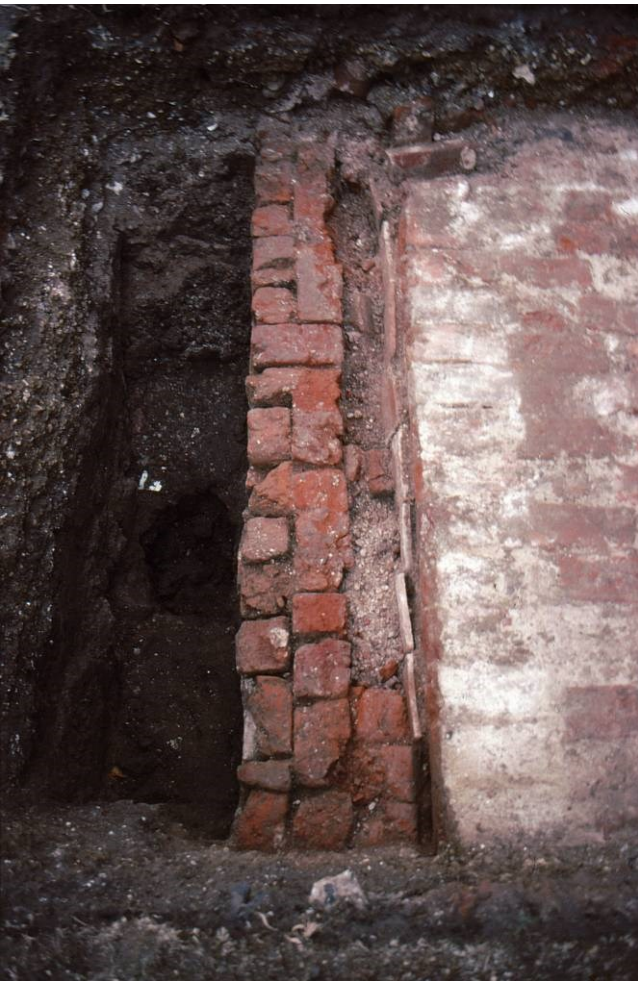
Figure 49. The top of foundation [CT22] with [CT21] on the right. Looking west.

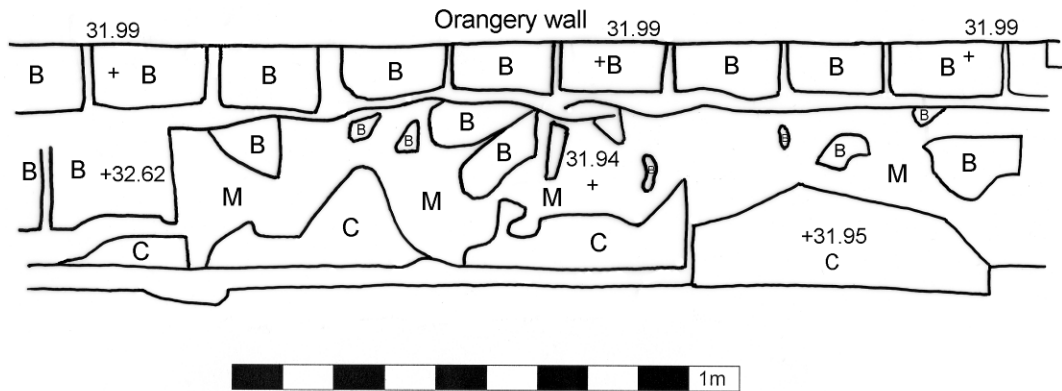
Figure 50. The top of foundation [CT29].

This consisted of chalk with the remains of brick on the top. The brick was bonded with grey slightly chalky mortar. There was a marked crack between [CT29] and a brick offset from the base of the orangery wall.

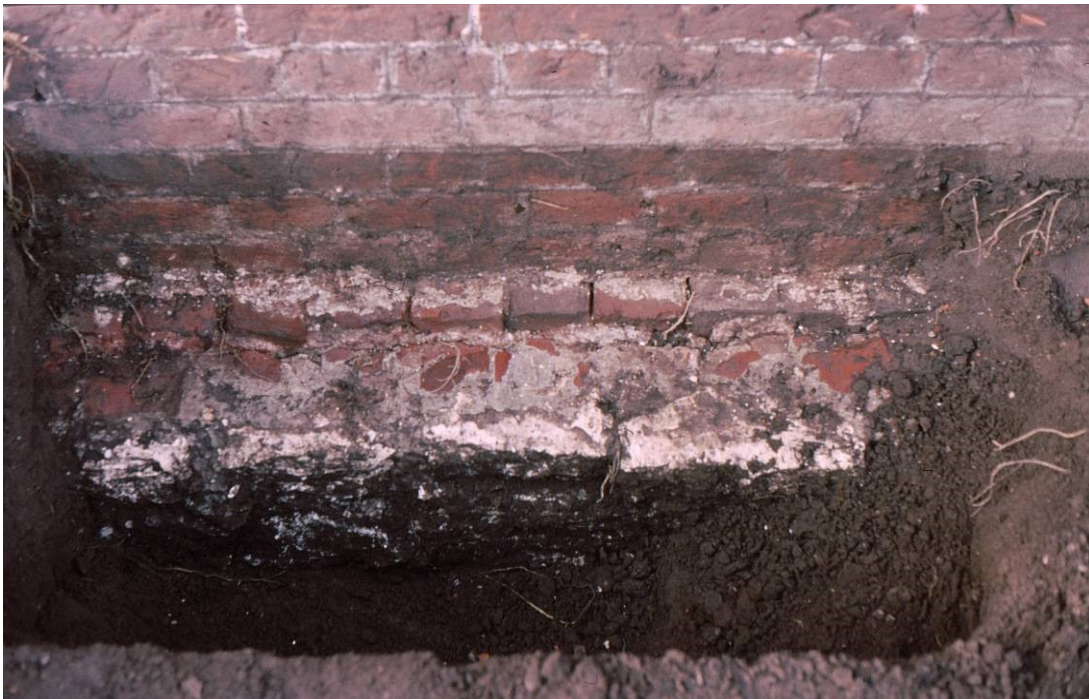
Figure 51. The top of foundation [CT29] next to the orangery wall.

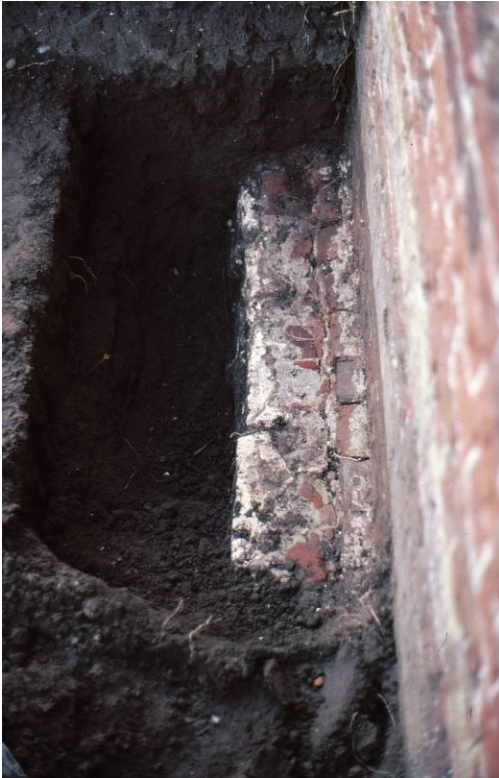
Figure 52. Foundation [CT29] looking west with the orangery wall on the right.

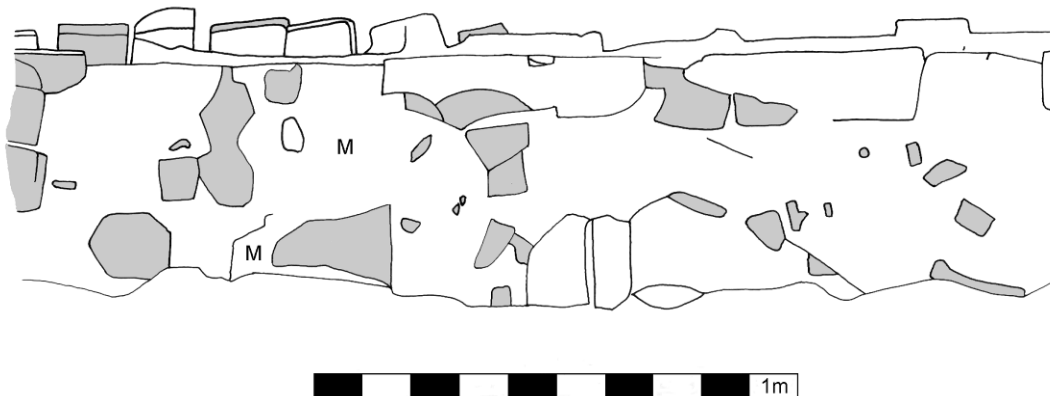
Figure 54. Plan of foundation [CT30]. M = mortar; grey shading = brick.

This was aligned east-west. It consisted of three poorly and irregularly laid courses of soft red smooth finished bricks. The centre and west end was bonded with medium grey brown mortar. The mortar on the outside was browner, softer, and not spotted with chalk.

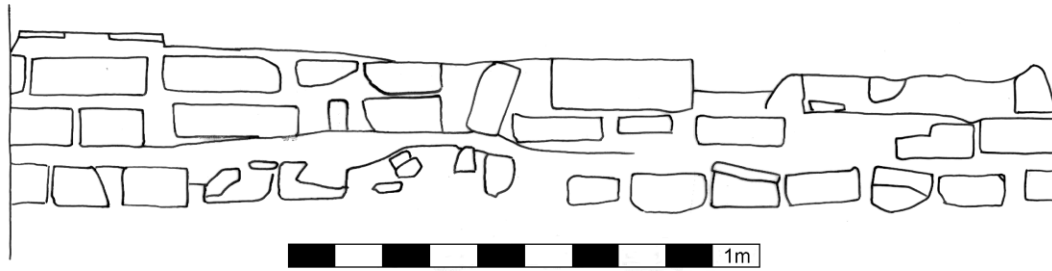
Figure 55. The north side of foundation [CT30].

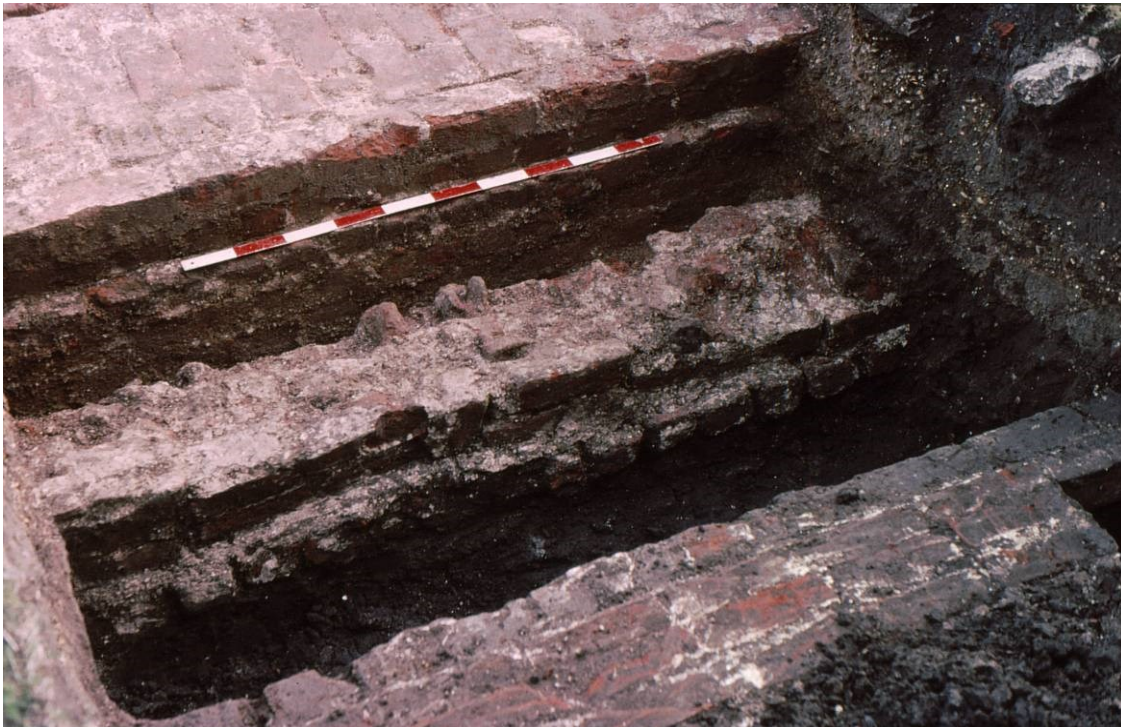
Figure 56. Foundation [CT30] looking west of south. [CT21] in the background and culvert [CT20] in the foreground.
