# **Excavations at Honeywood, Carshalton, 1997**

Carshalton & District History & Archaeology Society  
Occasional Paper 7

Site location:

Honeywood Museum, Honeywood Walk, Carshalton SM5 3NX  
TQ 2781 6449

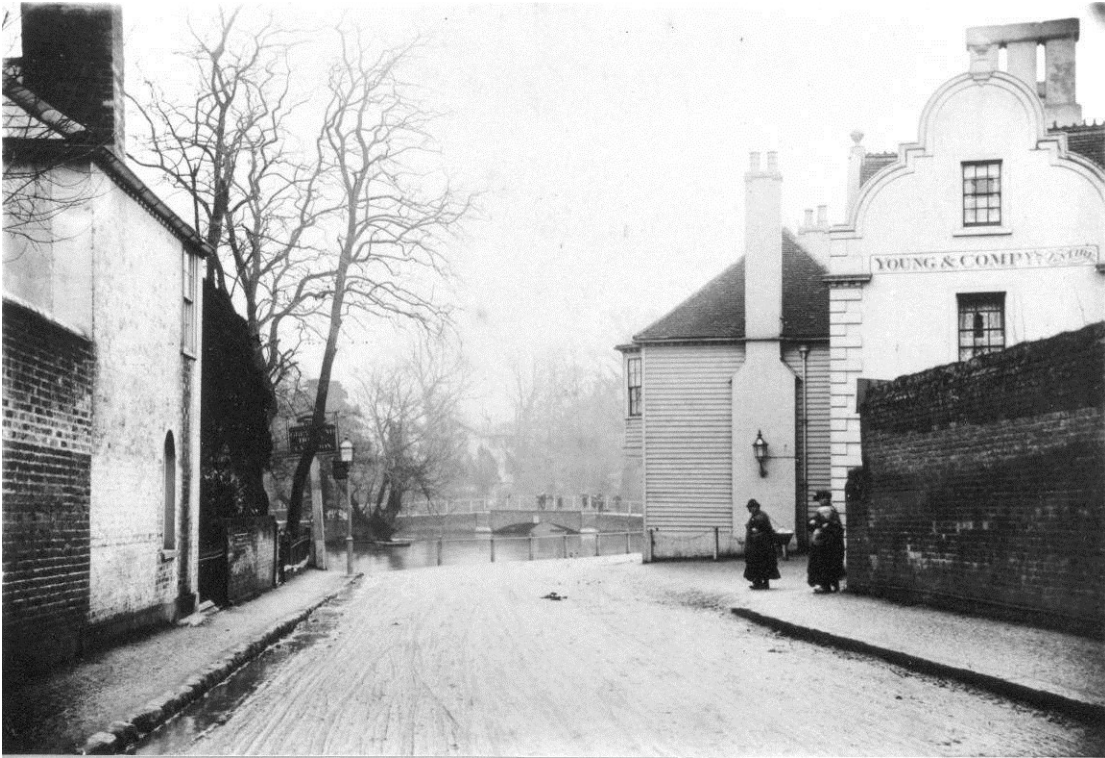
Figure 7. The Pound Street building or back extension to Honeywood. Note the water running down the gutter. Is this ground water seepage or rain?

There was a small rectangular two-storey brick building in the Pound Street wall to the rear of Honeywood. The photos show that the building had a pitched roof with a hip at each end (figures 6 and 7). There was a tall chimney rising from the lower edge of the roof on the Pound Street side. The west side had a window on the first floor slightly off centre to the north. The lower part of this side wall is hidden behind the garden wall. The south wall facing Pound Street

had a window on the second floor towards the eastern (Ponds) end. A dark stain ran down the wall from the bottom of the window to the pavement. There was a second window with a round-headed top at ground floor level just west of the stain. The top of the windows in the west and south wall were at eaves level. There was dentiled brickwork along the eaves.

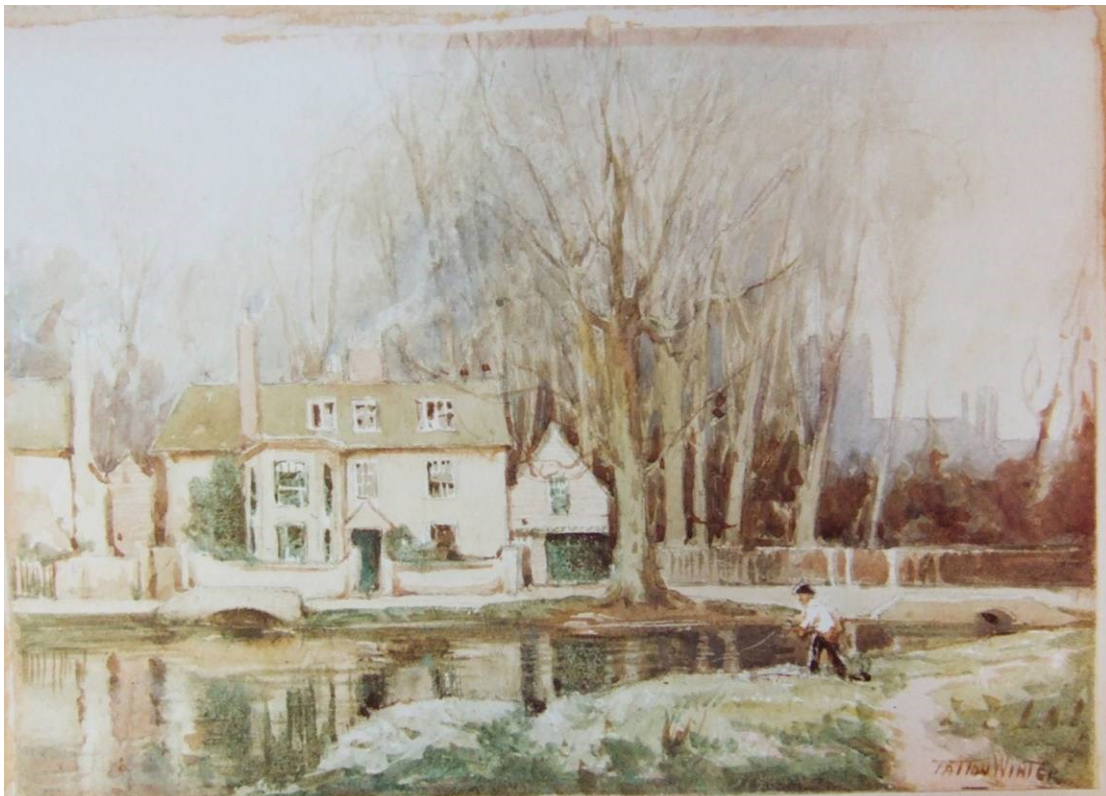
Figure 8. Painting by William Tatton Winter. A note on the back of a photographic copy in the Sutton Local Studies Collection says 'From a painting originally owned by Dr. A.V. Peatling now possession of his son T.P. [?] Peatling. S. Africa'. This and the painting below are likely to date from about 1883. Tatton Winter came to live in Carshalton that year while Honeywood was demolished the following year.

It is clear that the front of the house had a central bay which contained six tall narrow windows, three on each floor. There was a ground floor and first floor window on each side of the bay. The windows on the first floor were narrow but not as tall as those in the bay. The two ground floor windows were wider. The front was white and appears to have been rendered. There was a string course running across both the walls and the bay at first floor level. There is no sign of a door in the front of the house. It seems likely that the bay window was an addition. There were three dormer windows in the roof and three chimneys. One large exterior stack was built against the north end of the house probably in line with the roof ridge. It had a prominent offset just below eaves level. The second chimney was on the roof (ridge?) behind the southern end of the bay window while the third was on the southern gable and projected from it. The second and third chimneys were narrower than the first.

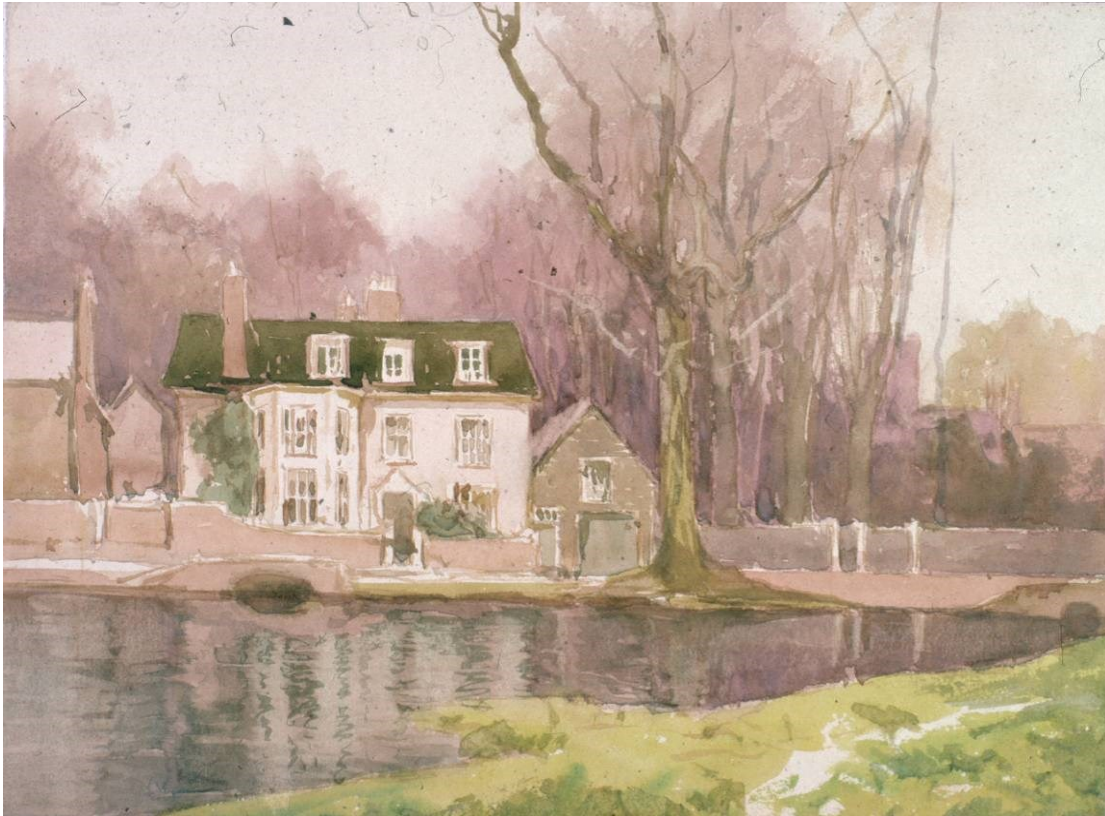
Figure 9. A watercolour by William Tatton Winter in the Sutton Museum collection CA.173.

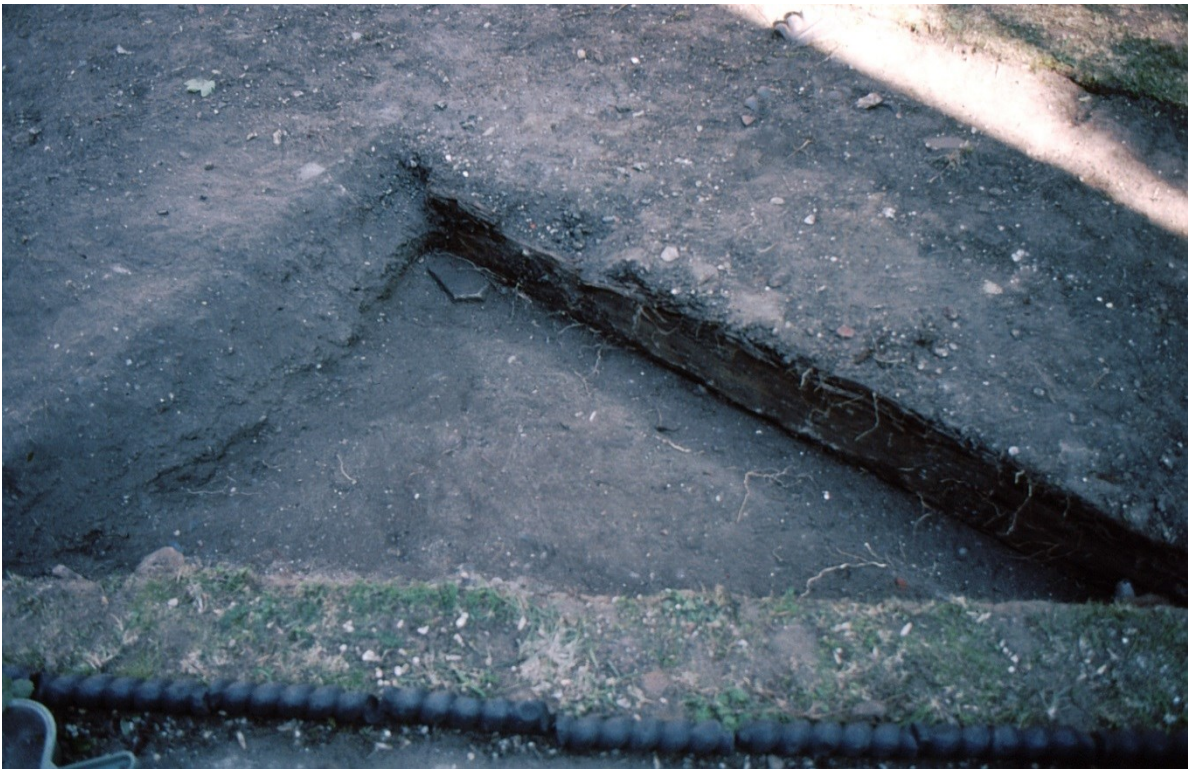
Figure 14. The cut for the cold frame looking southeast.

Layer [HD2] rested on [HD3] which passed under it, and it also rested on [HD4] which occupied a triangular area at the north end of the trench. Layer [HD4] filled a well-defined cut [HD5] which is shown on figures 13 and 14. Layer [HD4] consisted of loose rubble in a sparse earth matrix. There was brick, roof tile (some machine-made), flower pot, modern window glass, yellow burr brick, knobbly flint, large red floor tiles and concrete including some with metal mesh reinforcement.

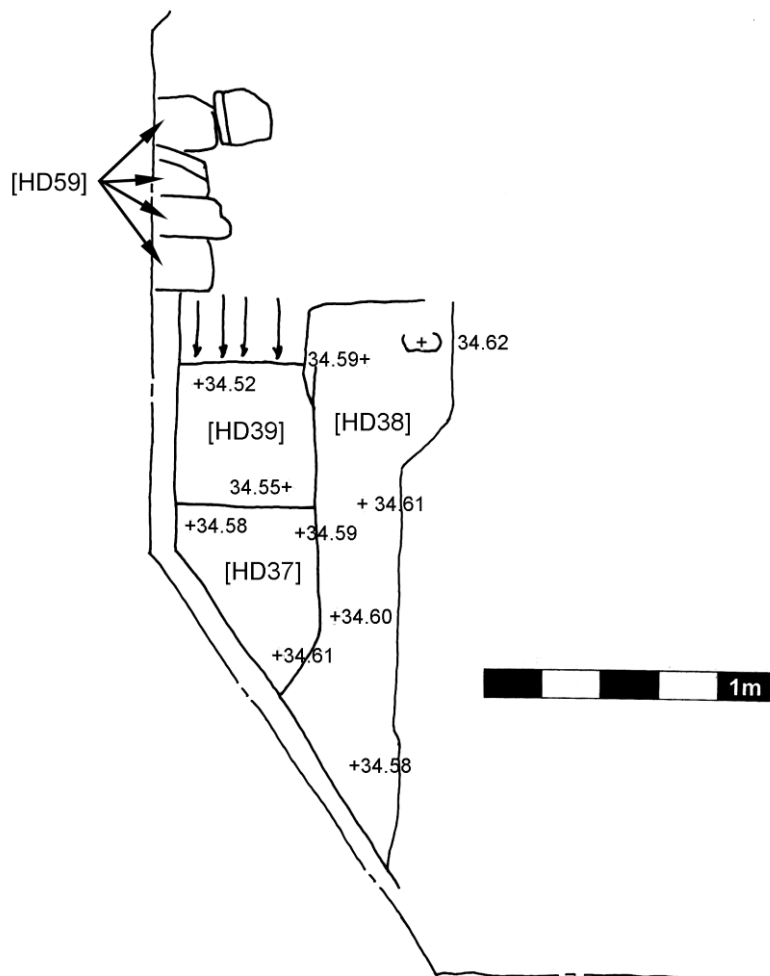
Figure 18. The west area in HD after the removal of the gas pipe. [HD37], [HD38] and [HD39].

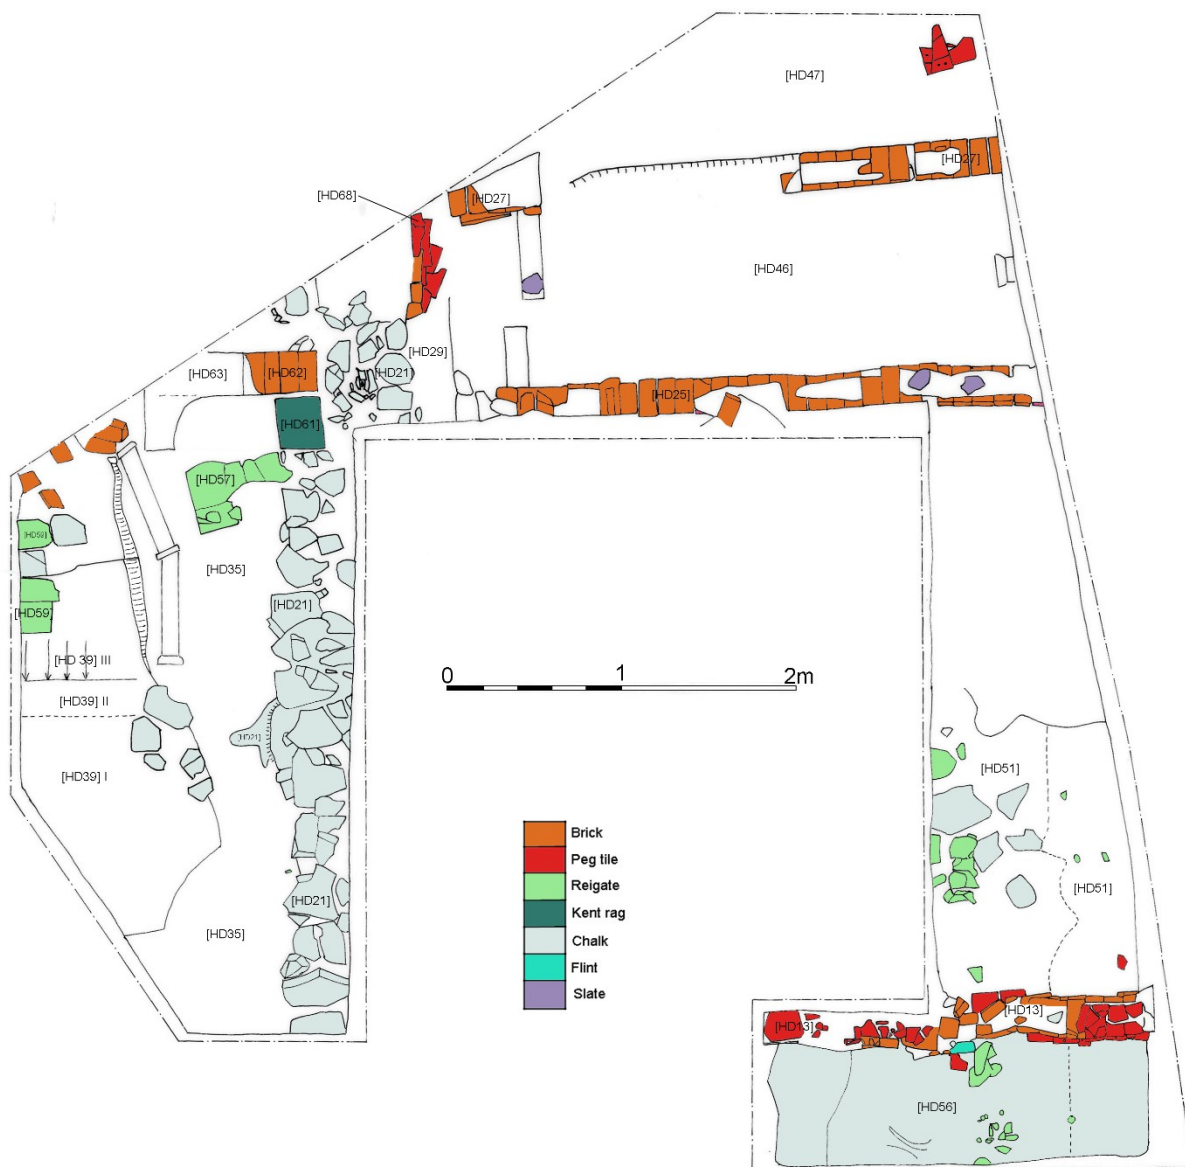
Figure 21. Trench HD showing the main foundations and structures.

Layer [HD39] consisted of tightly packed broken chalk rubble mostly under 0.2m with rare pieces of flint (figure 21). The deposit sloped down to the west and formed a foundation for the stone blocks [SB59]. The layer was not excavated but appeared to rest on the gravel deposit [HD35]. It is described in detail in section 6.2.

Layer [HD34] largely covered a line of Reigate blocks [HD57] shown on figure 21. The west end of the line terminated with an ashlar block with smoothed faces on the west and south sides. This projected through the top of [HD34] and must have been covered by [HD33]. At the east end the blocks appeared to run under the chalk foundation [HD21]. The deposits immediately north of [HD57] consisted of large sub-angular flint in very stiff medium brown earth flecked with much chalk mostly under 10mm in size.

When [HD8] had been removed the East Area was divided into two parts by an east-west aligned brick foundation [HD13] shown in figure 21 and described in section 6.3. The layer to the south of the foundation was [HD11] while those to the north were [HD15] and [HD36].

Layer [HD51] at the south end of the area consisted of about 50% chalk and 40% flint in a brown earth matrix. The top of the layer is shown in figure 21. Most of the chalk was in a large patch on the west side while flint was more common to the east. The chalk was large – up to 30cm in size, angular, and closely packed. The flint was up to 20cm in size but mostly smaller. It was of very mixed size and shape. The larger pieces tended to be knobbly while the smaller were rounded, sub-angular or angular. There was an irregular concentration of Reigate stone rubble towards the west side as shown in figure 21. The deposit was not excavated.

There were also two small deposits by the chalk foundation [HD21]. These were [HD29] to the south and a brick and tile structure [HD68] to the north as shown in figure 21. These deposits are described in section 6.1. They appear to be a small survival from deposits cut away to insert the walls and drain described below.

This ran north-south across the trench as shown in figure 21. It consisted of large angular blocks of chalk bedded in pale brown sand. The blocks were packed fairly closely. The width was about 0.8m and the surviving height about 0.23m. There was a small chalk 'platform' on the west side of the foundation about 1.7m from the south end of the trench.

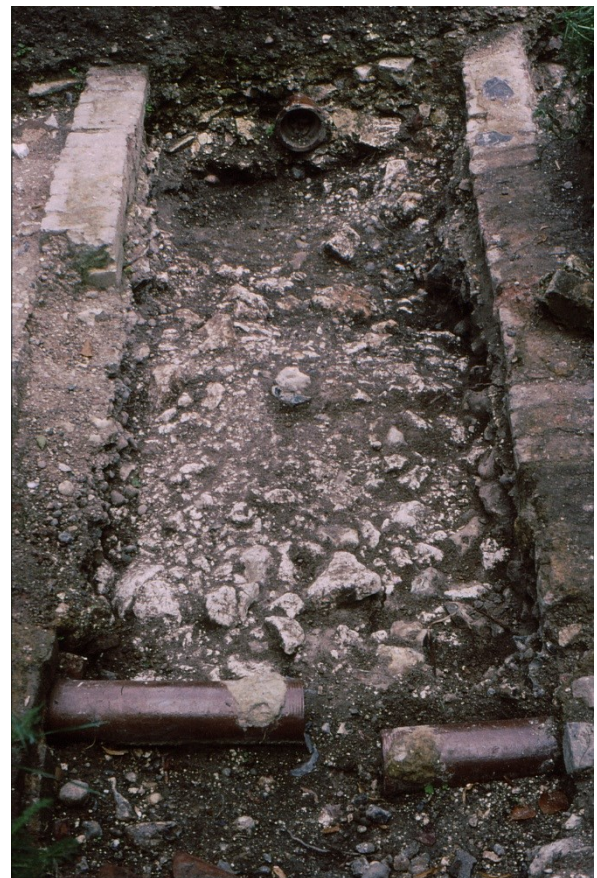
Figure 28 (right). The top of [HD53] looking east with part of [HD54] in the background.

Layer [HD53] consisted of broken angular chalk with blunt corners of very mixed size up to 230mm in a sparse matrix of pale brown sand. There was a gap in the east end of the deposit where the underlying layer was exposed (figures 27 and 28). None of the few finds were usefully datable.

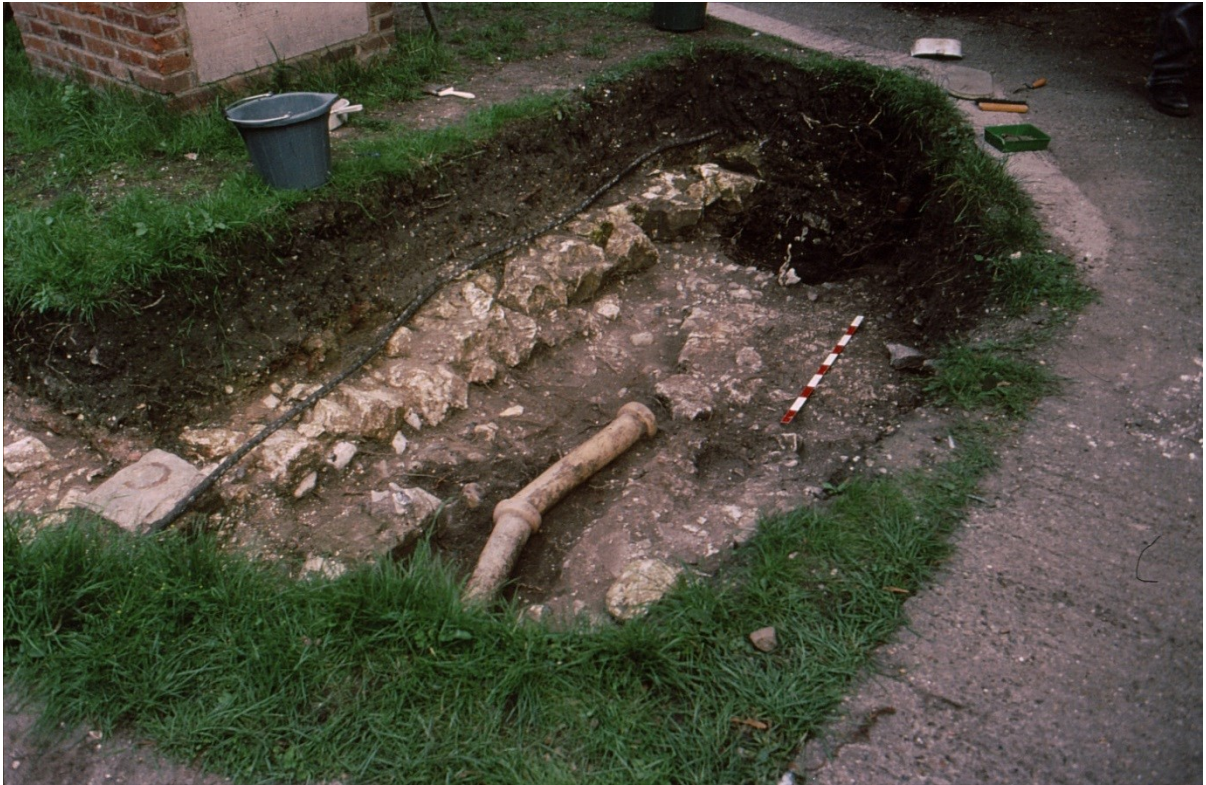
Figure 29. The west area looking southeast with foundation [HD21] along the far edge of the trench.

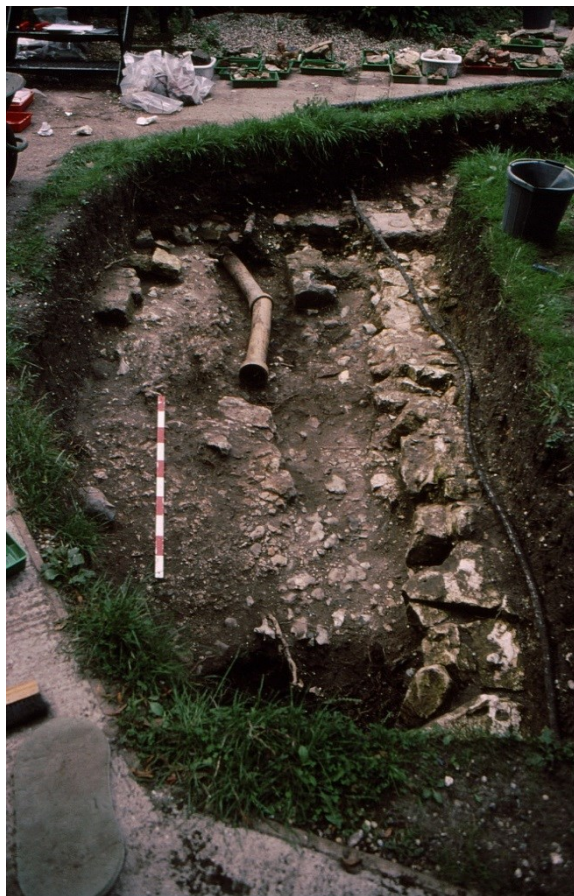
Figure 30. The west area looking north with foundation [HD21] on the right.

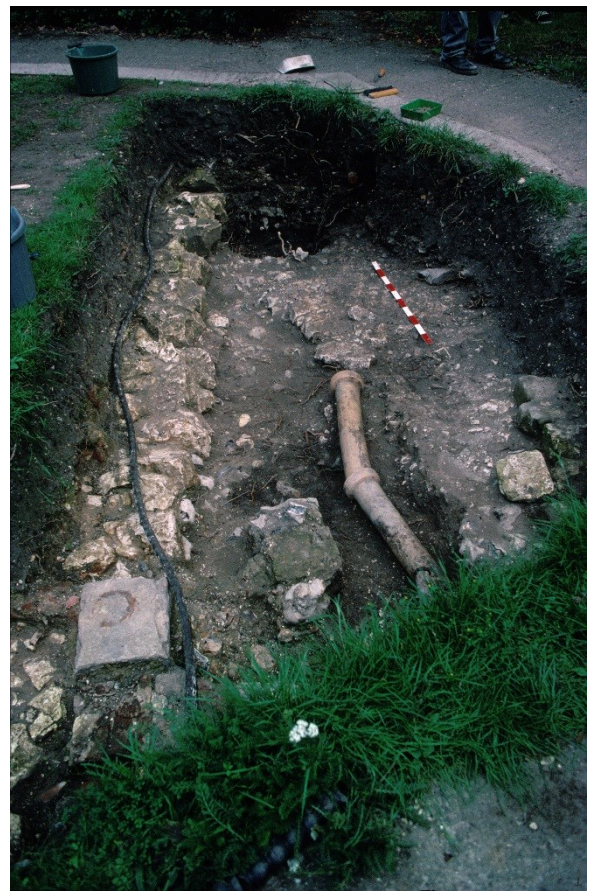
Figure 31. The west area looking south with foundation [HD21] on the left.

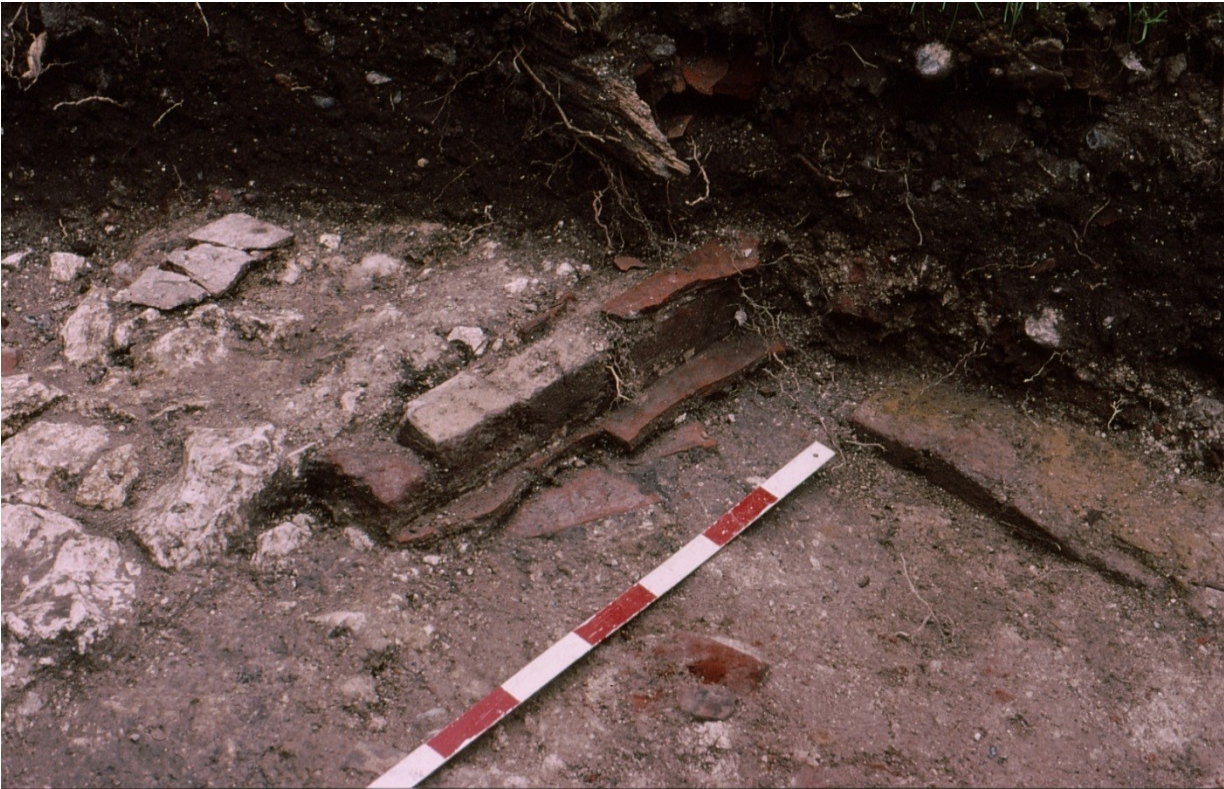
Figure 32. Brick and tile structure [HD68] against the east side of chalk foundation [HD21]. Looking northwest.

There were a fragments of a brick and tile structure [HD68] against the east side of the chalk foundation [HD21] (figure 32). This consisted of two bricks laid end to end against the chalk wall with fragments of two courses of peg tiles below and one above. The tile courses projected out beyond the brickwork. The purpose of this was unclear. The lower tiles appear to rest on chalk and brown earth although the base of them was not much above the orange clay.

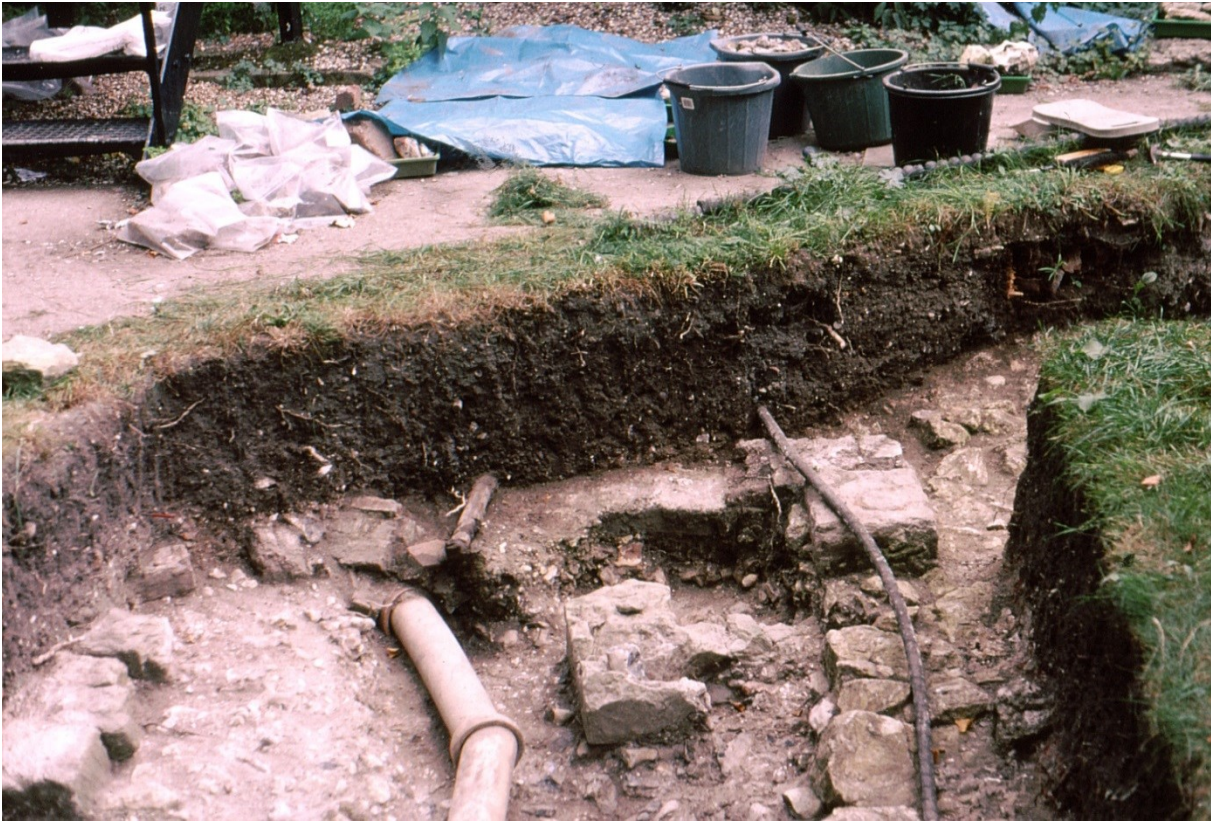
Figure 33. The north end of the West Area looking north. The stone structure [HD59] is on the far left. The stoneware drain pipe in cut fill [HD22] appears towards the centre with Reigate stone structure [HD57] to the right of it. The chalk foundation [HD21] is on the far right below the cable. Stone block [HD61] can also be seen below the cable.

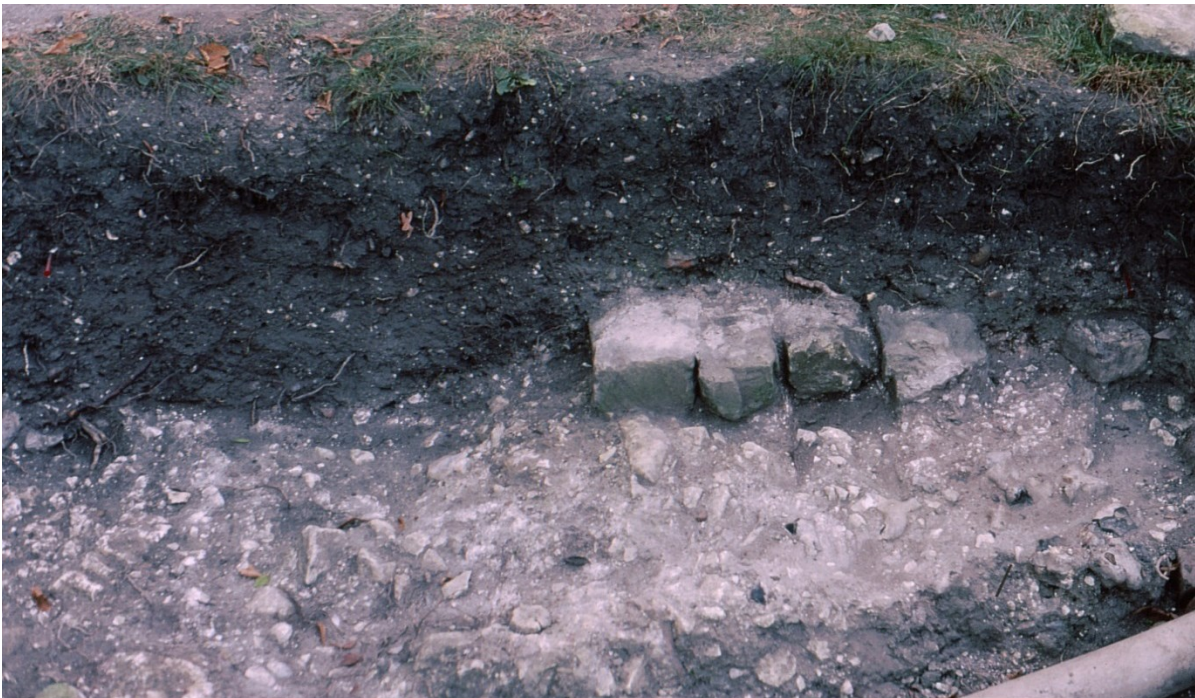
Figure 34. The West Area looking west. Stone structure [HD59] with the chalk bank [HD39] below and to the left of it.

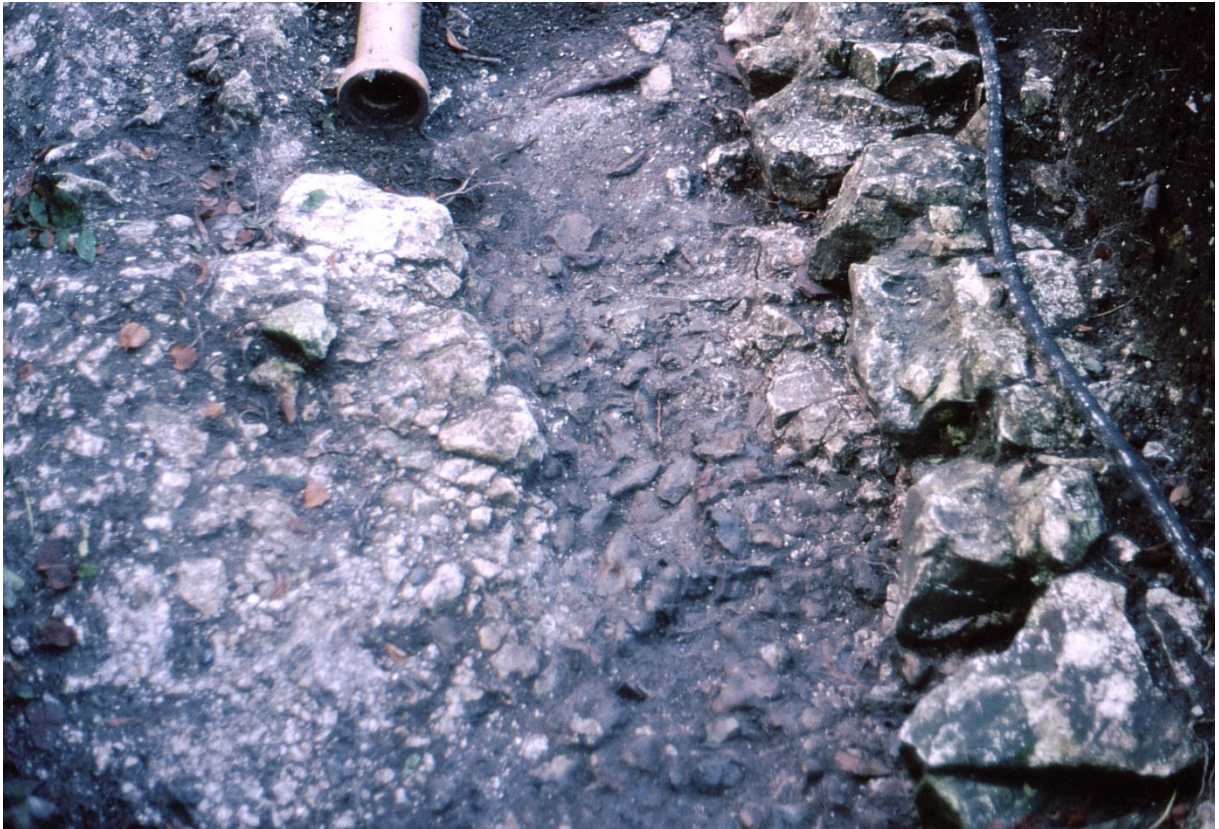
Figure 35. The West area looking north. The east side of chalk slope [HD39] to the left. Chalk foundation [HD21] to the right with the chalk 'platform' beside it. The two are separated by gravel layer [HD35]. The stoneware pipe from cut fill [HD22] in the background.

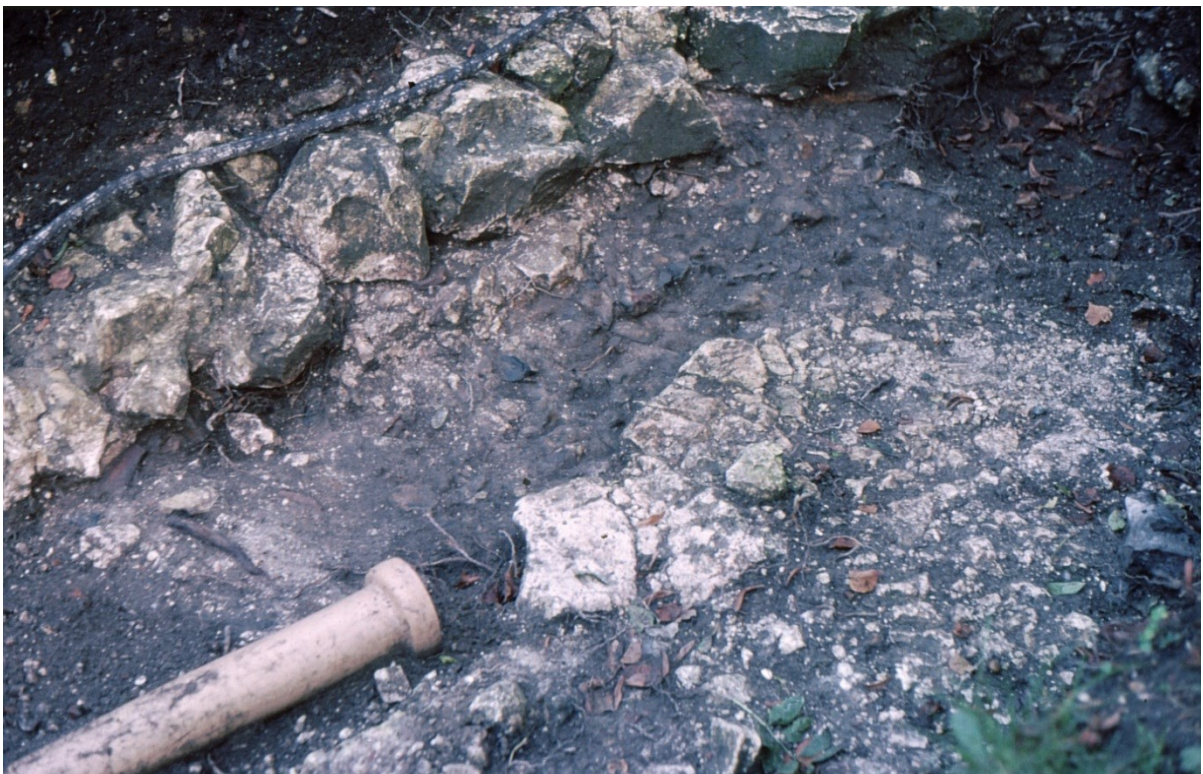
Figure 36. The West Area looking southeast. The east side of chalk slope [HD39] in the foreground. Chalk foundation [HD21] behind it with the chalk 'platform' beside it. The two are separated by gravel layer [HD35]. The stoneware pipe from cut fill [HD22] to the left.

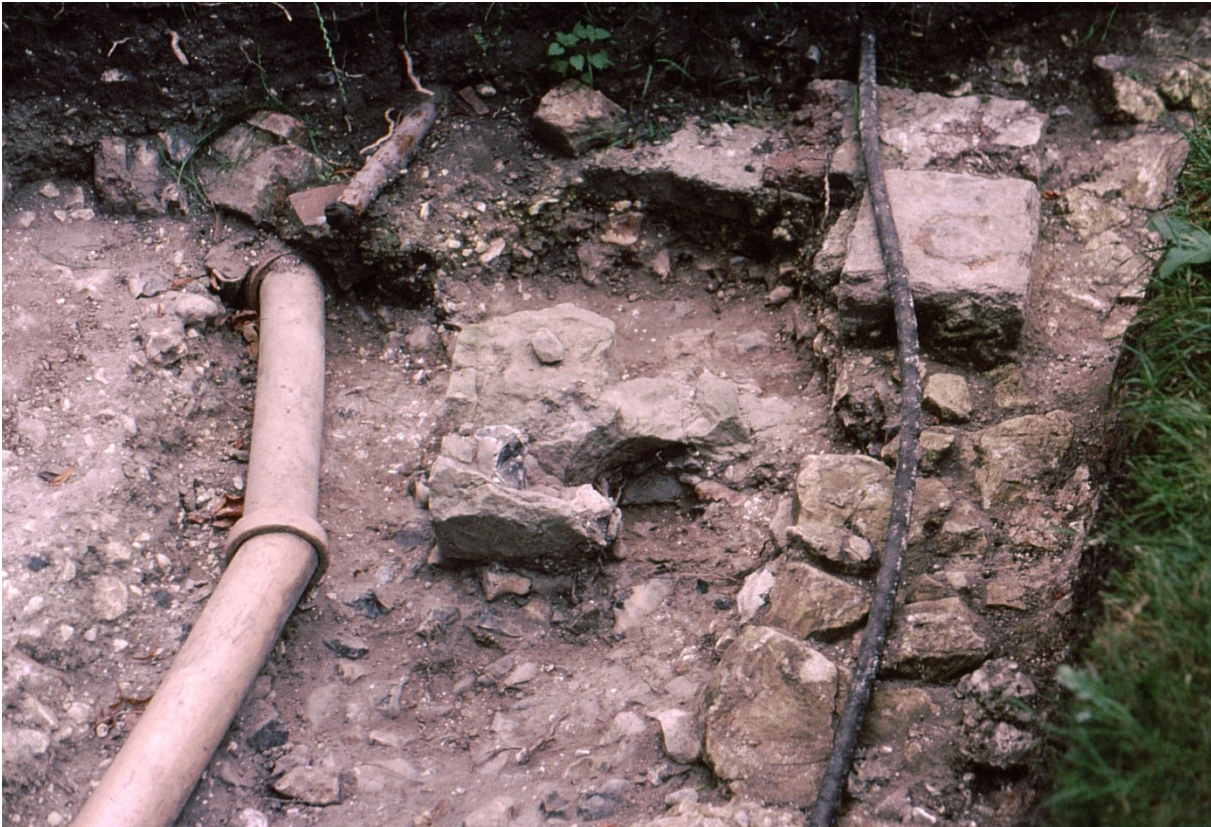
Figure 37. The north end of the West Area looking north. The stoneware drain pipe in cut fill [HD22] to the left. Reigate stone structure [HD57] in the centre with chalk foundation [HD21] and stone block [HD61] to the right below the cable.

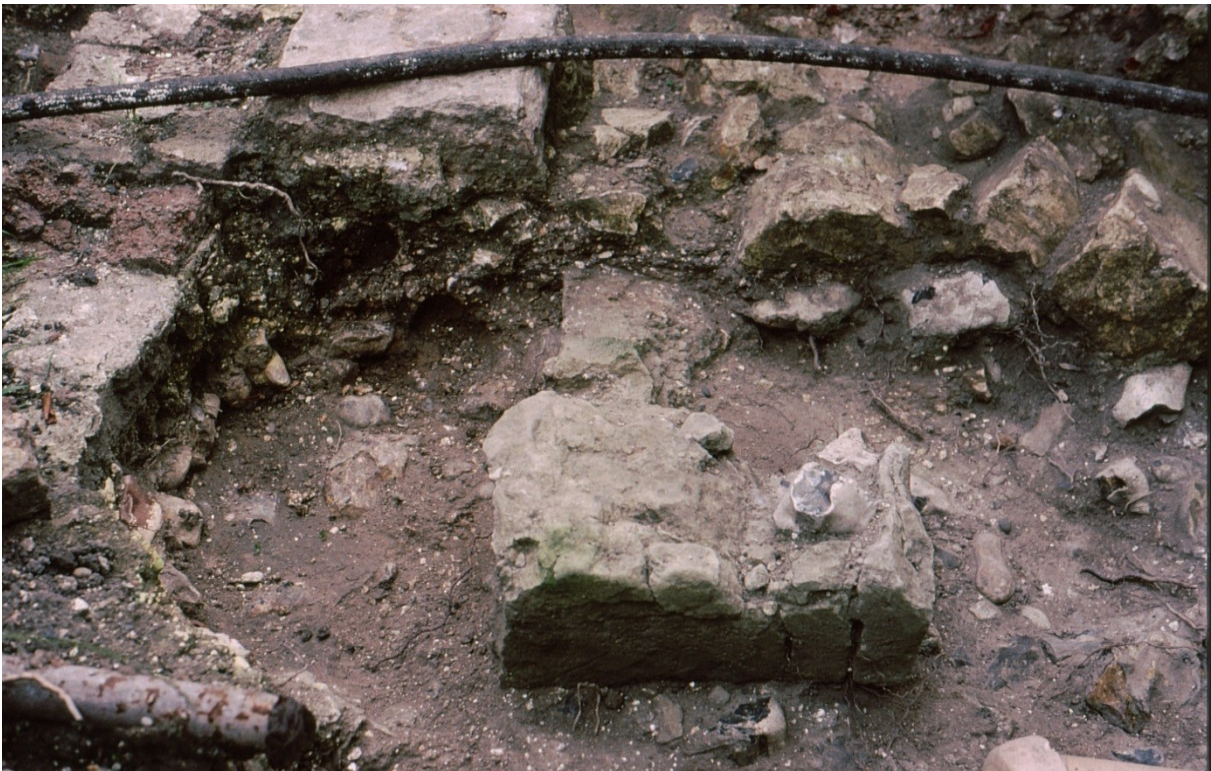
Figure 38. The West area looking east. Reigate stone structure [HD57] with chalk foundation [HD21] in the background. Note that the Reigate stone passes under [HD21].

Reigate stone foundation [HD57] was located on the opposite side of the cut. It was not exactly aligned with the stone blocks [HD59] and was also only one block thick from north to south rather than four. The levels also differed. However, the deposits to the north of [HD57] consisted of large sub-angular flint in very stiff medium brown earth flecked with much chalk which was mostly under 10mm. This is very similar to contexts [HD64] to [HD67] to the west of the chalk bank.

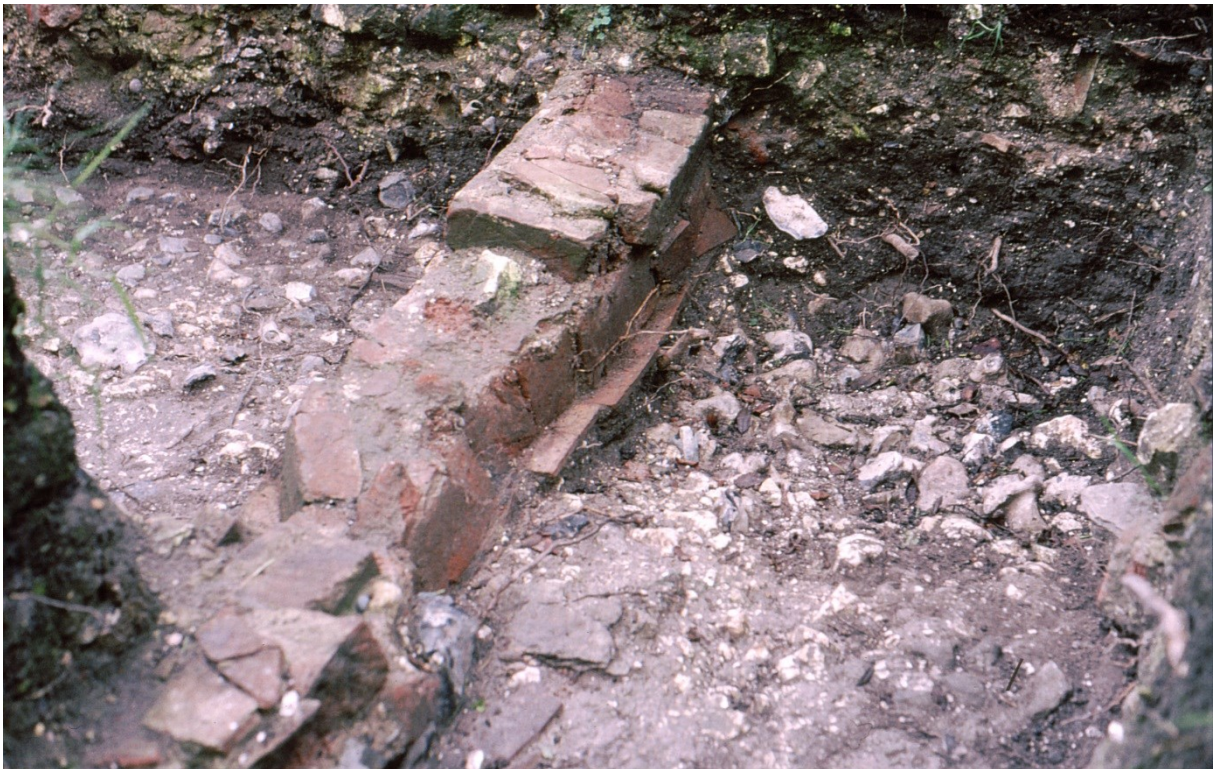
Figure 39. The southern end of the East Area looking east showing the damaged foundation [HD13].

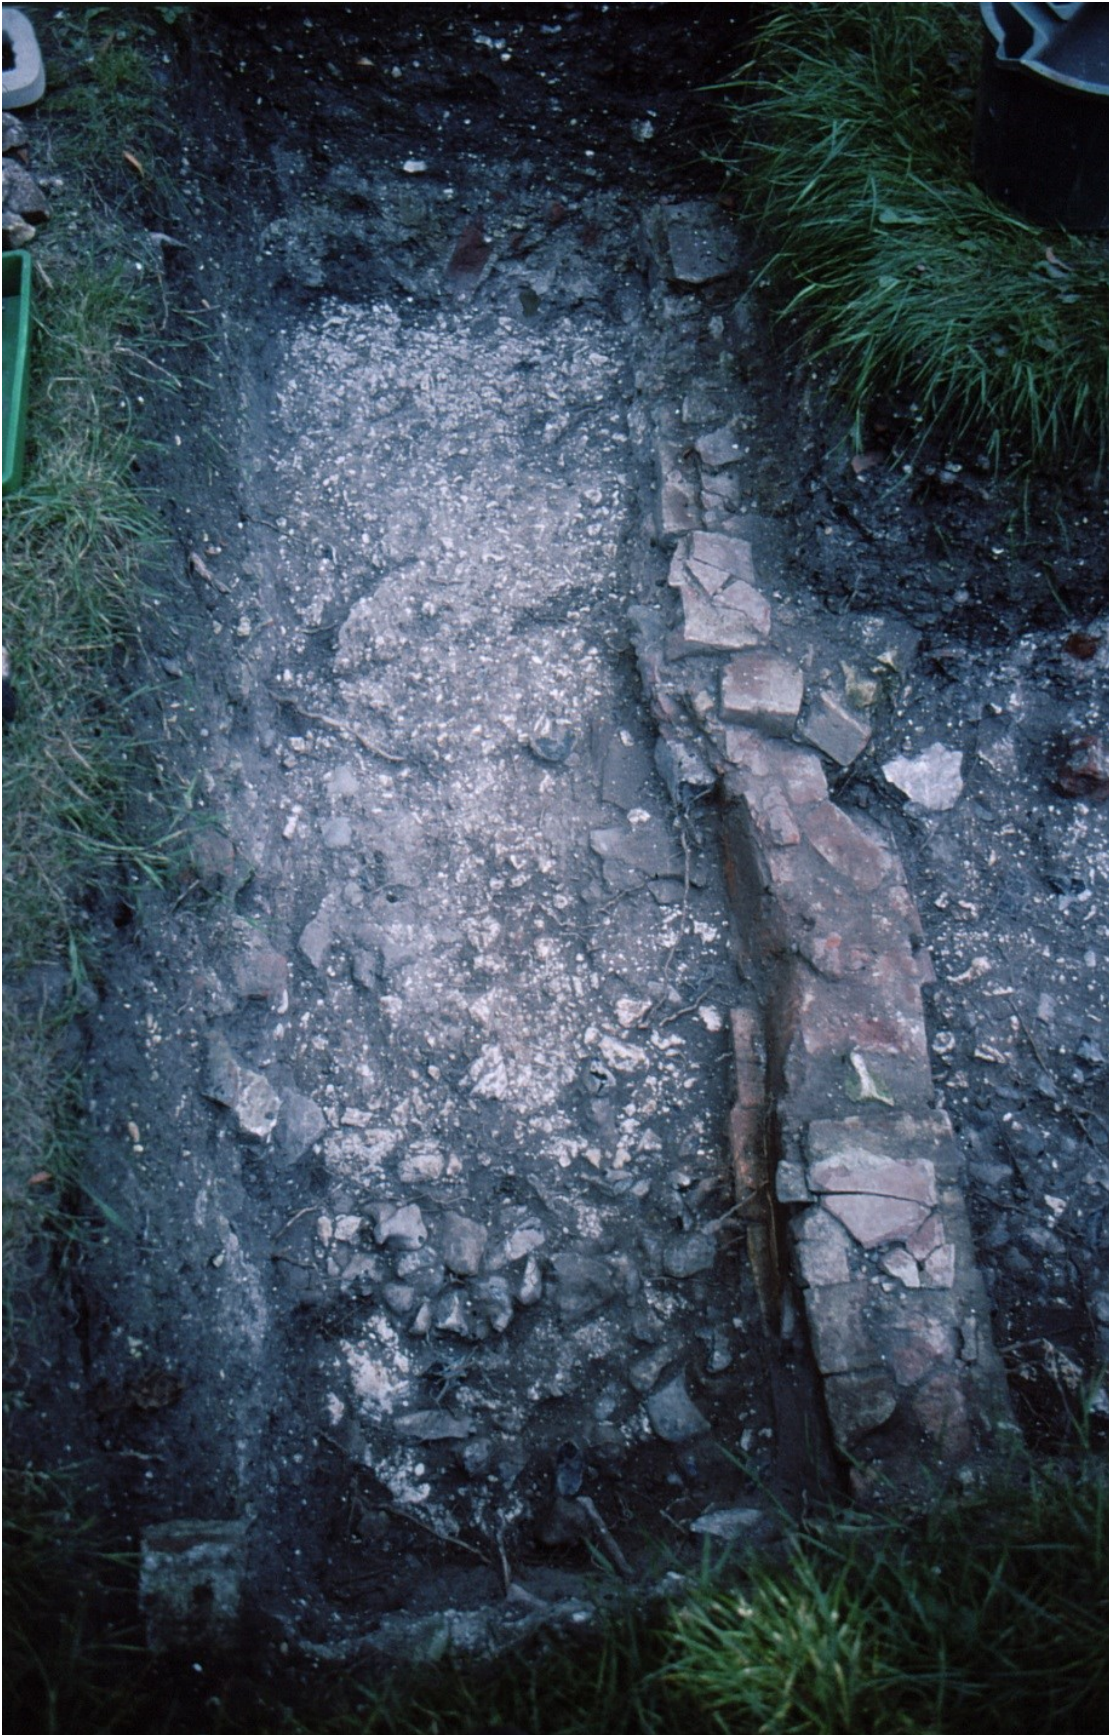
Figure 40. The south end of the East Area looking west. The top of foundation [HD13] to the right.  
The top of [HD56] to the left.

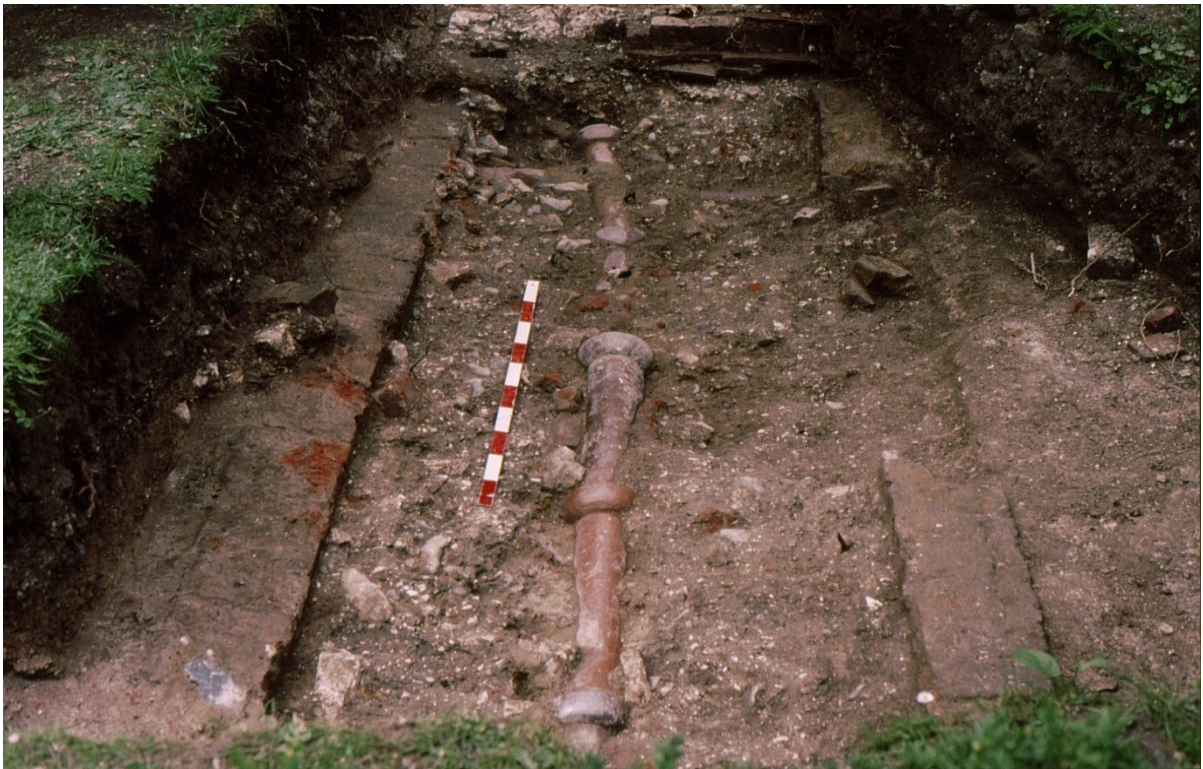
Figure 41. The North Area looking west. Foundation [HD25] to the left and [HD27] to the right. The stoneware drain pipe was in cut fill [HD32].

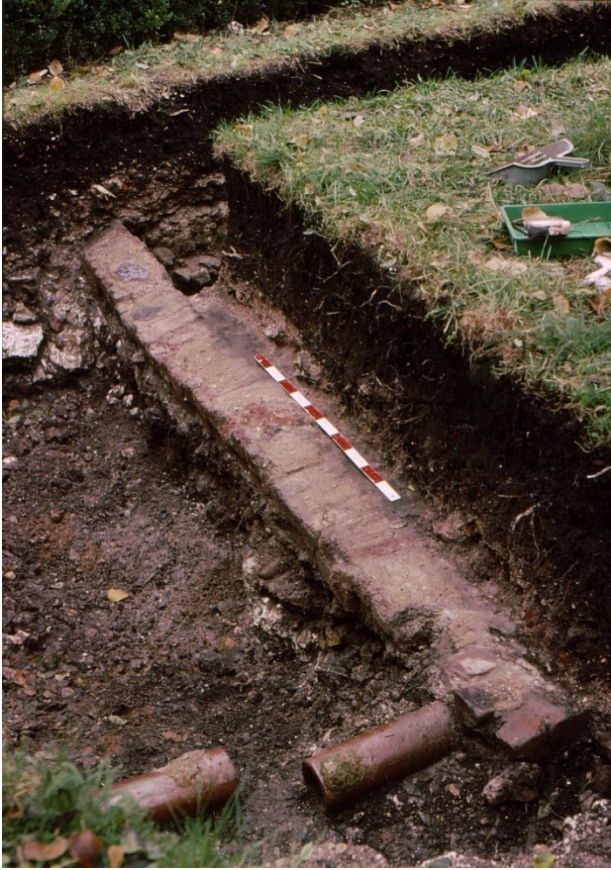
Figure 42. The North Area looking southeast with foundation [HD25].

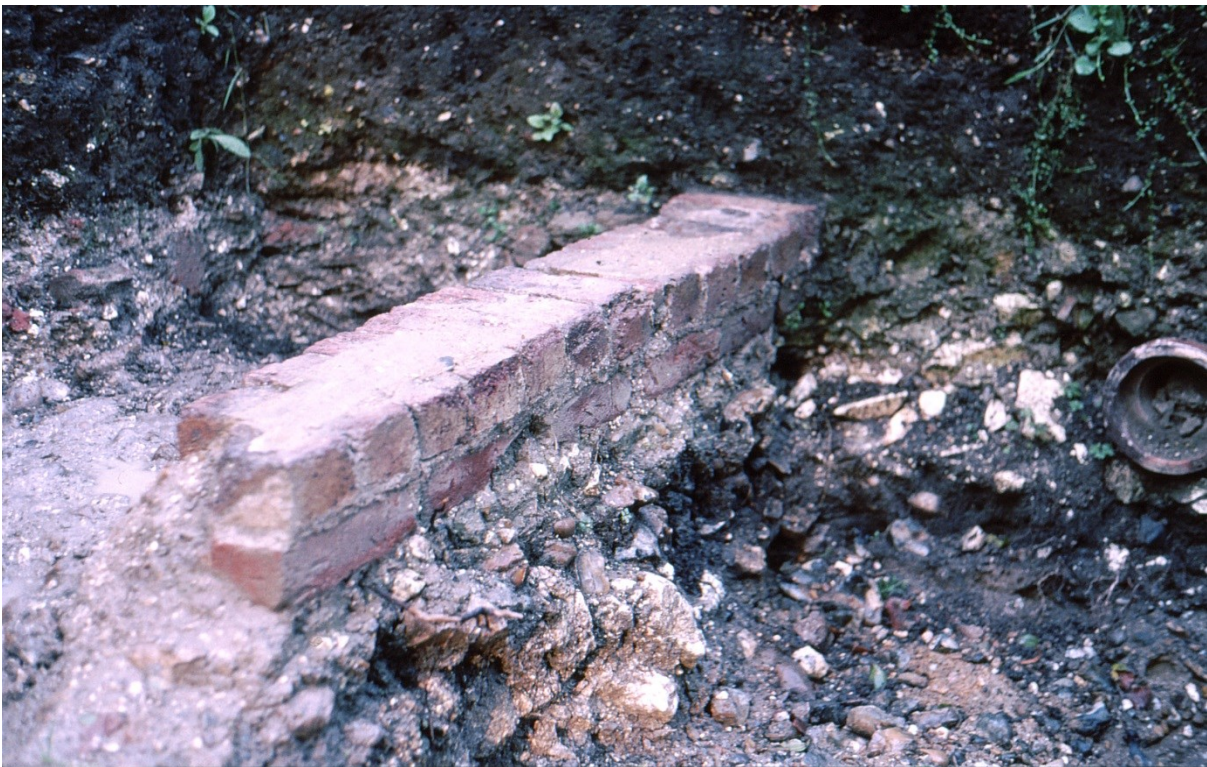
Figure 43. The North Area looking northeast showing the eastern end of [HD27].
