# **Excavations at Honeywood, Carshalton, 1997**

Carshalton & District History & Archaeology Society  
Occasional Paper 7

Site location:

Honeywood Museum, Honeywood Walk, Carshalton SM5 3NX  
TQ 2781 6449

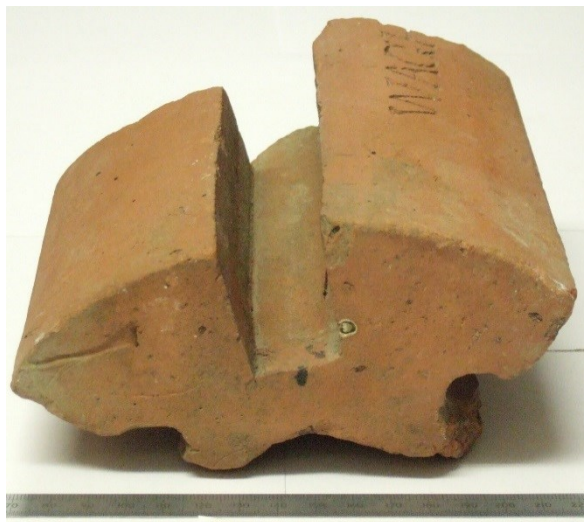
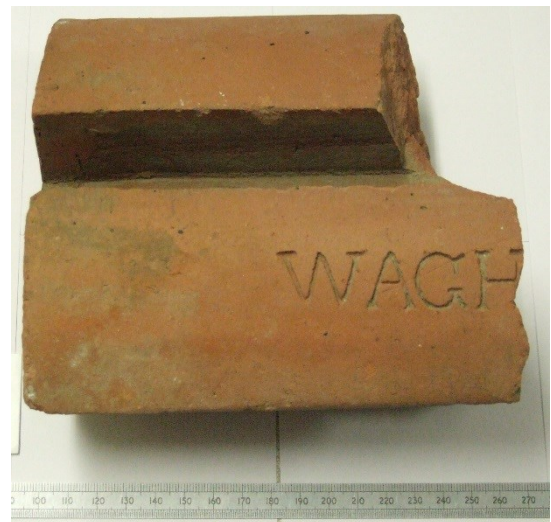
**Layer [HD23]**

<60> Ridge tile? Similar to <61> Hard red fairly fine body. Marked 'WAGH...' probably for Richard Waghorne or his son who operated the Nonsuch pottery from the early nineteenth century until 1851. Surviving length 153mm. 1,781g.

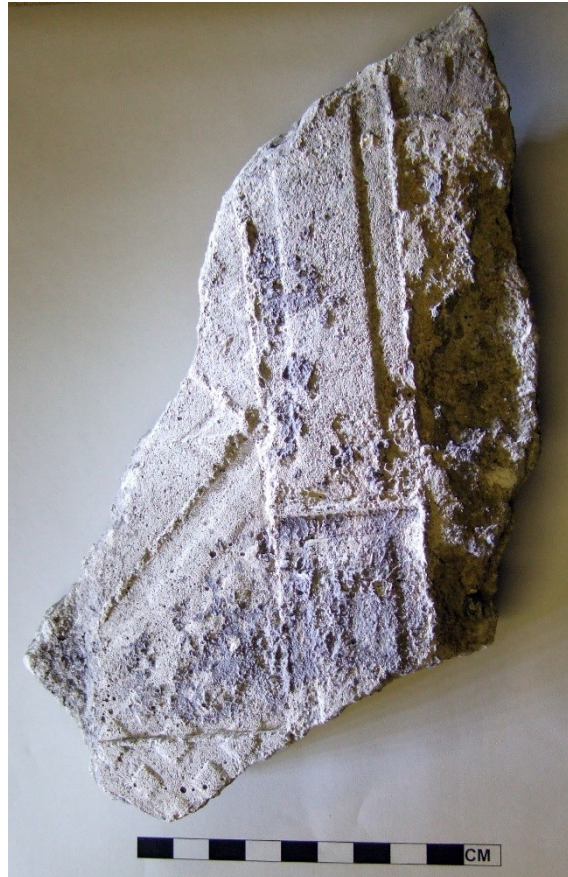
- <24> Rough chalky mortar with flint to 18mm overlaid with finer hard grey mortar which is in turn overlaid finer more yellow mortar with the impressions of small floor tiles some triangular with a side of 75mm. Impressions partly overlaid by dark grey lime scale. Total thickness up to 34mm. 630g.  
The rectangular tiles impressions have a width of 38mm (1.5in)  
The triangular tile has a side 75mm (3in) long.
