# **Carew Manor, Beddington**

**A report on historical and archaeological investigations of  
the house and moat, 1979-2014**

**Volume 1: the house and its owners**

**John Phillips and Nicholas Burnett**

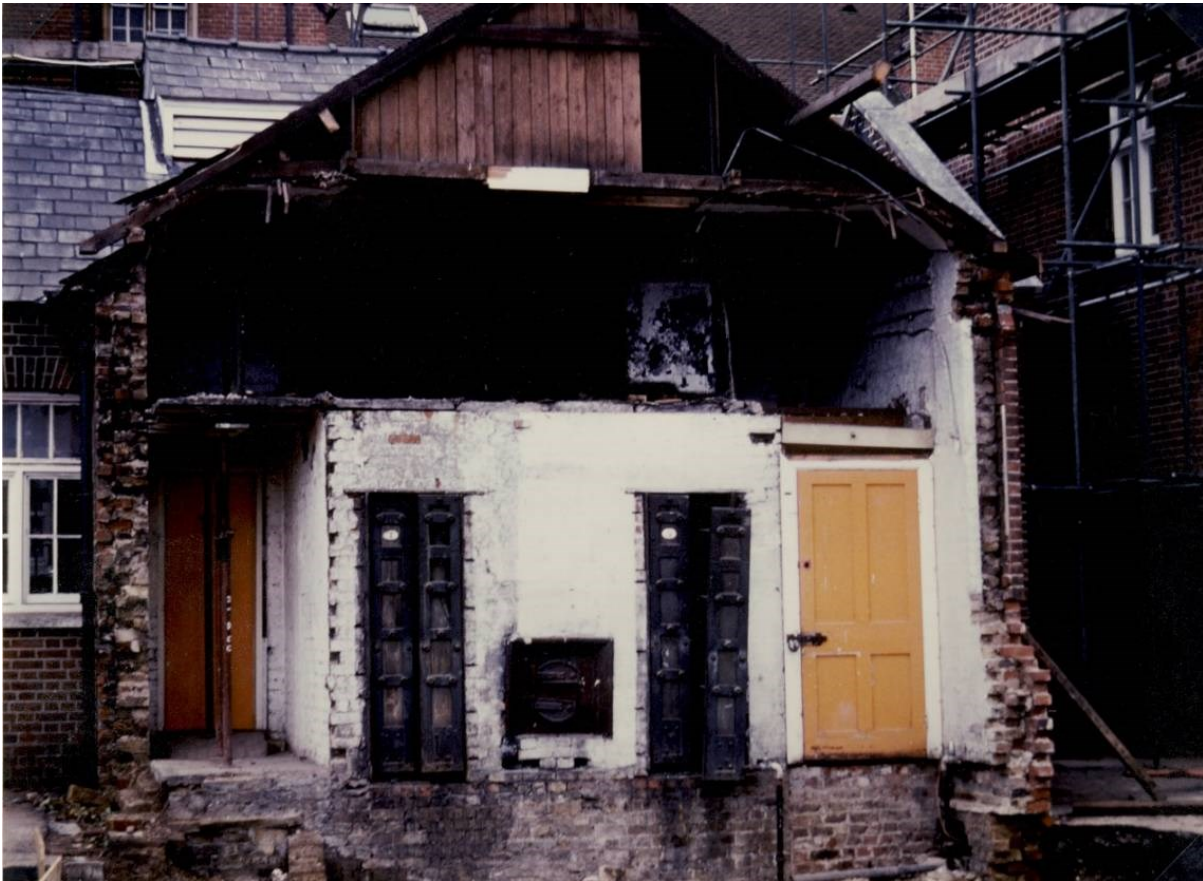
Figure 8. The former laundry in 1983. The north end of the building has been demolished. Note the ends of the drying racks with the massive cast iron fore grate between them. The wood at the top of roof enclosed a water tank.

<sup>225</sup> The racks survived until 1983 when the northern end of the building was reconstructed from the foundations up.

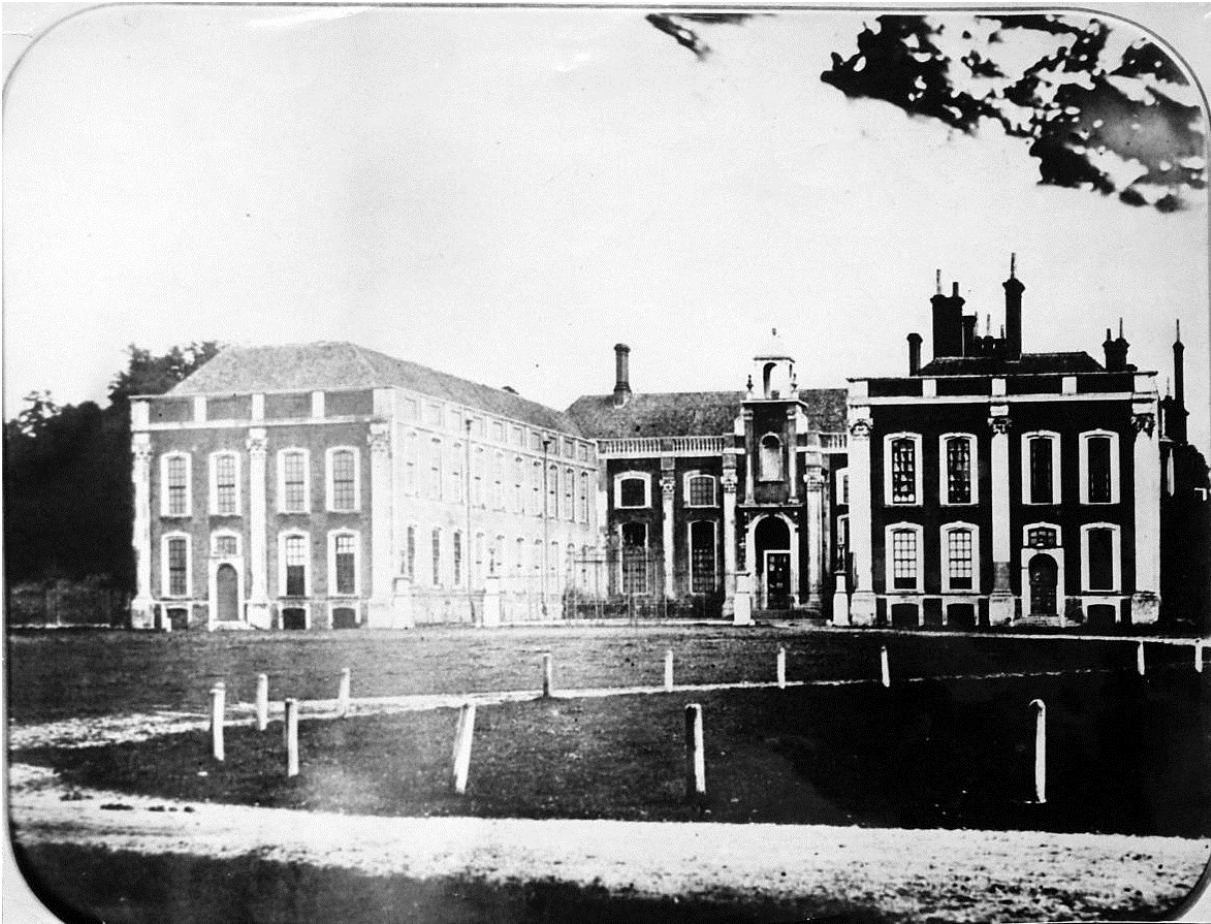
Figure 13. The west front from a photograph taken shortly before the Victorian refacing (Sutton Local Studies Collection).

<sup>253</sup> See Colen Campbell's elevation of the west front (figure 11) and one of the early photos (figure 13).

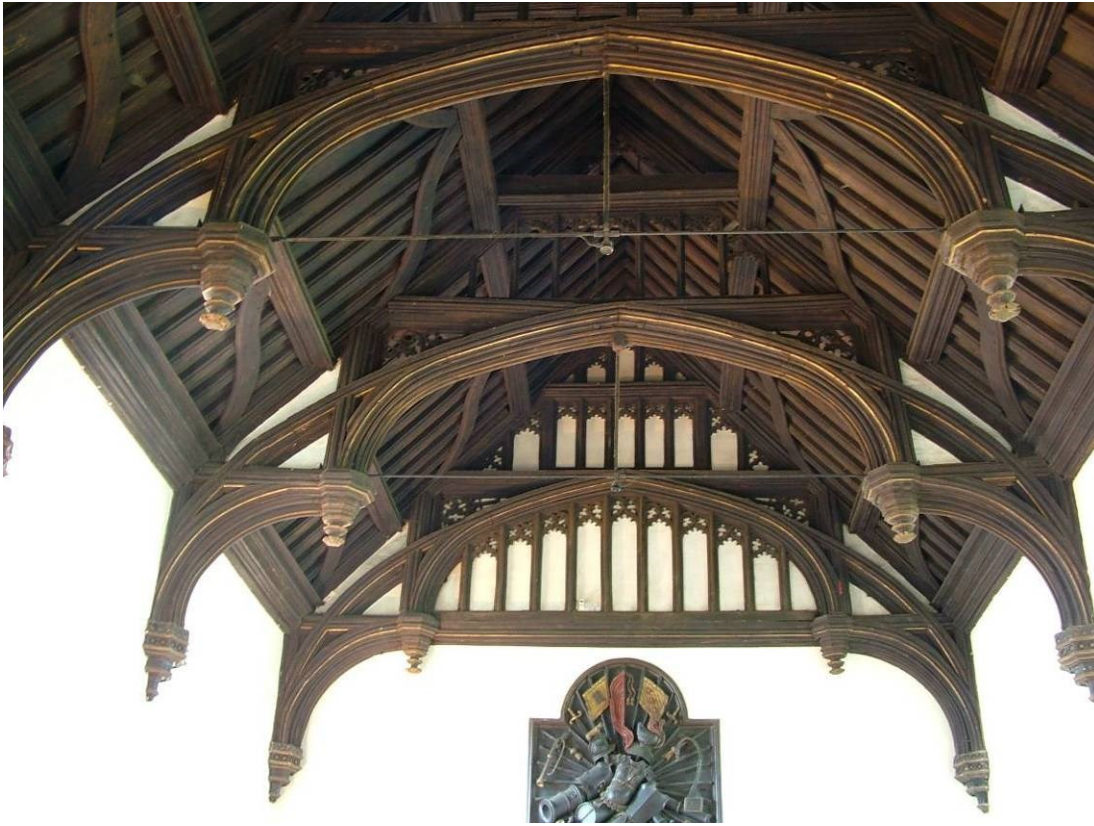
Figure 15. Looking north May 2004.

Each truss has a pair of hammer-beams and hammer-posts. Tie-beams cross the roof just above the junction of the hammer-post and the rafters. Arch-braces run from the centre of the tie-beams down through the hammer-post and hammer-beam to the corbels on the hall wall. There are curved braces from the arch-braces to the hammer-posts and from the bottom of the hammer-posts to the wall. The gaps between the hammer-posts and arch-braces and the arch-braces and principle rafters are filled with plaster panels. Each truss has a second tie beam fairly close to the apex of the roof. The area between this and the lower tie-beam is filled with tracery. There are side-purlins just below the tie-beams which have ogee-shaped braces below them. The bottom of the hammer-posts have pendants with are decorated with single roses.

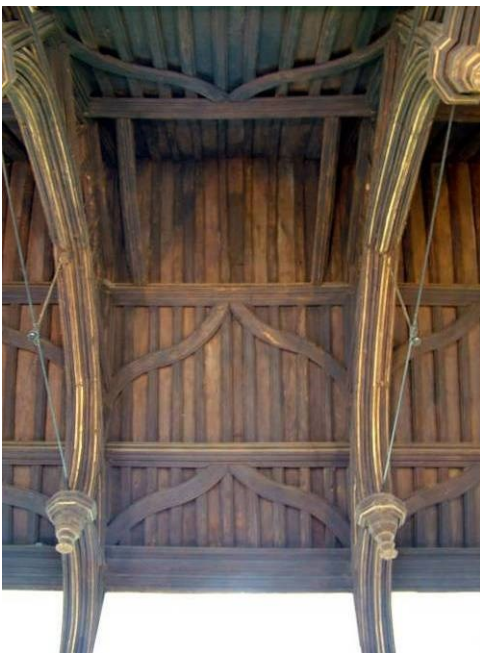
Figure 16. The east side of bay 2.

In bay 2 the upper side-purlins support two timbers which run across the roof (figure 16). These are not found the other three bays and it seems likely that these originally supported a louver above an open hearth. The household accounts for 2-9 July 1570 record a payment to 'Ric wona for a daie making of a caffolde for ye loves on ye hale xij<sup>d</sup>' and the following account mentions 'bares glasse for y<sup>e</sup> Lover' which suggests that the structure was no longer a smoke outlet.<sup>229</sup>

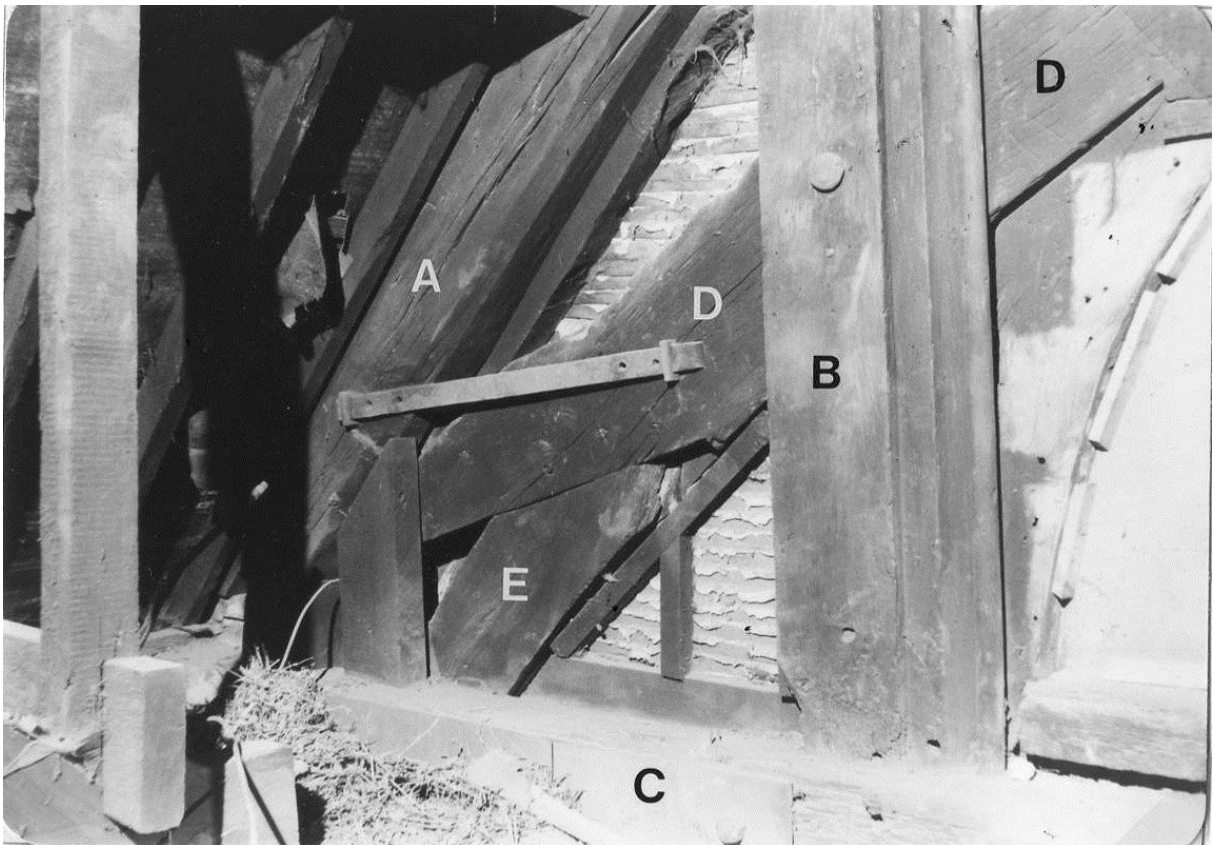
Figure 19. The east end of the north side of truss 1. A = rafter, B = hammer-post, C plate resting on the hall wall, D = the arch brace which turns aside to join the rafter, E = timber continuing the line of the arch brace.

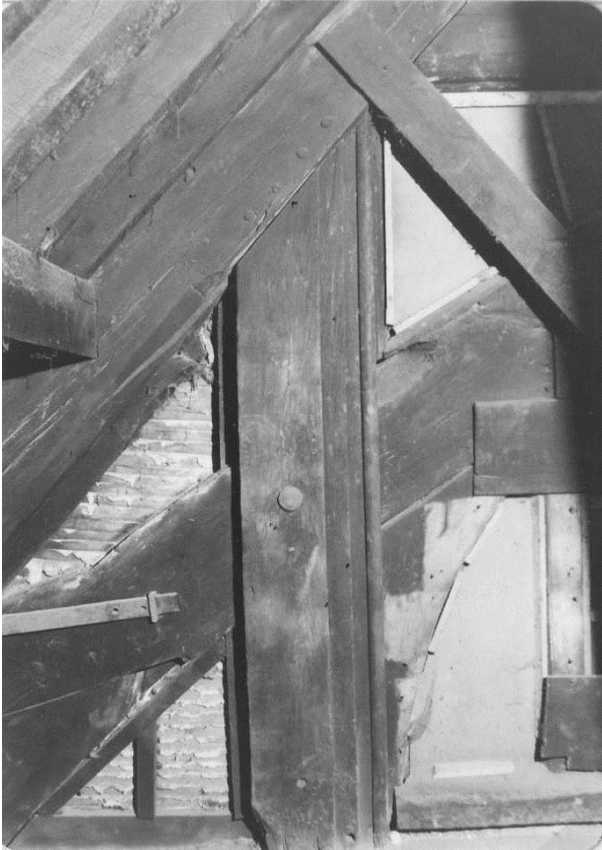
Figure 20. Truss 1, the north side of the eastern hammer-post.

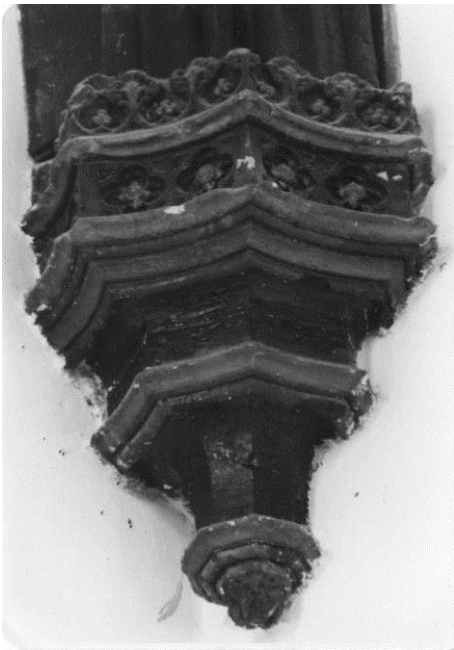
The roof rests on stone corbels at least visually although perhaps not structurally. The decoration on the corbel on the east side of truss 1 is fully finished but all the others are in varying states of incompleteness with parts of the decoration only in outline.

Figure 21. The corbel on the east side of truss 1.

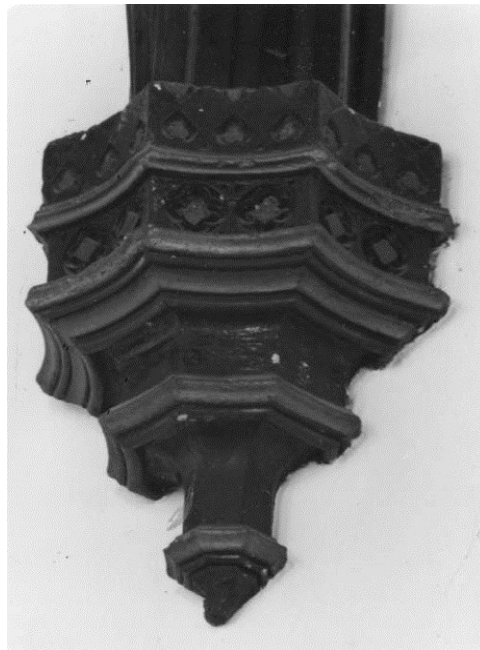
Figure 22. The corbel on the east side of truss 2.

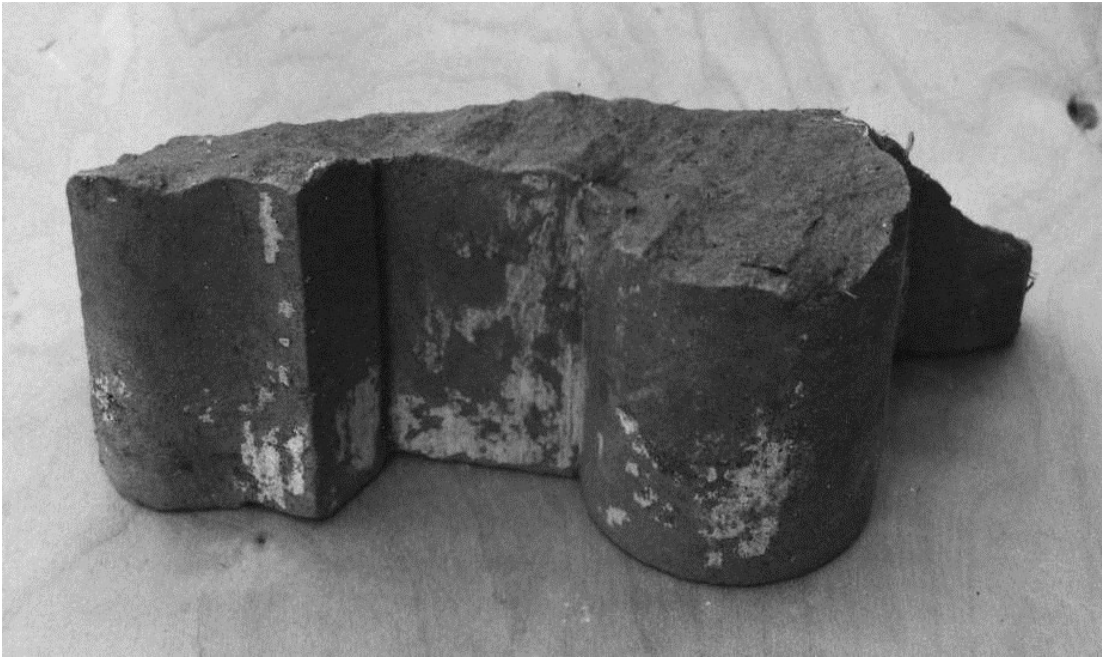
Figure 23: Find <5> from trench CM. Part of a window moulding reconstructed in figure 24 below.

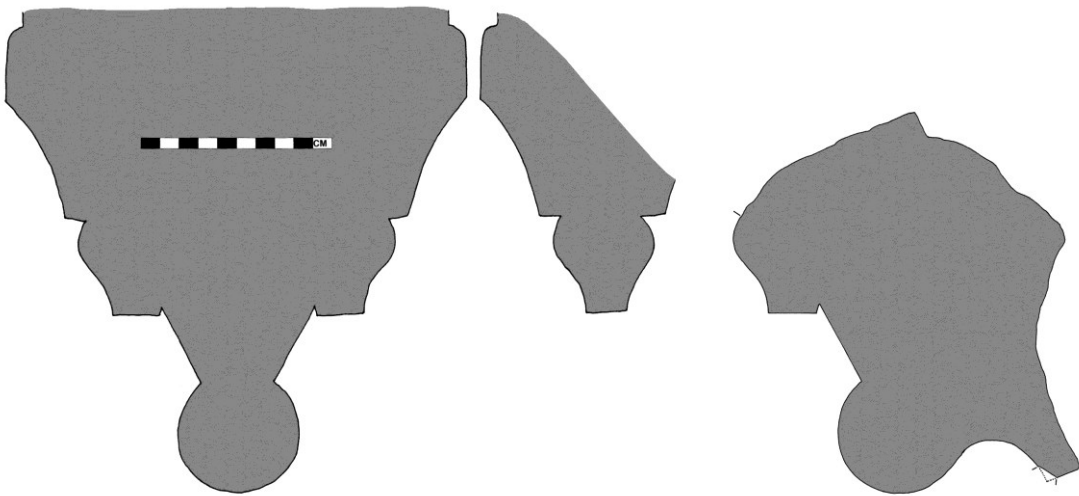
Figure 24. Reconstruction of the mouldings from trench CM. Central mullion moulding to the left, secondary mullion in the centre and the side of the window to the right.

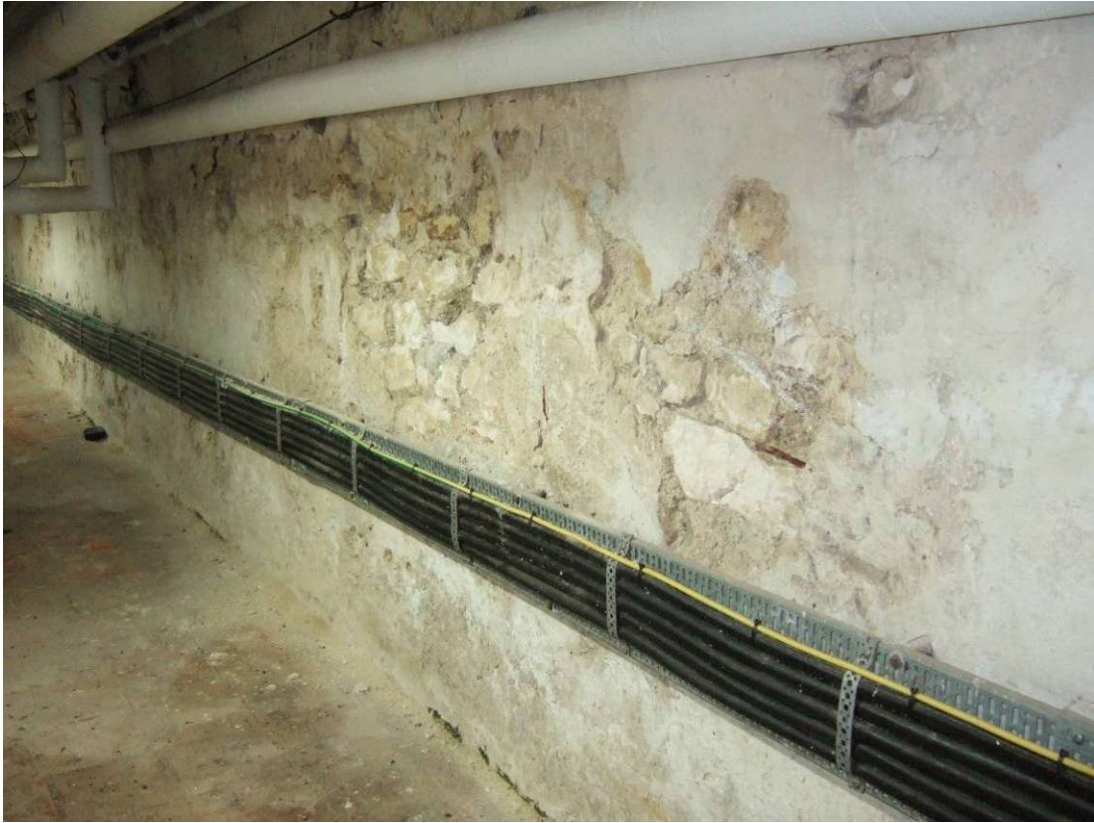
Figure 29. The west wall of the passage below the hall looking south in May 2010.

A passage runs below the west side of the hall connecting the cellars beneath the service block to those in the north wing (figure 29). The passage is vaulted and is 2.26m high and 1.59m wide. Both walls have been plastered but this has fallen off in many places exposing the underlying structure. The west side is the foundation of the western wall of the hall and is of chalk rubble with a few fragments of roof tile and, in one place, some brick. The other wall is mostly of eighteenth century-looking brick with some areas of rubble. There are a few blocks of chalk and Reigate stone. At the southern end there is an area covered with peg tiles which are 260mm by 155mm. There are four niches in the east wall. There is a hole in the back of one of these and the fill behind it appears to be loose grey sand which in this context cannot be natural.

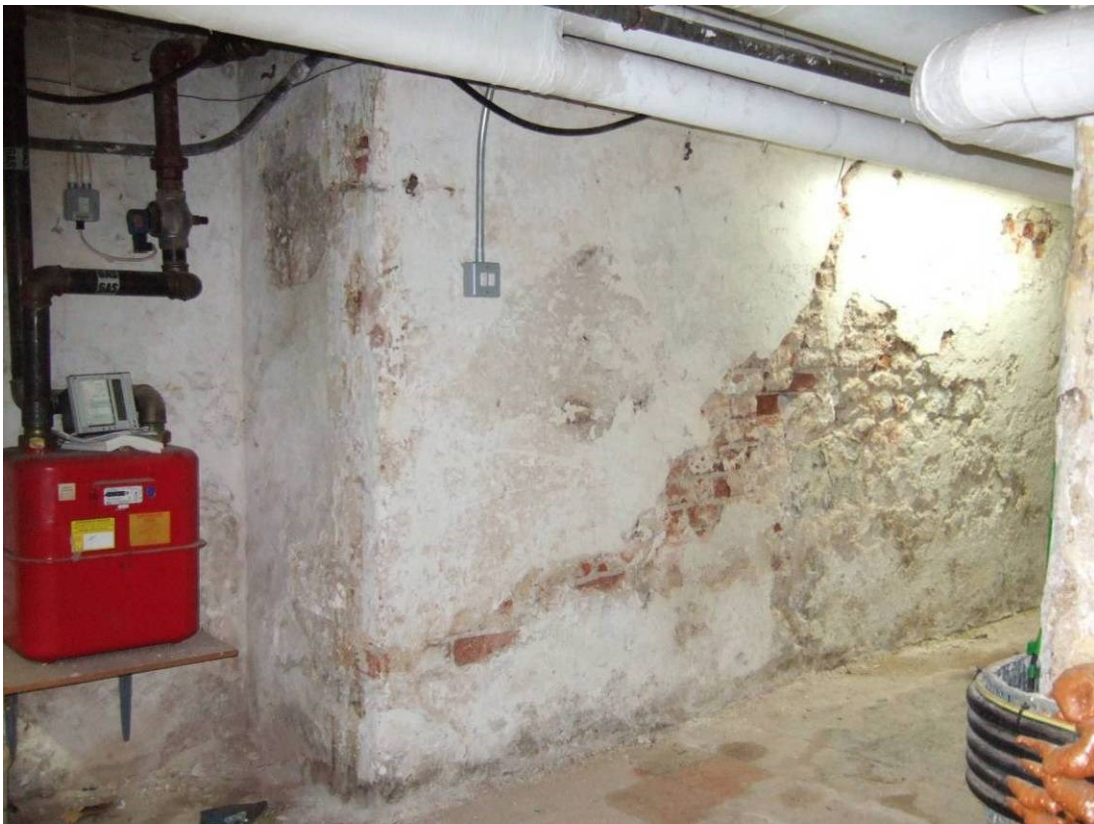
Figure 30. The east wall at the north end of the passage below the hall. Note the bond-break between the brick and the rubble.

There is a bonding break in the east wall 1.62m from the north end of the passage. It rises vertically from the floor to a height of 0.98m and then appears to be corbelled out in a southerly direction (see figure 30). This must mark the junction with the north wall of the hall.

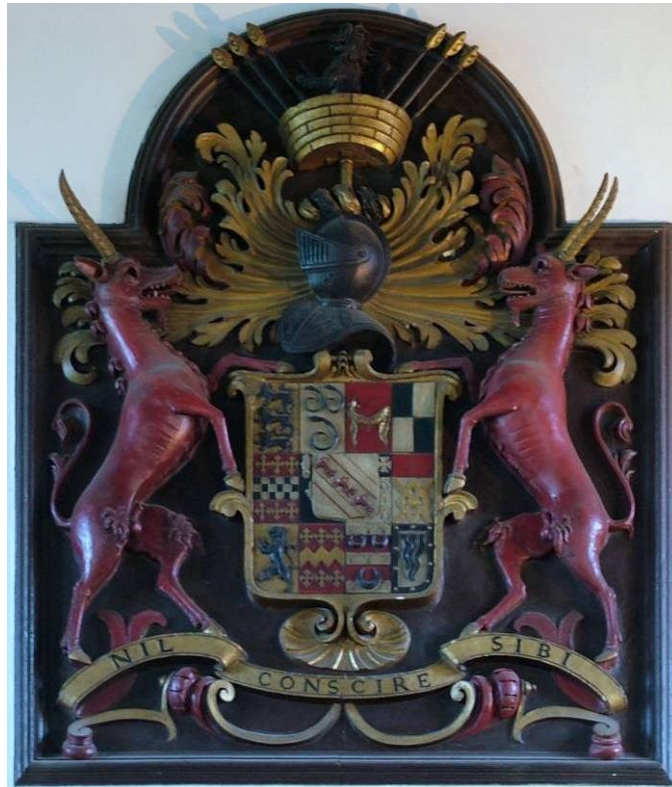
Figure 34. The plaster panel on the south wall of the great hall (above) and the north wall (below).

south walls. These survive and are shown in figure 34. They are of plaster and are well moulded in high relief. The southern panel contains the Carew arms with the Hacket arms in pretence so the scheme must there postdate Nicholas Carew's marriage to Elizabeth Hacket on 2 February 1709 and predate her father's death in or before 1721.<sup>263</sup> The northern panel is a trophy of weapons and armour of various periods from classical to eighteenth century. There are banners carrying the Carew and Hacket arms and the couples intertwined initials appear on the pouch on the left hand side of the display.

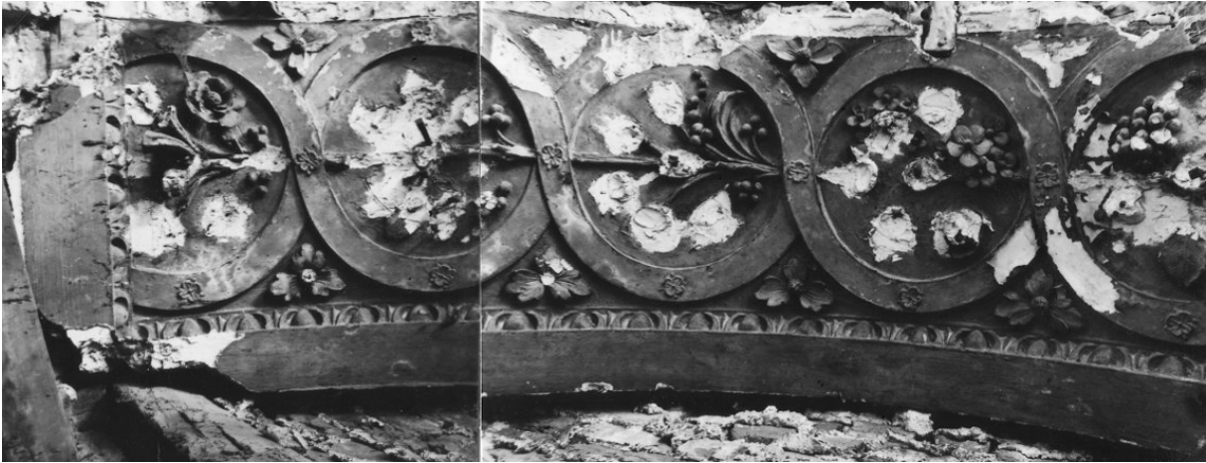
Figure 35. The underside of the opening which formerly connected the northeast corner of the hall to the parlour.

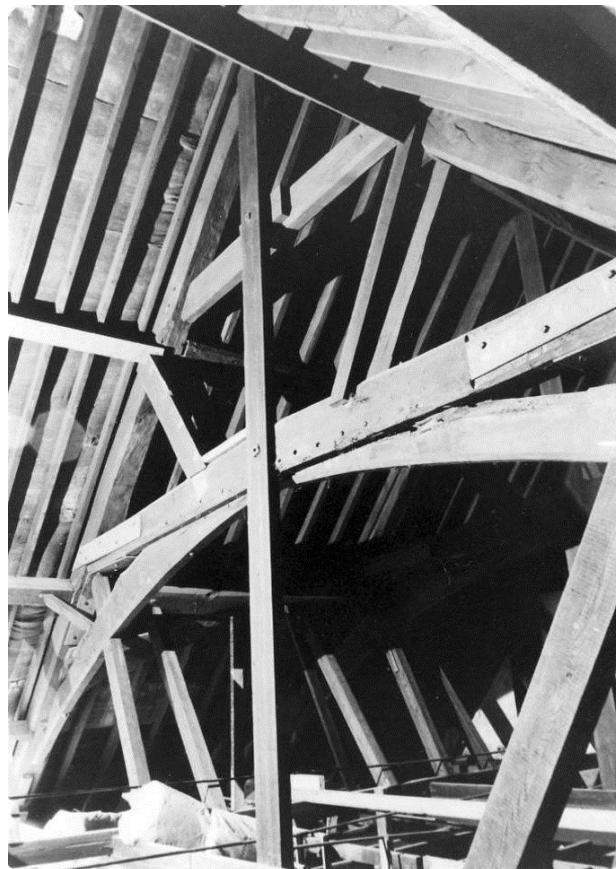
Figure 38. The service area roof showing the south side of truss 7. February 1981.

The service area roof has two early trusses and another which dates from the nineteenth century (figures 37 to 40). The trusses have been numbered continuing from the hall roof so the two early ones are 6 and 7 and the nineteenth century one is 8.

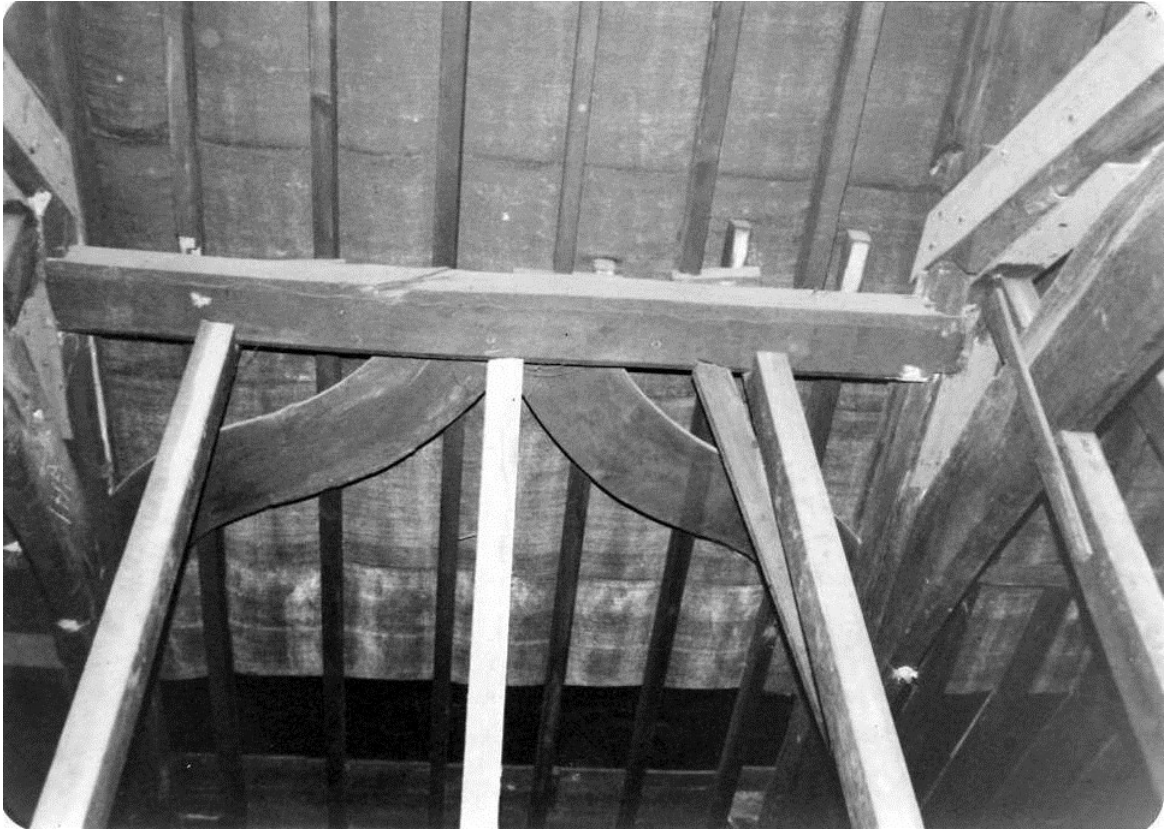
Figure 39. The surviving set of braces on the west side of the service area roof between trusses 6 and 7. February 1981.

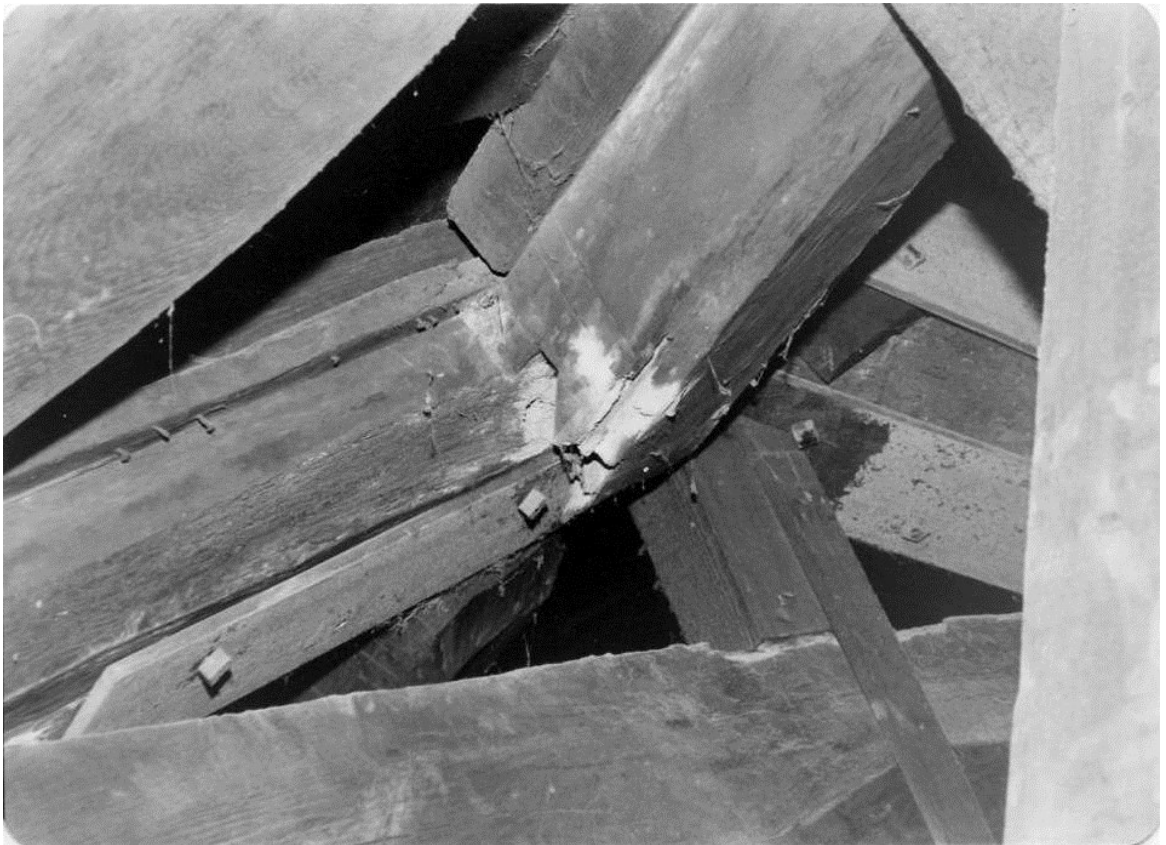
Figure 40. The west side of the service area roof showing the junction between the purlin and the south side of truss 6. February 1981.

There are double diminished haunched tenons for purlins on both sides of trusses 6 and 7 (see figure 40). There are tenons for braces to the purlin between trusses 6 and 7 and also to the purlin running south from the east side of truss 7. However, there is no tenon for a brace on the opposite side of the roof. The purlins are simply slotted into the top of truss 5 which forms the south end of the hall roof. This suggests that the service roof is later than the hall roof although there is unlikely to be much difference in date. Hewett says that diminished haunched tenons were probably developed by Richard Russell, the carpenter responsible for

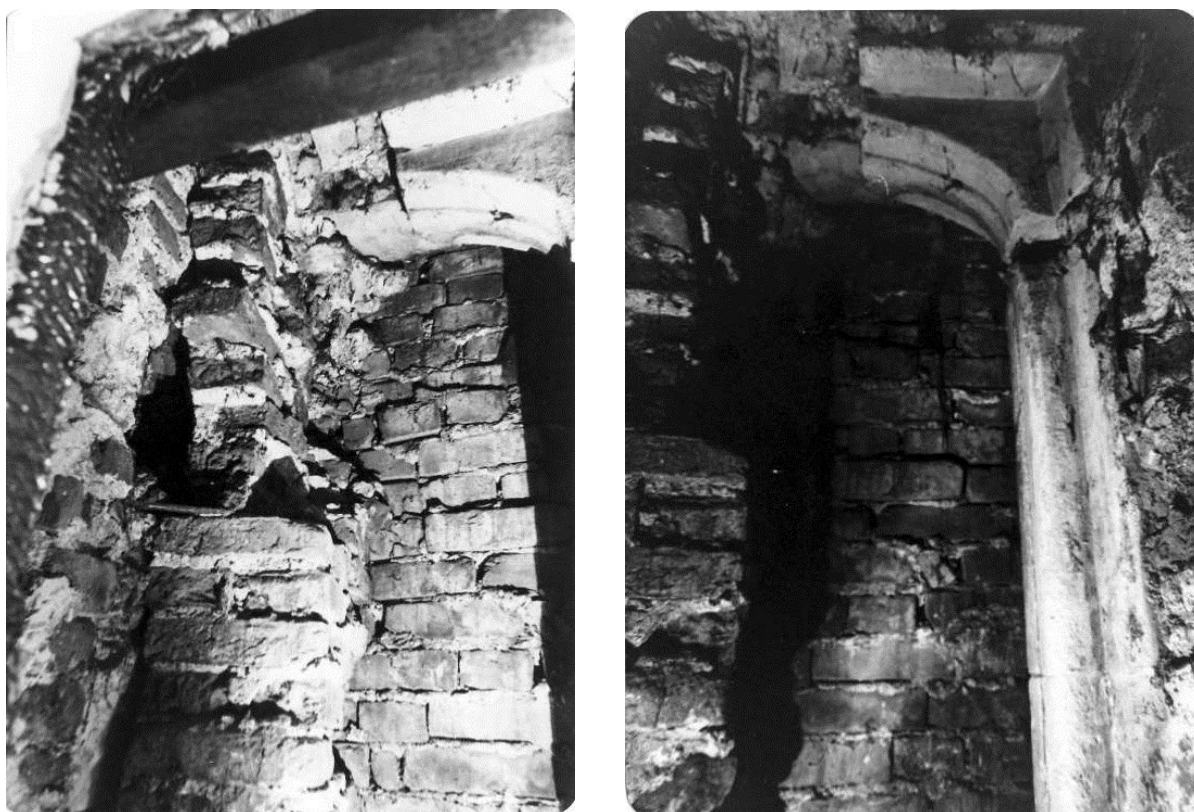
Figure 41. The Foster window showing the surviving south side and the rough brickwork installed after the north side had been removed. The windows were blocked when the house was refaced in the eighteenth century.

The north side of the Foster window has been removed and replaced with rough brickwork using thin bricks of sixteenth or early to mid-seventeenth century date. This may be associated with the construction of the staircase shown on Colen Campbell's plan (115 on figure 36). We do not know when this staircase was constructed. If the window was still open in the early eighteenth century it would have been bricked over then as it does not fit with the classical re-facing of the east front.

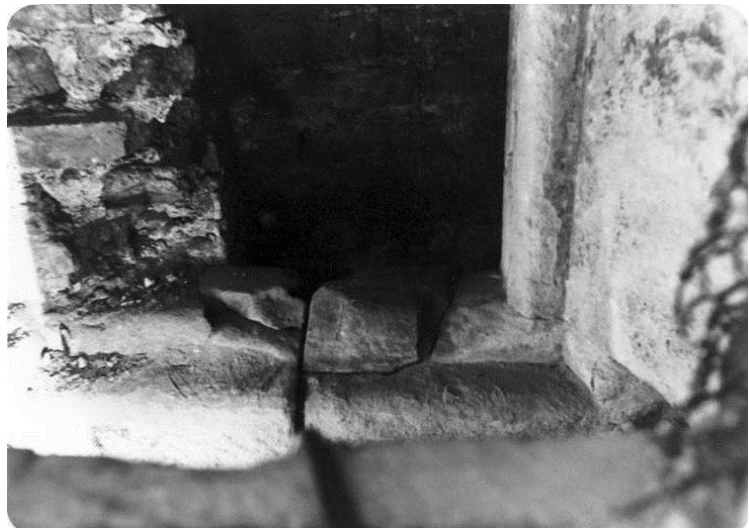
Figure 43. The bottom of the window.

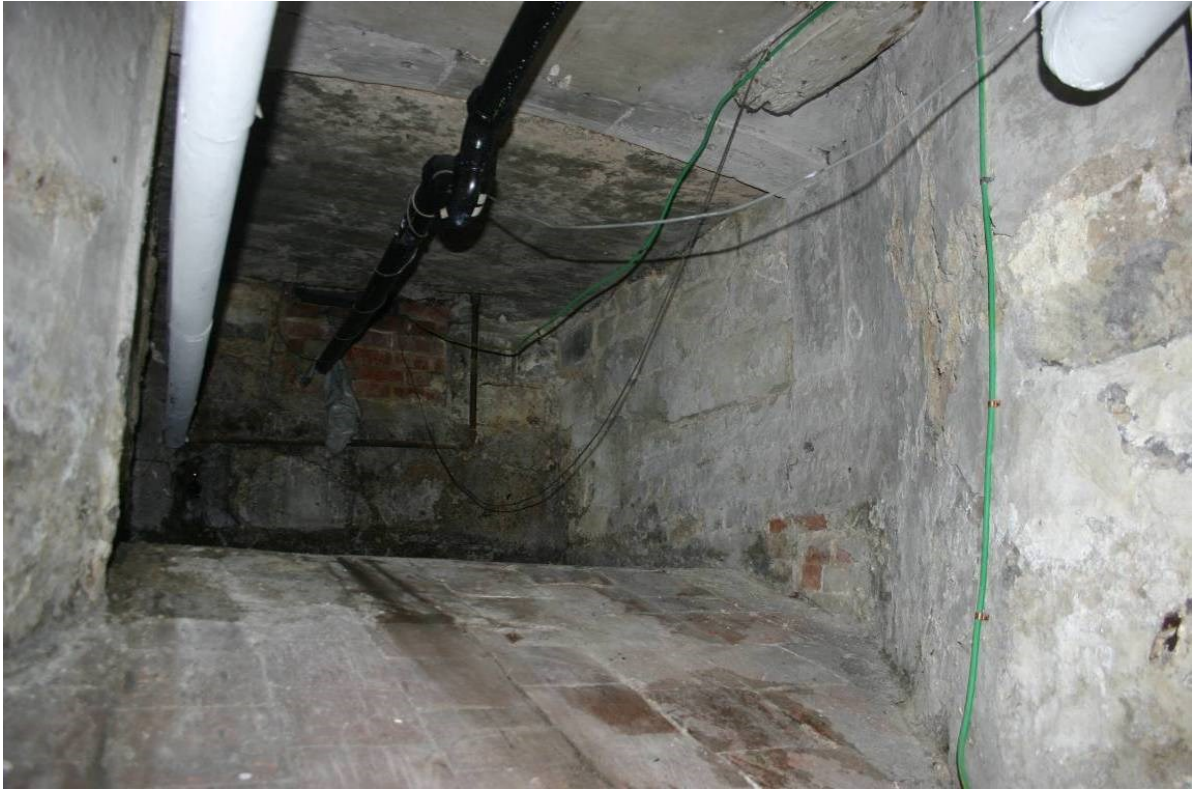
Figure 49. The barrel chute on the west side of cellar 6 in August 2007.

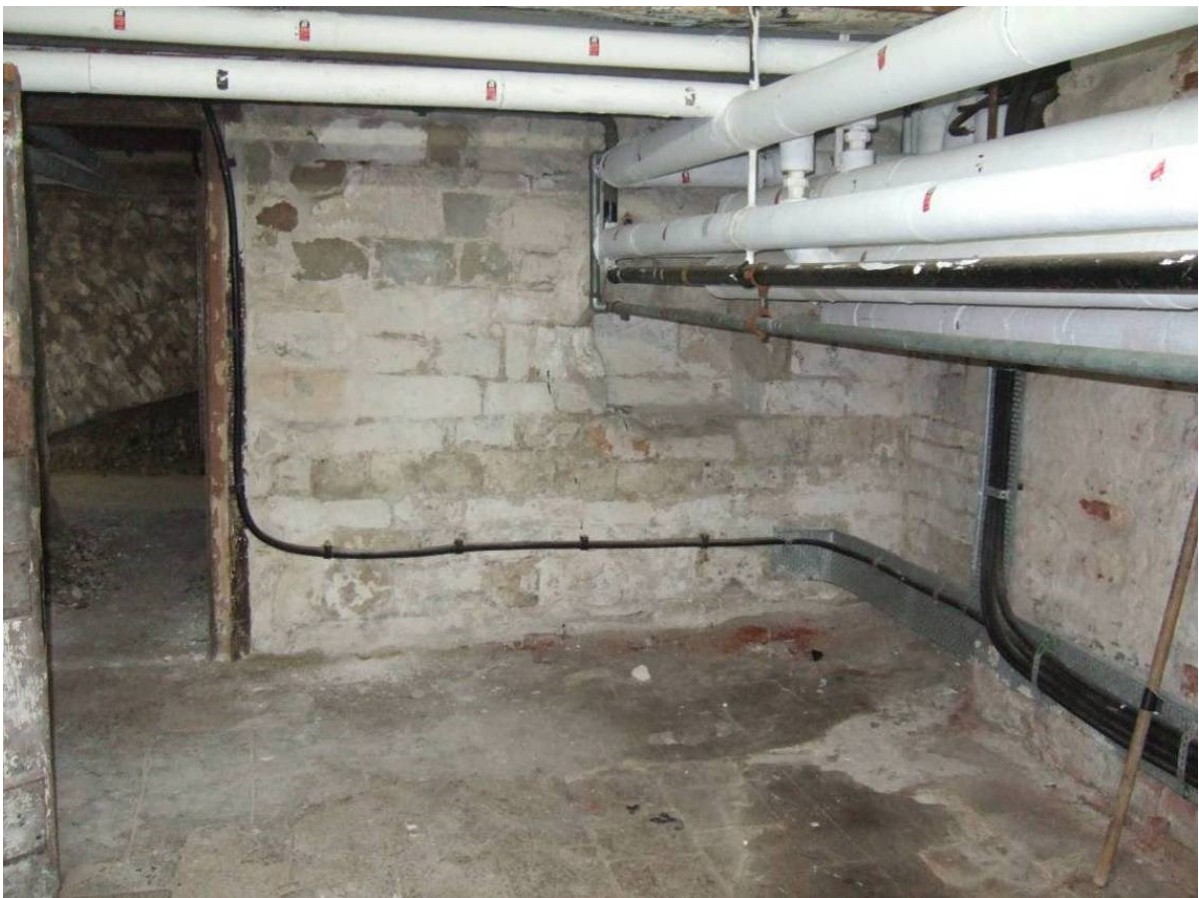
Figure 50. The south wall of cellar 6 in May 2010. The door on the left opens to the passage cut through the foundations of the former kitchen.

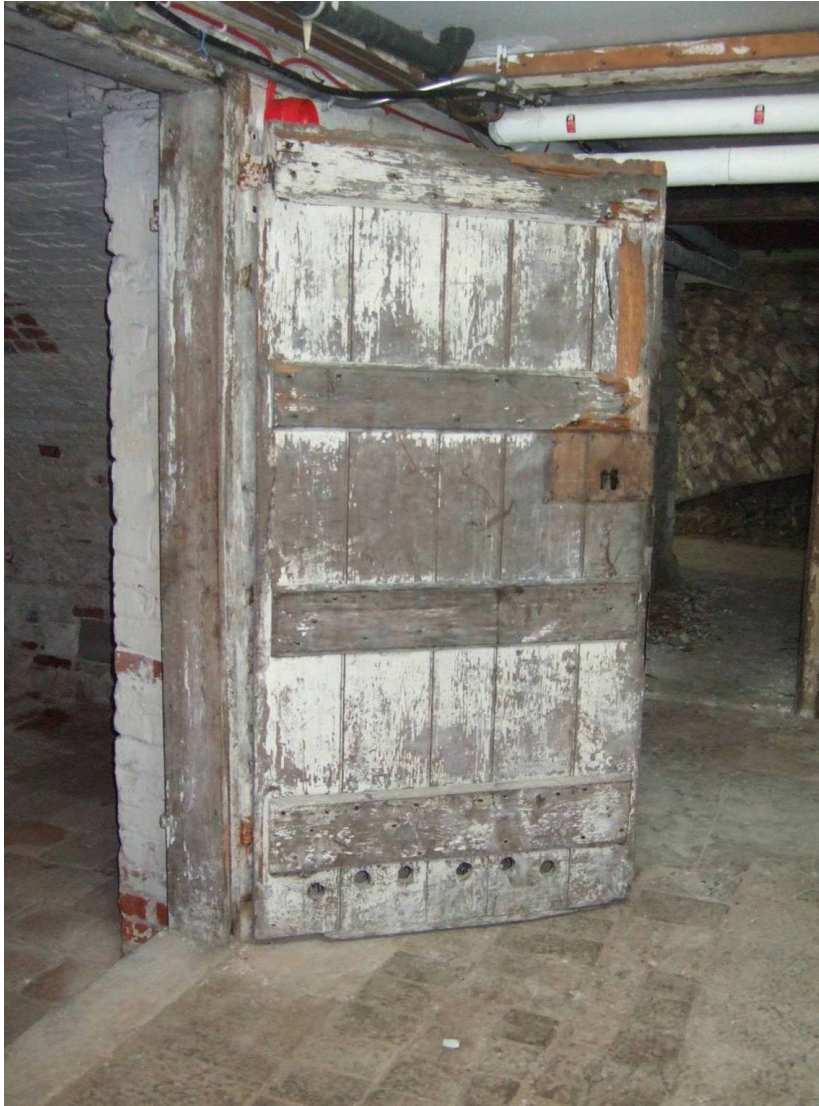
Figure 51. The door between cellar 6 (right) and cellar 7 (left) in May 2010.

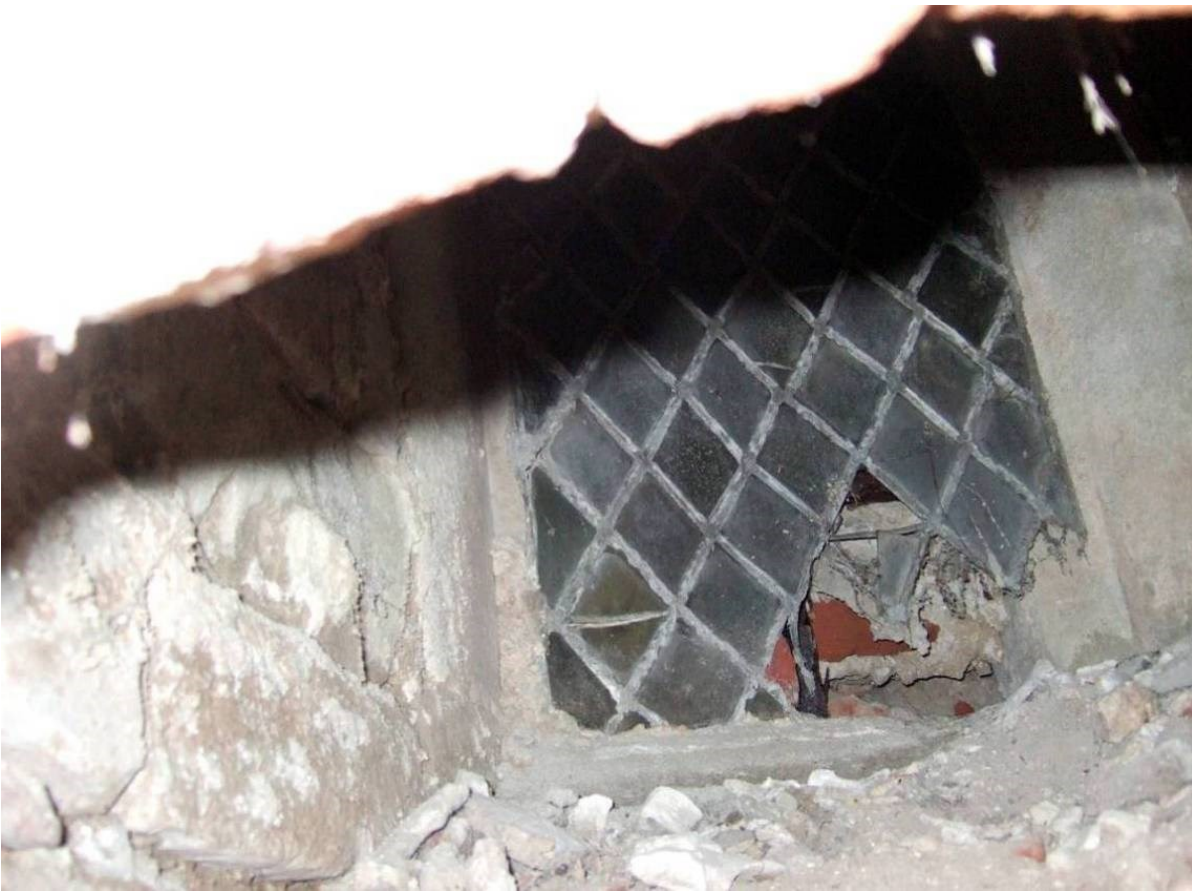
Figure 54. A bricked up window in the east wall of cellar 7 seen through a small gap between the vault and wall in September 2009.

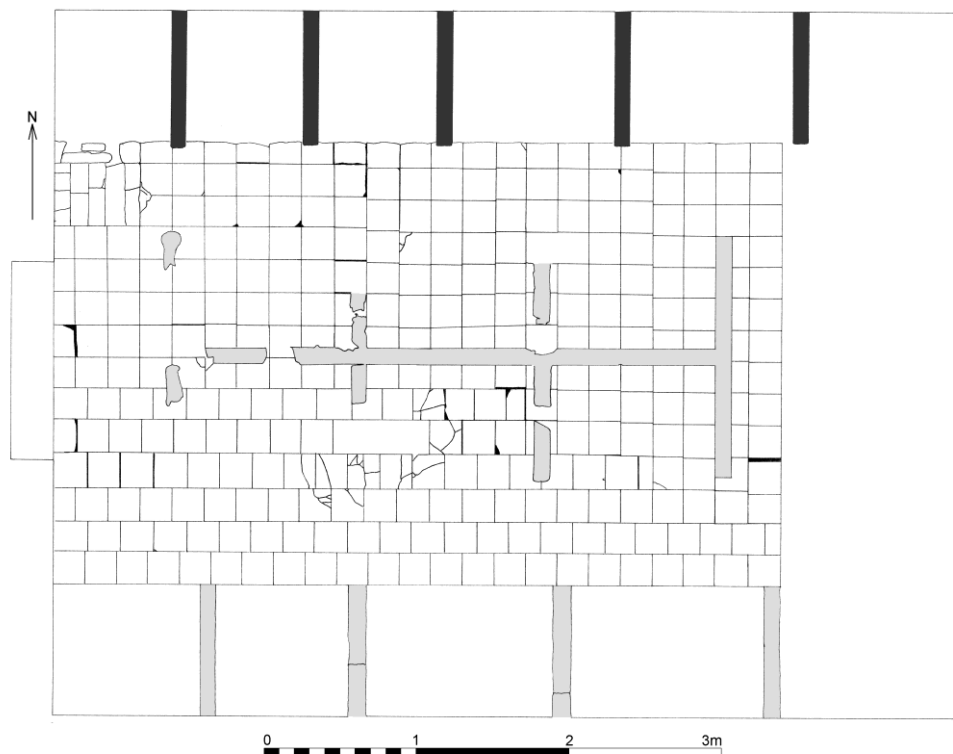
Figure 55. Plan of the floor of cellar 7 showing the bottom of the wine racks (dark grey) and the scars from the demolished ones (light grey). The blank areas around the edge of the cellar are brick-floored.

The floor beneath the bins on the north and south side of the cellar is of brick but the rest is covered with tiles. These have a red body and a few still have traces of yellow or green glaze over a white slip. They are 8 inches square (20.3cm) and 1½ inches (3.8cm) thick and have bevelled edges. A few preserve pin marks in the corner. The crazing of the glaze shows that it had been applied after a biscuit firing. This was the usual practice in the Netherlands and they were probably made there in the late fifteenth or early sixteenth century.<sup>267</sup> The tiles are now rather irregularly laid and are likely to have been reused.

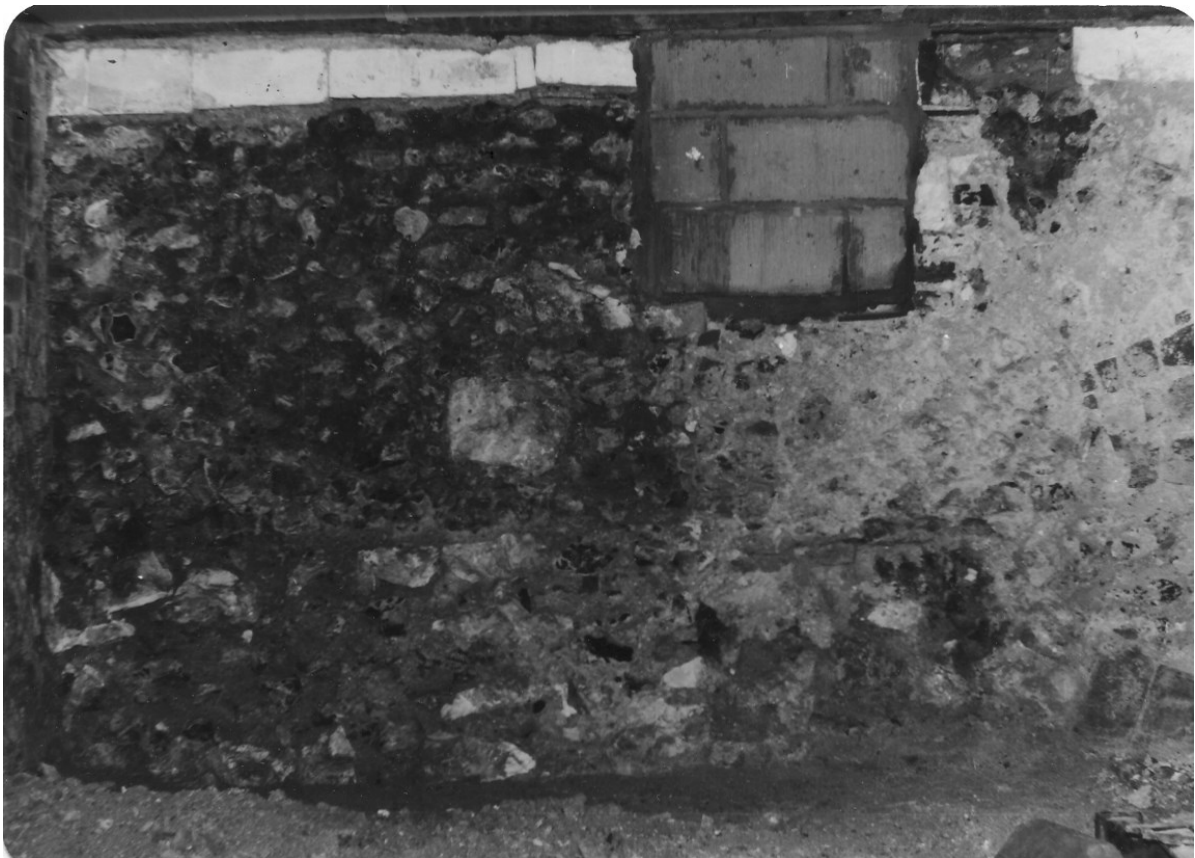
A – gap where a stone block has been removed; B – flint and mortar; C – Earth and flint; D – brick and lump of chalk; E – flint and mortar where the south wall has been cut back; F – timber lintels; G – ‘cupboards’ built into the wall; H – butt joint in the brickwork.

Figure 62. The south wall of cellar 8.

The earliest part of cellar 8 is probably the south wall (figure 61). The greater part of the bottom of the wall is made of flint bonded with mortar although there is a section of chalk, flint and loose earth in the centre which is probably some sort of filled feature. The upper part of the east end is of flint and earth and it is possible that the eastern end is made of the same material although it is largely covered with plaster. There is a blocked window at the top towards the centre with an area of flint and hard mortar below. The wall has a thickness of about 1.52m and the outer face would have dropped directly into the moat.

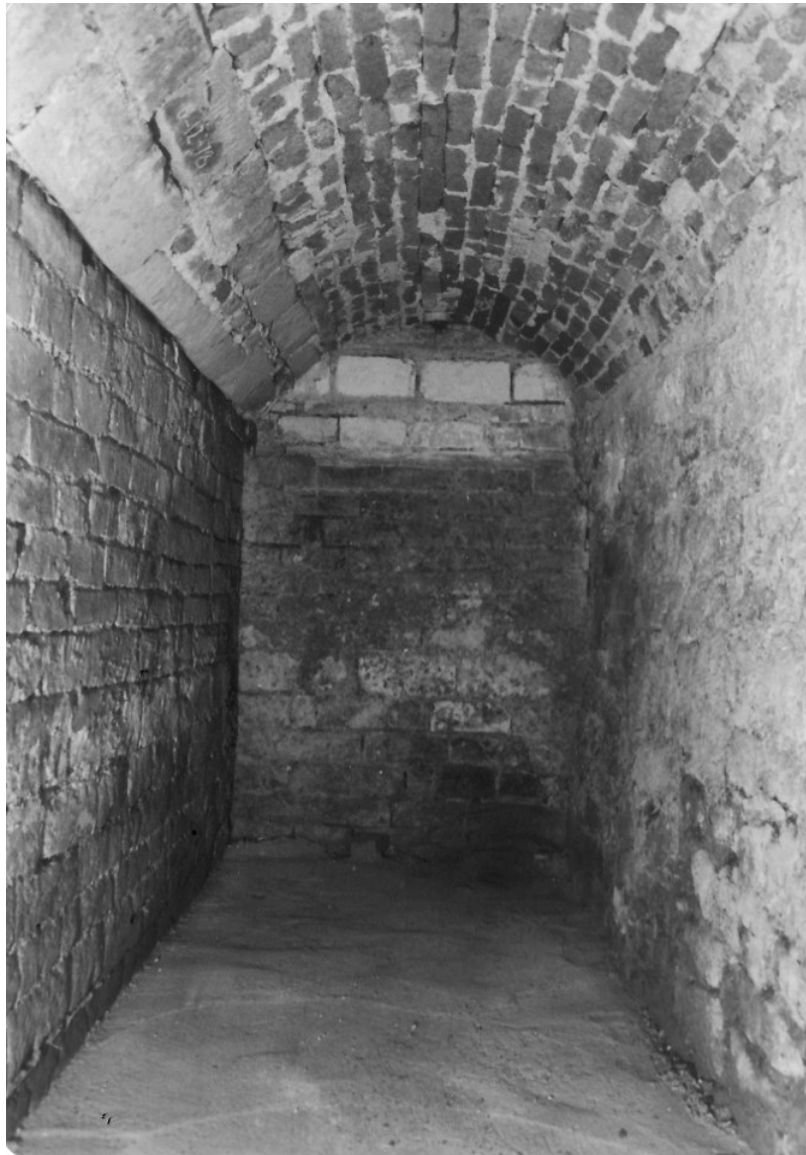
Figure 65. Cellar 9 looking west.

Cellar 9 (figures 65 and 66) is small and rectangular with chalk block walls and a rather roughly made vault of brick and chalk blocks which is probably an addition or replacement. The south and west walls of the cellar are much more neatly made than the north wall.
