# **Carew Manor, Beddington**

**A report on historical and archaeological investigations of  
the house and moat, 1979-2014**

**Volume 1: the house and its owners**

**John Phillips and Nicholas Burnett**

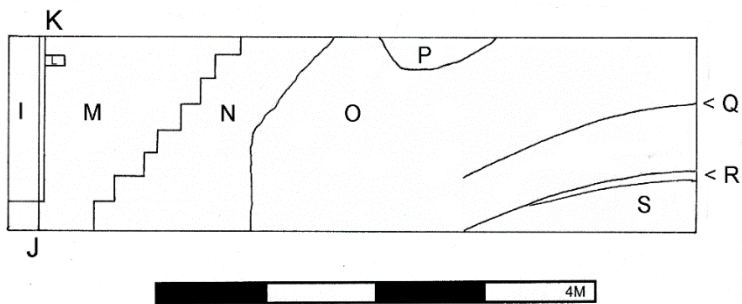
Figure 67. Diagram of the south and west walls of passage 2.

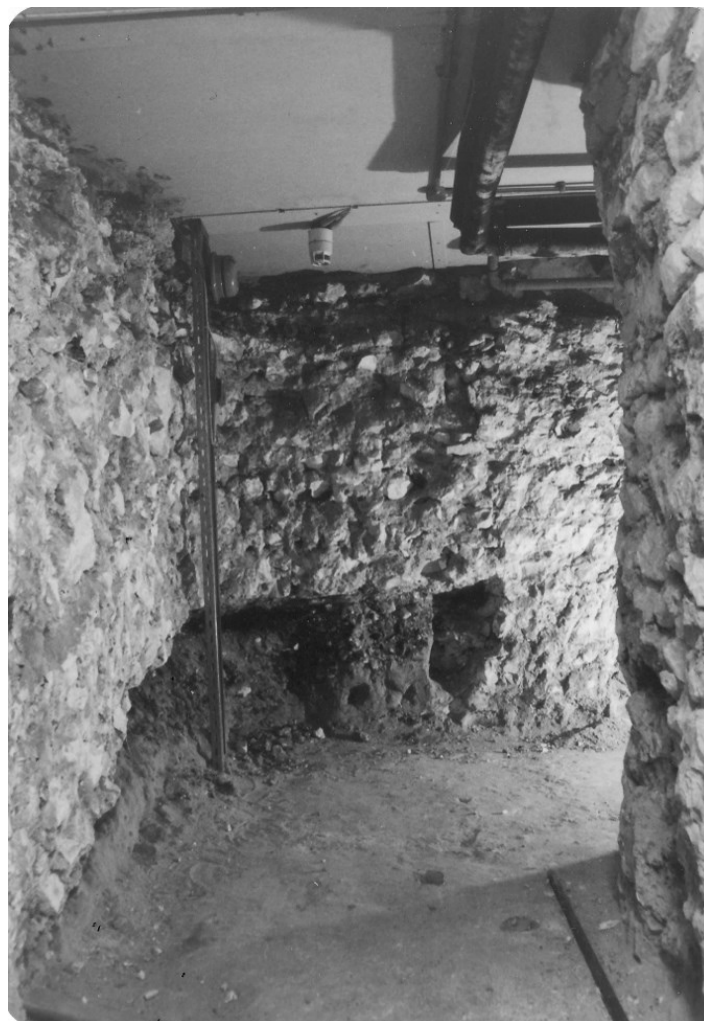
Figure 68. Passage 2 looking west showing the chalk rubble kitchen foundations, the vault and its earth fill.

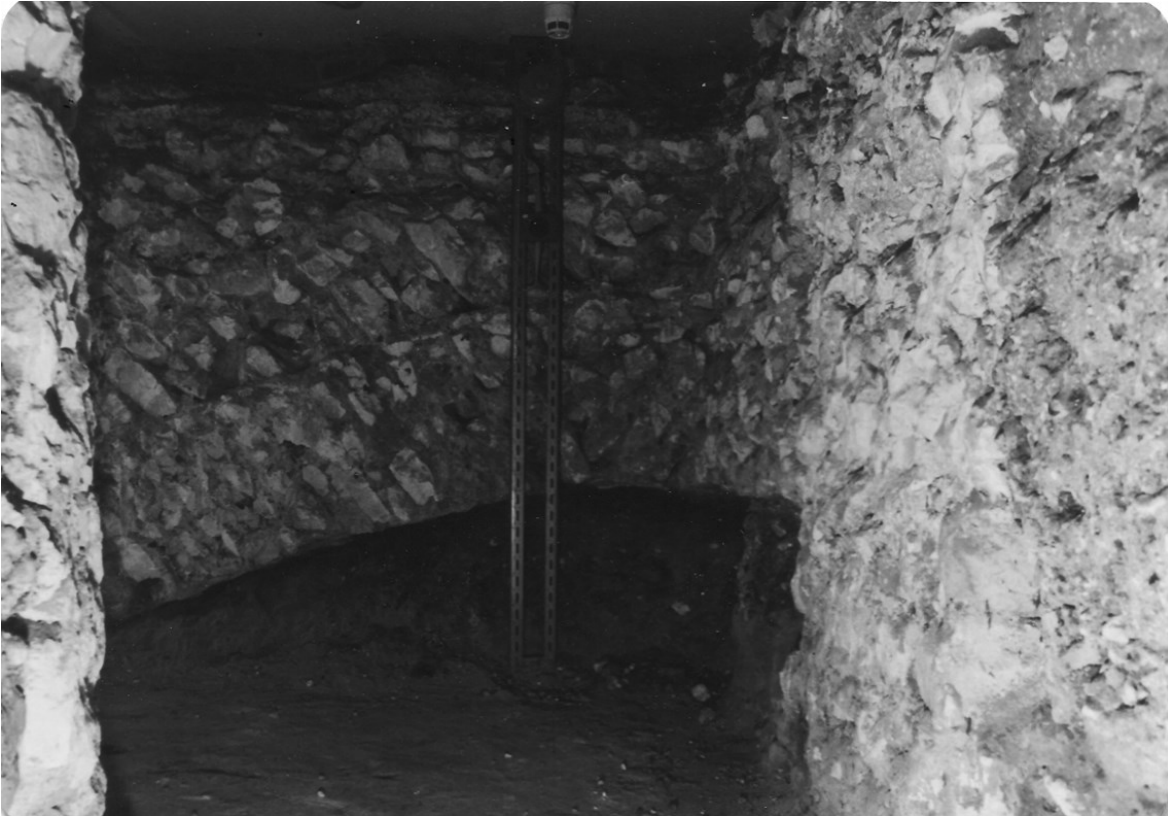
Figure 69. Passage 2 looking south showing the vault and arch above it.

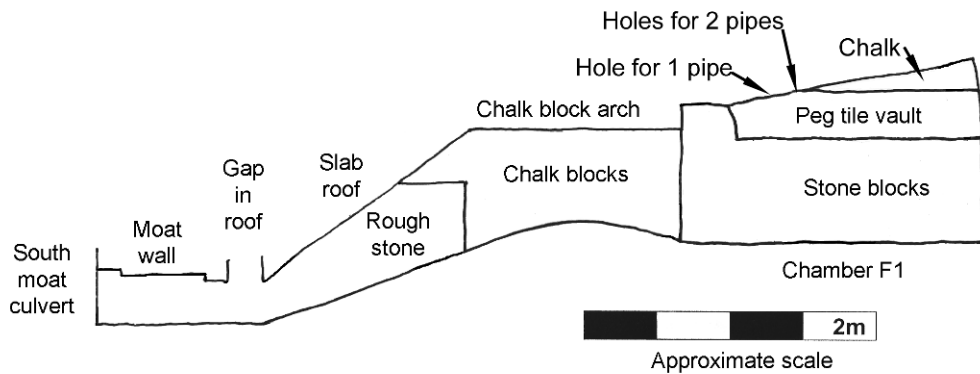
Figure 72. Section through side drain F1. The scale is approximate. The distances along the drain have been measured in difficult conditions. The height of the floor at the end has been measured as has its height relative to the floor of the main south moat culvert. The other heights are estimates.

The only known structure which may date from the pre-Carew period is the base of a large privy which survives in the foundations of the kitchen block and can be accessed from a side drain (F1) which runs into a culvert laid in the former moat around the house (see section 6.4.2). The

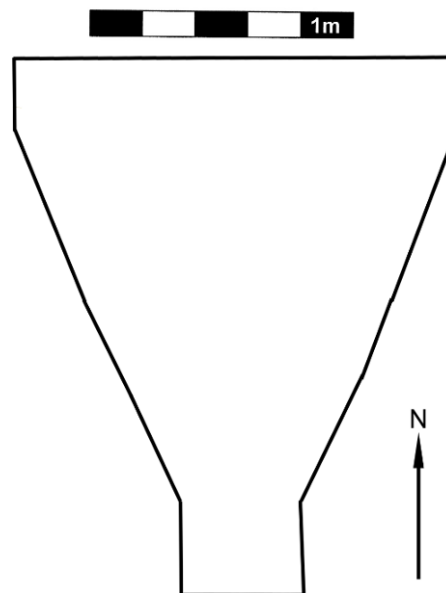
Figure 73. Plan of the chamber at the end of F1.

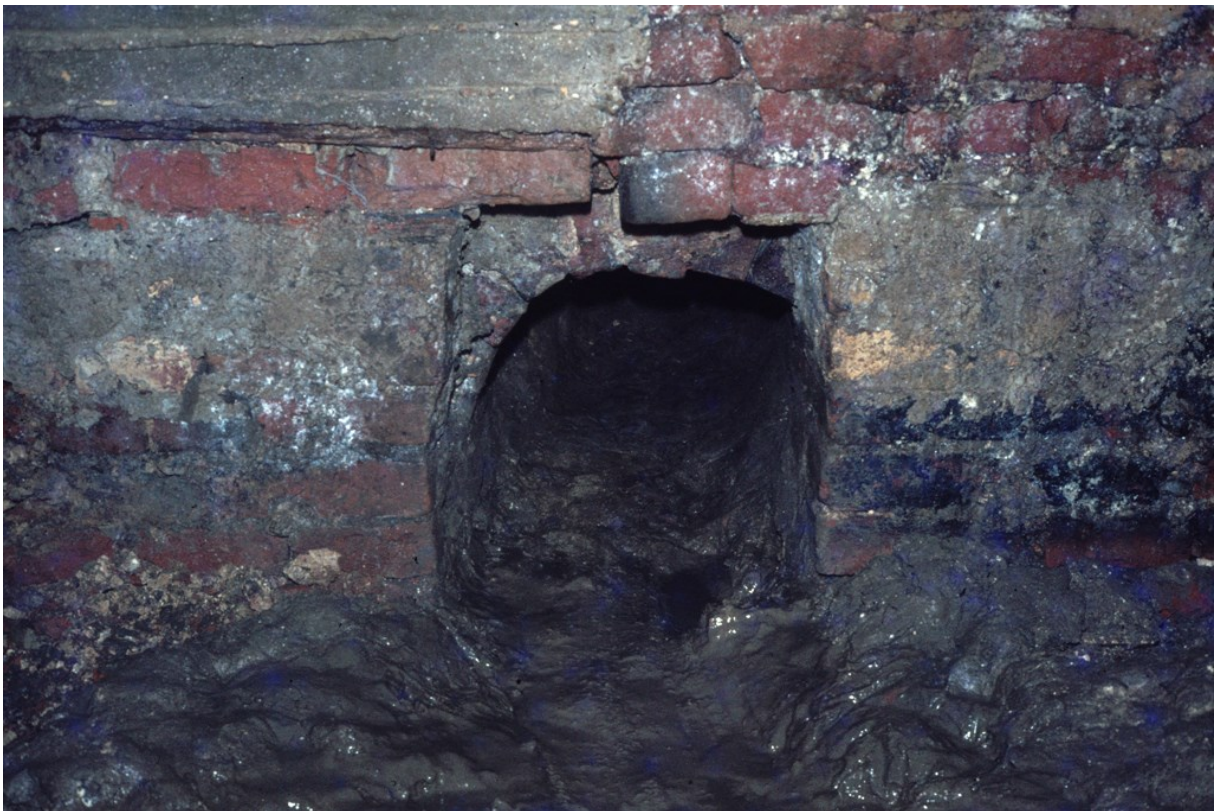
Figure 75. The main moat culvert showing entrance to side drain F1,

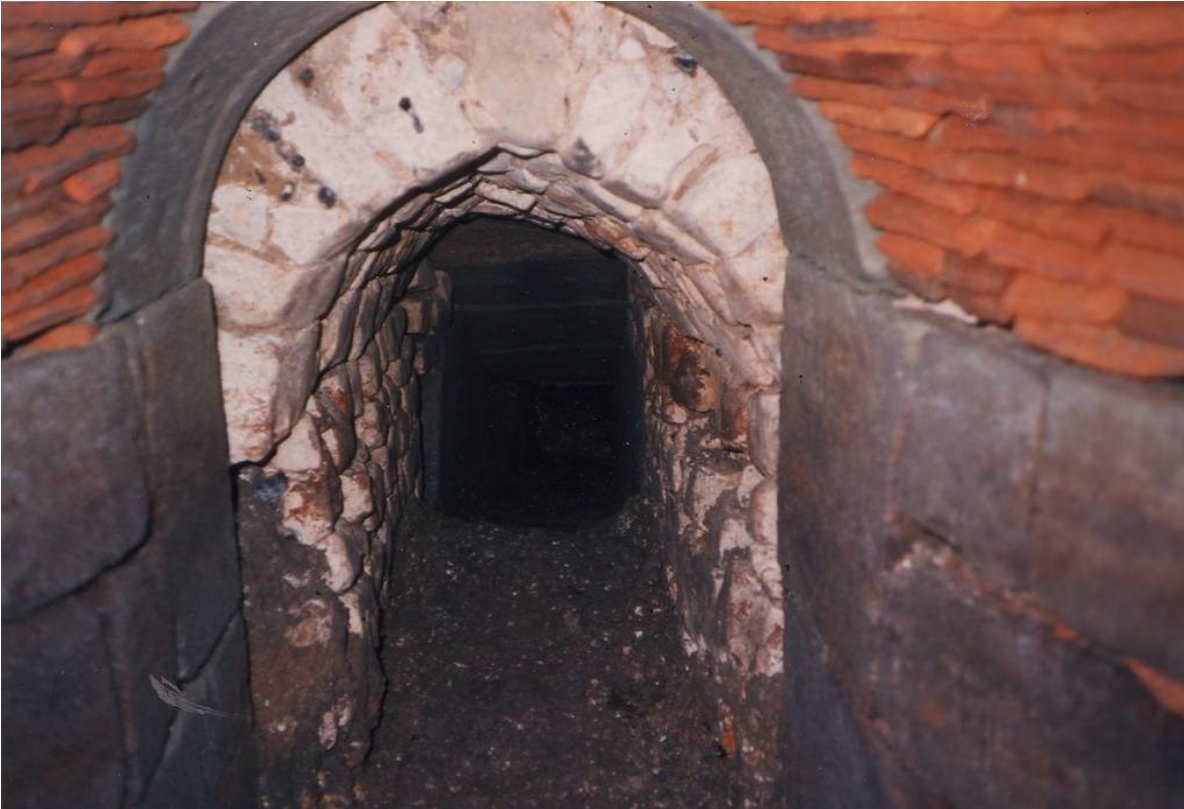
Figure 76. Culvert side drain F1 looking from the end chamber south towards the main moat culvert.

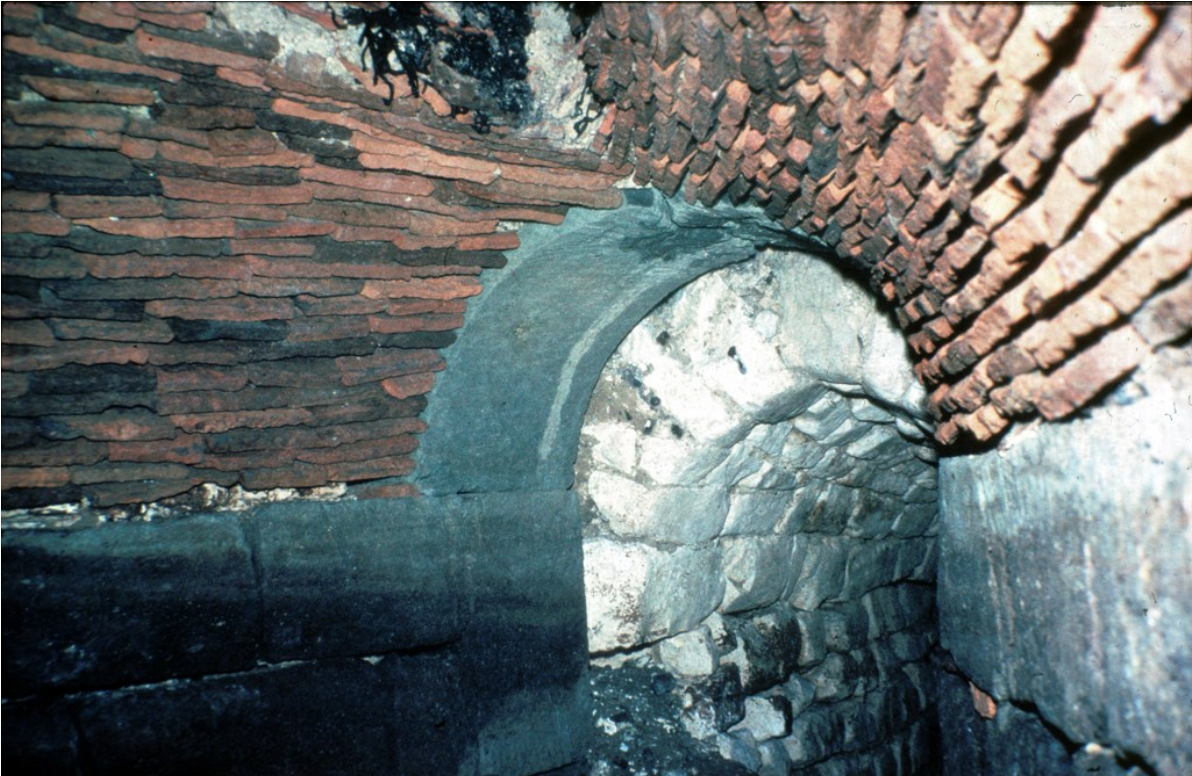
Figure 77. The chamber at the end of F1 showing the vault and the exit towards the main culvert.

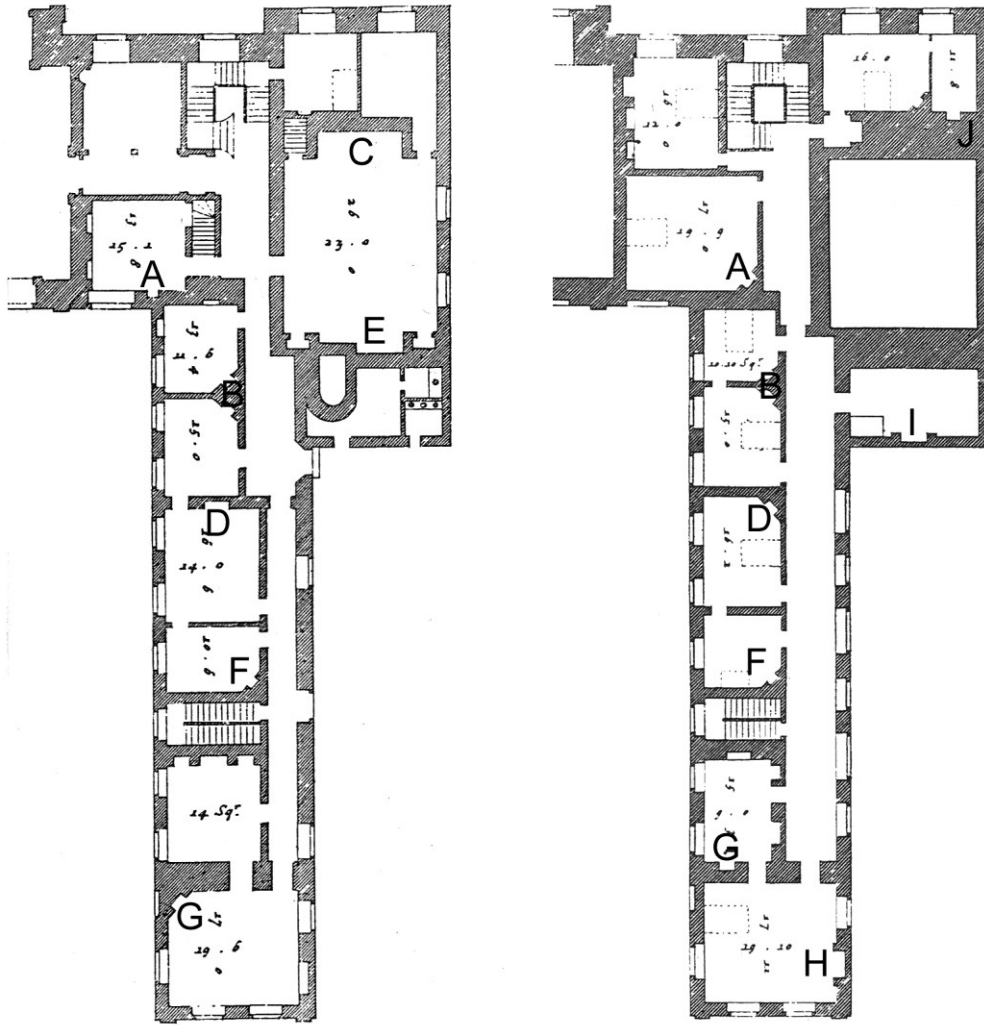
Figure 85. The Campbell plans of 1717, ground floor (left) and first-floor (right) with the lettering of the chimney stacks used in figures 82 to 85. Stack H also served the extension on the south side of the wing end added after the plan was made.

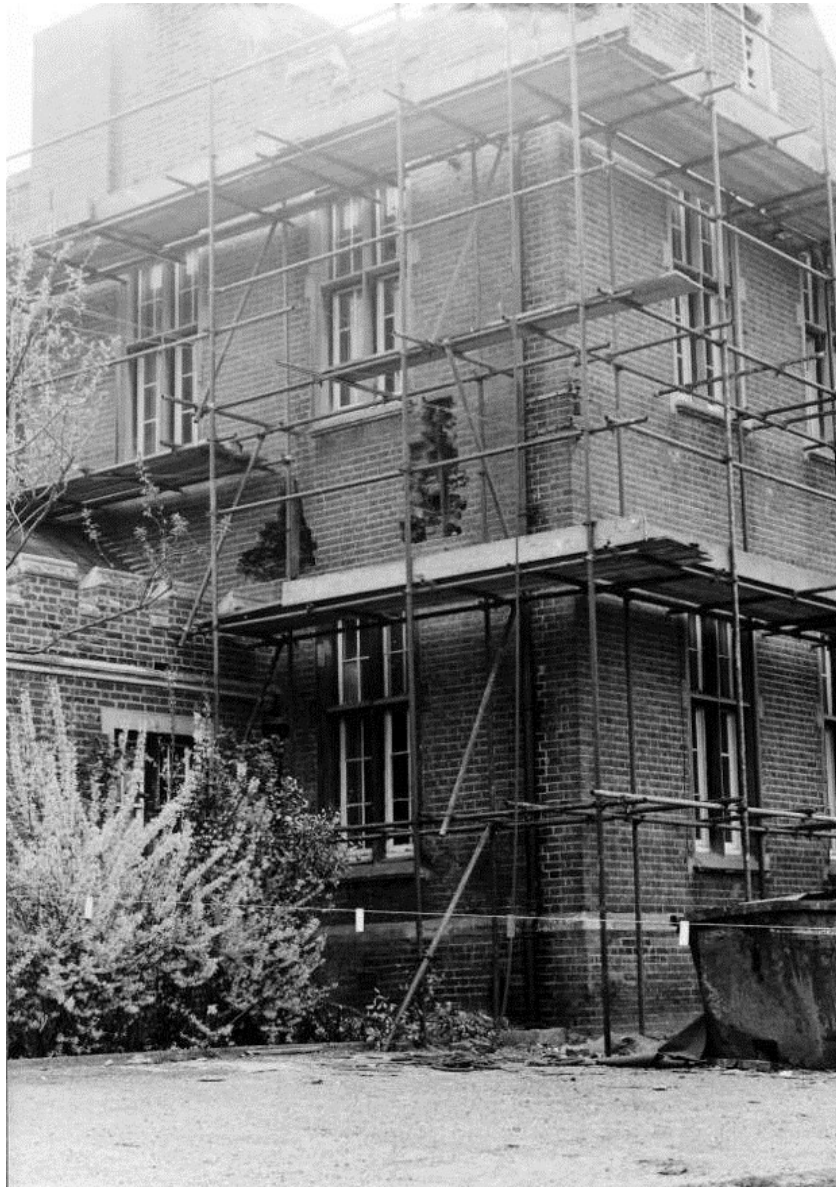
Figure 86. The two cuts AE near the northwest corner of the south wing, April 1984. The bottom of the west cut was 4.62 m above ground level.

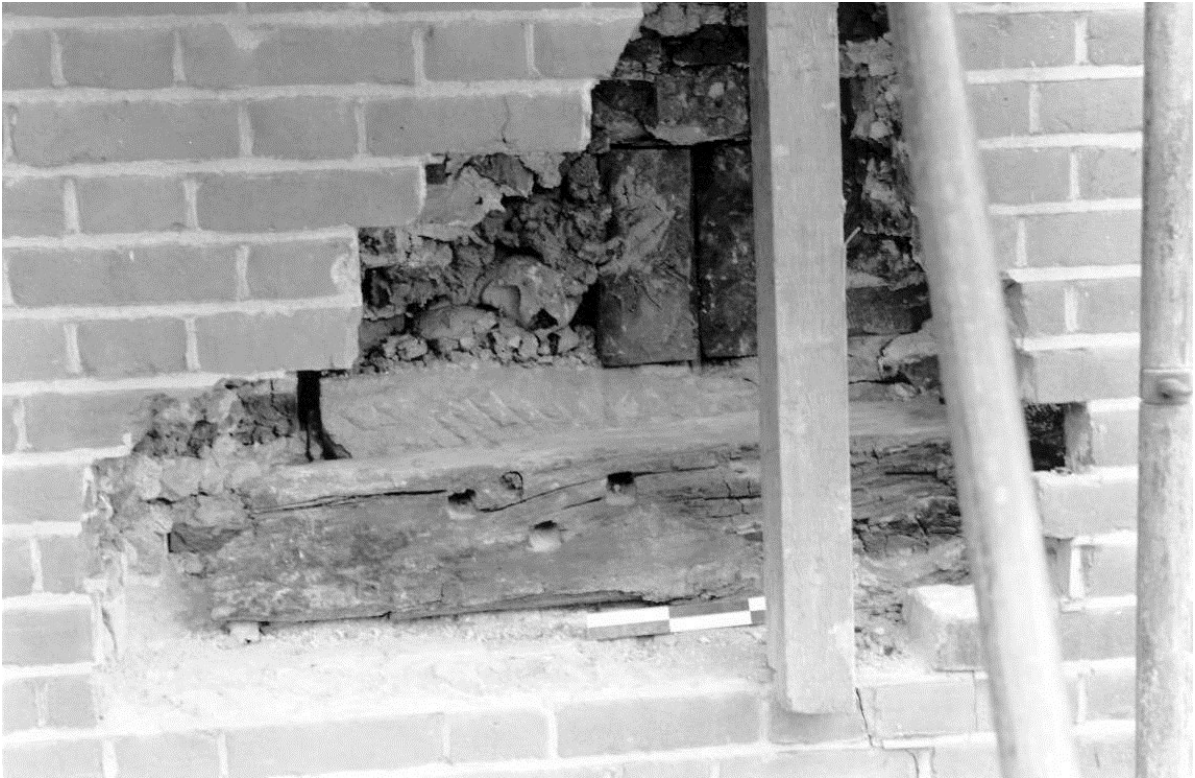
Figure 87. Above and below. AE – timber exposed in the east cut, 1984.

Behind the facing the wall was of irregular 'Tudor' style bricks in white mortar. In the eastern cut there was a piece of stone embedded in the brickwork with the ends of two beams resting on it. They were separated by a vertical iron bar. The timbers were higher than they were wide and had shrunk leaving a gap between them and the mortar (figure 87). One had a mark on the end grain, possibly 'm8c' (figure 88).

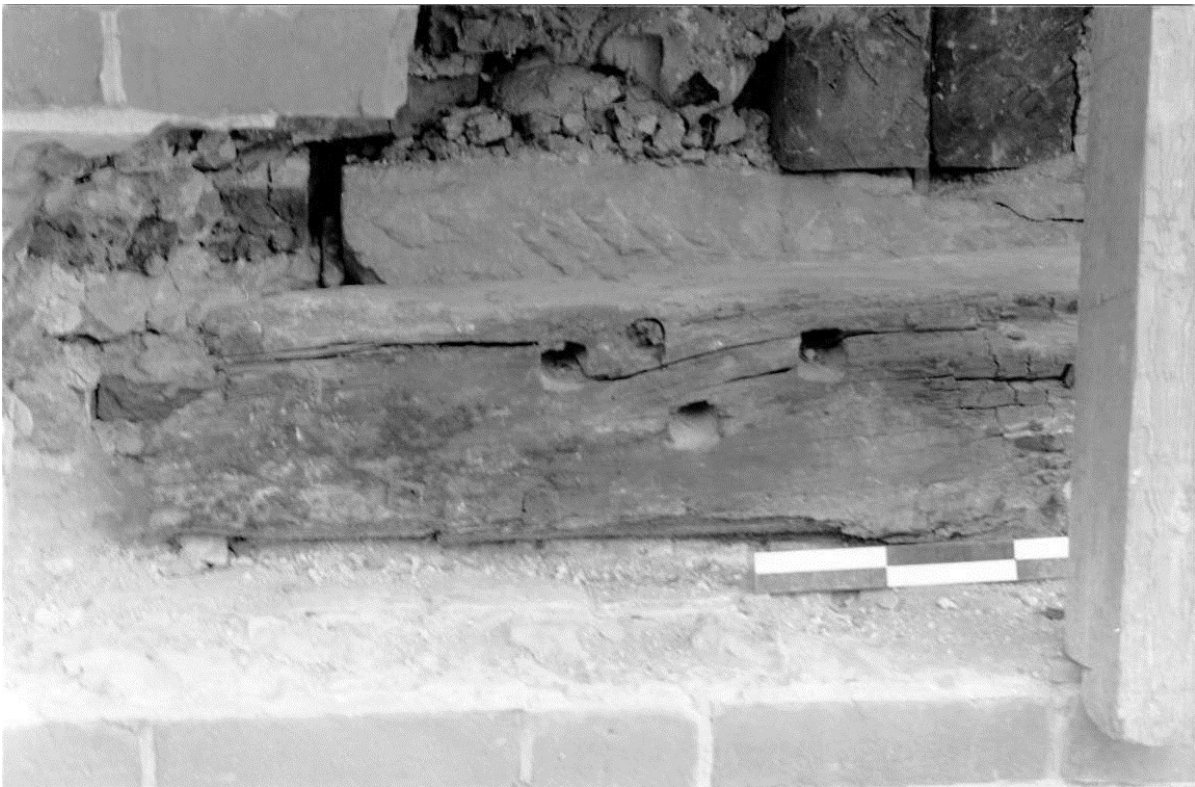
Figure 88. Elevation (above) and plan (below) of the east end of the timber in cut AE east side. (Drawing with missing peg-hole added from a photo).

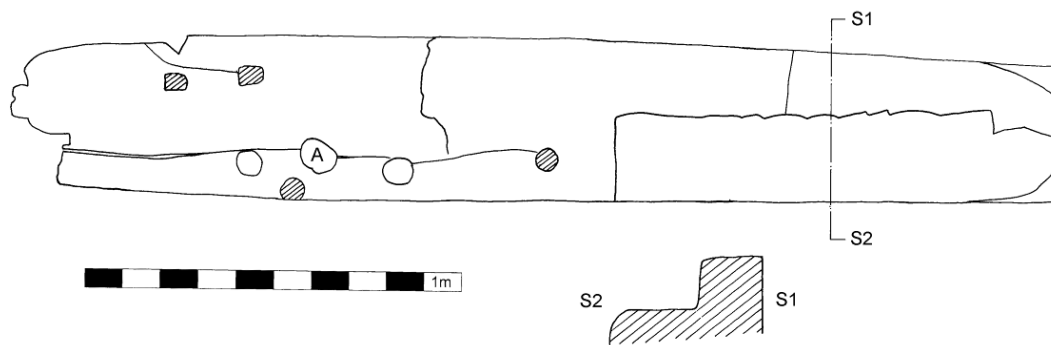
Figure 89. The south or inner side of the timber found in AE east cut drawn after it had been removed from the wall. The holes are faceted and appear to have been cut with a curved chisel rather than a drill. The shaded holes still had pegs in them. The hole marked A sloped upwards towards the top of the drawing.

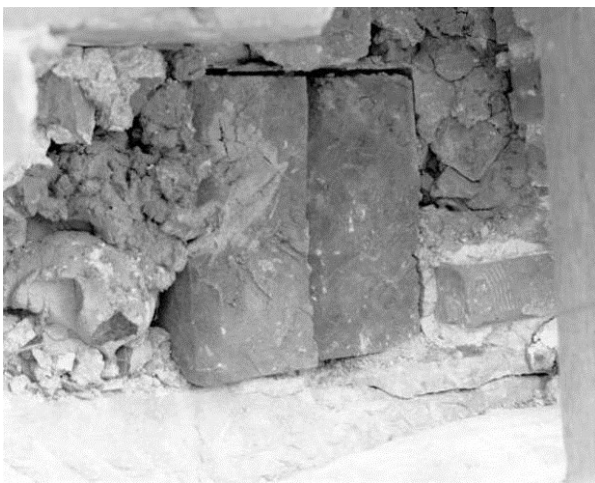
Figure 90. Cut AE – the end of two timbers resting on a stone block all embedded in the north wall of the south wing (above and below).

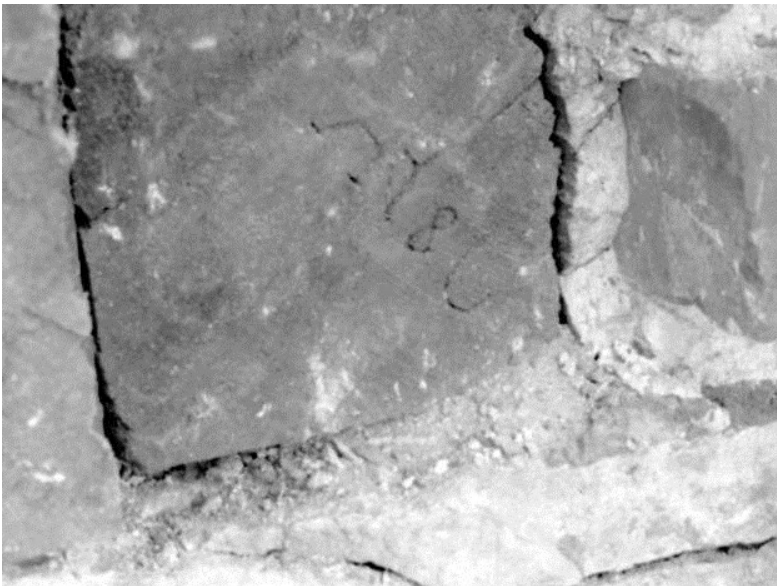
Figure 92. Detail of a mark – possibly ‘m8c’ – cut into the left hand timber in figure 90.

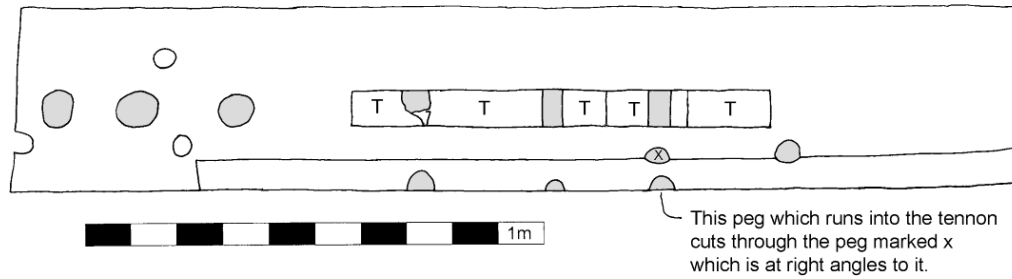
Figure 93. One side of a timber form the upper part of the south wall of the south wing probably near the former bath block. T marks one large tenon. The pegs were still in situ in the grey shaded holes.

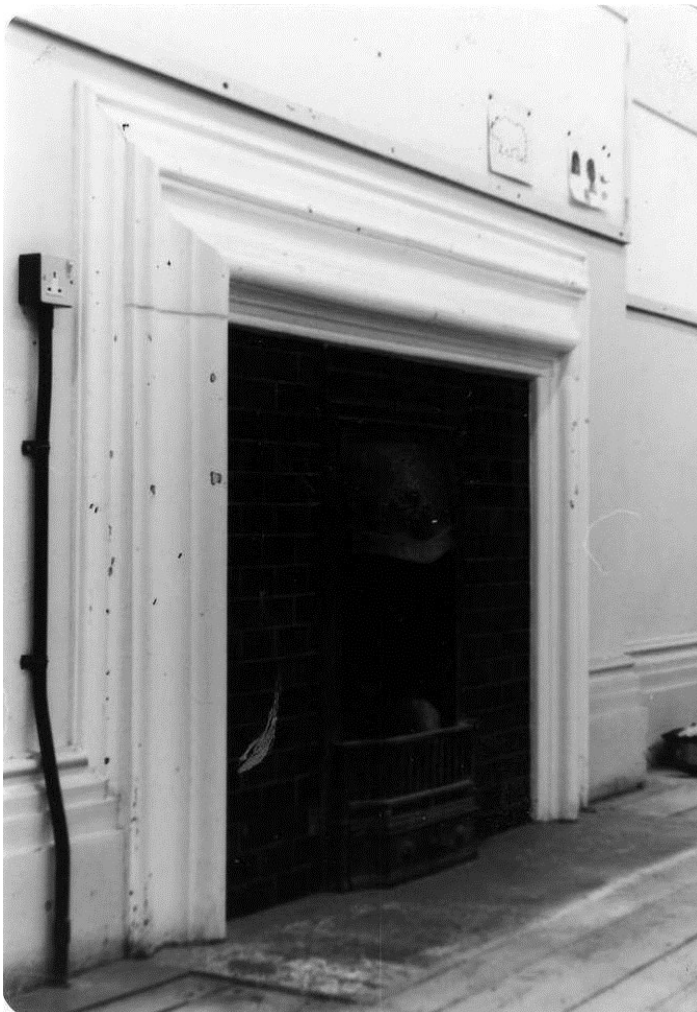
Figure 94. Fireplace on the north wall of room 134 at the southwest corner of the south wing.

Room 134 on the ground floor at the southwest corner of the south wing has a bolection moulded fireplace in the centre of the north wall. This is of marble but is now covered with paint (figure 94).

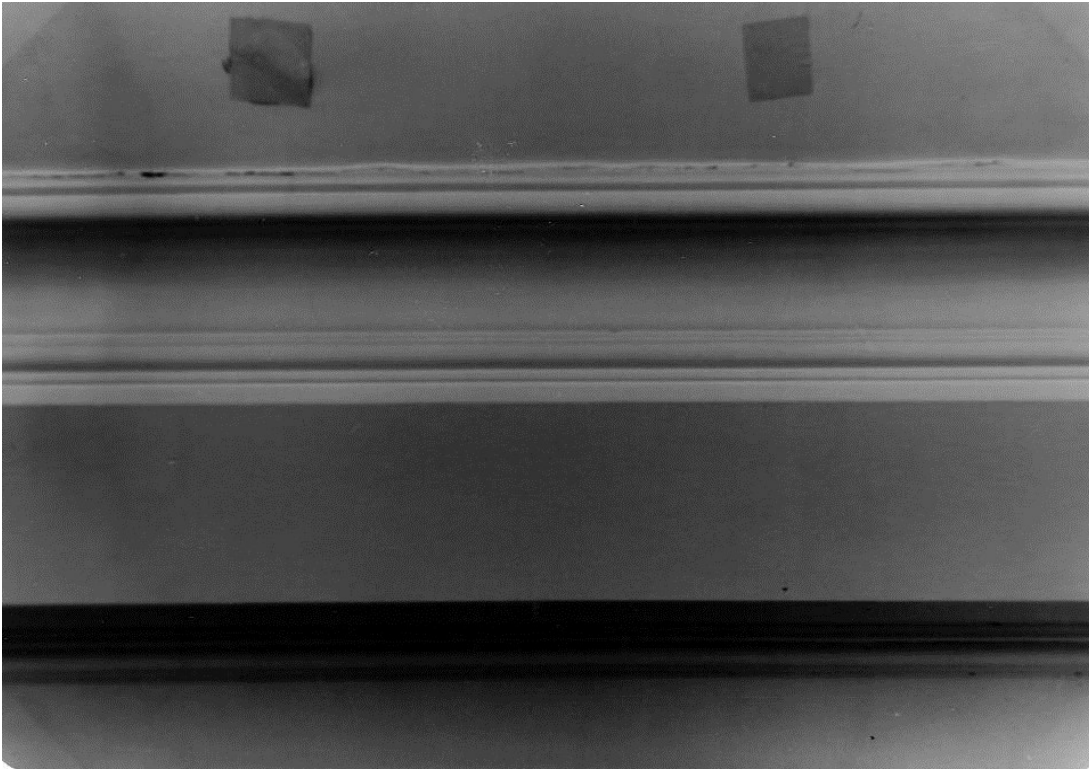
Figure 95. The moulding on the ceiling of room 134.

The ceiling of the room is divided into three sections by two north – south aligned joists which are decorated with mouldings as shown in figure 95.

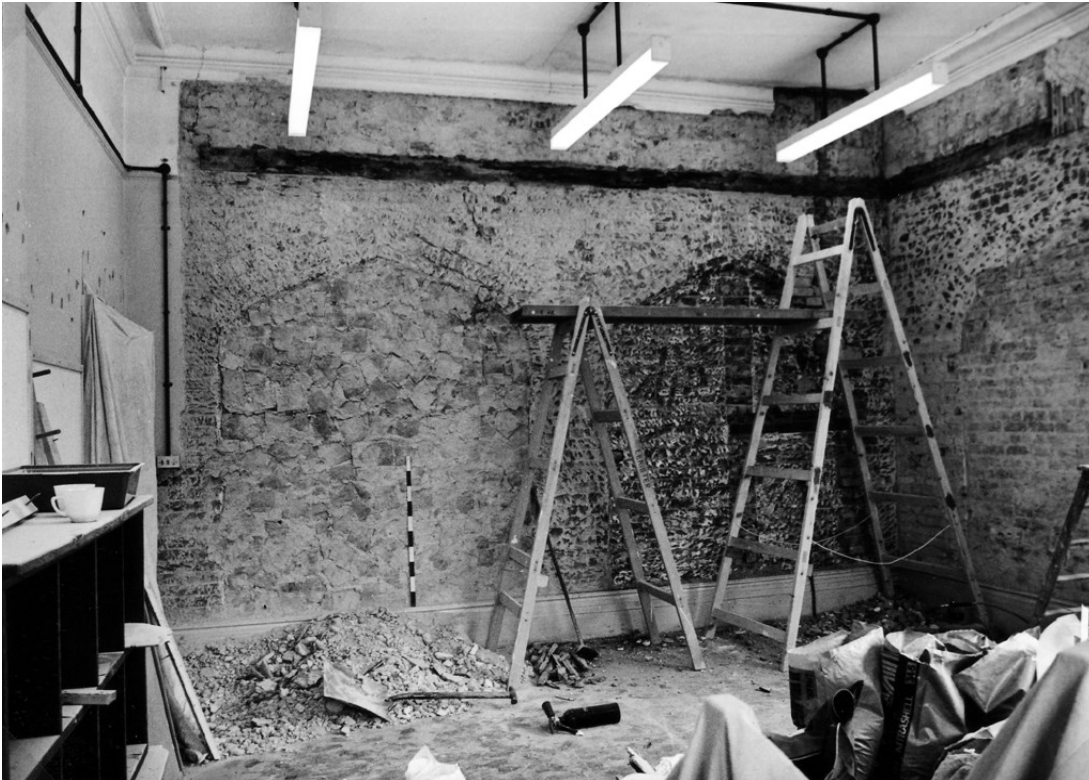
Figure 99. Blocked arches exposed in the east wall of room 134 on 1 September 1986.

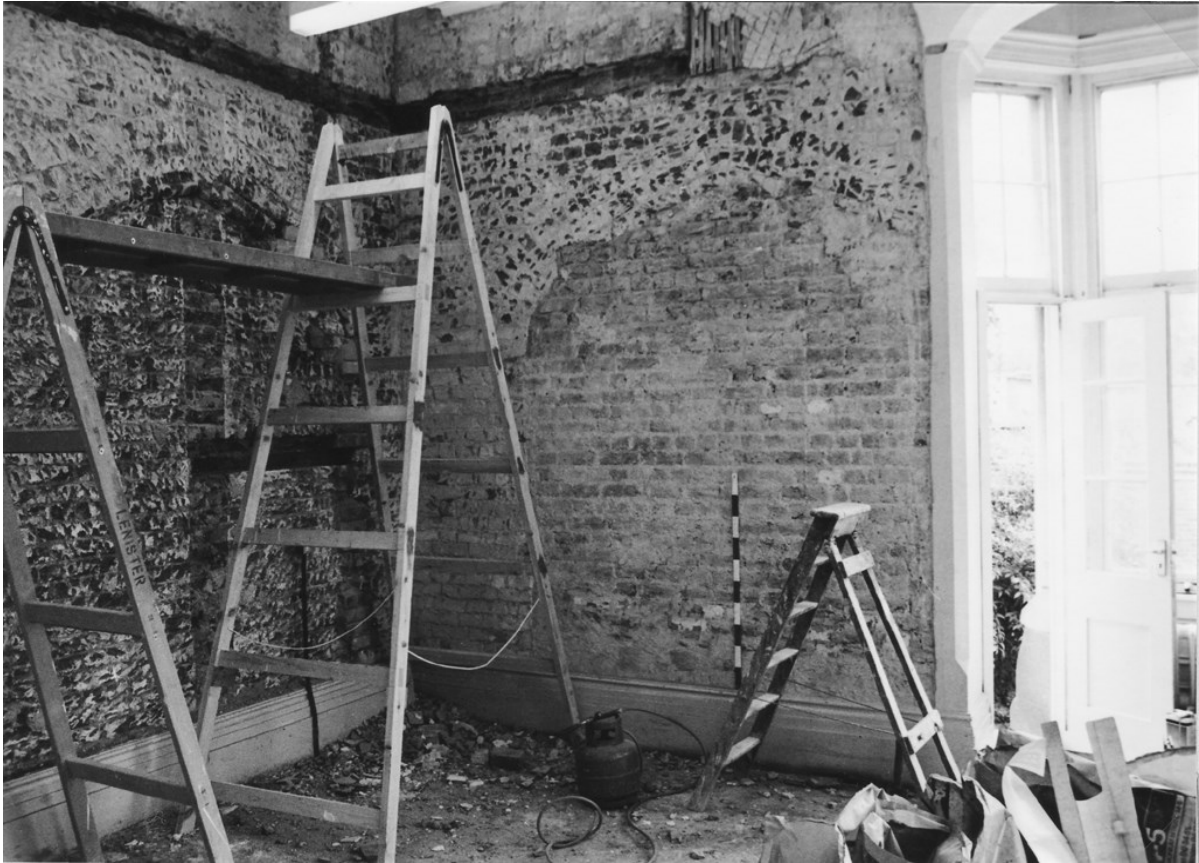
Figure 101. Part of a blocked arch in the south wall of room 134 on 1 September 1986.

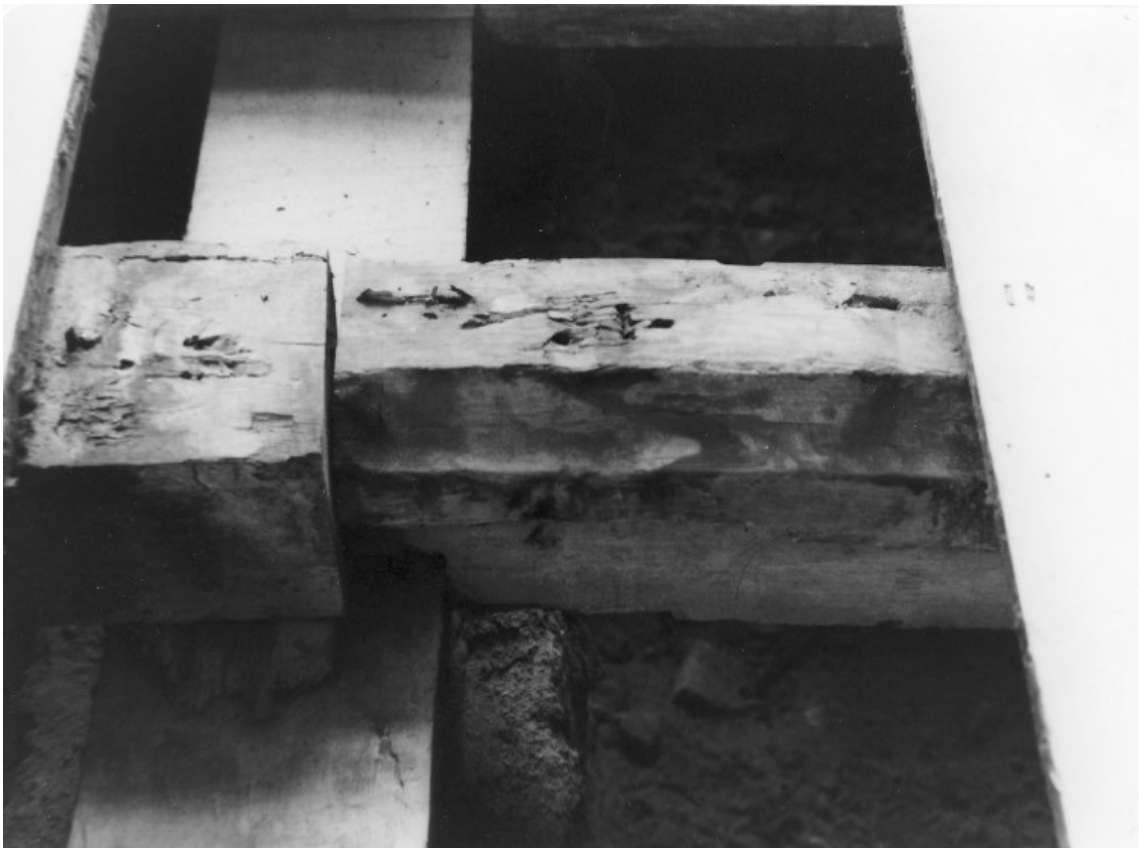
Figure 110. Upper floor joist 5 with lower joist 3. Looking west.

**Upper floor joist number 5** included a section of timber about 1.8m long which stretched between lower joists 2 and 3. The timber was 140mm high and had a maximum width of 117mm and had the mouldings shown in figure 108. There was a carpenter's mark on the underside as shown in figure 109. The original function of this timber is uncertain although it appears to be part of larger moulding.

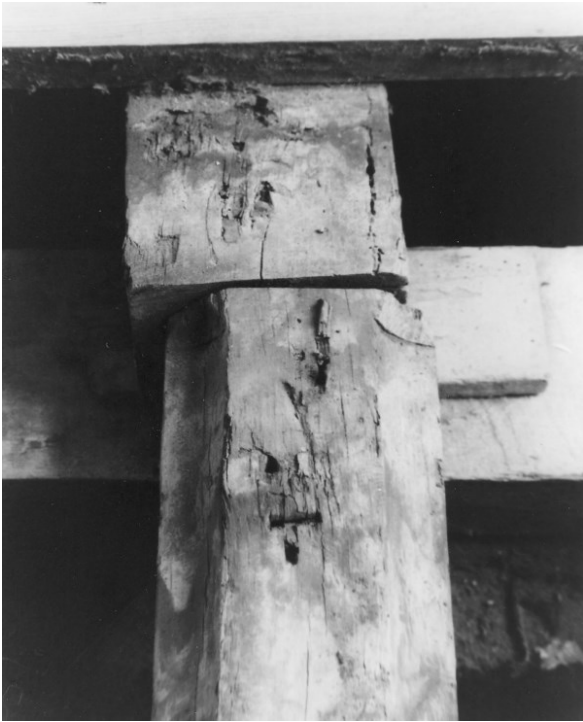
Figure 111. Upper floor joist 5 with lower floor joist 3 looking south.

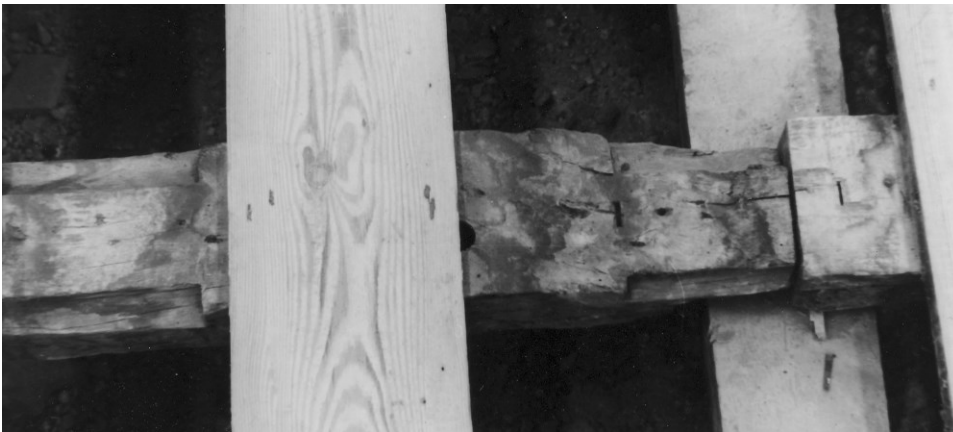
Figure 112. Upper floor joist 6 and lower floor joist 2. The upper view looks east, the lower south.

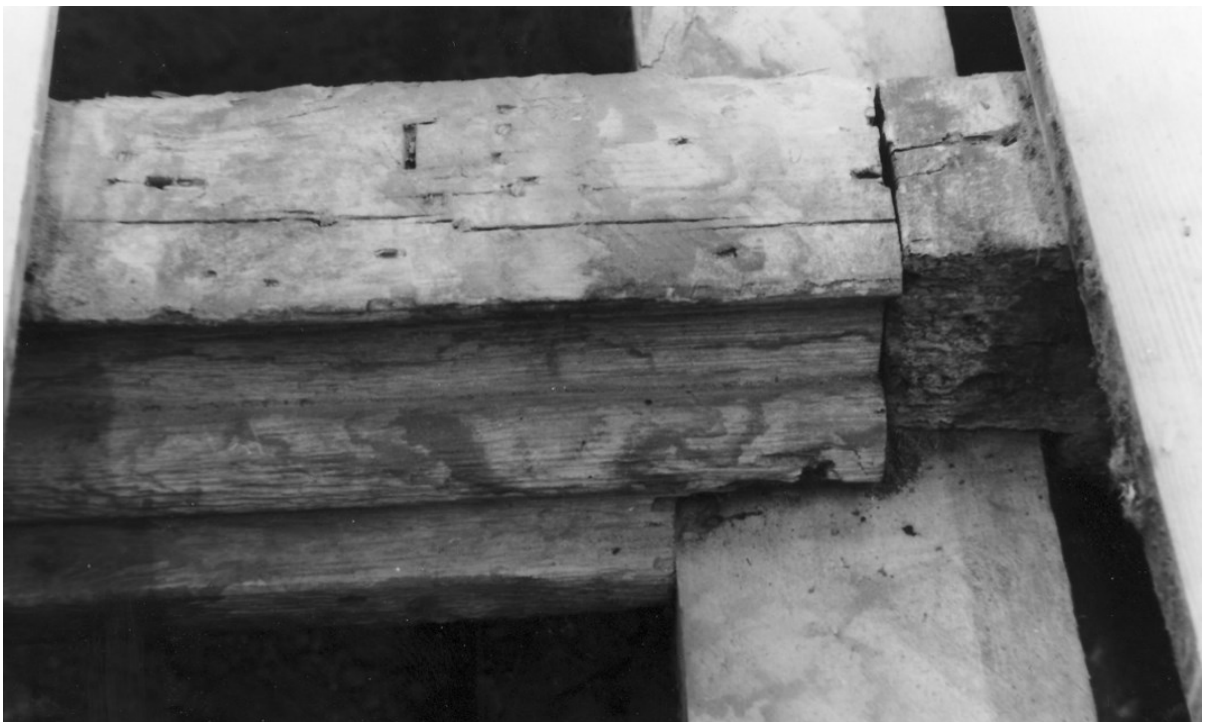
Figure 114. Upper joist 9 with lower joist 2 on the right. Looking east.

This contained a piece of timber about 1.8 m long with the moulding shown of figure 113. One end rested on lower joist 2, the other on lower joist 3. The timber had a height of 135 mm and a maximum width of 150 mm.

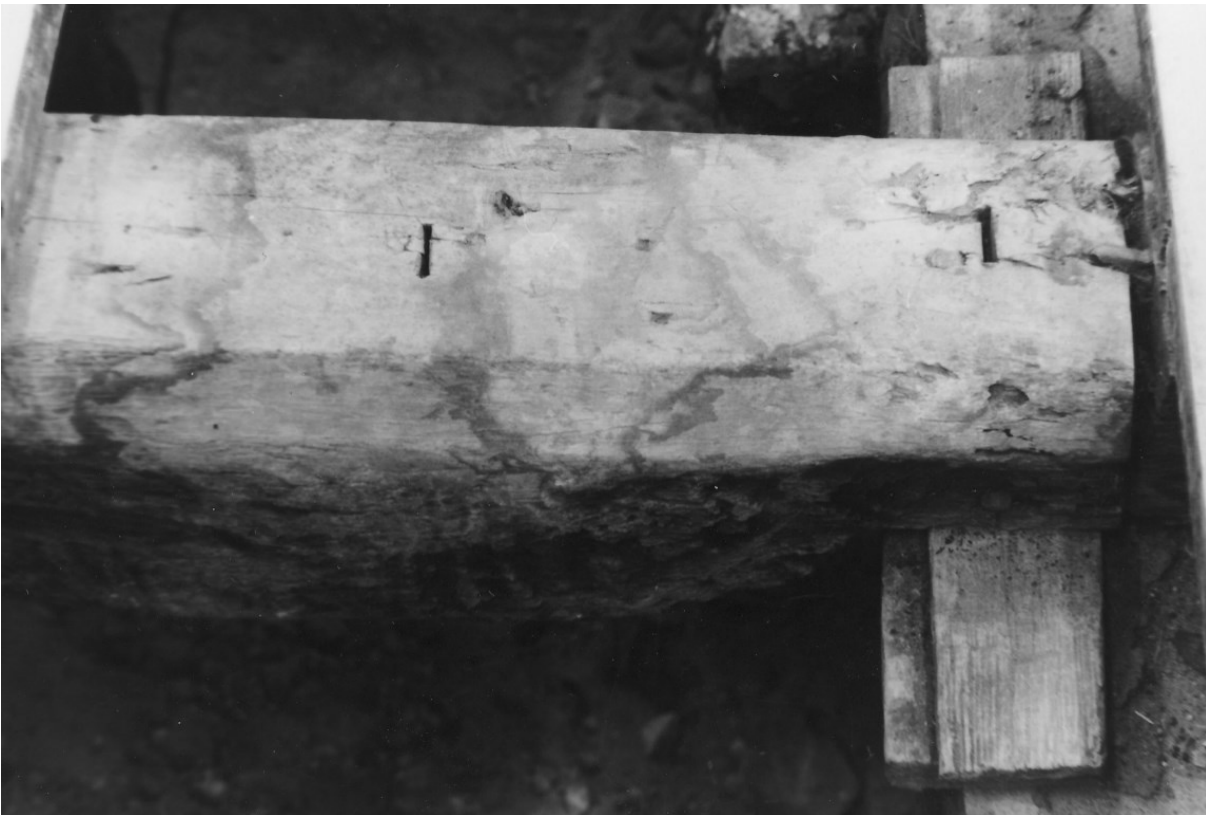
Figure 116. Upper joist 15 with lower joist 2 on the right. Looking east. Note the charring on the underside of the timber which is about 1.8m long.

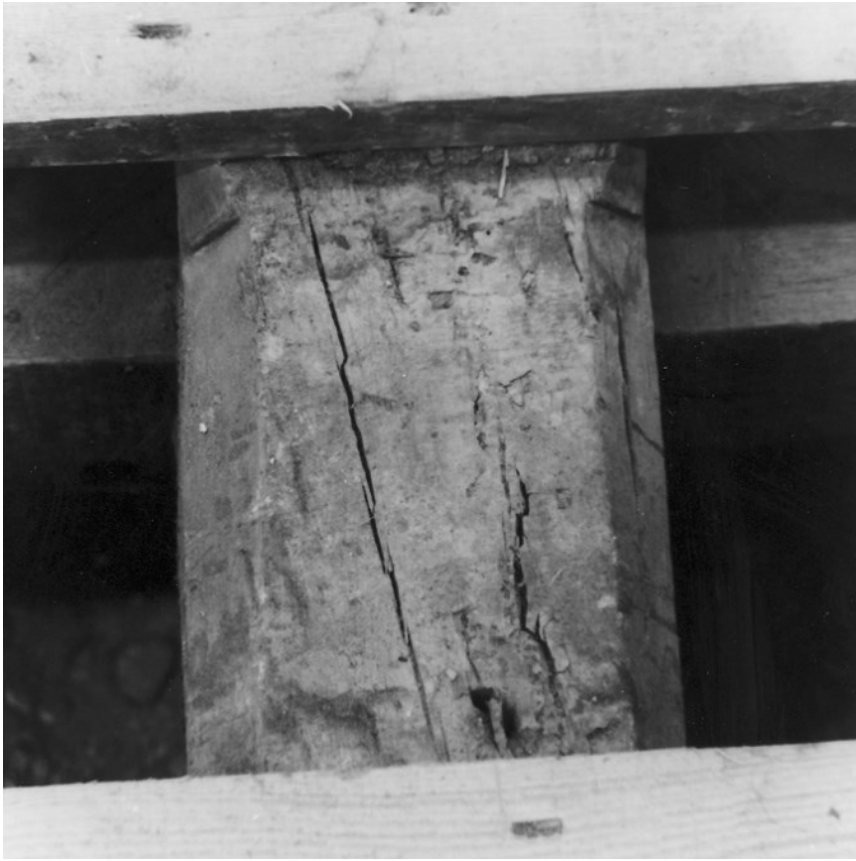
Figure 117. Upper joist 15 with lower joist 3. Looking north.

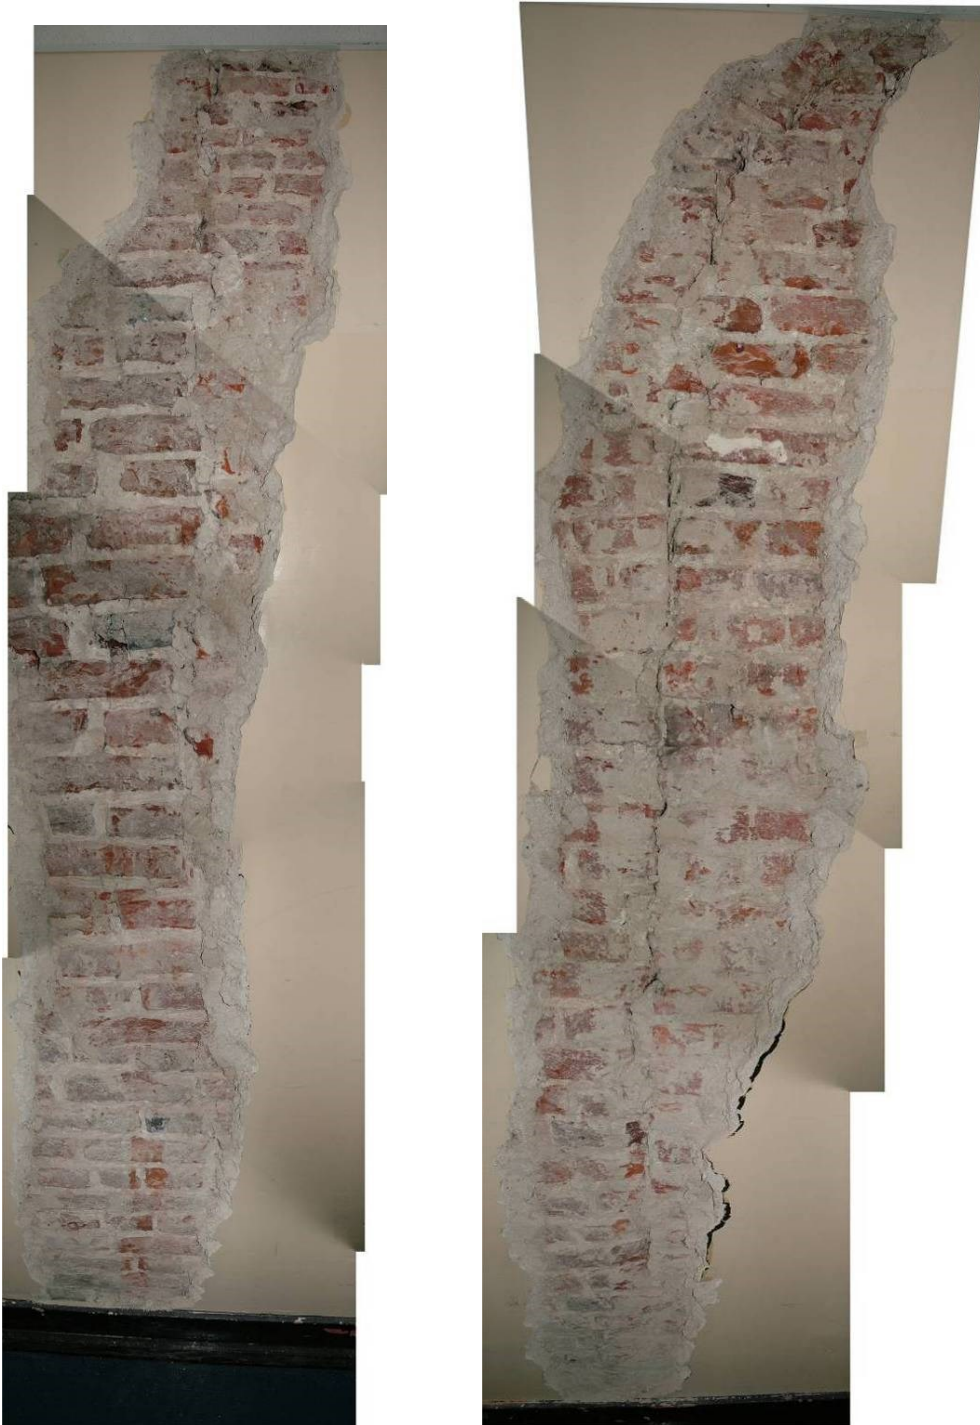
Figure 120. Photo mosaic of crack DJ (left) and crack DK (right) at first-floor level on the north side of the north wall of the hall. August 2005

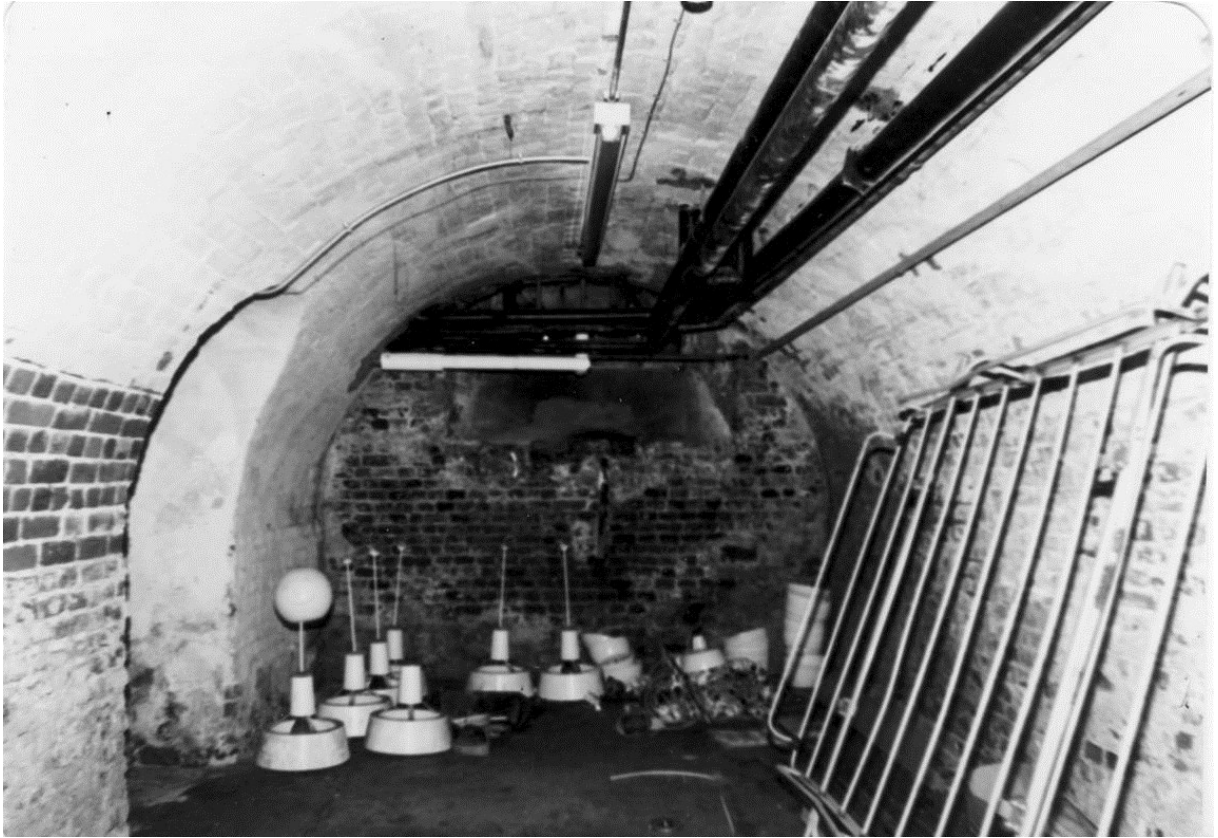
Figure 121. Cellar 4 looking east in the 1980s. Note the contrast between the eighteenth century bricks in the vault and the Tudor ones in the end wall which is the eastern outer wall of the north wing. The door to cellar 5 is on the left.
