# **Carew Manor, Beddington**

**A report on historical and archaeological investigations of  
the house and moat, 1979-2014**

**Volume 1: the house and its owners**

**John Phillips and Nicholas Burnett**

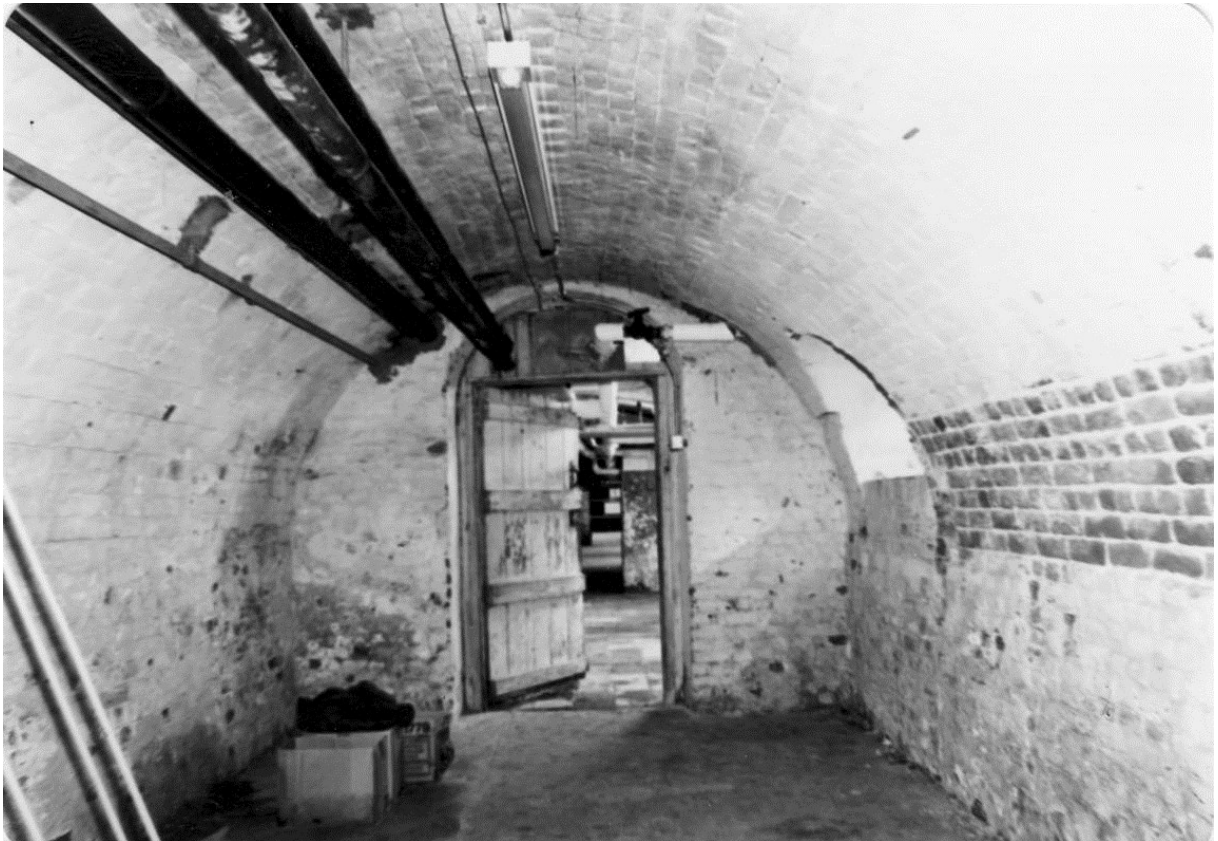
Figure 122. Cellar 4 looking eastwards towards cellar 3.

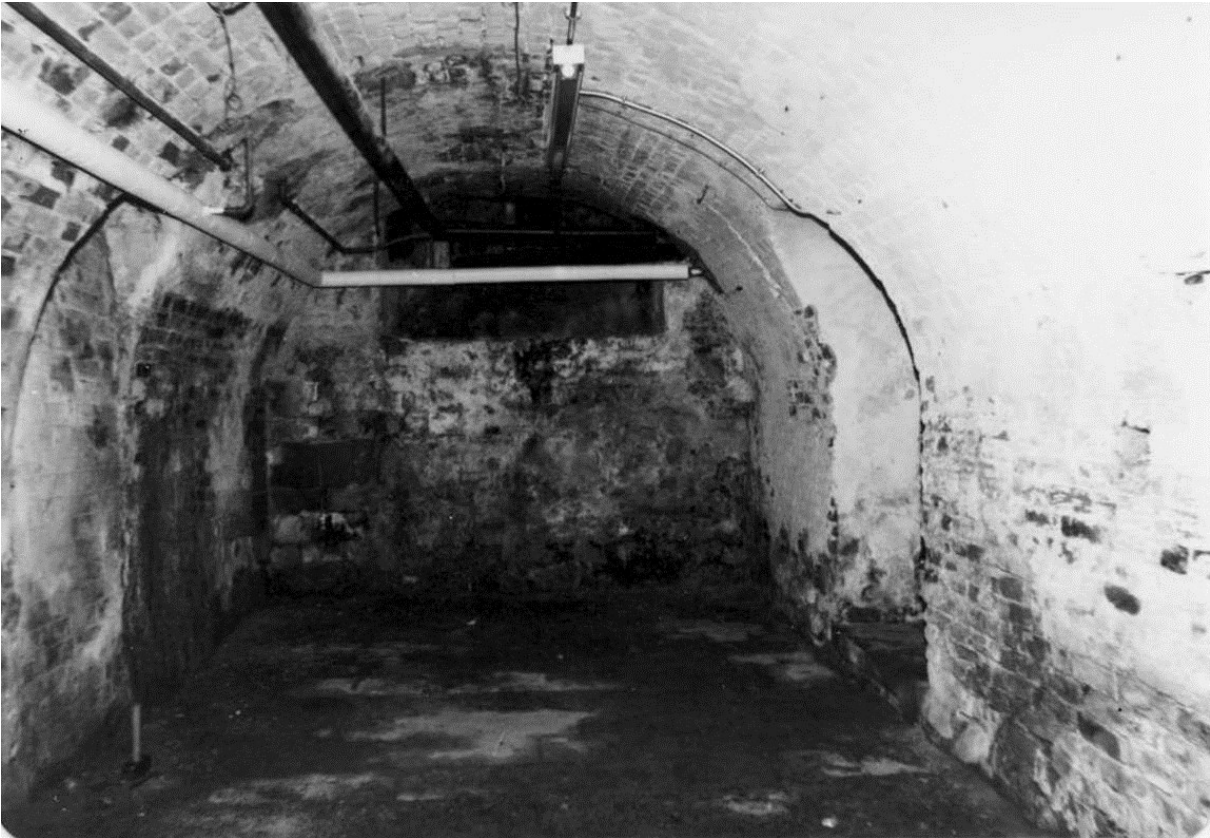
Figure 123 Cellar 5 looking east in the 1980s.

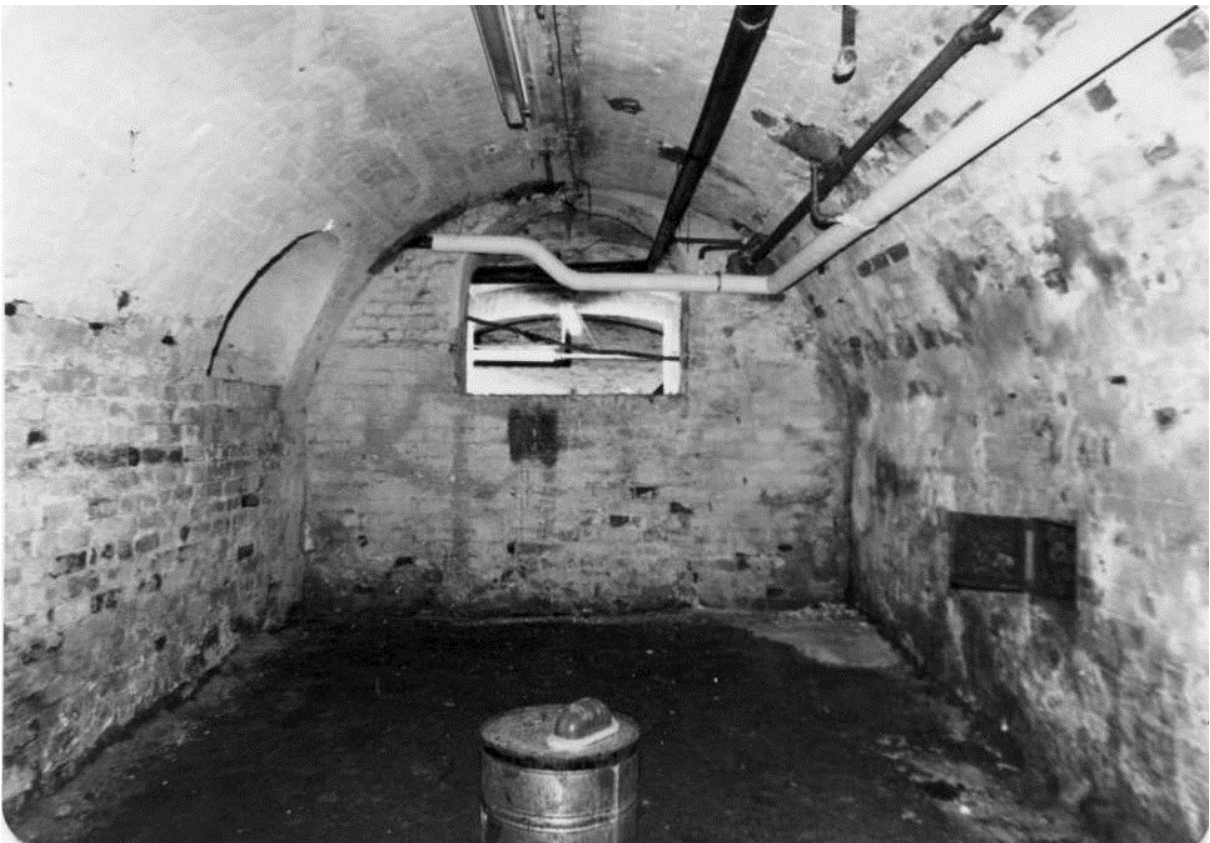
Figure 124. Cellar 5 looking west in the 1980s.

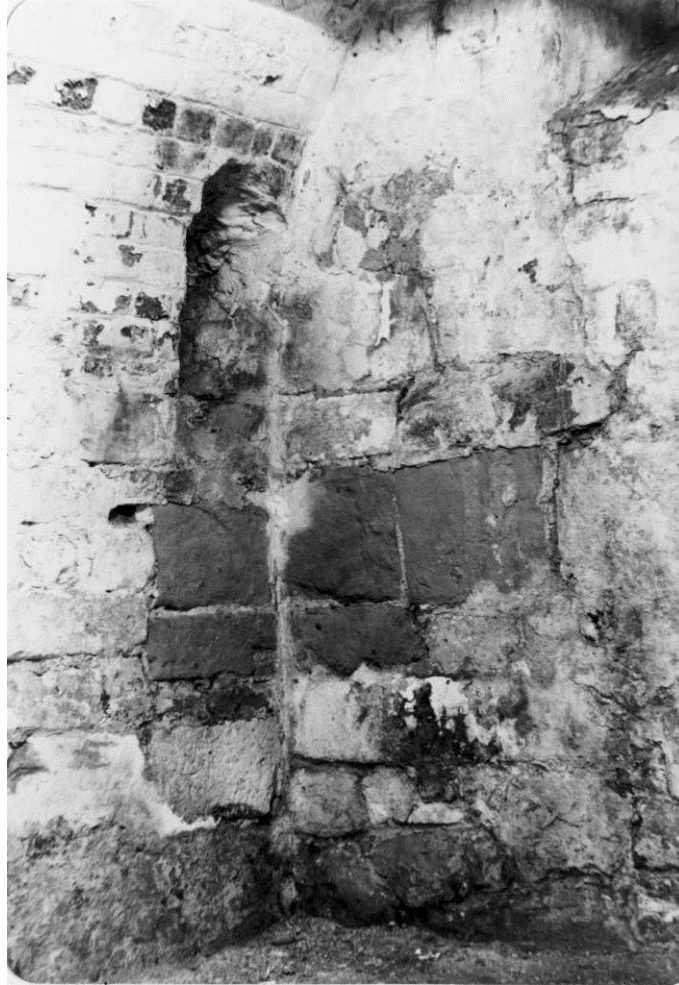
Figure 125. Stone blocks in the wall at the north east corner of cellar 5.

The foundations of the residential block are exposed in the east walls of cellars 4 and 5 which contain a substantial amount of brick. In Surrey this is unlikely to be earlier than the second half of the fifteenth century.

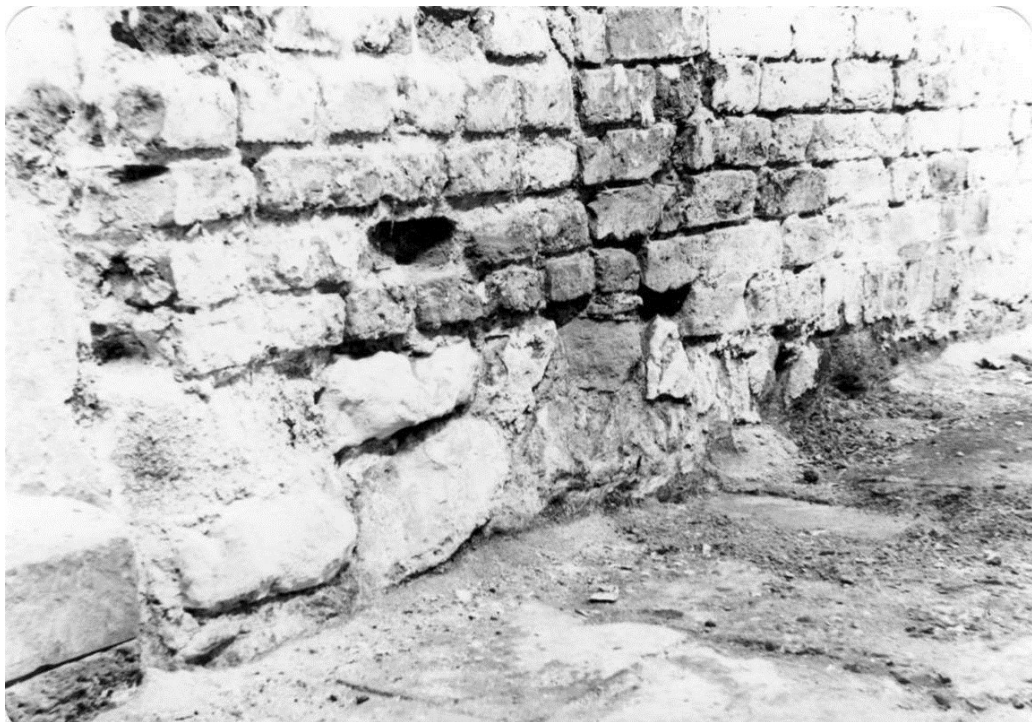
Figure 126. Stone underlying the brickwork at the bottom of the south wall of cellar 5.  
The door to cellar 4 is on the left.

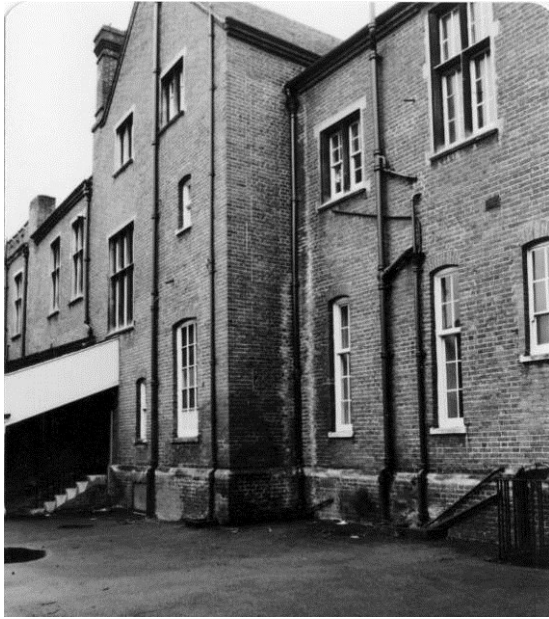
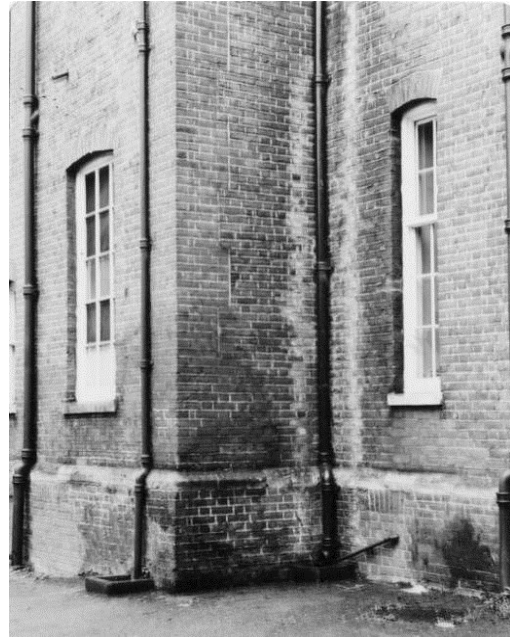
Figure 128. A bonding break on the offset of the north side of the north wing. Looking east. 10 May 1981. Note the segmental headed windows.

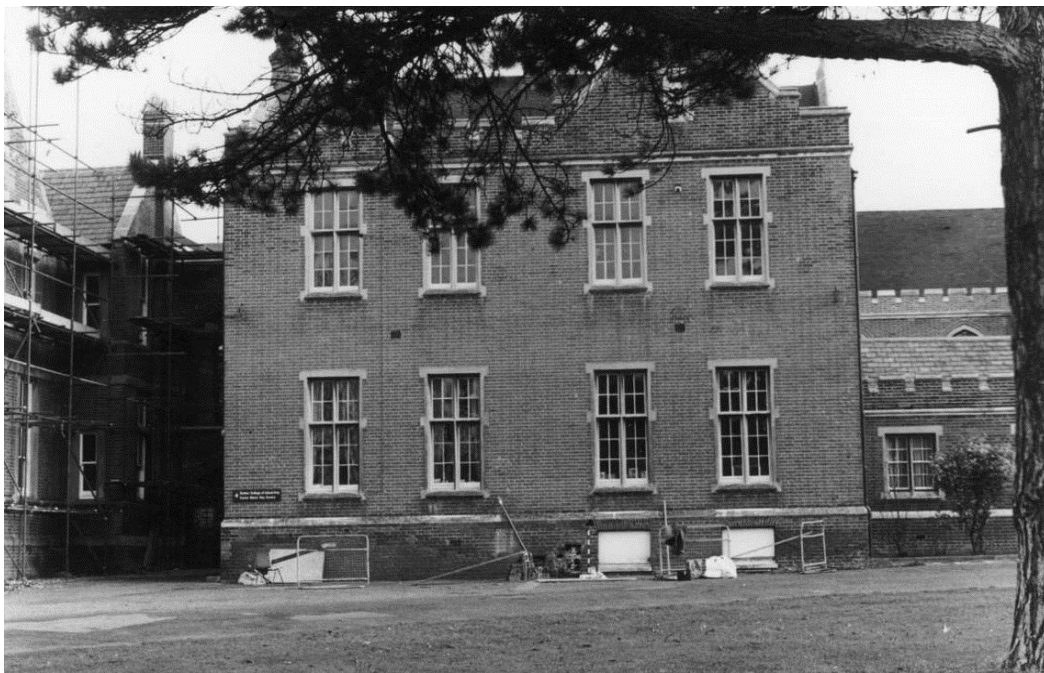
Figure 129. The west end of the north wing showing the cuts made in the repair work at the boundary between the earlier wing and the eighteenth century extension. 12 February 1984.

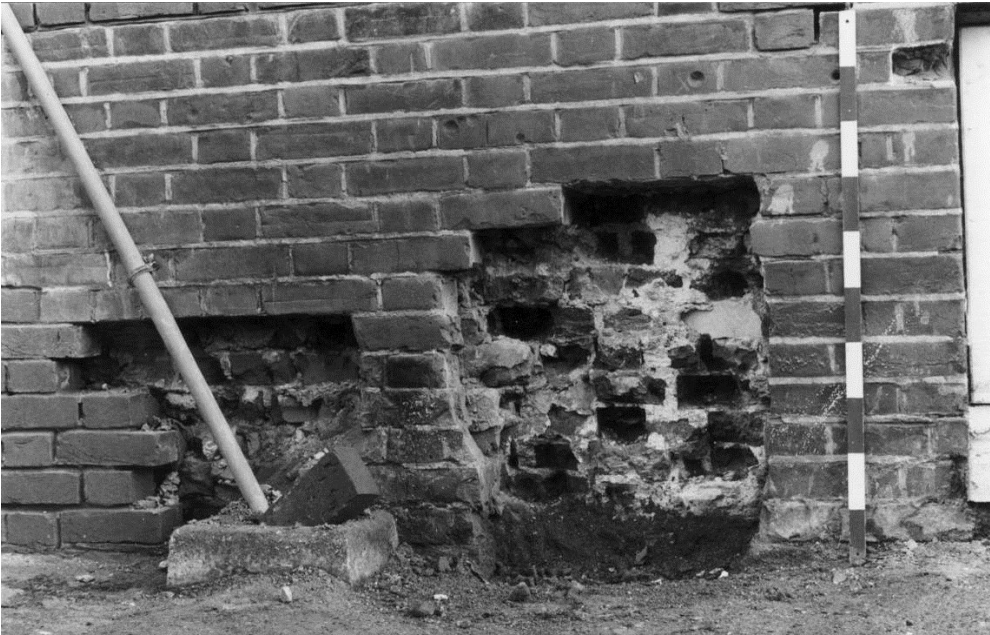
Figure 130. The west end of the north wing showing the cuts made in the repair work at the boundary between the earlier wing and the eighteenth century extension. 12 February 1984.

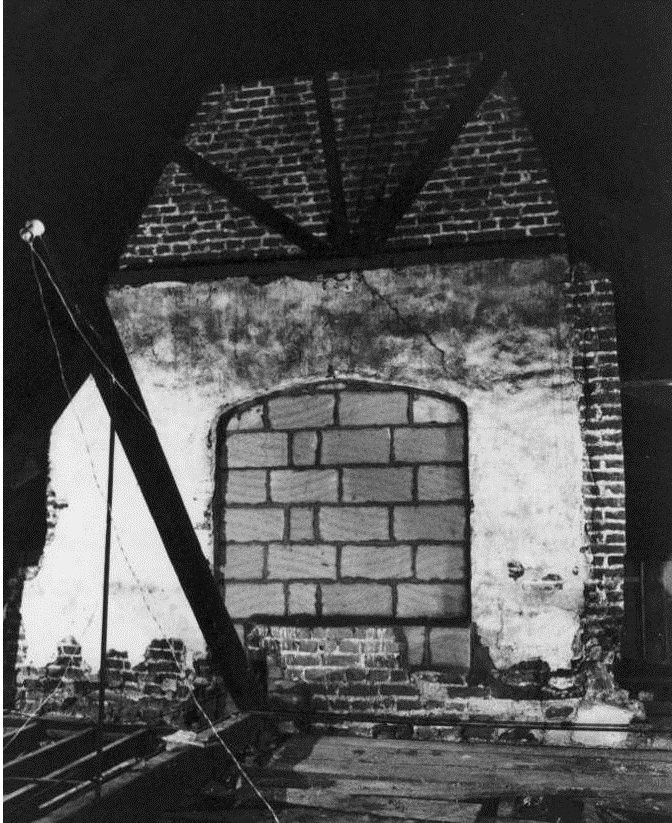
Figure 131. The north or wing side of the chimney stack on the north wall of the hall on 25 April 1982 after it had walled off with breeze blocks.

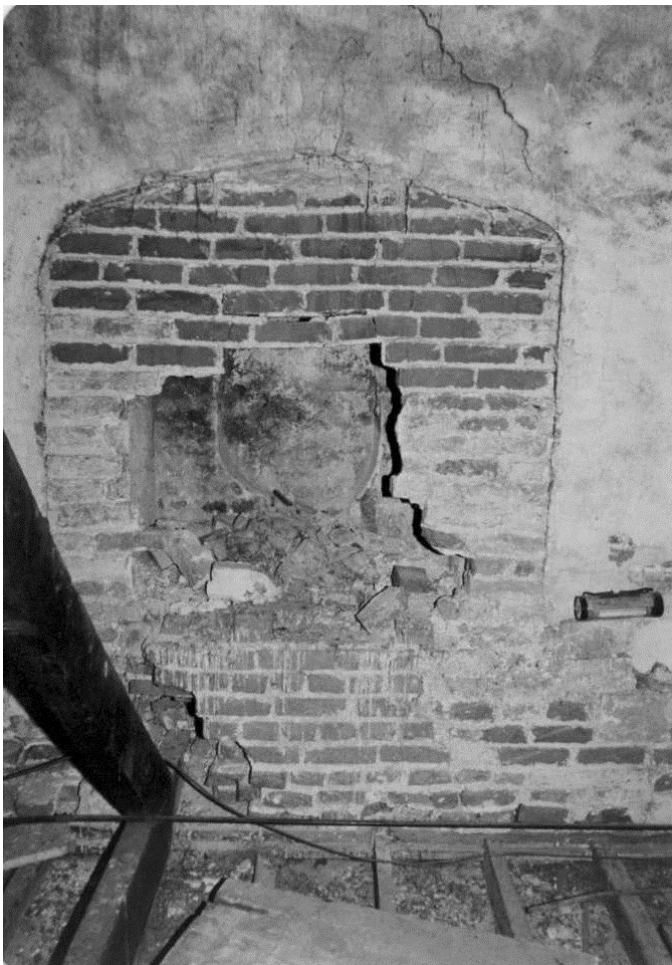
Figure 132. The fireplace in the chimney stack on the north wall of the hall in 1981 after the brick blocking had partially collapsed. Note the U-shaped ledge at the back of the fireplace.

There is the base of a large chimney stack of thin Tudor-type brick on the north wall of the hall with a fireplace facing into the attic of the north wing (figures 131 and 132). The chimney itself has been removed but is shown on the photographs of about 1860 and on earlier prints. The stack contains three flues. The central one served the attic fireplace. One of the others must have gone down to the fireplace in the centre of the north wall of the hall while the other is likely to have served a fireplace on the first-floor of the north wing.

By 1980 the fireplace had been blocked with soft red bricks of eighteenth or nineteenth century date. These were removed in 1981 and were replaced with breeze blocks. This provided a brief opportunity to record the fireplace and a quick sketch was made by Doug Cluett under time pressure (figure 133). The fireplace had a width of 1.56m. The lower part of the back had been built out 11.5cm leaving a U-shaped slot 0.61m wide and 0.72m high with a further narrow slot at the bottom. The hearth in front of the slot was flat with small steps on either side. The lower part of the fireplace was mostly plastered and was not much sooted. This odd arrangement must have served a specific purpose. The U-shaped slot looks like the seating for a boiler or perhaps a metal stove. Could it be the remains of an early hot water supply? The date is unclear but could be as early as the sixteenth century.

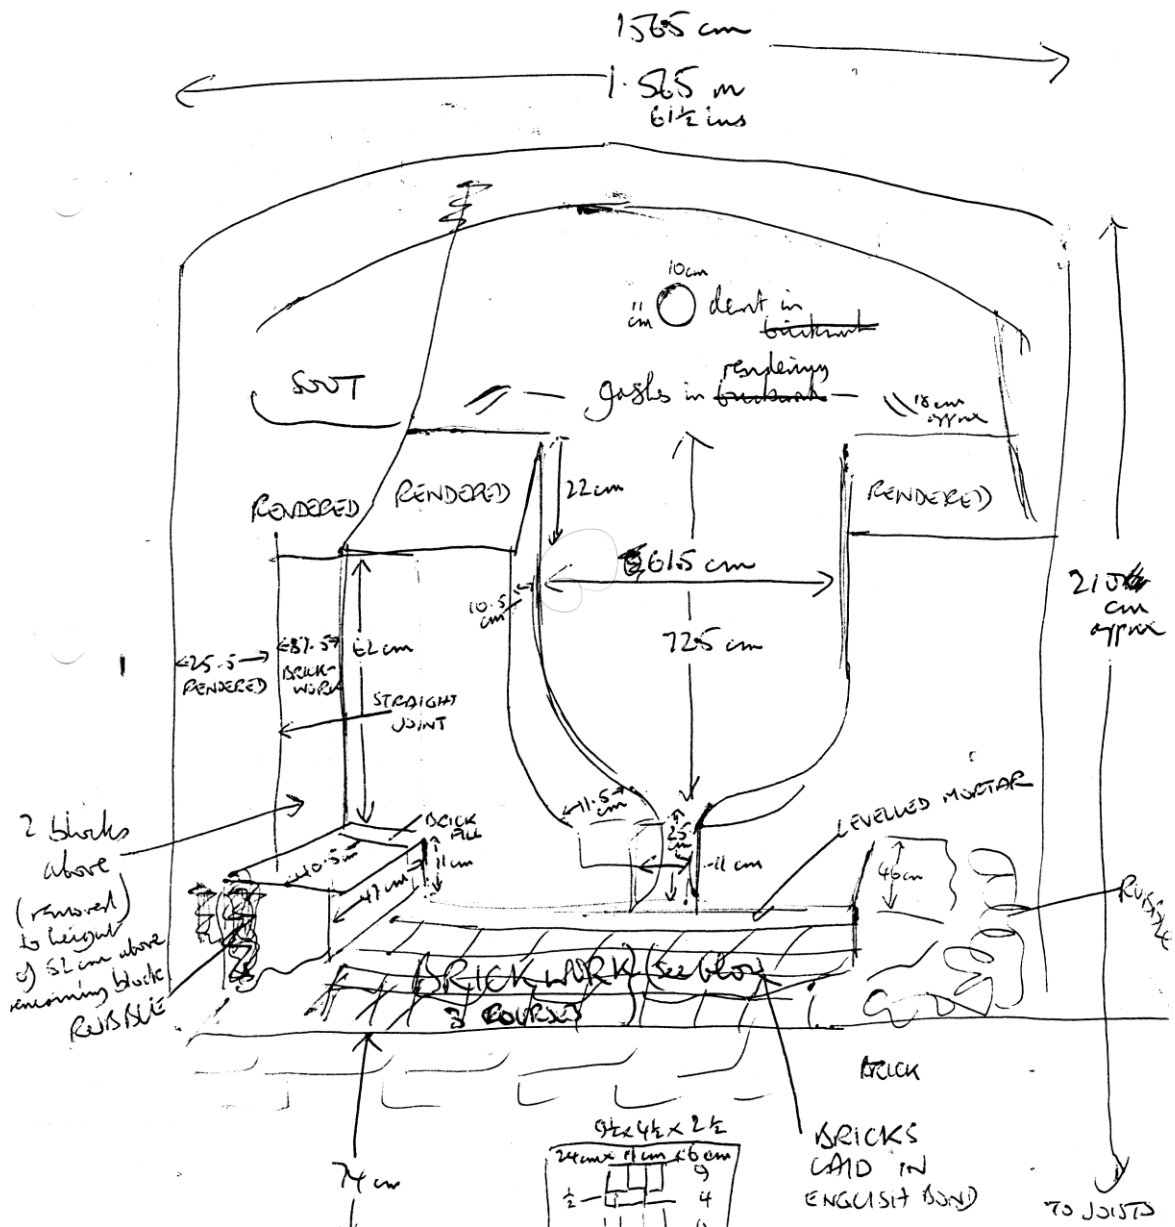
Figure 133. Sketch of the fireplace on the north wall of the hall made by Doug Cluett in 1981.

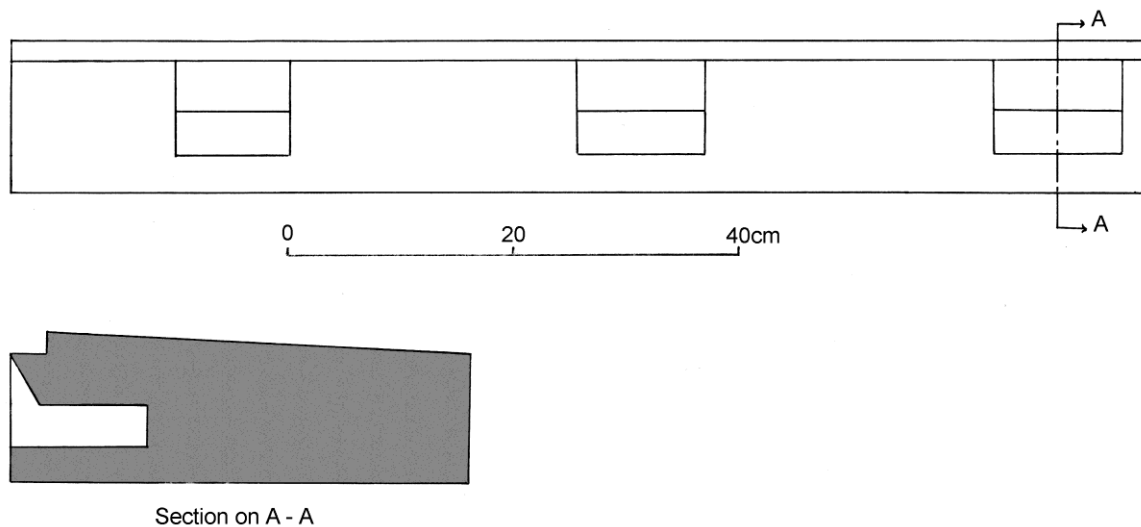
Figure 134. A timber found in the attic of the north wing near the end of the hall. It has a line of mortises on both sides – not just the one shown in the drawing.

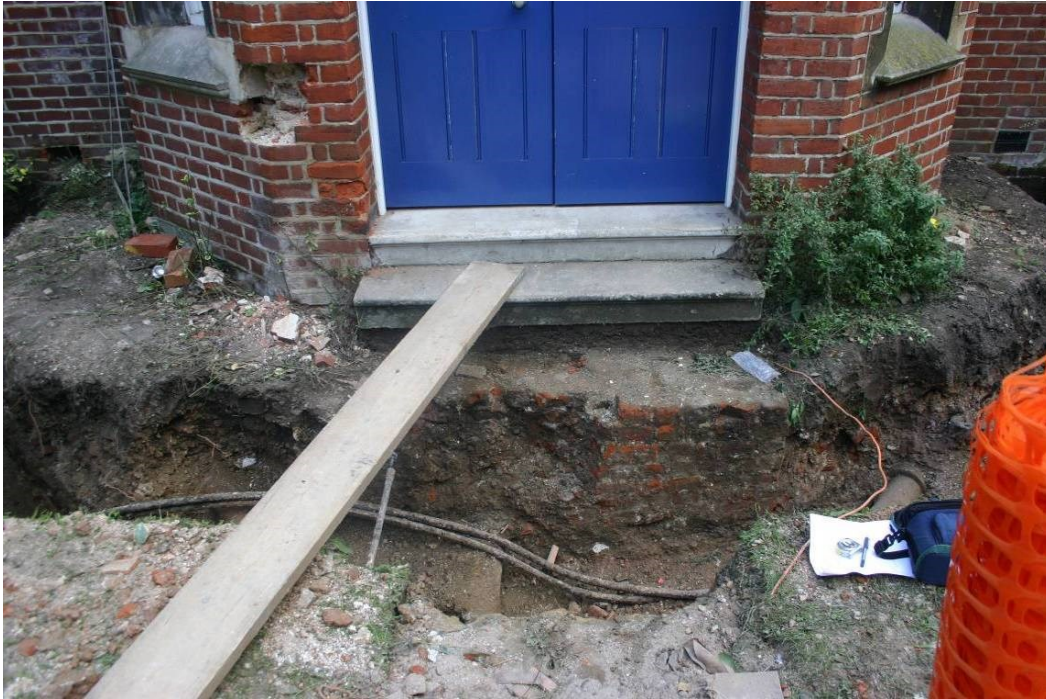
Figure 135. The trench looking west with the centre of the wing in the background. Note the brick structure below the steps.

In 2007 Jeffrey Perry of Sutton Archaeological Services carried out a watching brief on the foundation trench for a small extension on the east side of the centre of the present west wing (figures 135 to 137).<sup>306</sup> The stratigraphy was recorded on the north side of a rough and irregular trench. Ignoring a pipe and cable trench the stratigraphy consisted of

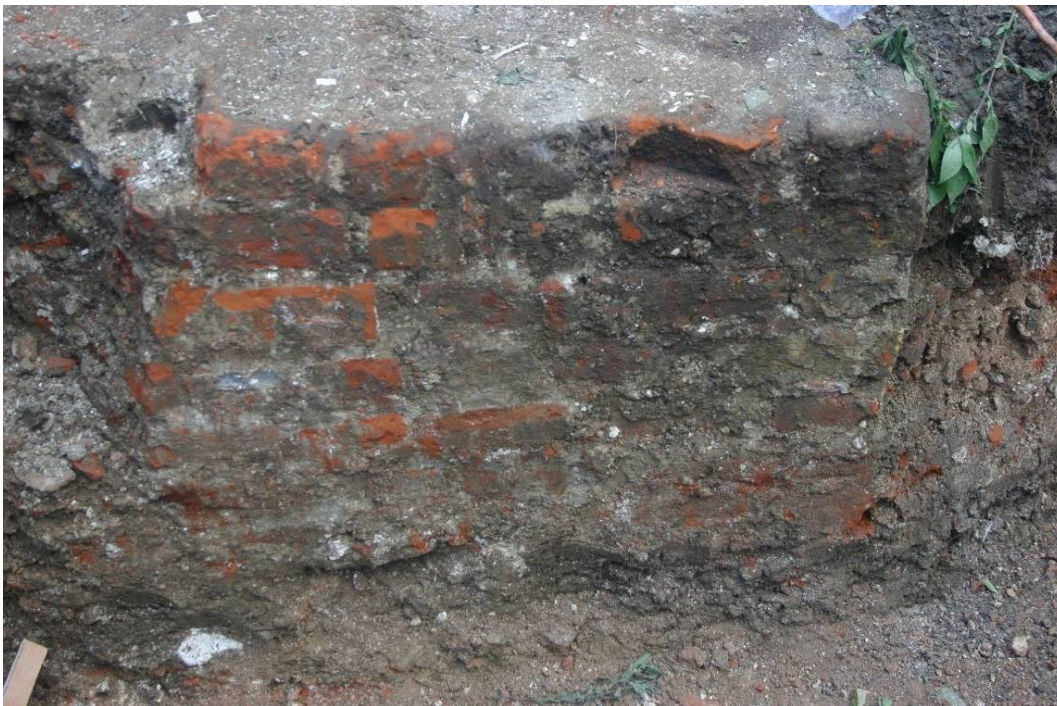
Figure 136. Detail of the structure shown above.

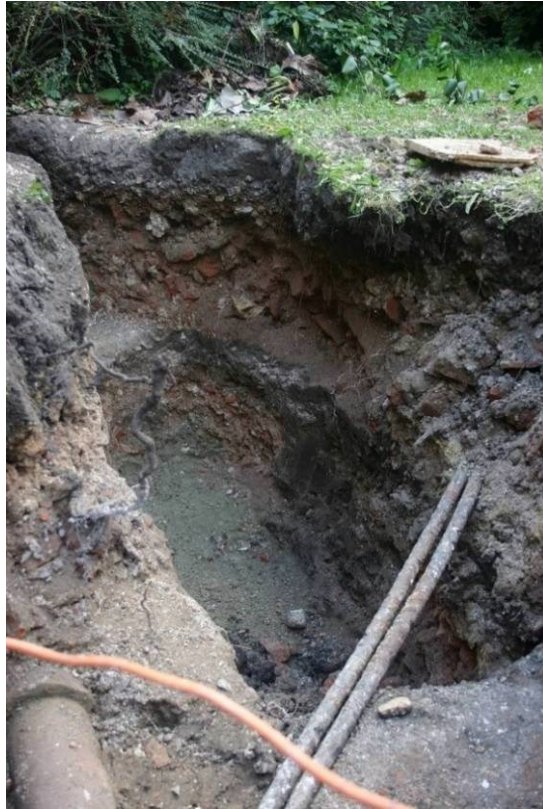
Figure 137. The deposits at the northwest corner of the trench.

[011] Greensand. The upper part of this contained small fragments of brick, probably derived from [008] as several hard trowellings left a clean sandy surface. The top of the deposit was at 31.56m OD.

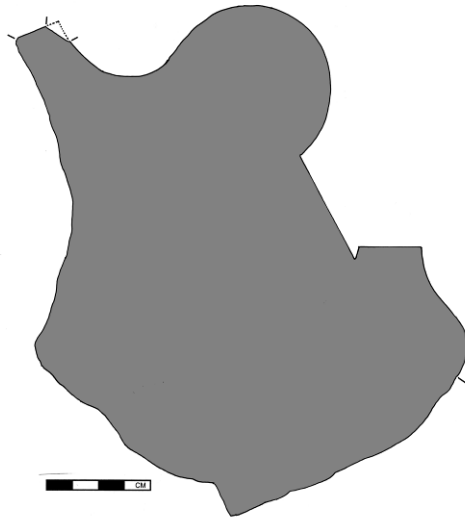
Find <85> from [CM15]. Oolitic limestone. Surviving length of moulding 35mm.

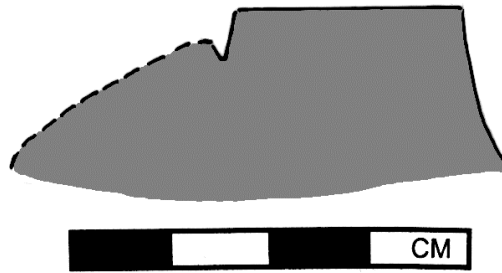
Right: the moulding on finds <169> and <201> from [CM15]. Two joining pieces of white oolitic limestone slab 26mm thick.

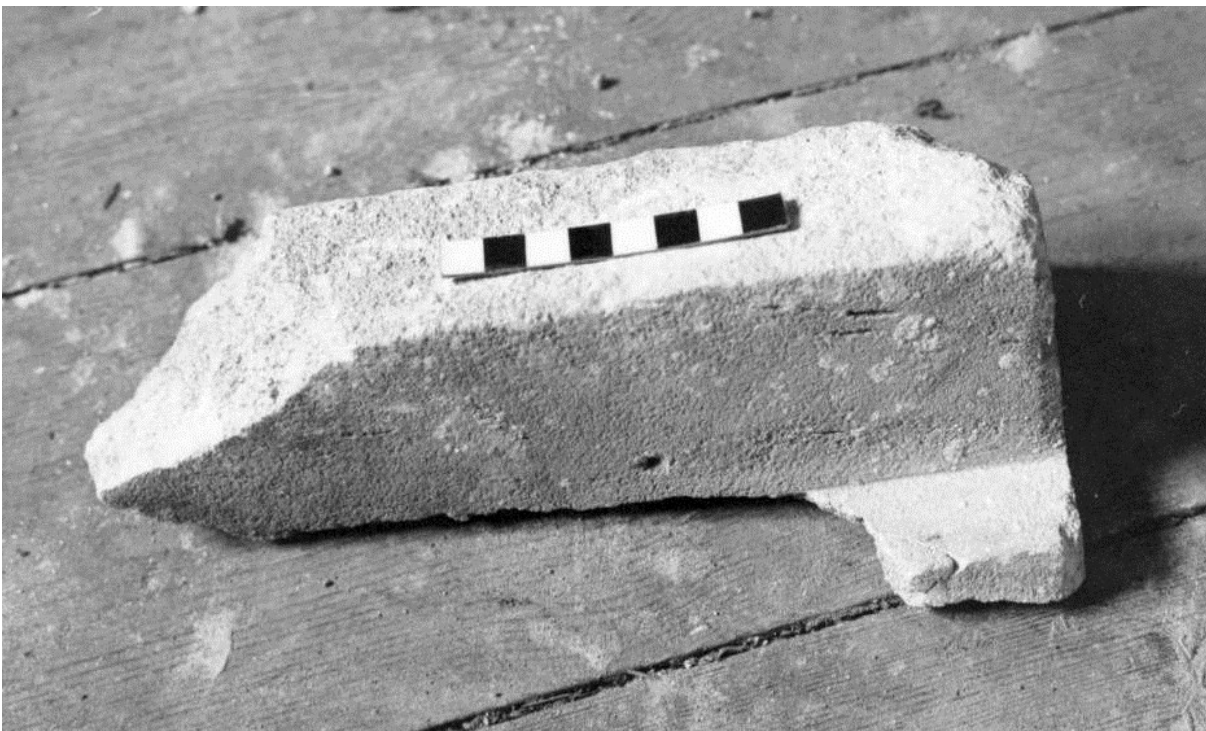
Stone block SB 3. Scale 8cm.

Stone block SB 3. Oolitic limestone reused in the fireplace on the north wall of the hall.

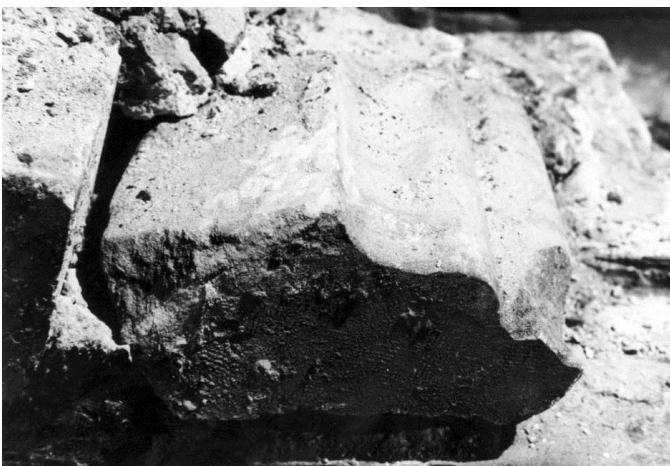
Stone block SB 1 as found. At the base of the northwest corner of the chimneystack on the north wall of the hall. Looking south.

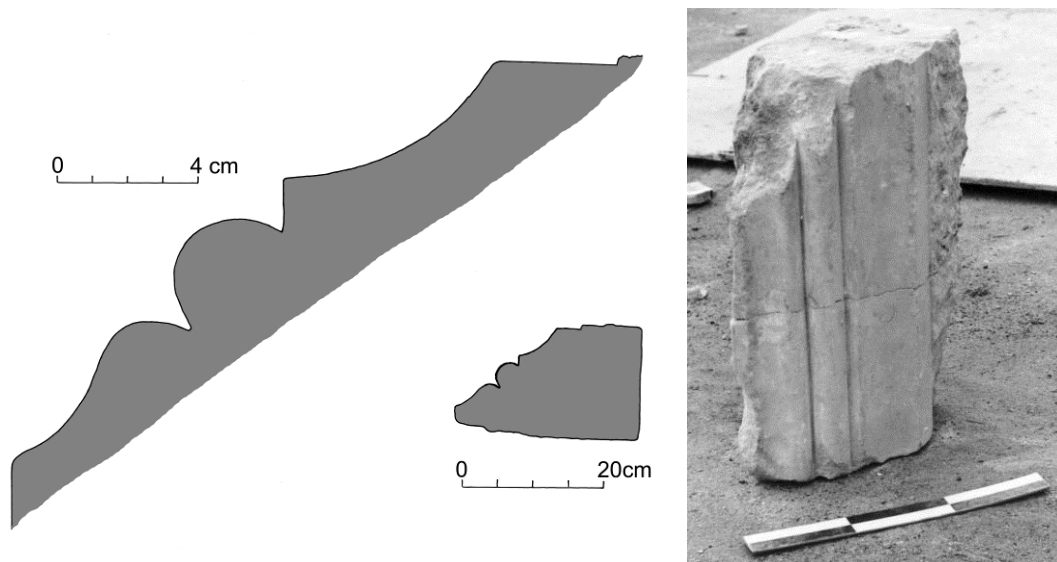
Stone blocks SB 120 and SB 121. Reigate stone. Section of with detail of the moulding to the left. Length at right angles to the drawings 42cm. Squared at both ends.

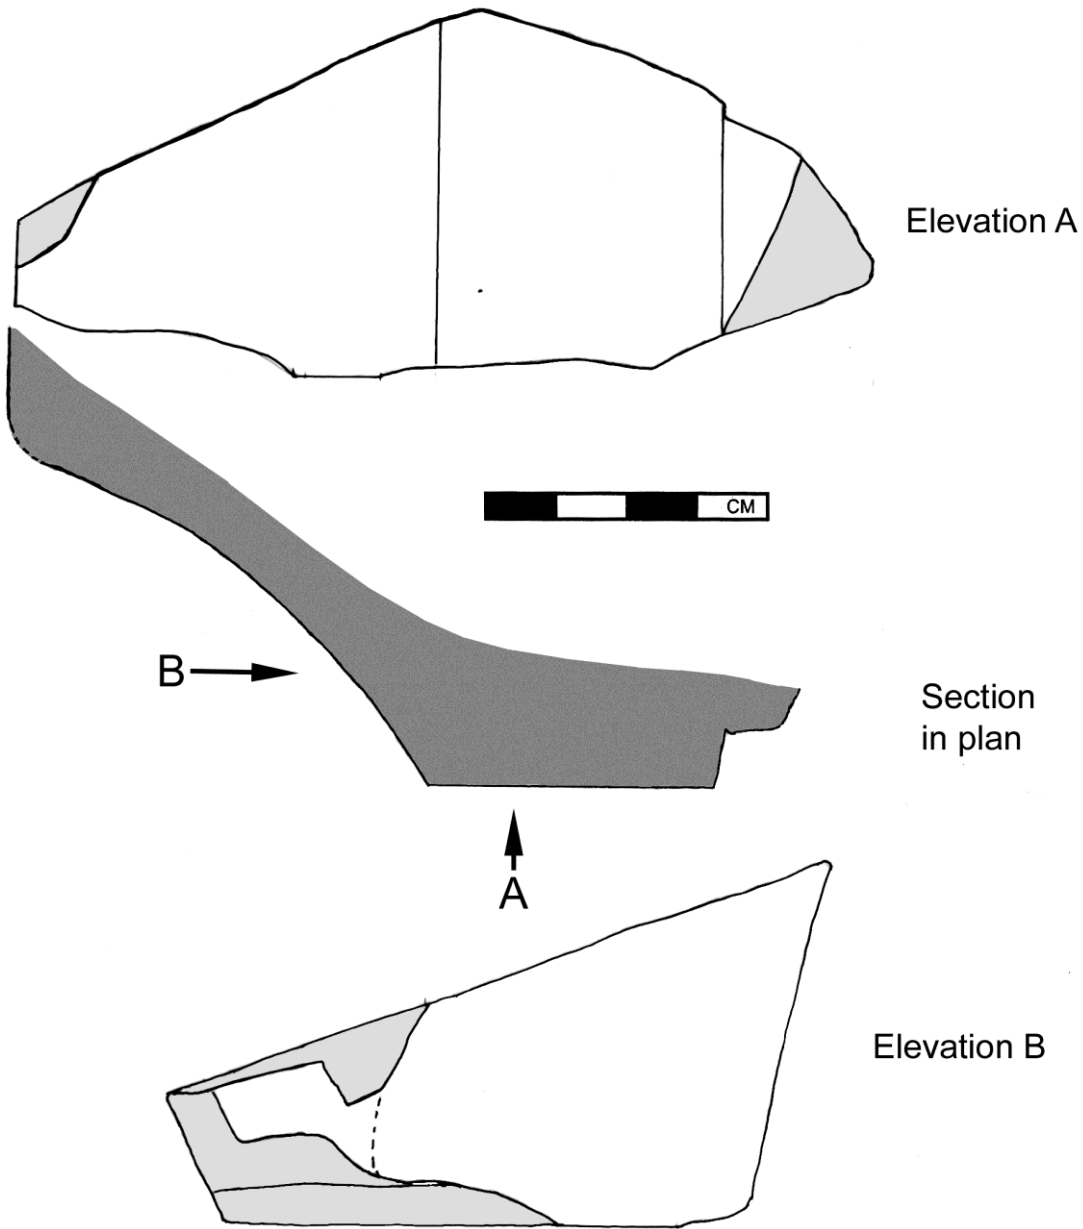
Find <177> from [CM15]. Reigate stone. Part of the bottom of a window head. With glazing slot. Estimated window width 240mm.

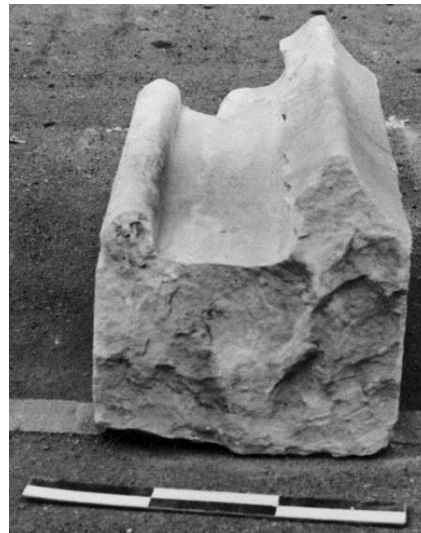
Reigate stone block SB 119. The moulding is very similar to the drip-course shown on the upper part of the kitchen walls in Buckler's drawing of 1827. Similar drip-course can be seen in the Tudor parts of Hampton Court including the great hall, the base court, the clock court and tennis court.

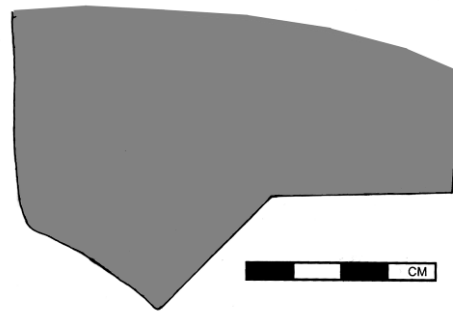
Reigate stone block SB 126 from the south wall of the gym. Surviving length of moulding 45cm. One end squared, one broken.

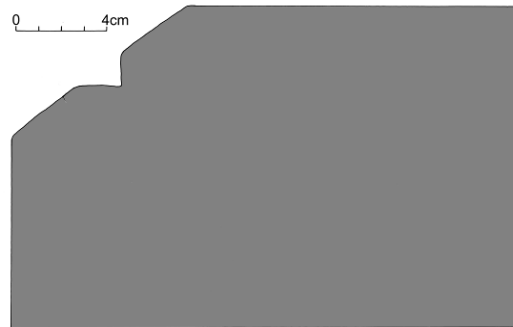
Find <32> from [CH3]. Reigate stone. Small block with top bottom and 6 other faces. Maximum length at right angles to the figure 85mm. Probably part of a window. Some areas grey from burning.

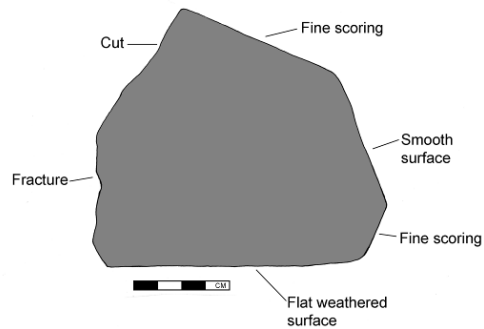
Reigate stone block SB 125 from the south wall of the gymnasium. Surviving length of moulding 11cm.

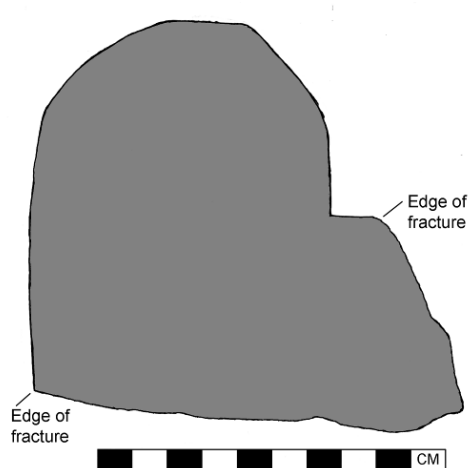
Stone block SB 20 found lying in the garden in the courtyard in 1985. Reigate stone?

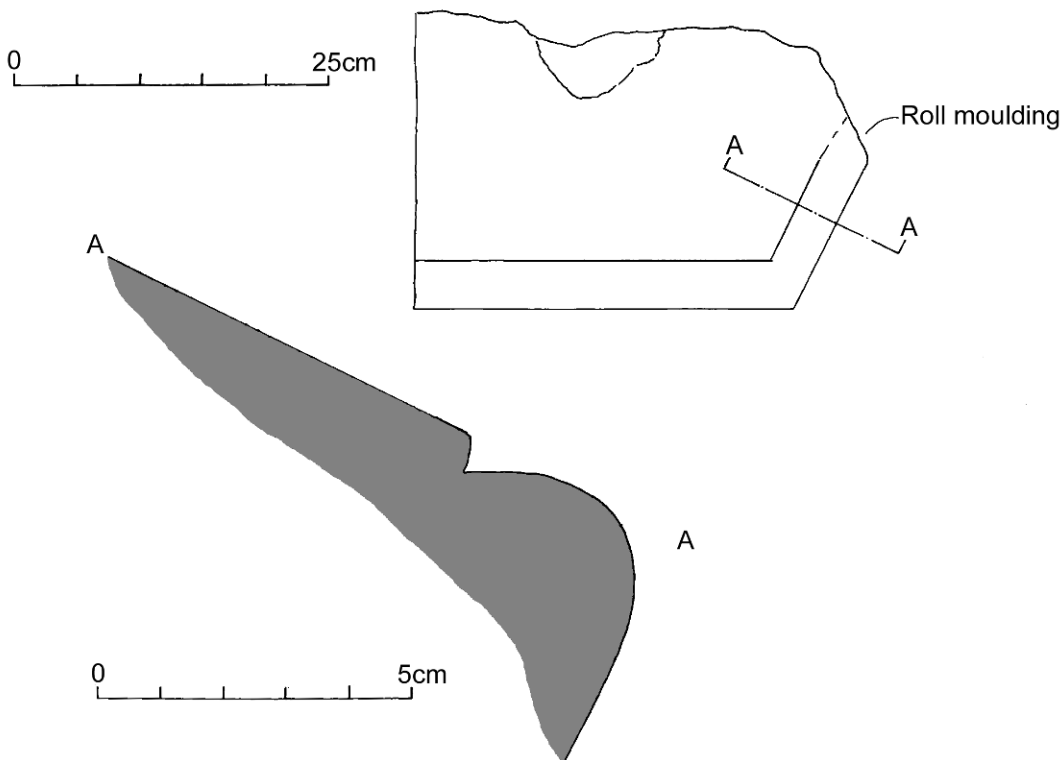
Reigate stone block SB 101 with detail of the moulding. From the south wall of the gymnasium.

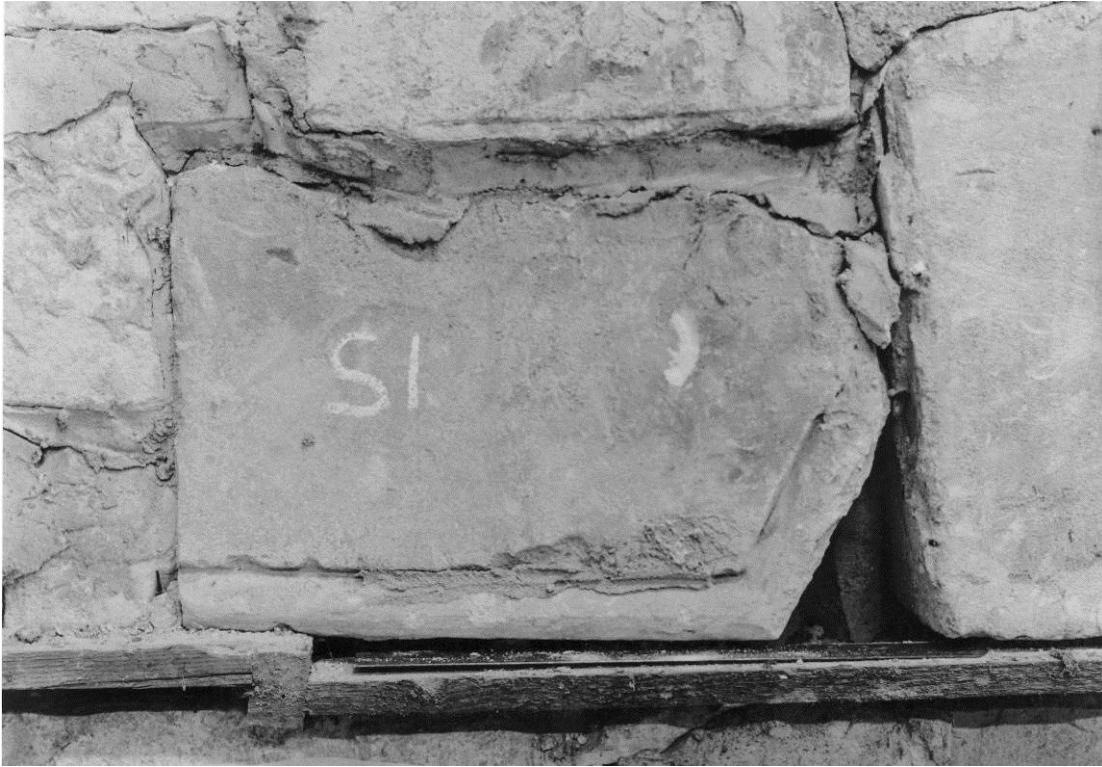
Stone block SB 101 in situ in the gymnasium wall.

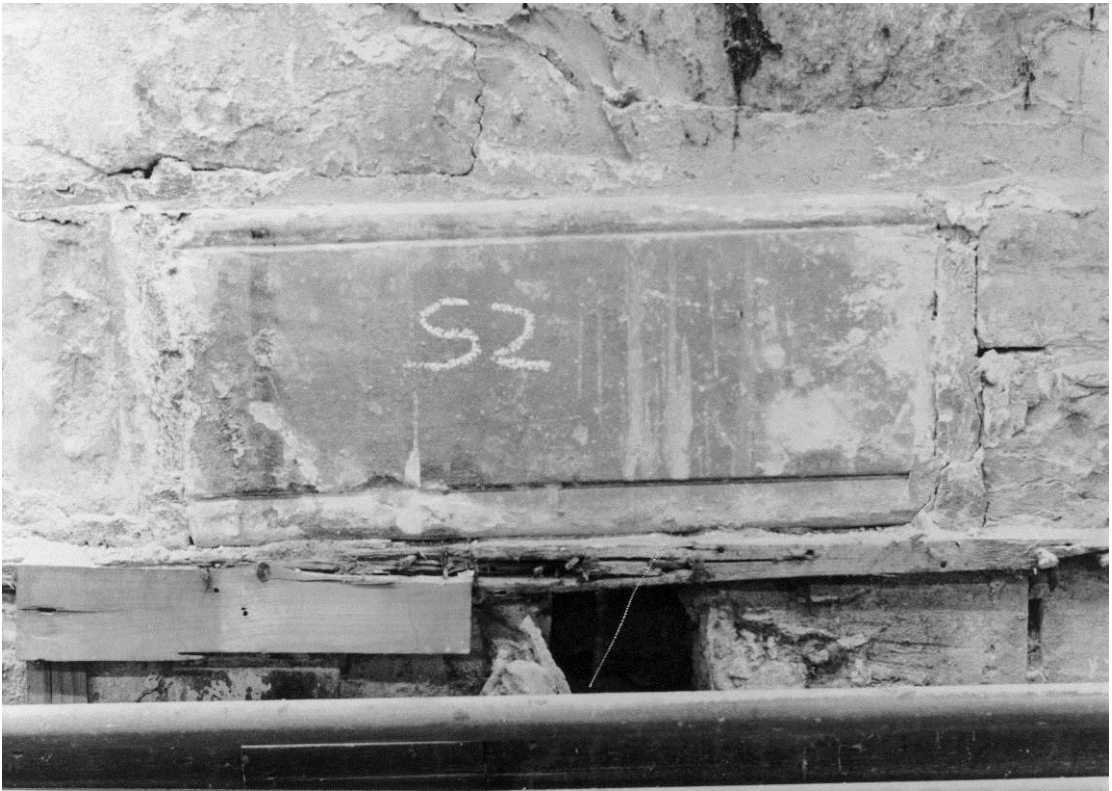
SB 102 in situ in the gymnasium wall.

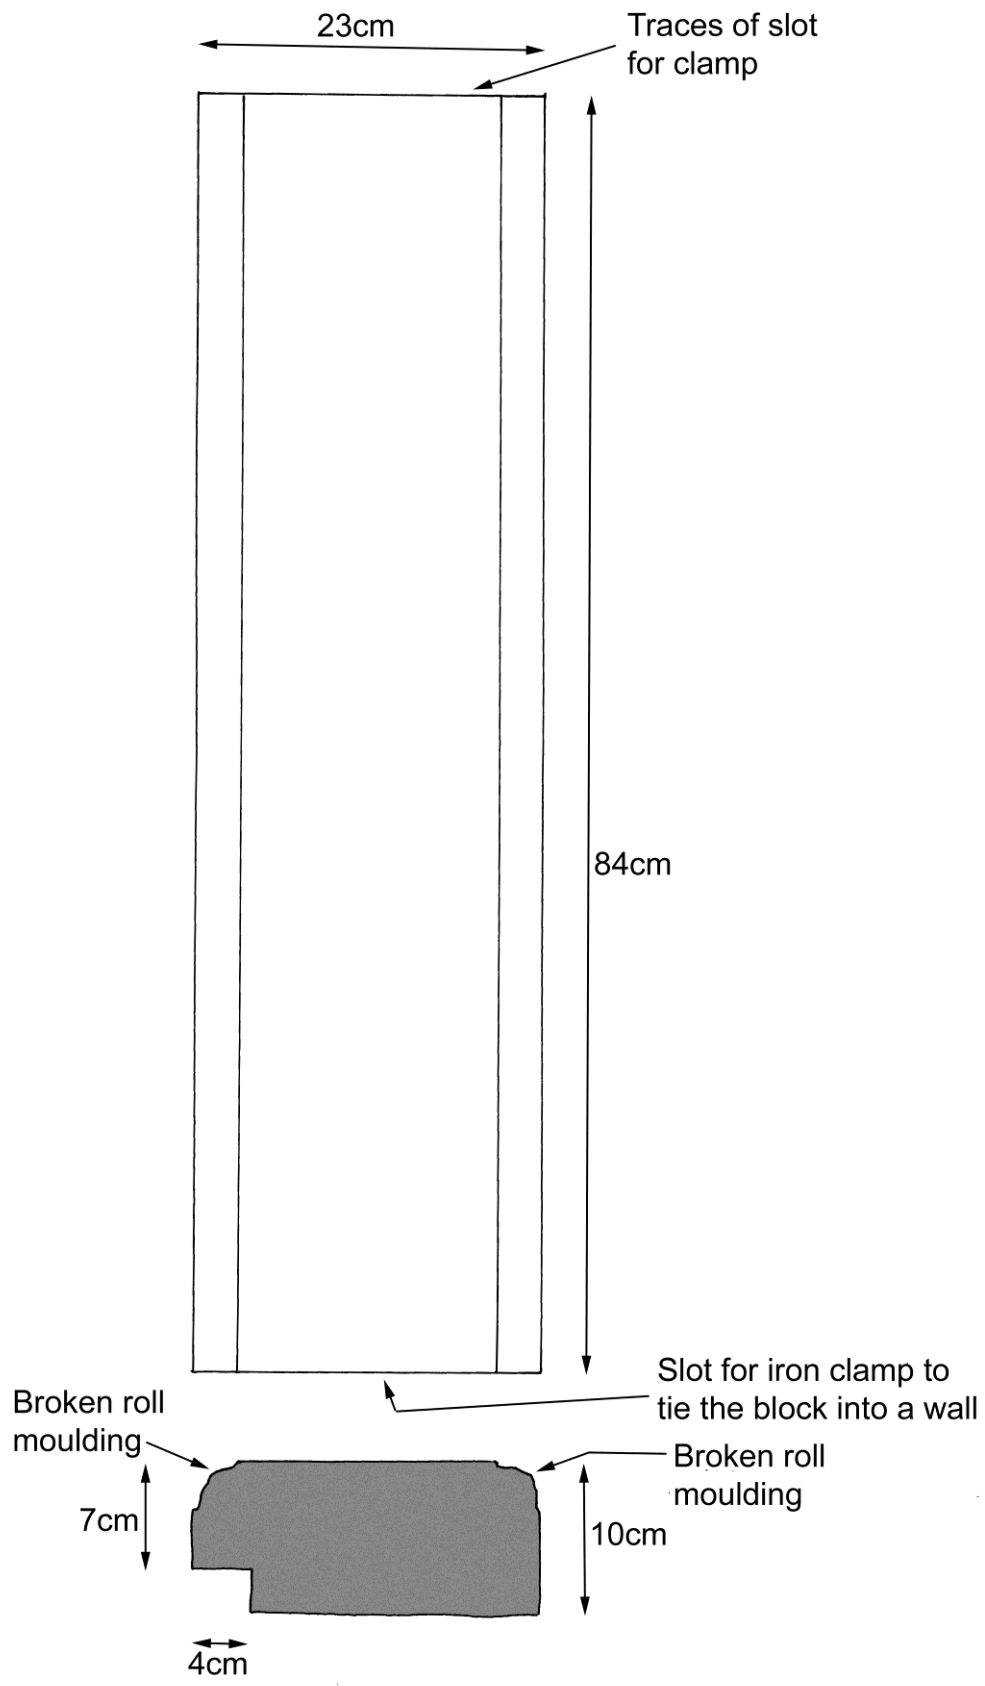
Sketch drawing of Reigate stone block SB 113 from the south wall of the gymnasium.

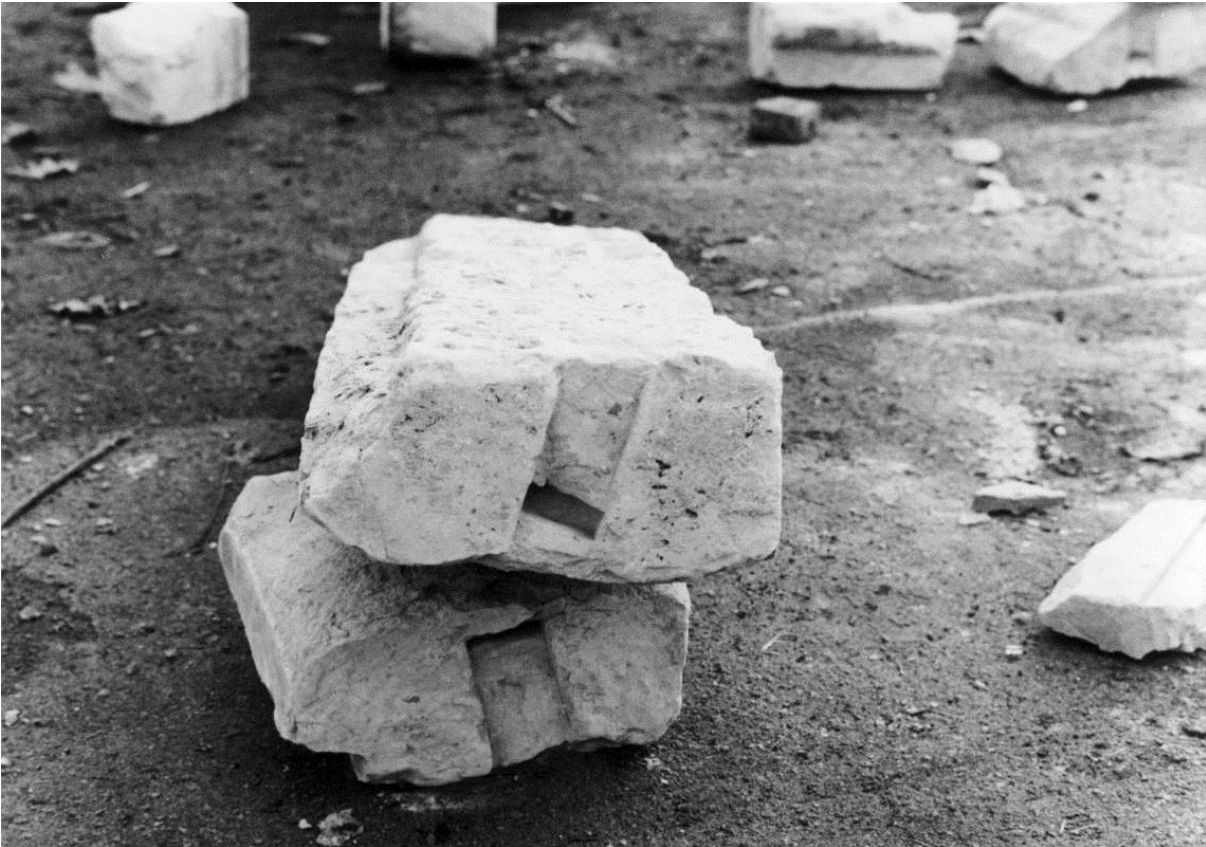
Cramp holes in the end of SB 113.
