# **Carew Manor, Beddington**

**A report on historical and archaeological investigations of  
the house and moat, 1979-2014**

**Volume 1: the house and its owners**

**John Phillips and Nicholas Burnett**

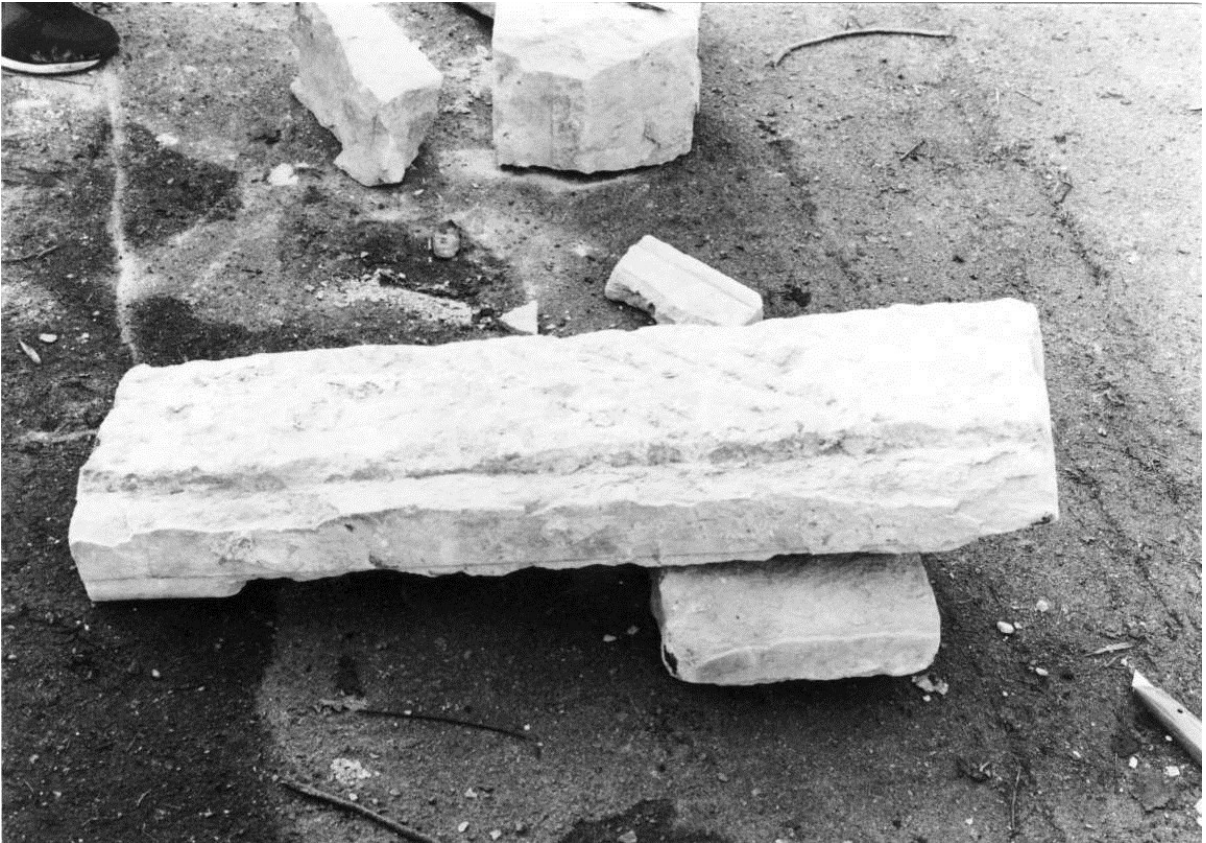
The edge and back of SB 113.

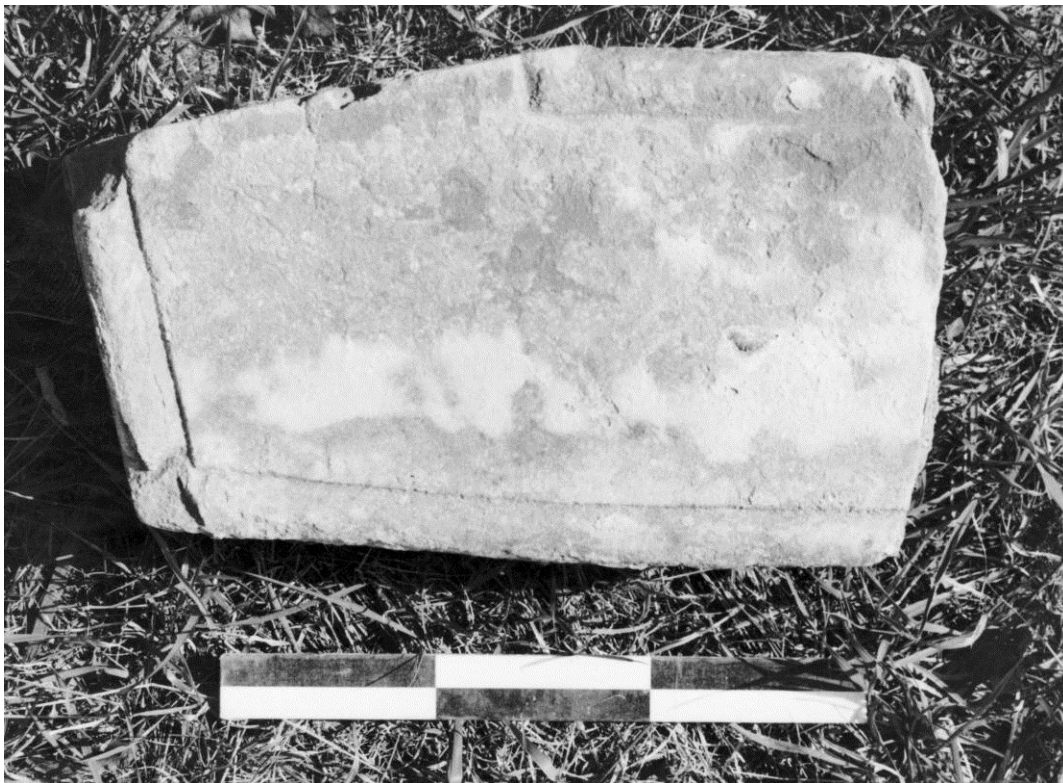
The front of block SB 131.

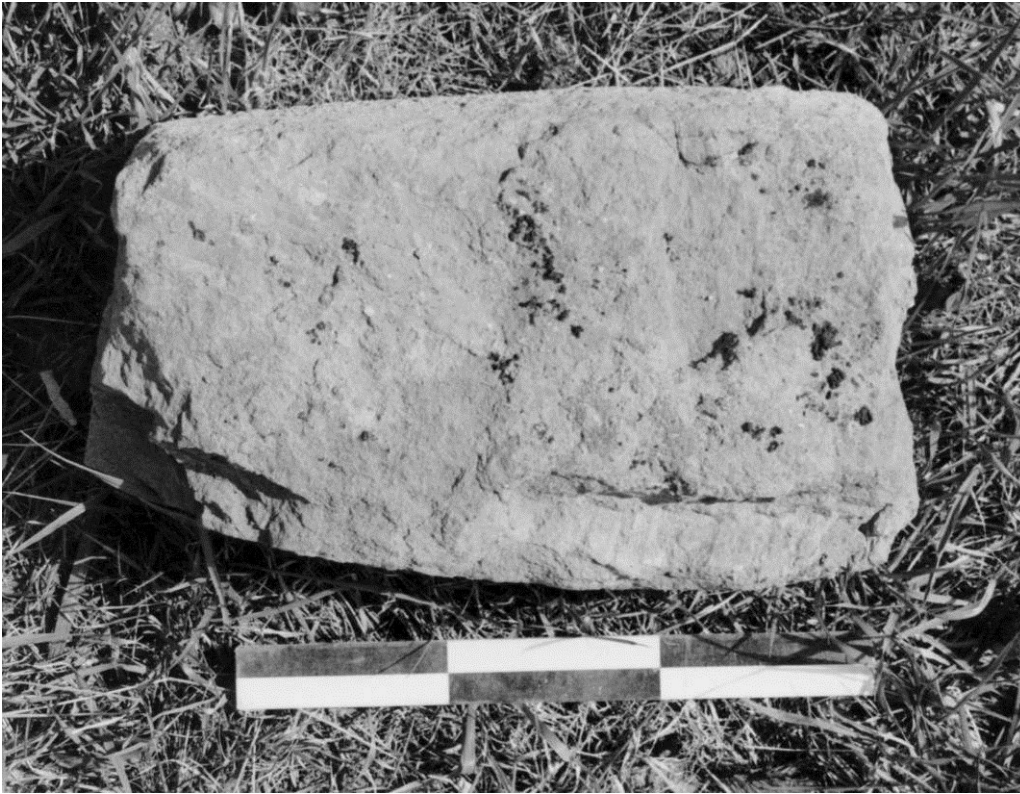
The back of block SB 131.

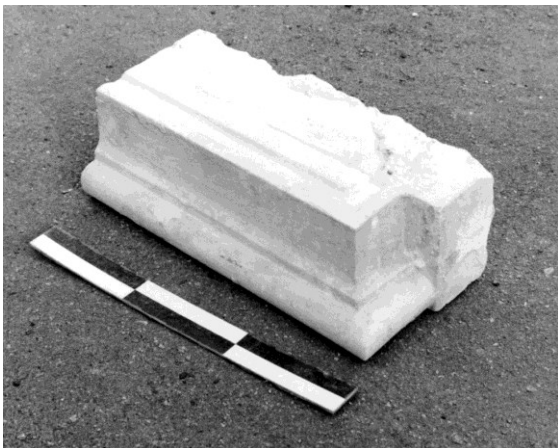
The underside of SB 115.

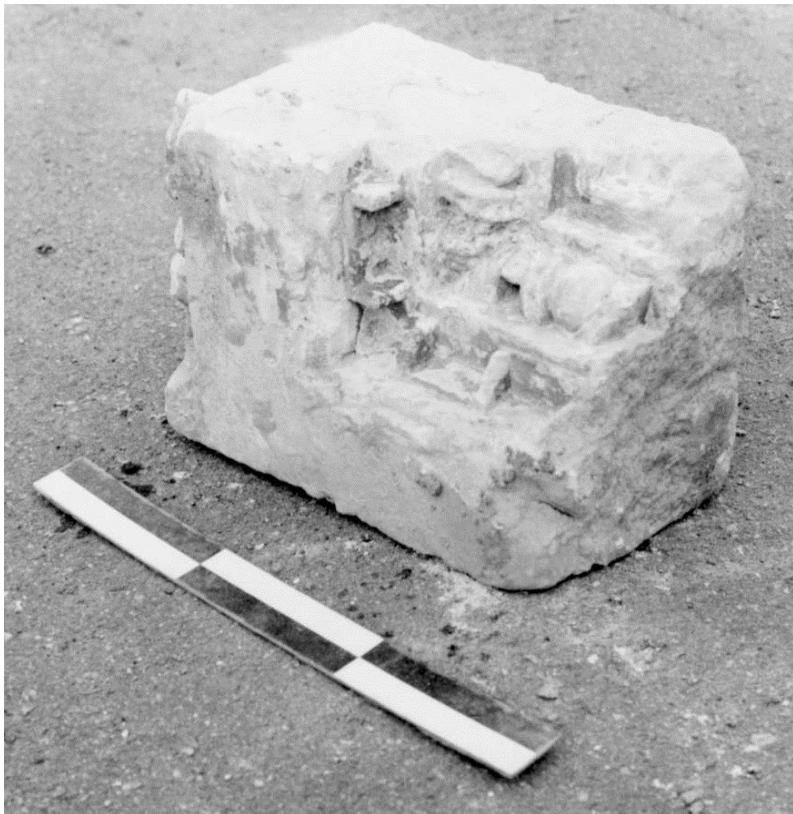
This block appears to have been reused. One face had foliate decoration probably from a medieval or classical capital. The block had then been reshaped to for part of a small cornice.

Stone block SB 132 from the south wall of the gymnasium. The foliate decoration is just visible on the far left edge.

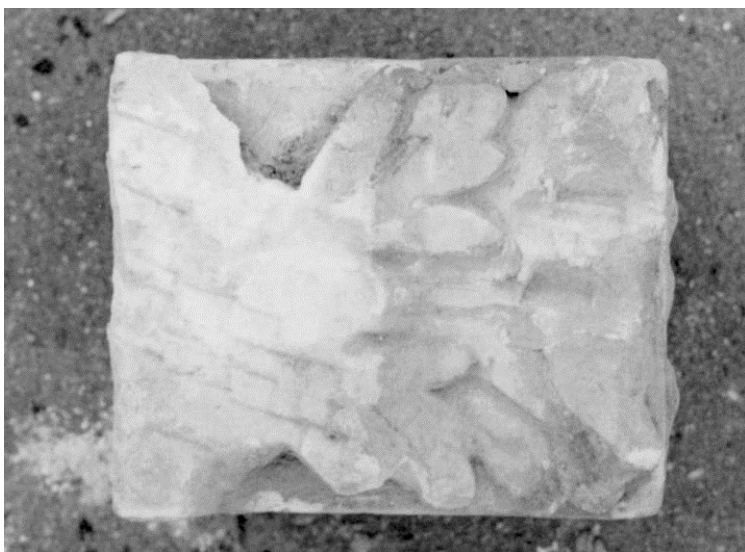
Stone block SB 132. Partly cut away foliate decoration on one edge.

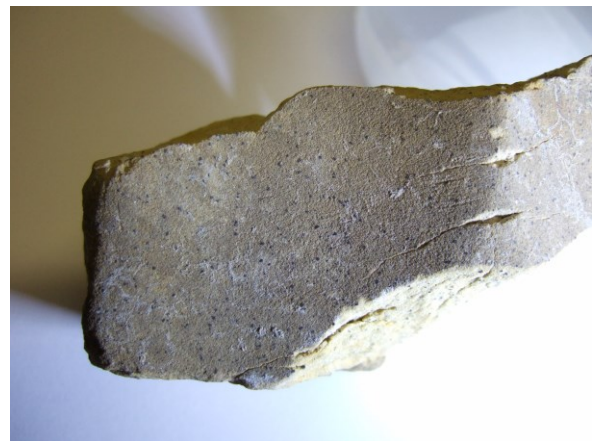
The surface.

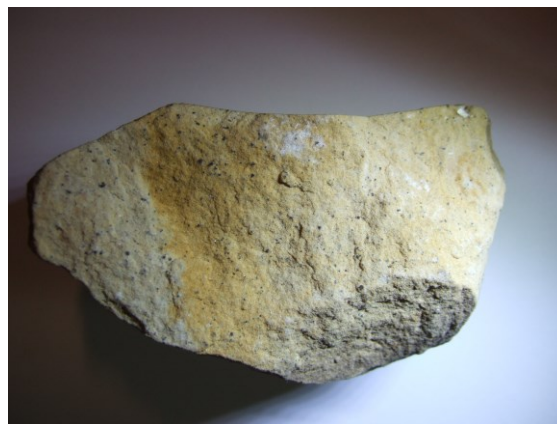
The fracture.

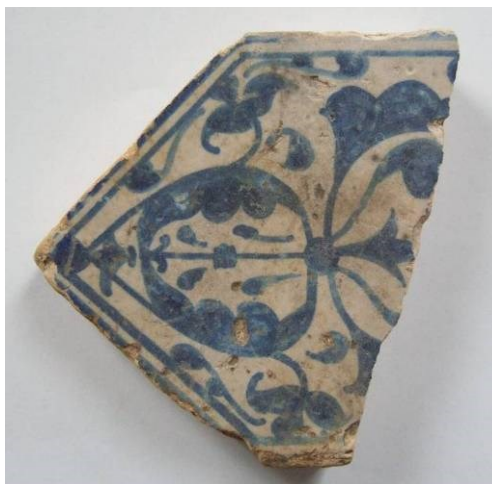
Hexagonal tile with blue and white tin-glaze from the gravels in the south arm of the moat culvert.<sup>331</sup> Width 90mm. Thickness 17mm. Mortar on the edge and base.

Gaimster and Hughes 1999 illustrate a very similar tile from the Broad Arrow Tower in the Tower of London. It was one of three hexagonal and two square tin-glazed tiles found in a context dated to the first half of the sixteenth century. Neutron activation analysis by the British Museum suggests that the tile was made in Antwerp.

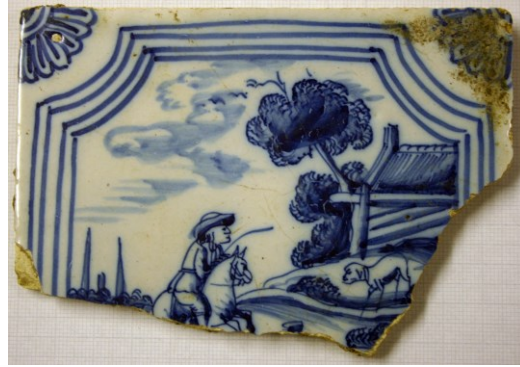
Top half. Width 125mm, thickness 6mm. Undercut edges. Found in 1980.<sup>335</sup>

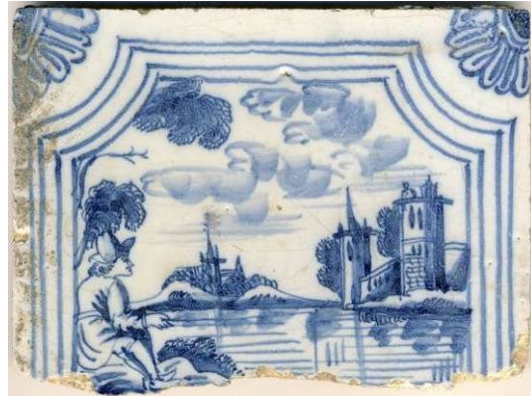
<50> Top right hand corner. Top edge slightly bevelled with some glaze on it. Edge bevelled at about 45 degrees. Surviving length of top edge 73mm, and side 65mm. Thickness 8 mm.

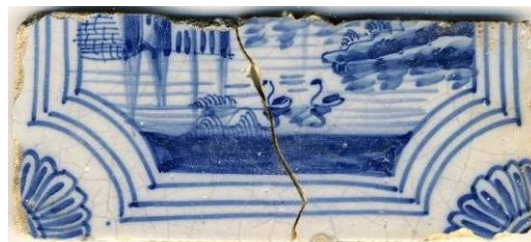
<51> and <52> Bottom in two pieces. Full width 125mm. Maximum surviving height 54mm. Bottom and left edge bevelled in two facets. The right edge bevelled at less than 45 degrees. Thickness 5mm.

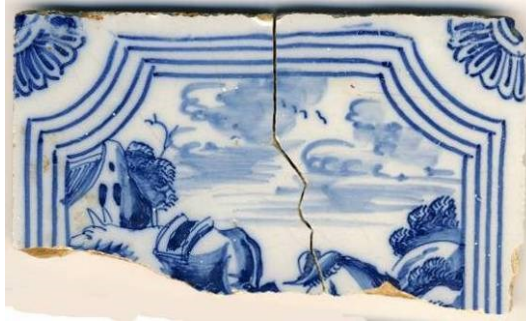
<53> and <54> Two joining pieces from the top. The left hand edge bevelled with two facets, the right bevelled at an angle of about 45 degrees. Full width 126mm, surviving height 73mm. Thickness 7 mm.

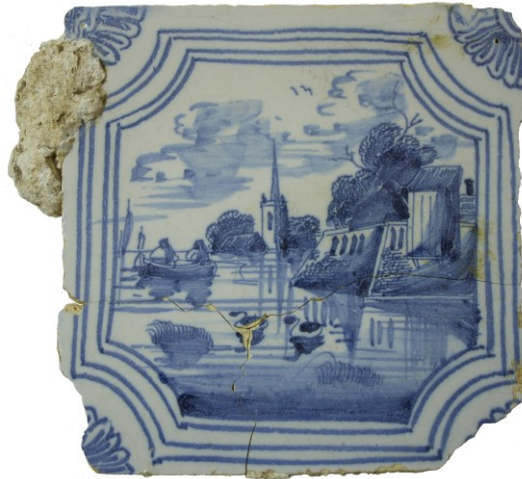
<55>, <56> and <57> tile in three joining pieces. 124mm wide, 125mm wide, 7.5mm thick. Under cut edges. Dimples on top corners. Two layer of mortar on the back.

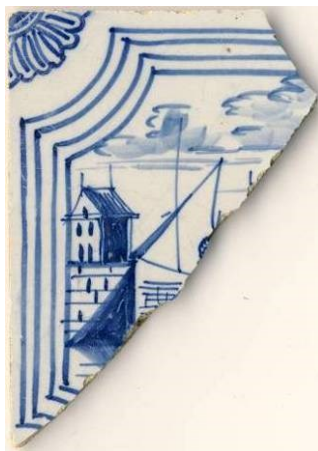
<58> Corner. Maximum surviving width 74mm, surviving height 105mm. Both edges bevelled with two facets.

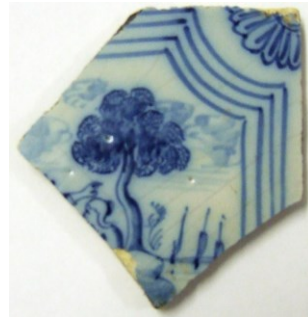
DA <2002> Corner of tile. 7mm thick.  
Rounded undercut edges.

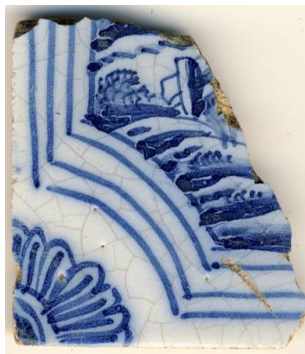
Find <39> from [CJ9]. Corner dimple.  
7.5mm thick. Undercut edges. Saw mark  
on the back.
