# **Carew Manor, Beddington**

**A report on historical and archaeological investigations of  
the house and moat, 1979-2014**

**Volume 2: the moat**

Carshalton & District History & Archaeology Society  
Occasional Paper 10

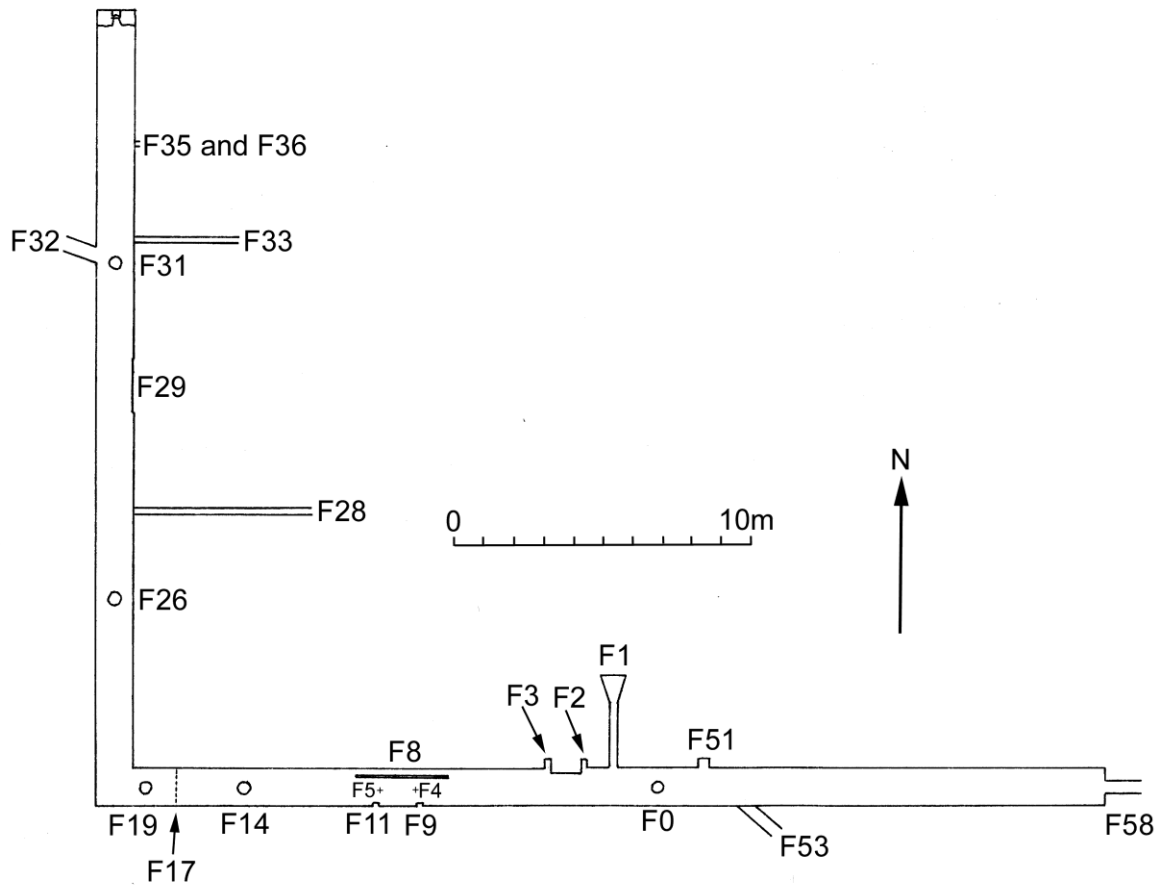
Figure 2. Key features in the culvert.

The main culvert was generally a two-brick-thick arch 2.7m wide and about 1.27m high. At the entrance manhole F0 (see figures 1 and 2) the gravel floor was at 30.26m OD and under normal conditions water level is at about the same height. The floor rises slightly to east so that it is generally dry. In the opposite, western, direction the floor drops slowly and becomes muddier. It deepens considerably before the southwest corner so that this end and the western arm have a floor of water-covered mud.

Several large blocks of chalk were found in the bottom of the north channel close to section A in figure 2. They were in a group close together and the tops were more or less at the same level below the base of the culvert wall. They seem to be a rather unlikely natural feature, but they could not be examined in detail, and their significance is unknown.

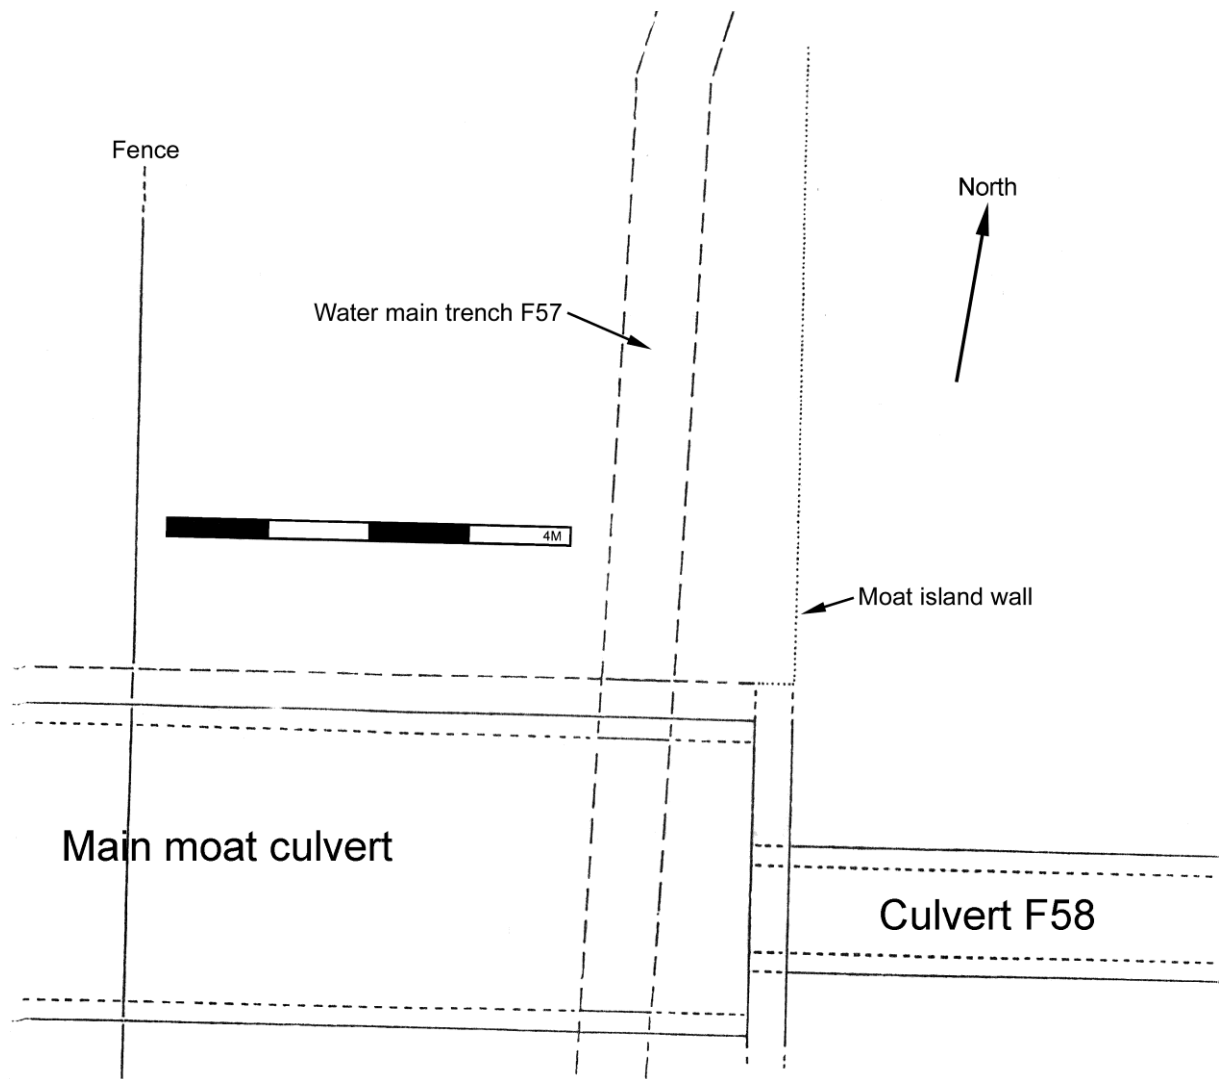
Figure 3. The moat culvert where the water-main F57 crosses from a drawing by Clive Orton.

The Sutton and District Water Company pipe crosses the culvert. This was laid in 1979 and led to the discovery of the culvert. The section was recorded by Clive Orton (figures 3 and 4). The culvert arch was one-brick-stretcher thick and had an internal width of about 2.7m. The trench cut through the stone facing of the moat island wall and passed into a substantial foundation. The report says that:

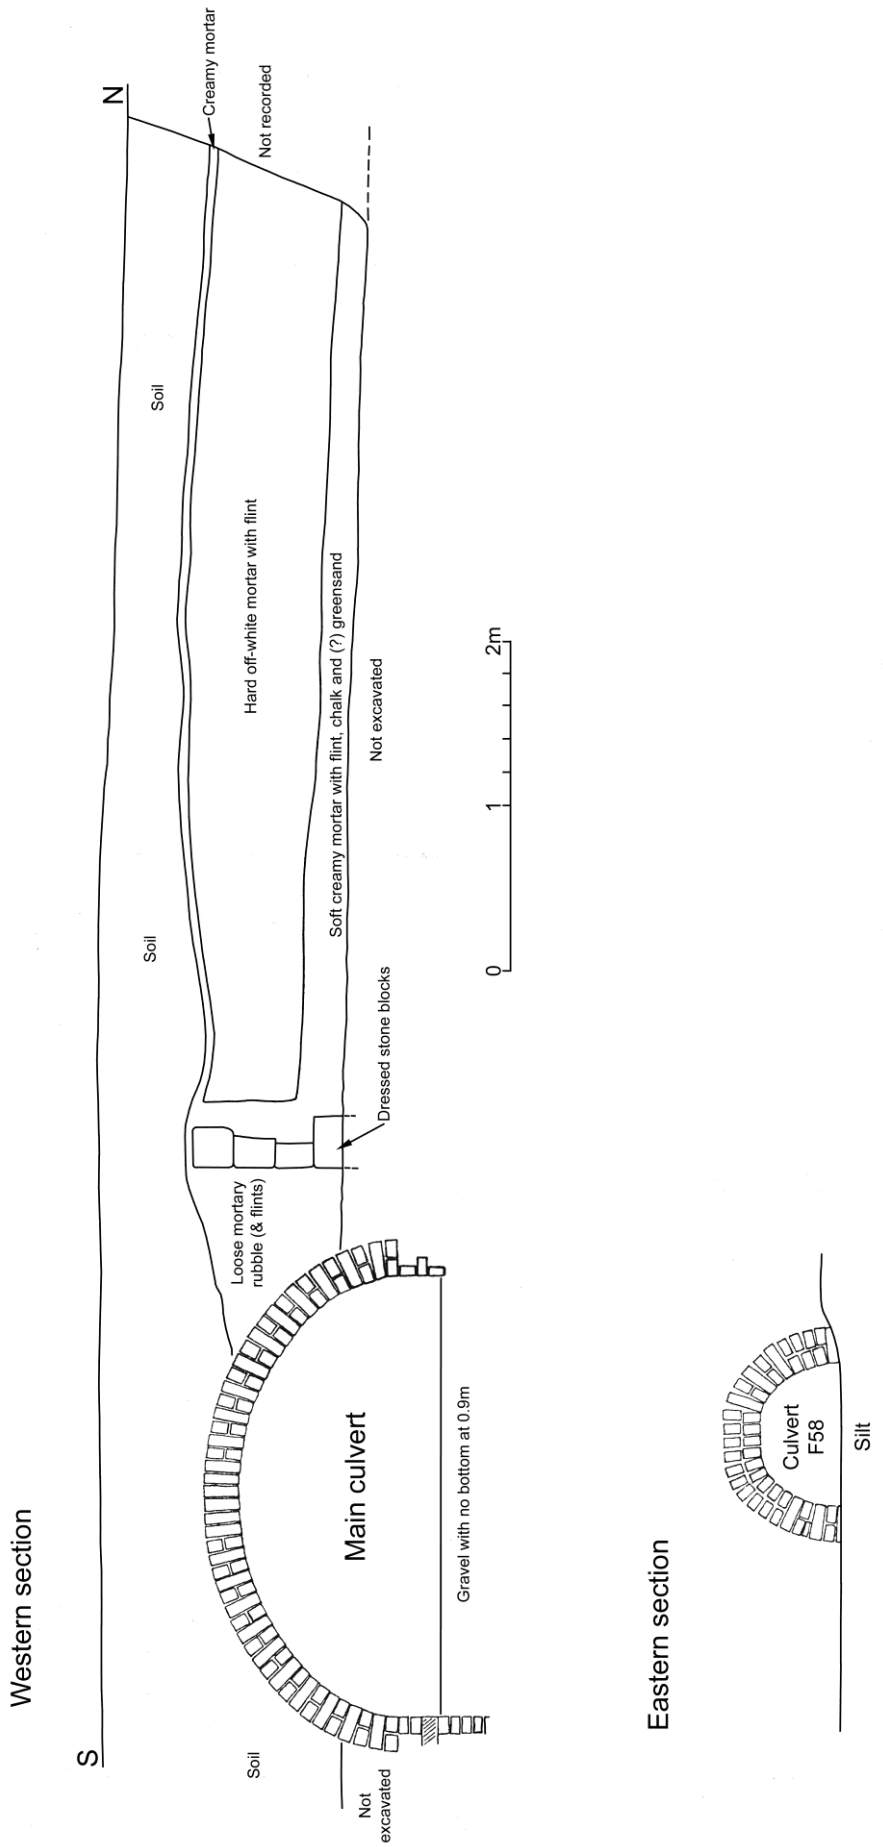
Figure 4. The section through the culvert and moat island exposed by the watermain trench. And the section of culvert F58. From a drawing by Clive Orton.

bottom of the foundation. The southern edge which was parallel to the culvert and about 0.4m (1ft 4in) from it, was revetted with large blocks of faced stone, probably Reigate stone ... The water main trench cut through this foundation raft at a slight angle, and emerged from the eastern edge, which was followed to a point about 20m (22 yards) north of the southern edge. Part of the eastern edge had been patched with brick, of the same sort as used for the culvert.<sup>5</sup>

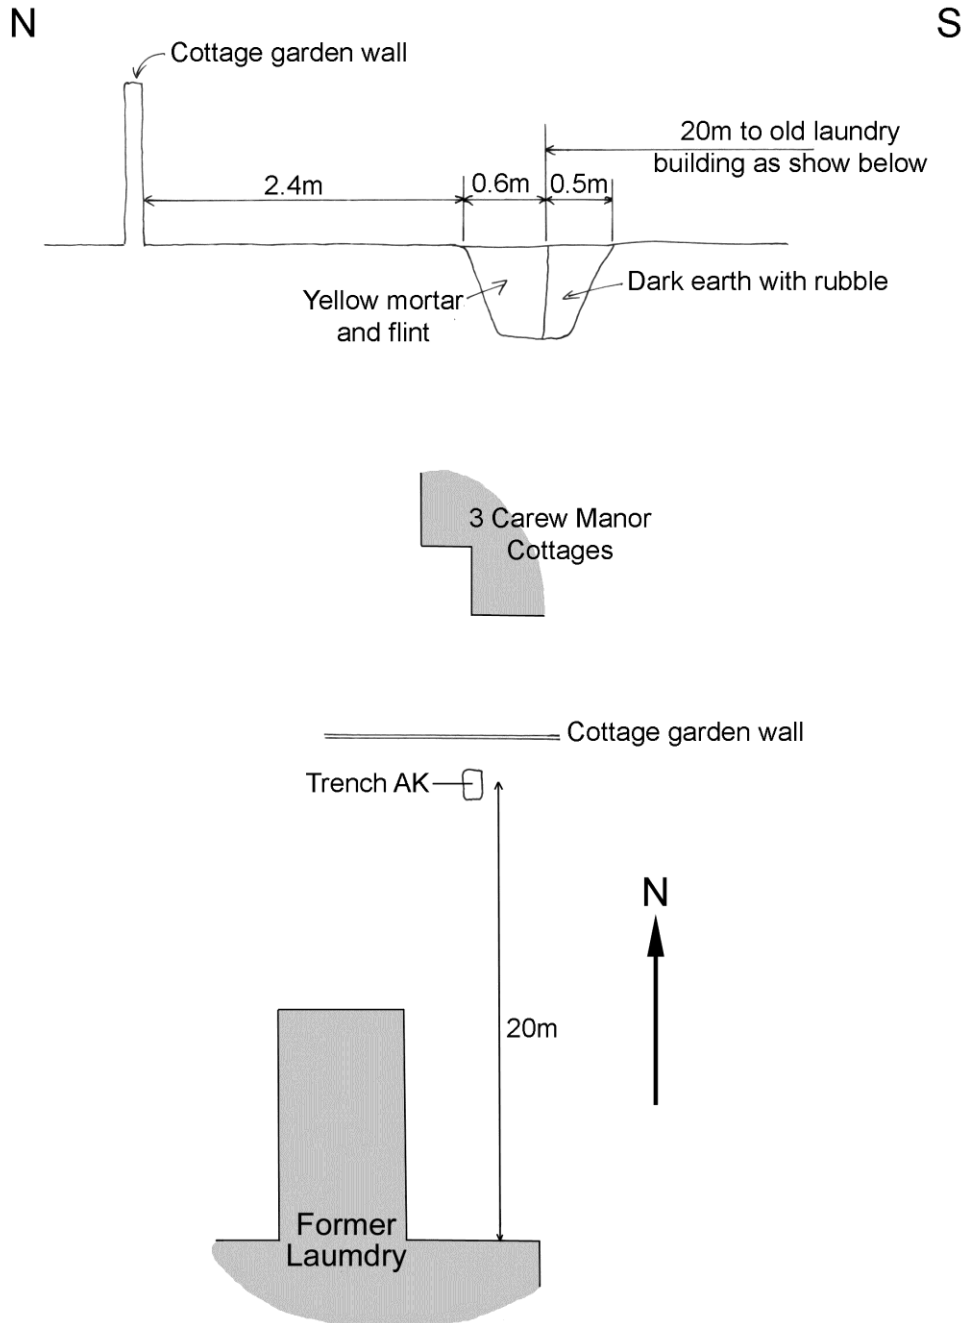
Figure 18. Location and sketch section of trench AK.

On 4 February 1990 a small contractor's trench was dug to the north of the former laundry building. It exposed a small part of a foundation (figure 18). The significance of the foundation is unclear although it may possibly have been part of the outer wall of the north arm of the moat.

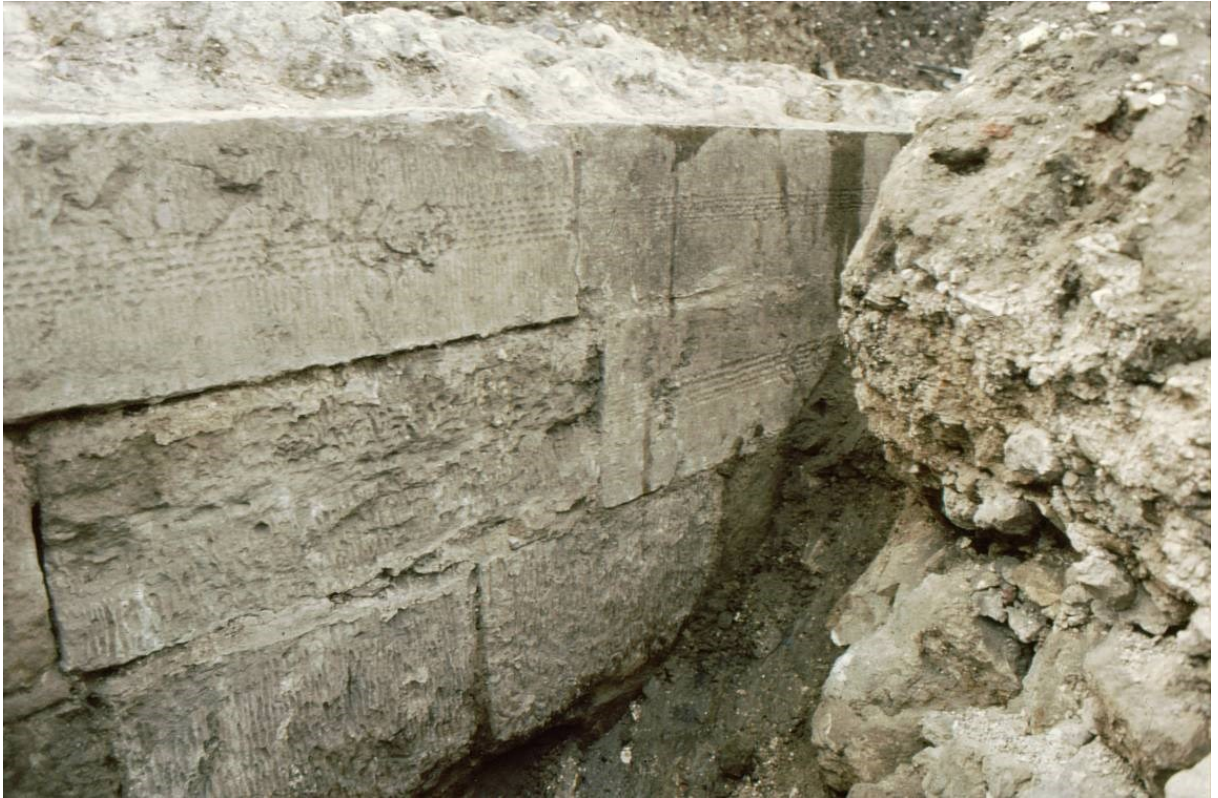
Figure 35. The outer face of the moat wall in trench CA.

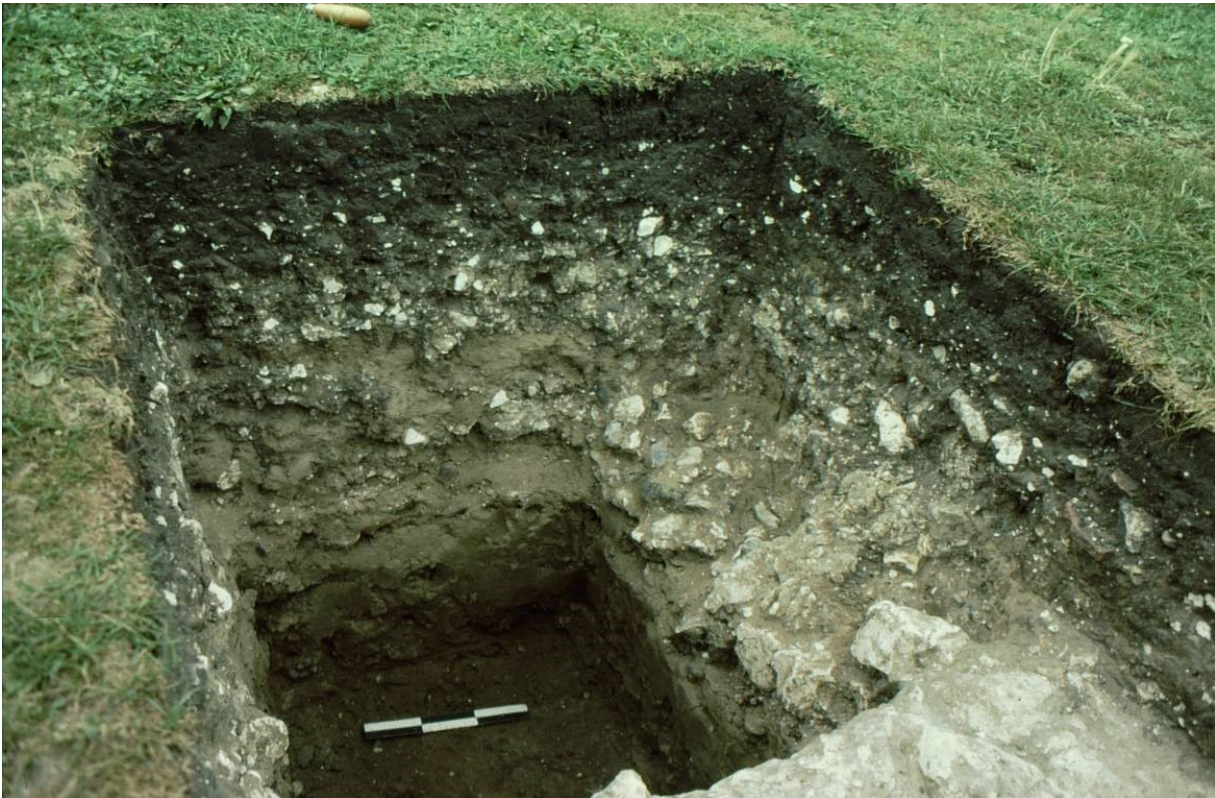
Figure 37. The fill behind the moat wall at the south end of CA.

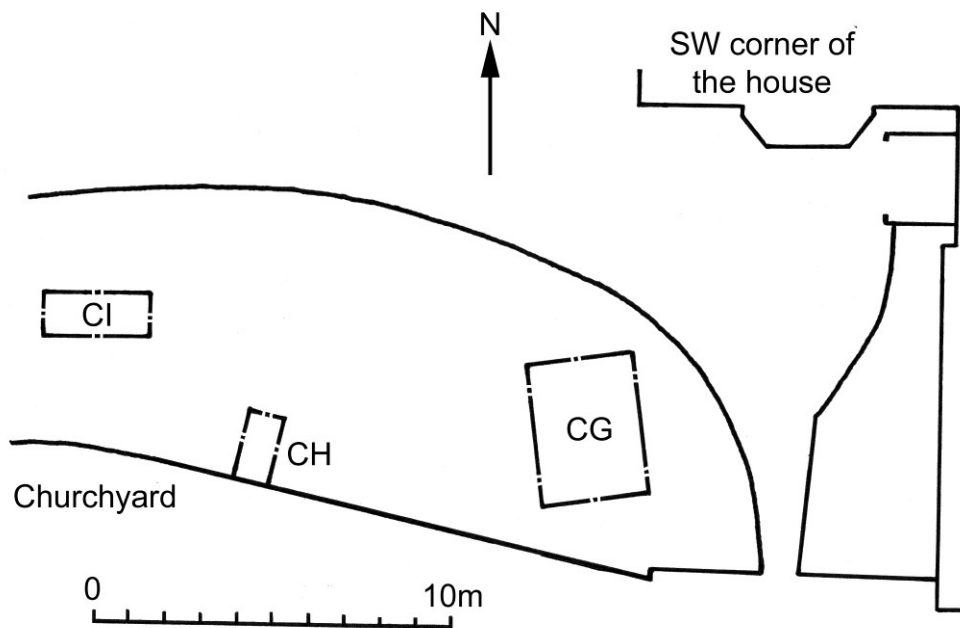
Figure. 39. The location of trenches CG, CH and CI.

Trench CH was 2m long by 1m wide and was dug down the outside of the churchyard wall in the position shown in figure 39. The main purpose of trench CH was to examine the foundations of the churchyard wall and to test the theory that it rested directly on the moat wall. It was mostly excavated with a mattock.

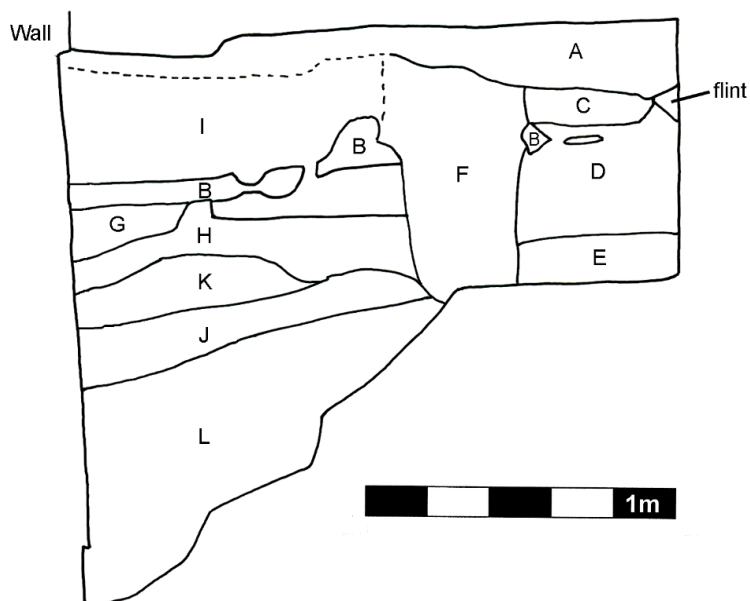
- X Light brown soil with much flint chalk and brick.
- Y Brown soil with a wide scatter of mostly small rubble and flint.
- Z Foundation of brick, chalk Reigate stone, a little flint and much bonding mortar.

Figure 47. Trench CH, the west side. 27 February 1992.

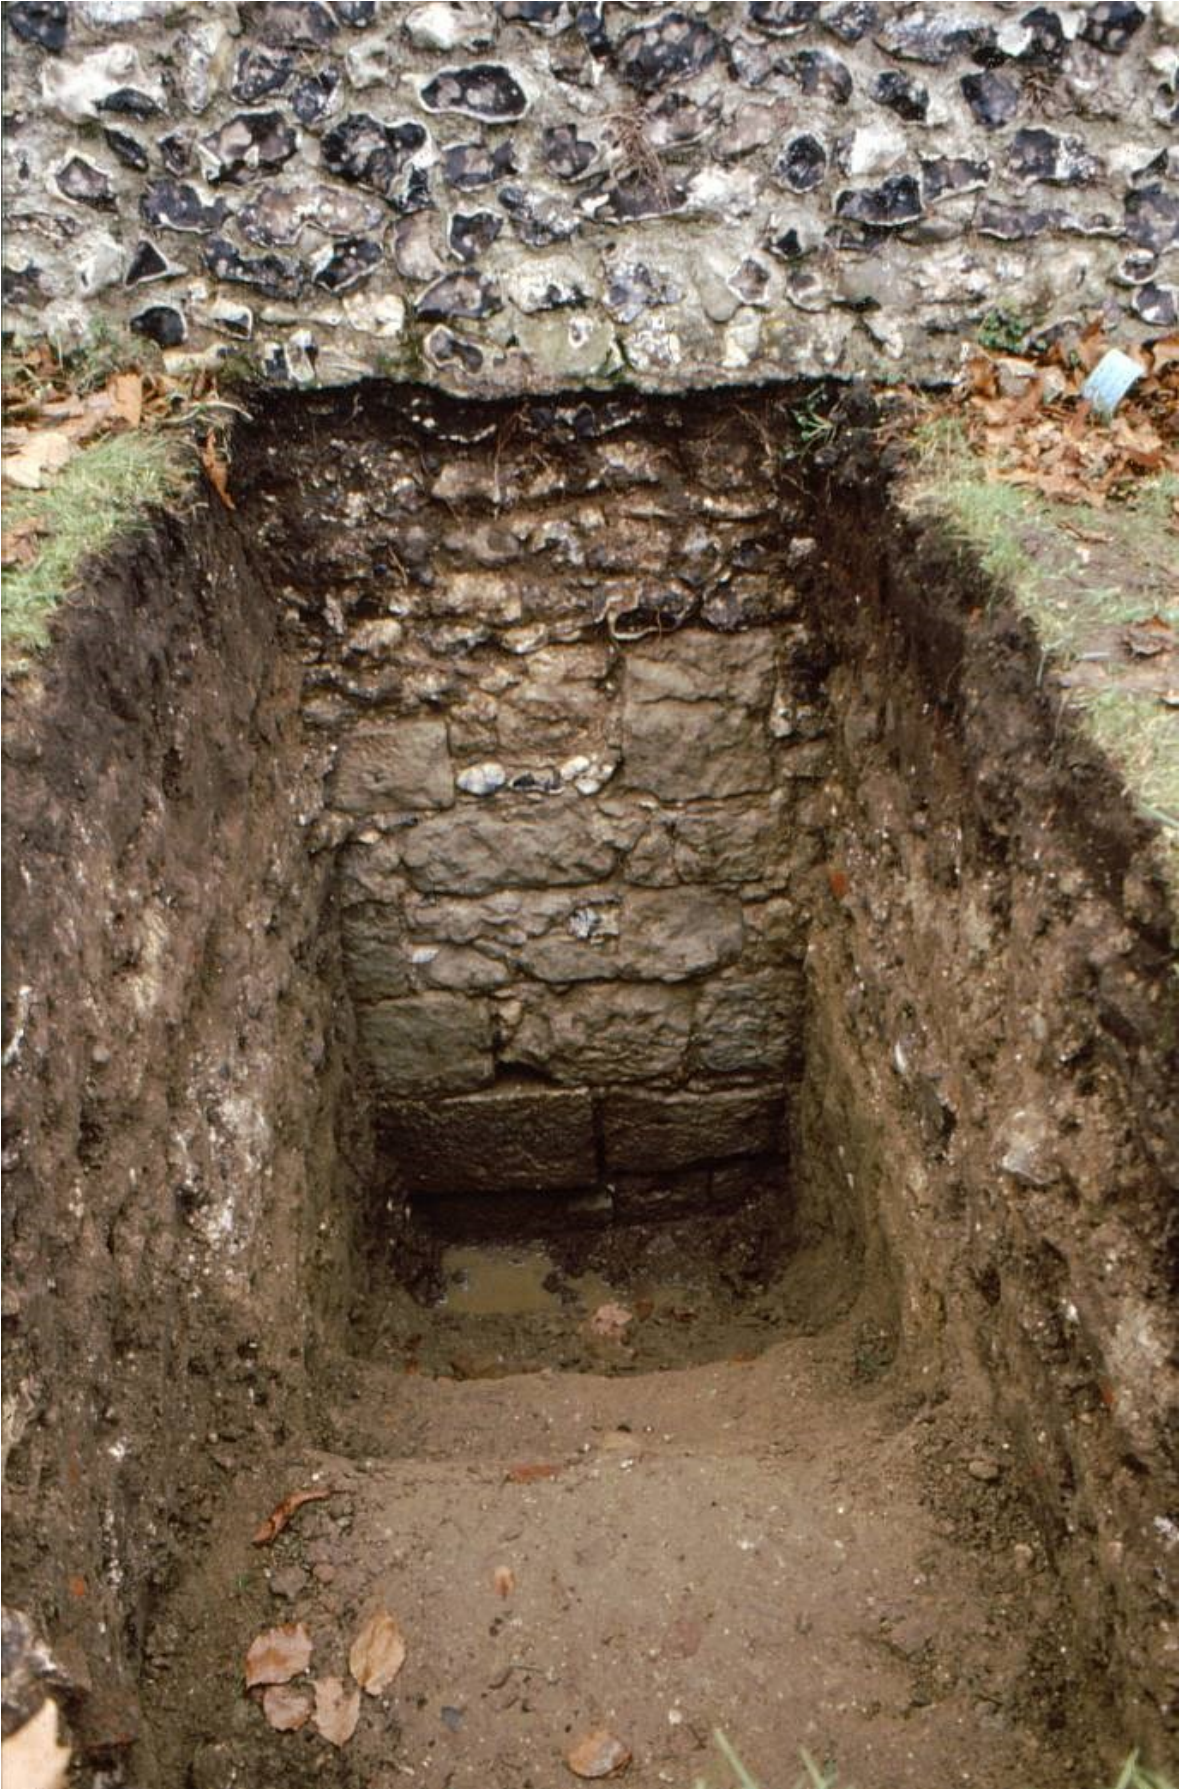
Figure 49. The moat wall in trench CH.

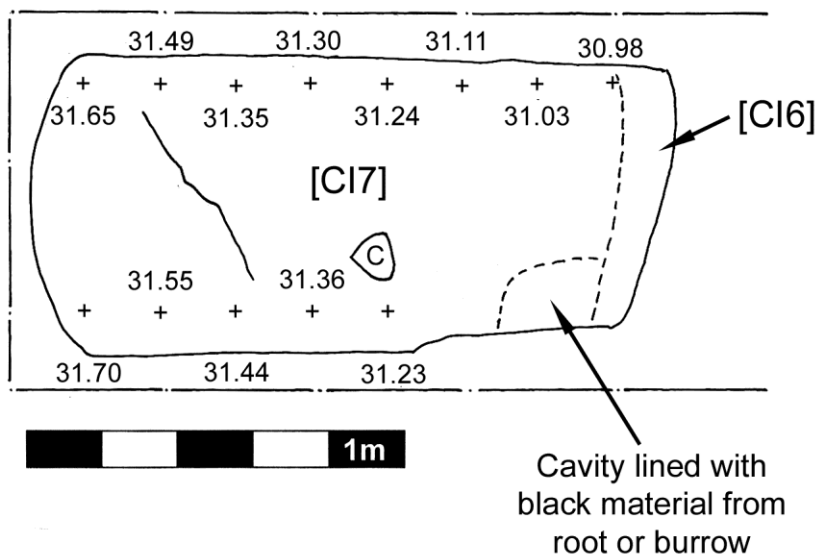
Figure 51. Trench CI showing the top of layer [CI7]. 9 March 1992.

- A Dark charcoal like line, probably a decayed root.
- C Chalk.

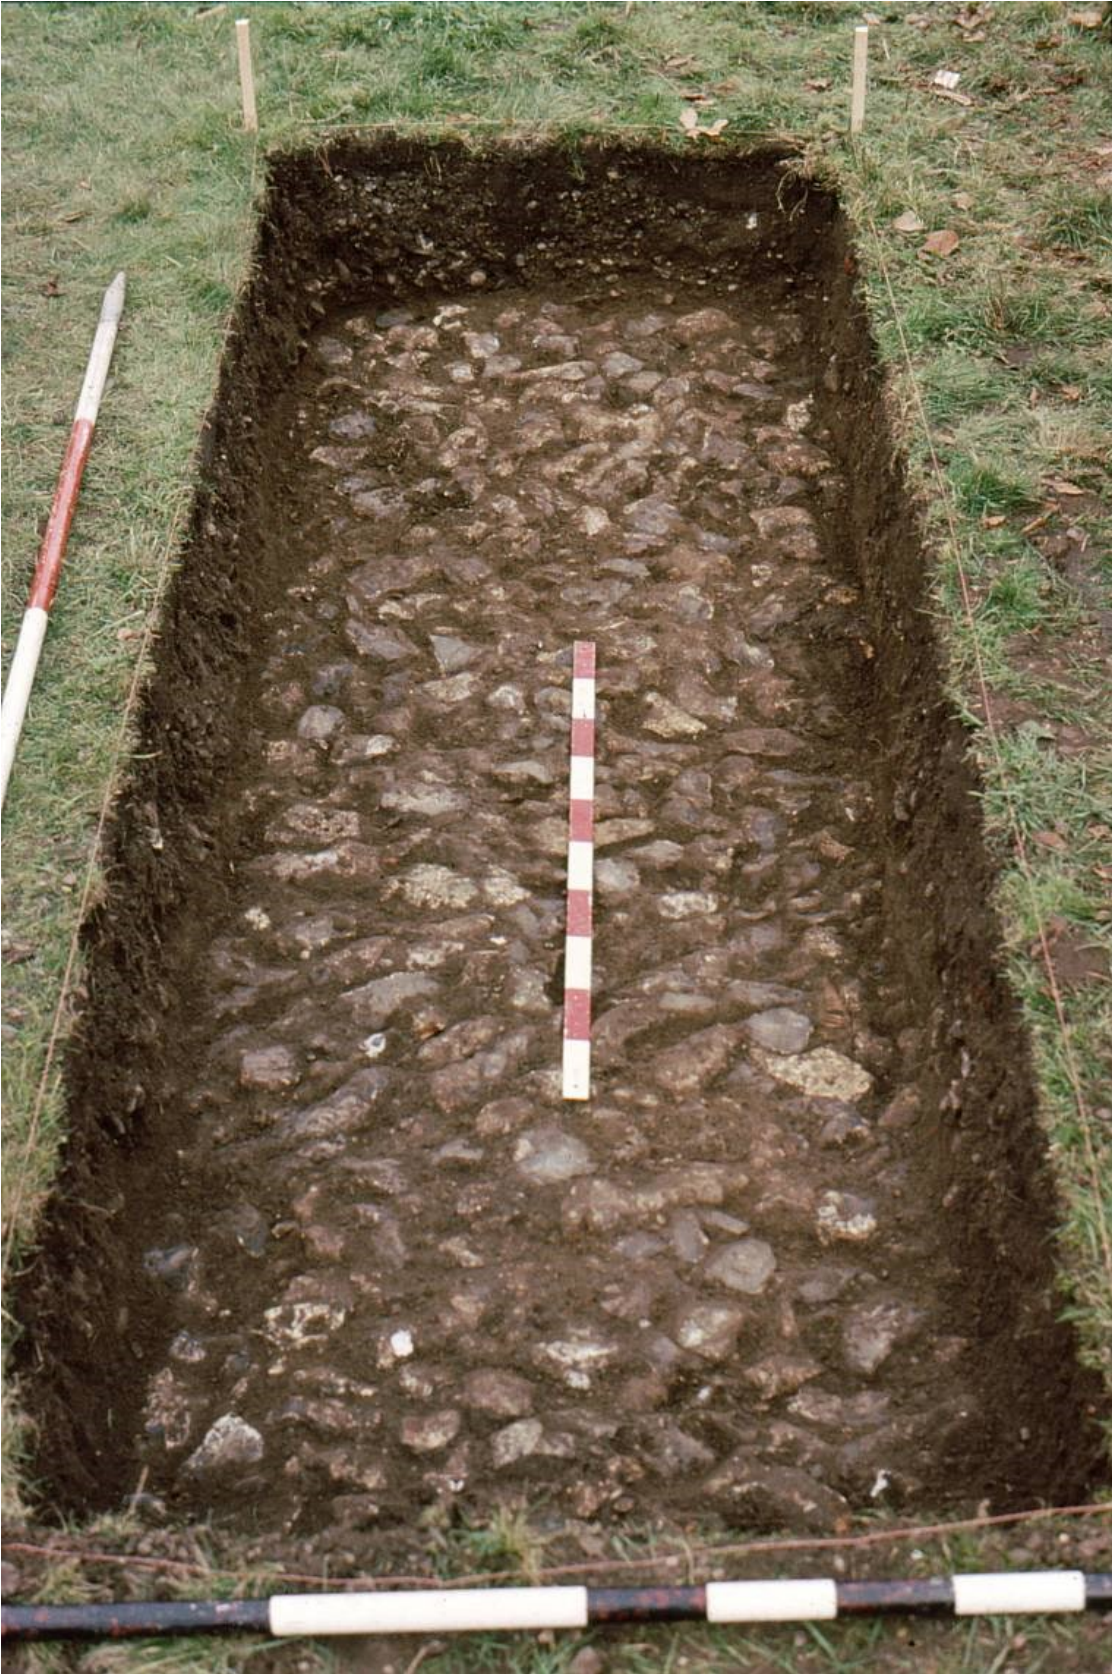
Figure 52. Top of cobbled surface [CI3] looking east.

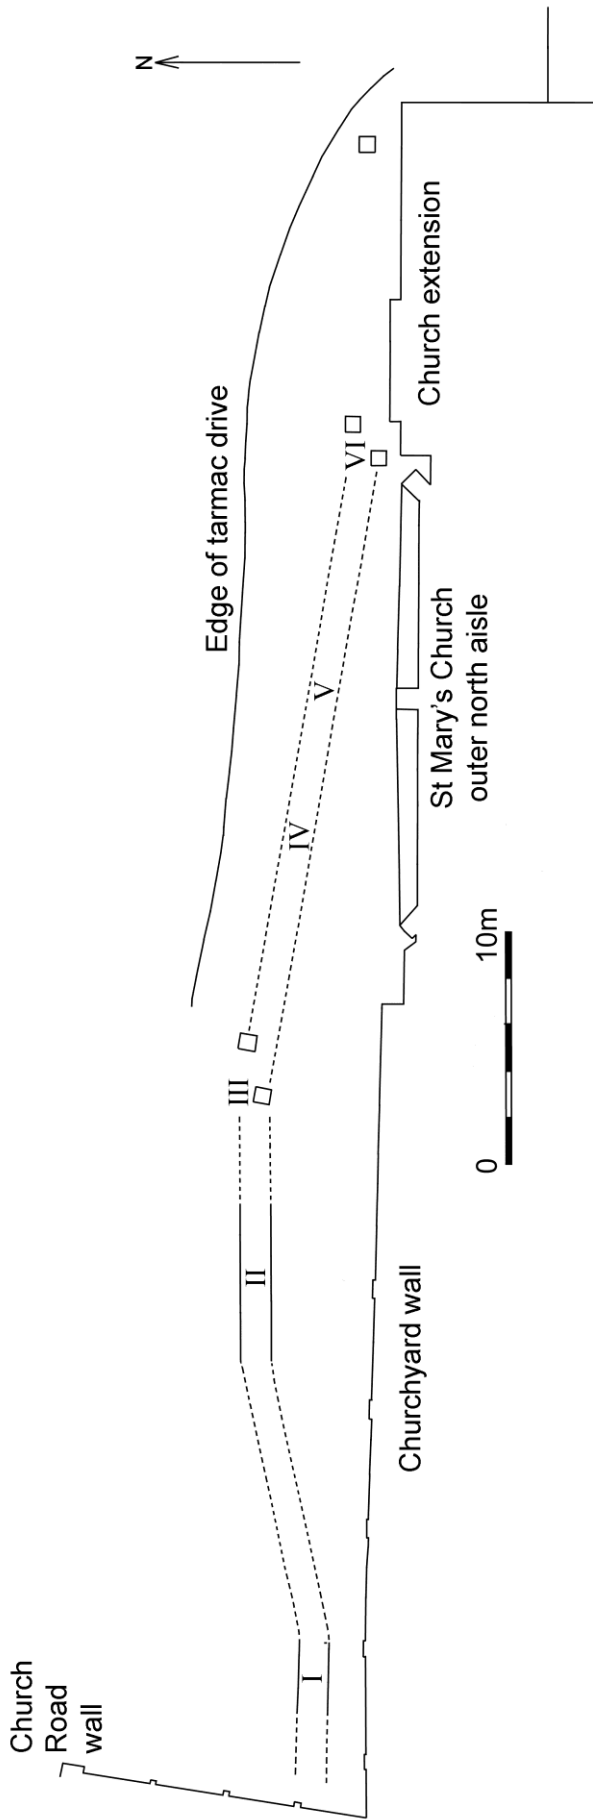
Figure 55. Plan of the contractor's trench excavated in 1994.

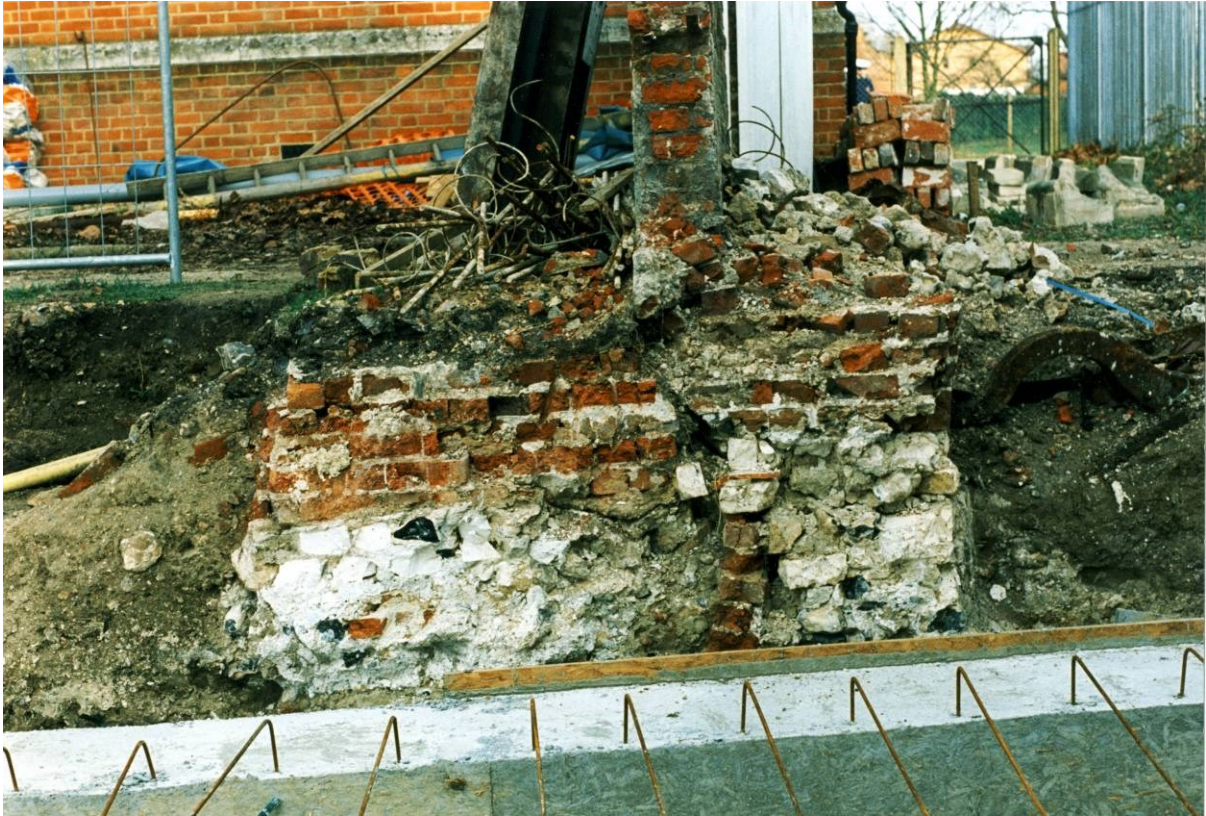
Figure 56. Section of the moat wall exposed in the foundation trench for the church extension. Looking east with the school gymnasium in the background. (For interpretation see figure 57).

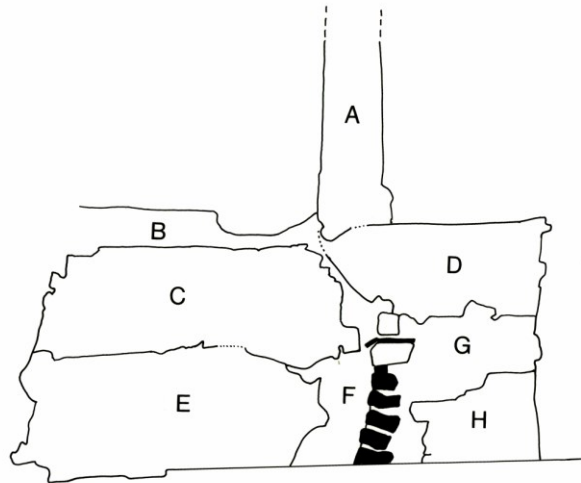
Figure 57. Interpretation of figure 56.

- Black. Brick facing if the former moat wall.
- A End of the wall between the northeast corner of the churchyard and the gymnasium.
- B Top soil.
- C Foundation of the wall which formerly ran from the northeast corner of the churchyard northwards to the house.
- D Foundation of the east wall of the churchyard.
- E This might be the lower part foundation C but the depth seems excessive. This might be explained by the wall crossing the fill of the moat fill.
- F Moat fill?
- G Repair or addition to the south wall of the moat.
- H Original part of the south wall of the moat.

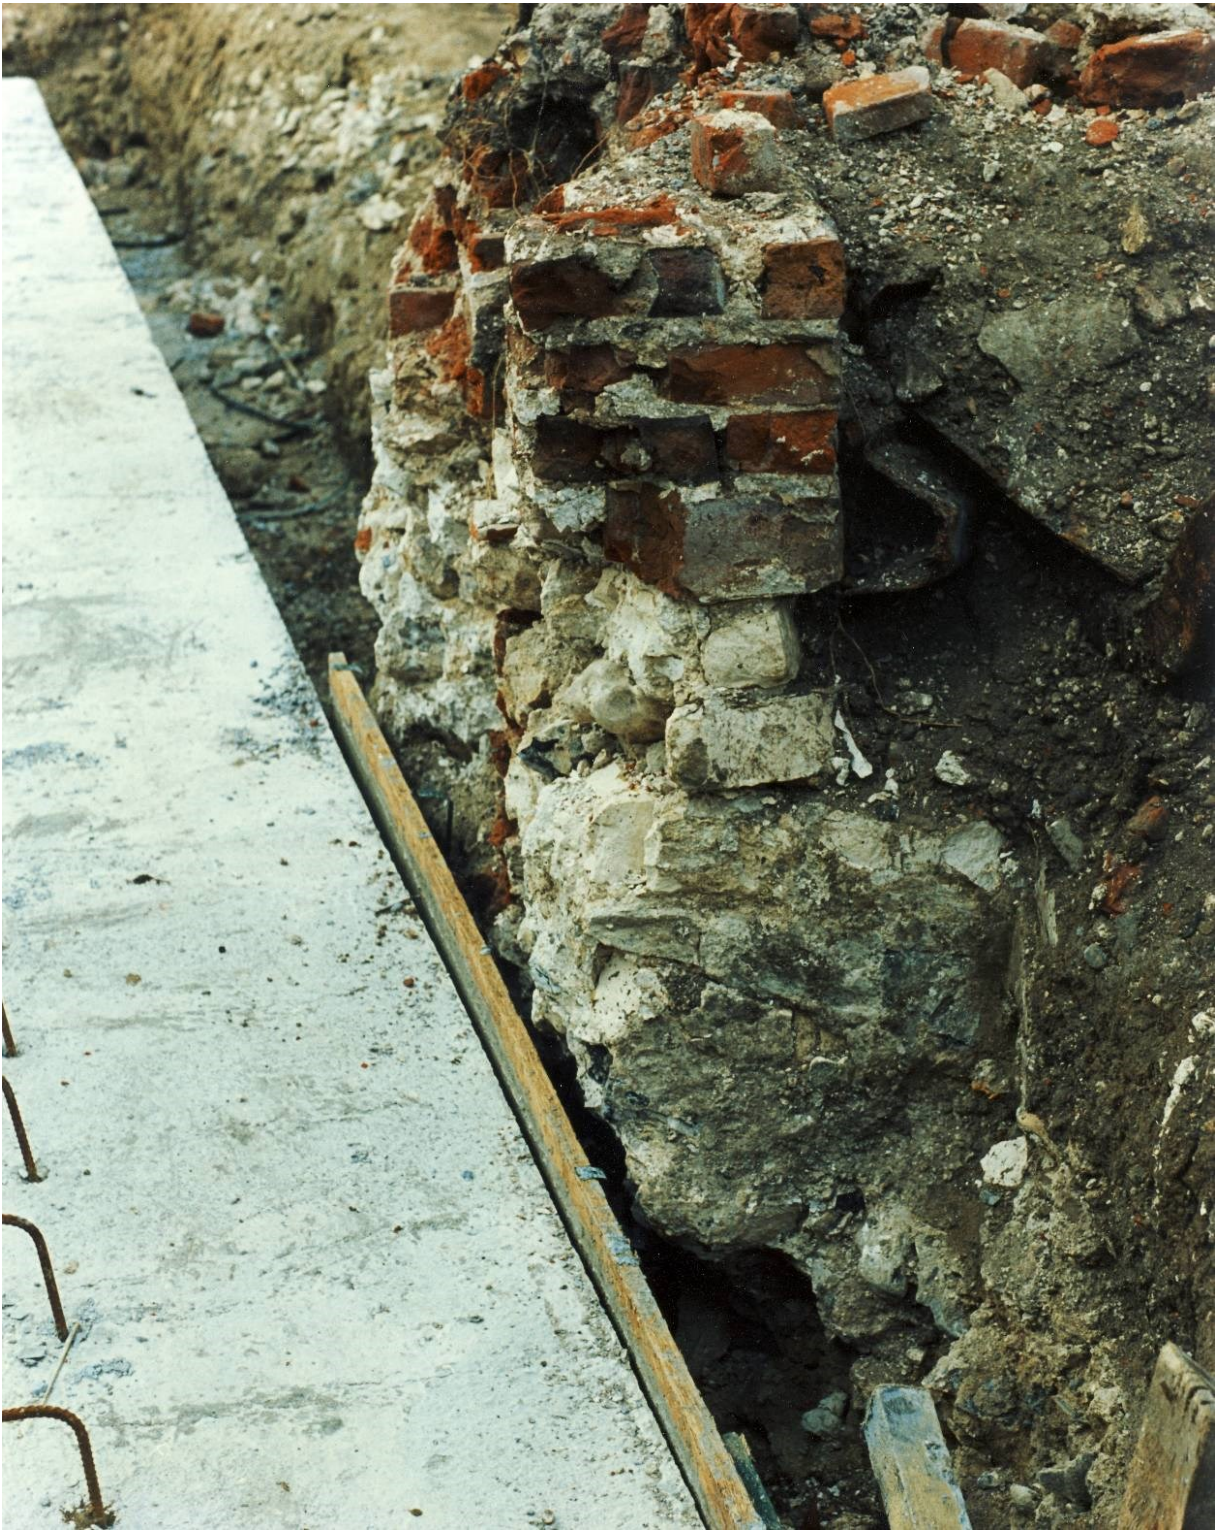
Figure 58. The stone and mortar foundation of the churchyard (moat) wall below the brick foundation of the wall connecting the churchyard to the south wing. Looking north.

Part of the foundation of the wall which connected the northeast corner of the churchyard to the south wing was removed when the extension foundation trench was dug. The wall ran across the top of the moat fill. The deposits to the west of the wall were investigated in trench CG and are described in detail above. They consisted, for the most part, of a series of layers of rubble underlain by sand. The upper part of deposits to the east of the wall, which were exposed in the foundation trench to a depth of about 0.9m consisted of light brown sandy earth. This appeared to rest on green sand with flint and Reigate stone, although this deposit was only exposed in the centre of the section. The trench penetrated to a maximum depth of 1.1m. The wall therefore formed a boundary between two different types of moat fill. This is odd as the north-south running wall does not quite reach the southern edge of the moat suggesting that it was not a retaining wall.

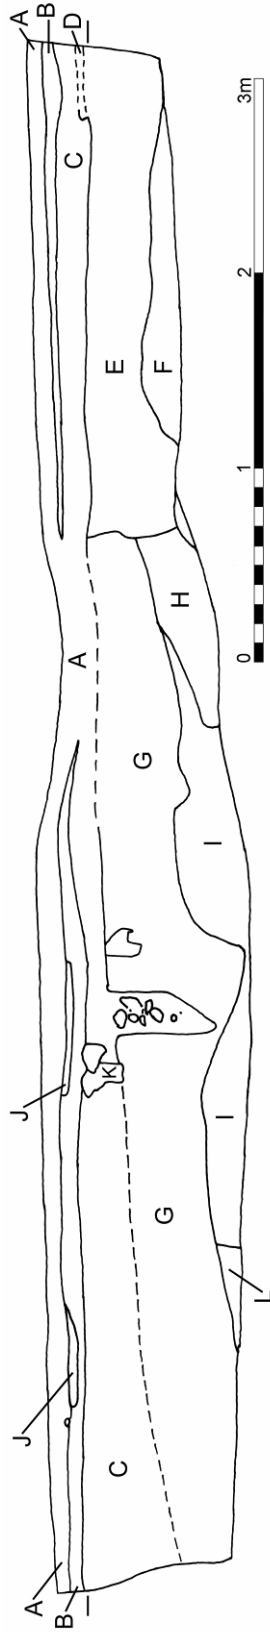
Figure 67. The west side of the main trench (CJ).

- A. Fine silt and dark soil
- B. Small stone in a matrix of dark soil.
- C. Fine dark soil with occasional flint chalk and tile.
- D. Small rounded and angular flint pebbles in dark soil.
- E. Light brown earth with a wide scatter of brick, chalk, tile and Reigate stone.
- F. Grey sand mottled with earth. Scraps of brick, chalk and flint.
- G. Orange sand streaked with earth from above. It merges into the layer above without a clear boundary. Occasional tile.
- H. Stiff grey-brown earth with occasional small pieces of chalk, flecks of charcoal and one or two scraps of CBM.
- I. Broken tile in crushed mortar and a little sand.
- J. Small orange flint gravel in orange sand.
- K. Brick and flint impression.
- L. Tile in yellow sand matrix.

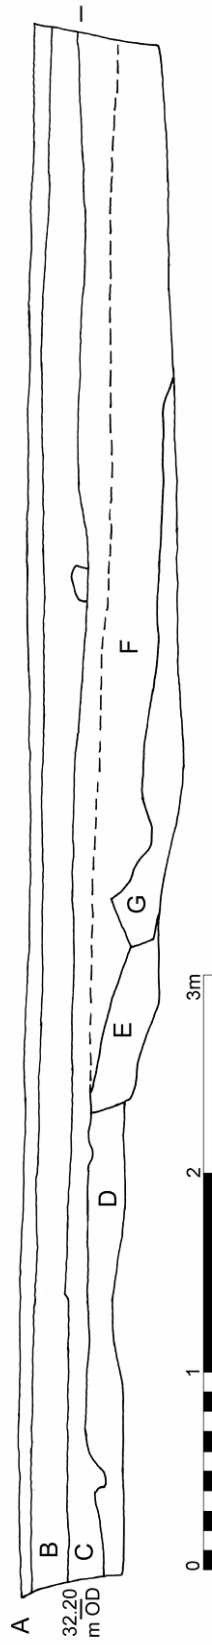
Figure 68. The east side of the main trench (CJ).

- A. Fine dark brown top soil.
- B. Dark brown soil with much flint and rubble including tile, brick, chalk and Reigate stone.
- C. Dark brown soil.
- D. Grey sand with a good deal of chalk up to 3 cm across. Scatter of flint tile and mortar.
- E. Brown earth slightly lighter than C. Scatter of small chalk and occasional tile.
- F. Yellow sand. The boundary with C worm streaked and rather arbitrary.
- G. Broken tile in fine broken mortar.

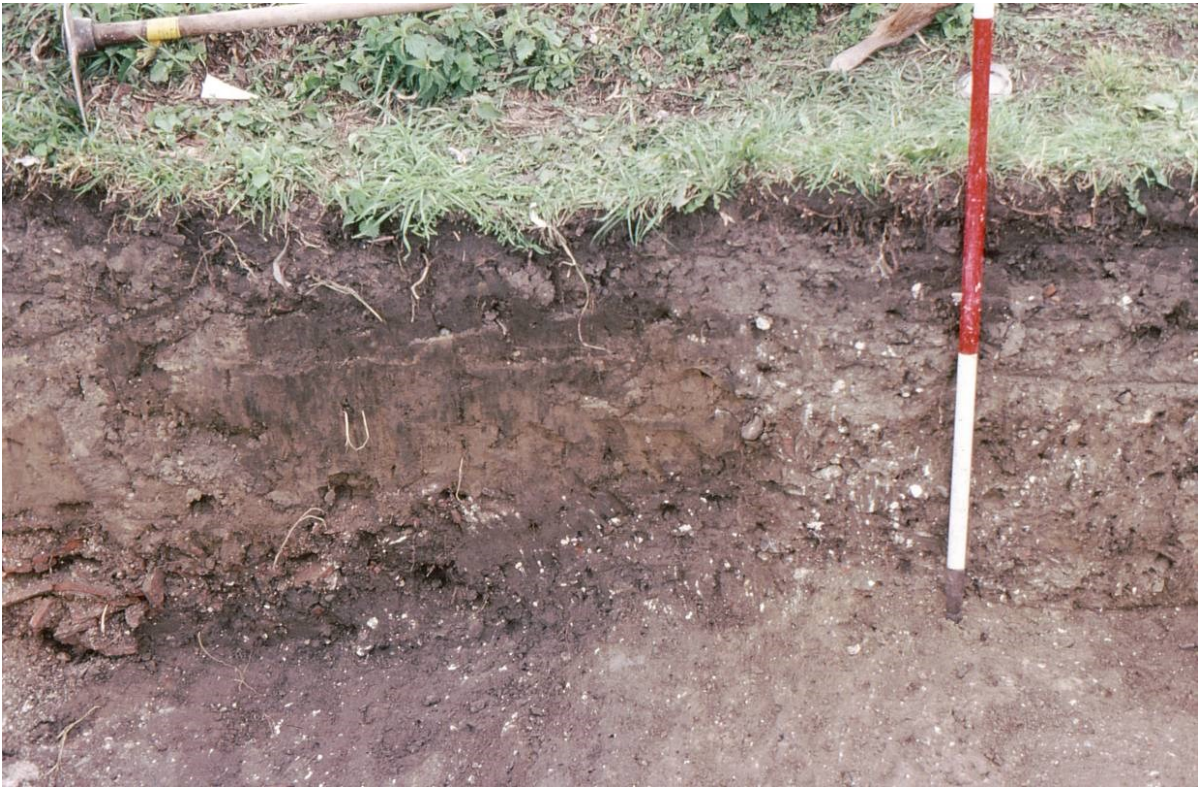
Figure 69. The boundary between layers [CJ8], [CJ9], [CJ10] and [CJ11] in the western side of the trench.

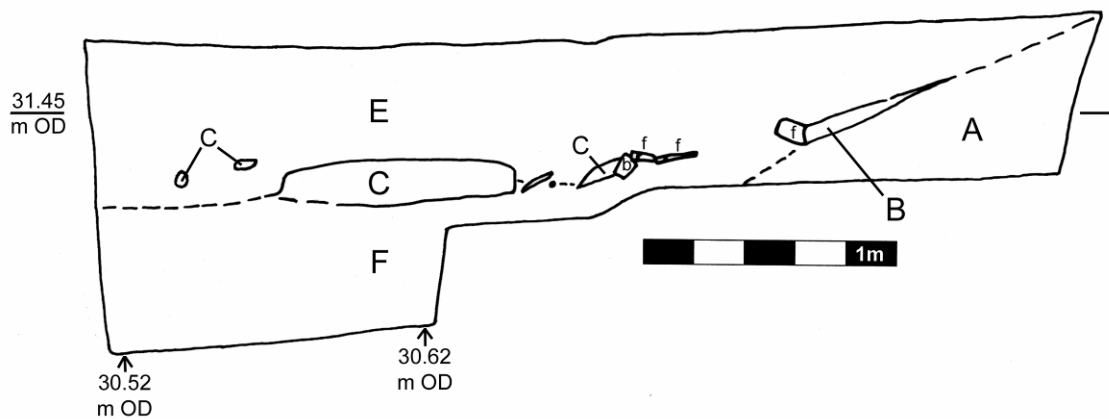
Figure 73. The east side of the inner trench in CJ.

- A Brown earth with a scatter of flint, brick and chalk particularly towards the top.
- B Brick and mortar mostly crushed.
- C Orange sand and small flint gravel with a little brick and mortar.
- E Brown sandy earth with a thin scatter of tile flint and chalk particularly along the top.
- F Matrix very similar to E but slightly more sandy. Lightly mottled with iron stain. Occasional flints and snail shells.
- b Brick.
- f Flint.

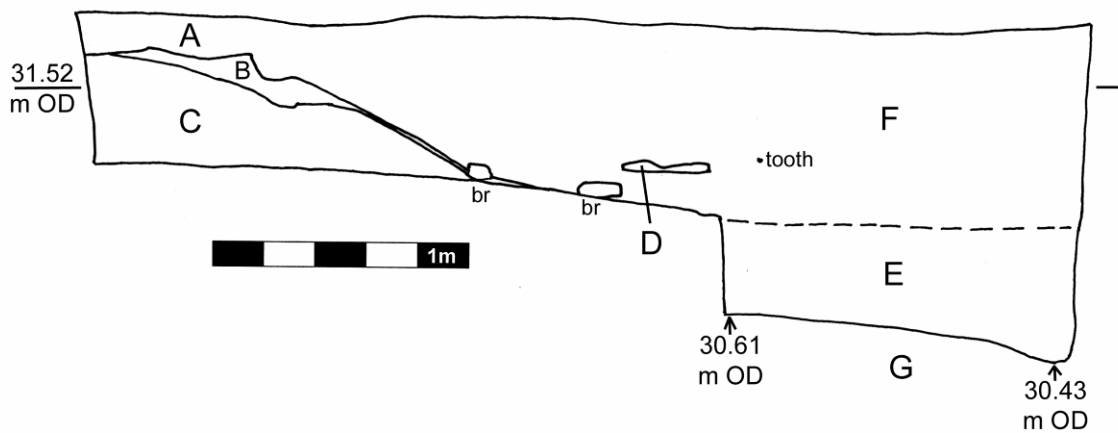
Figure 74. The west side of the inner trench in CJ.

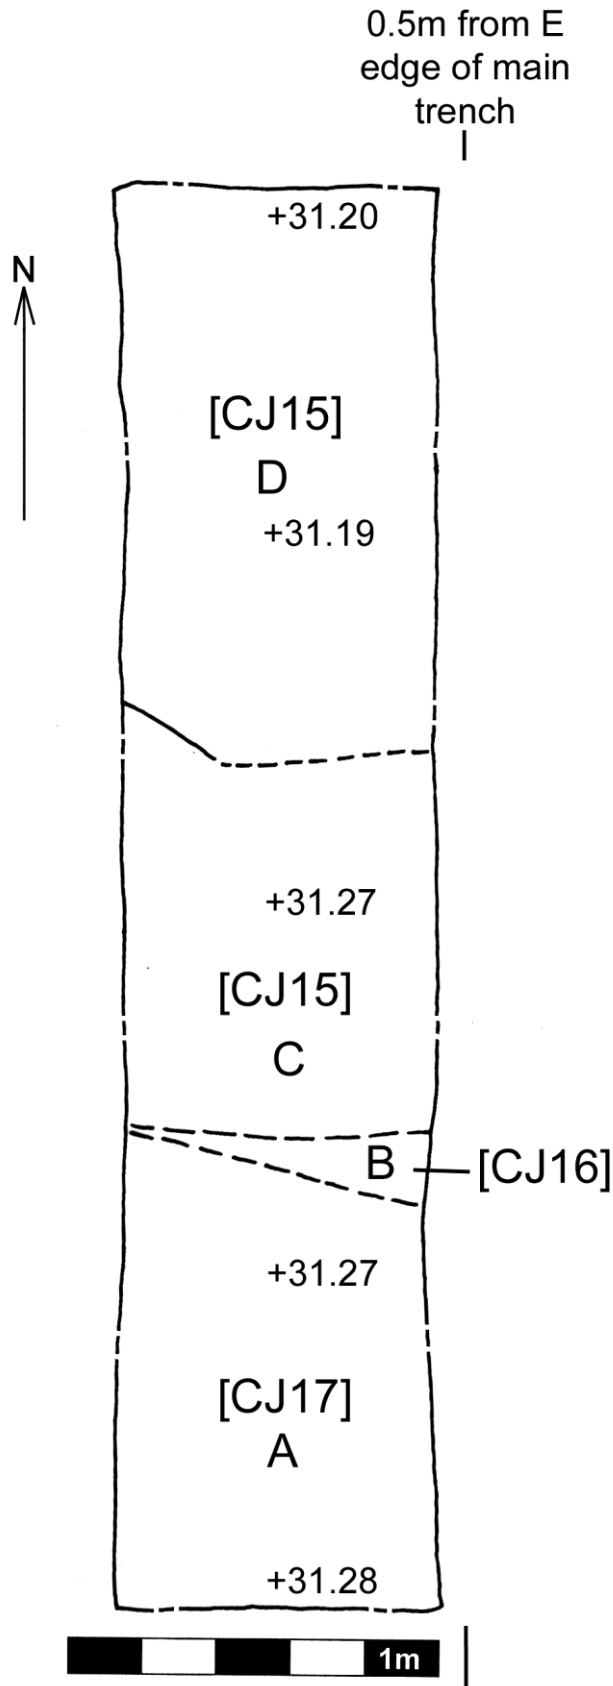
Figure 76. The inner trench in CJ with the tops of layers [CJ15], [CJ16] and [CJ17].
