# **Carew Manor, Beddington**

**A report on historical and archaeological investigations of  
the house and moat, 1979-2014**

**Volume 2: the moat**

Carshalton & District History & Archaeology Society  
Occasional Paper 10

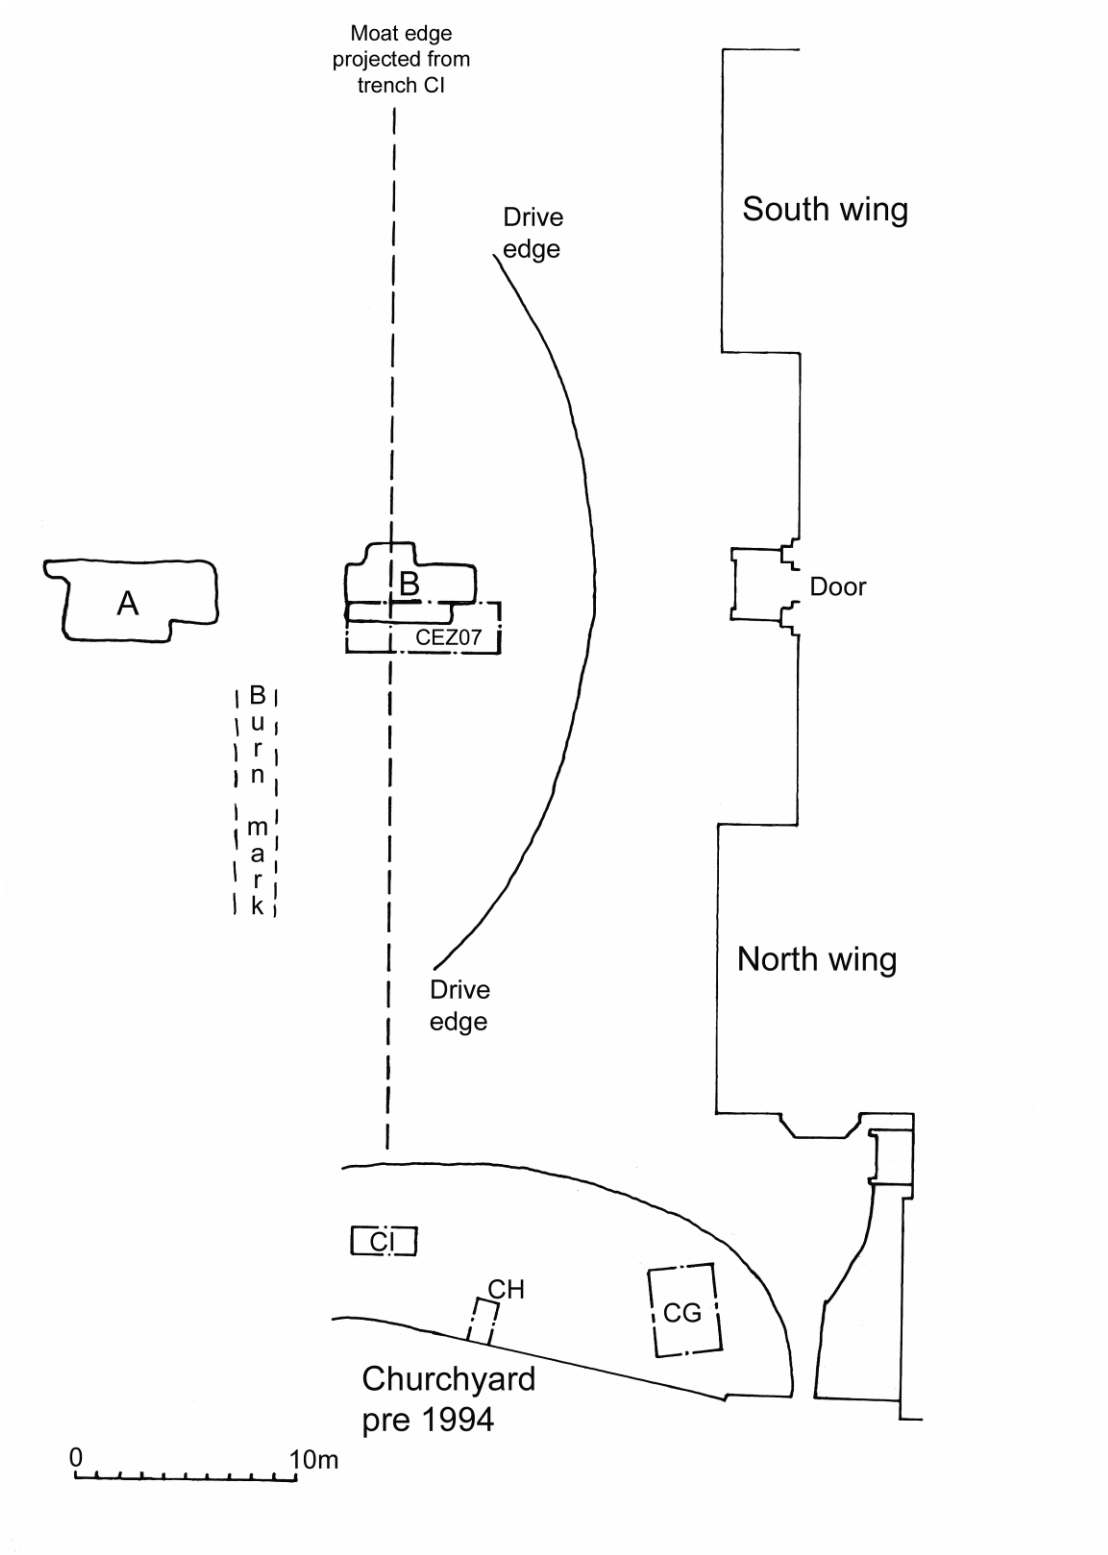
Figure 84. Plan of the site showing the three trenches excavated in 1992; the outer edge of the moat extrapolated from trench CI; two burn marks on the lawn labelled A and B, and trench CEZ07.

The trench was on the lawn on the west side of the main house (figure 84). It was 6m long east-west by 2.5m north-south. The northeast corner of the trench was 11m west of the bottom of the steps up to the main door in the centre of the west front.<sup>31</sup> The north edge was 0.8m south of the centre line of the steps.<sup>32</sup>

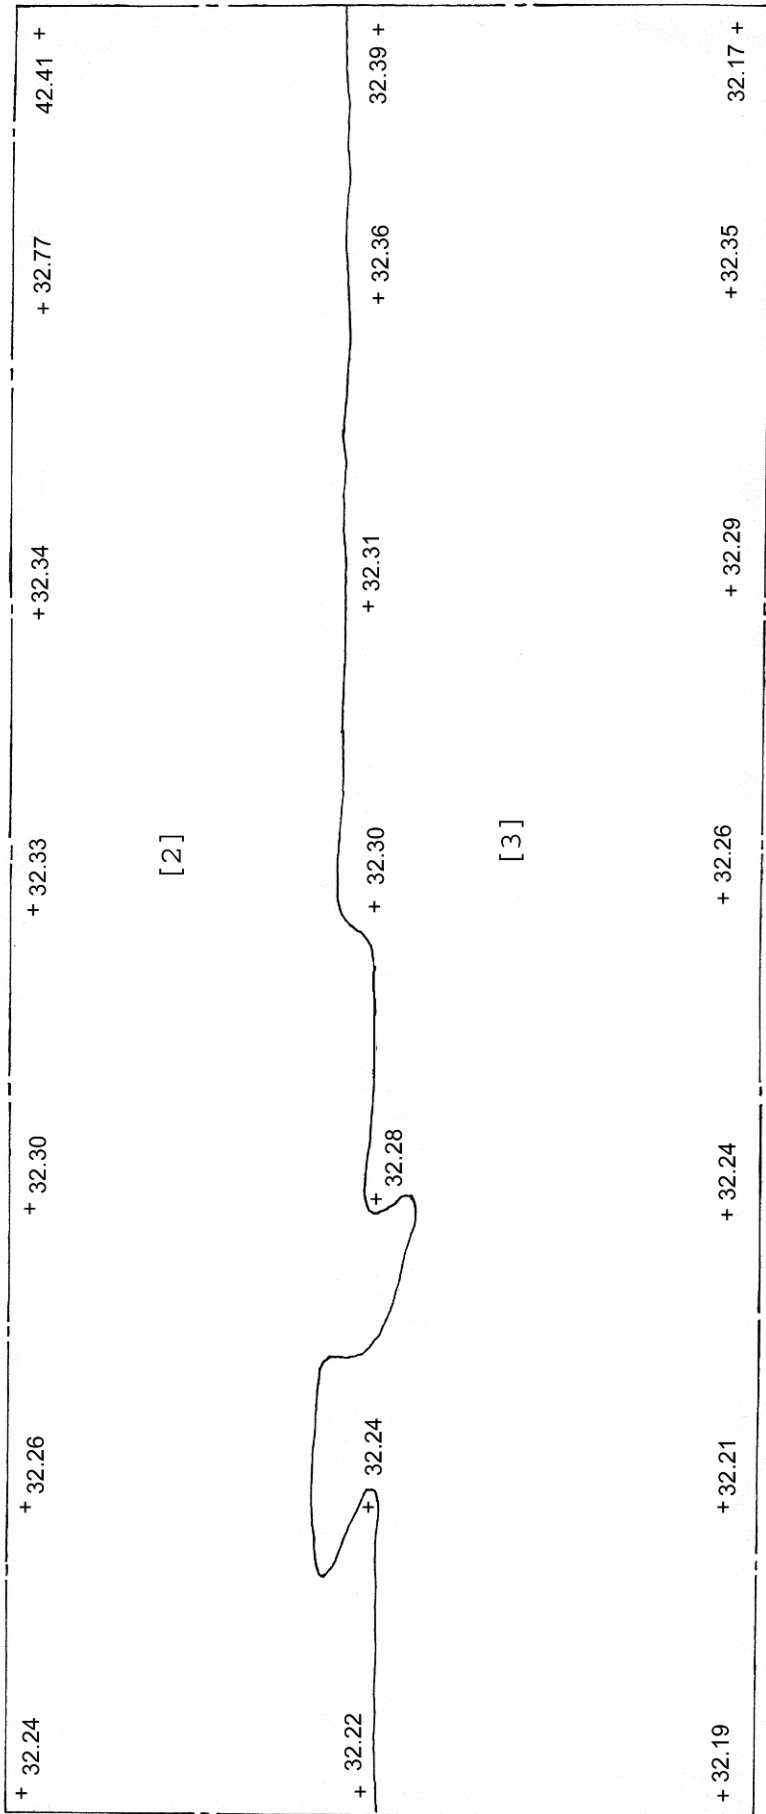
Figure 86. The tops of layers [CEZ2] and [CEZ3].

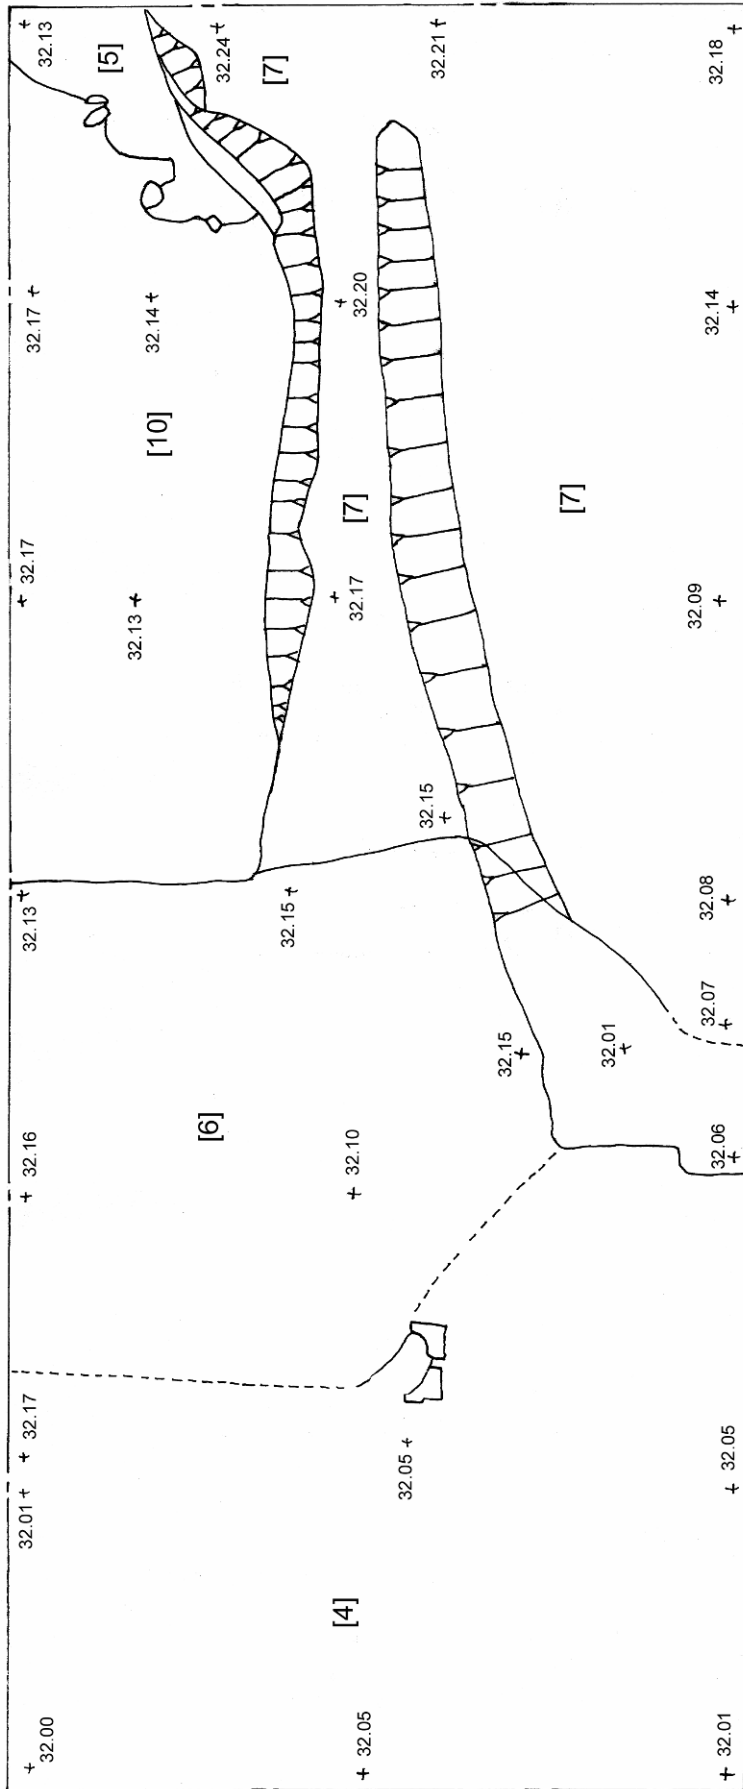
Figure 87. The deposits above the bridge abutment in trench CEZ. North at the top.

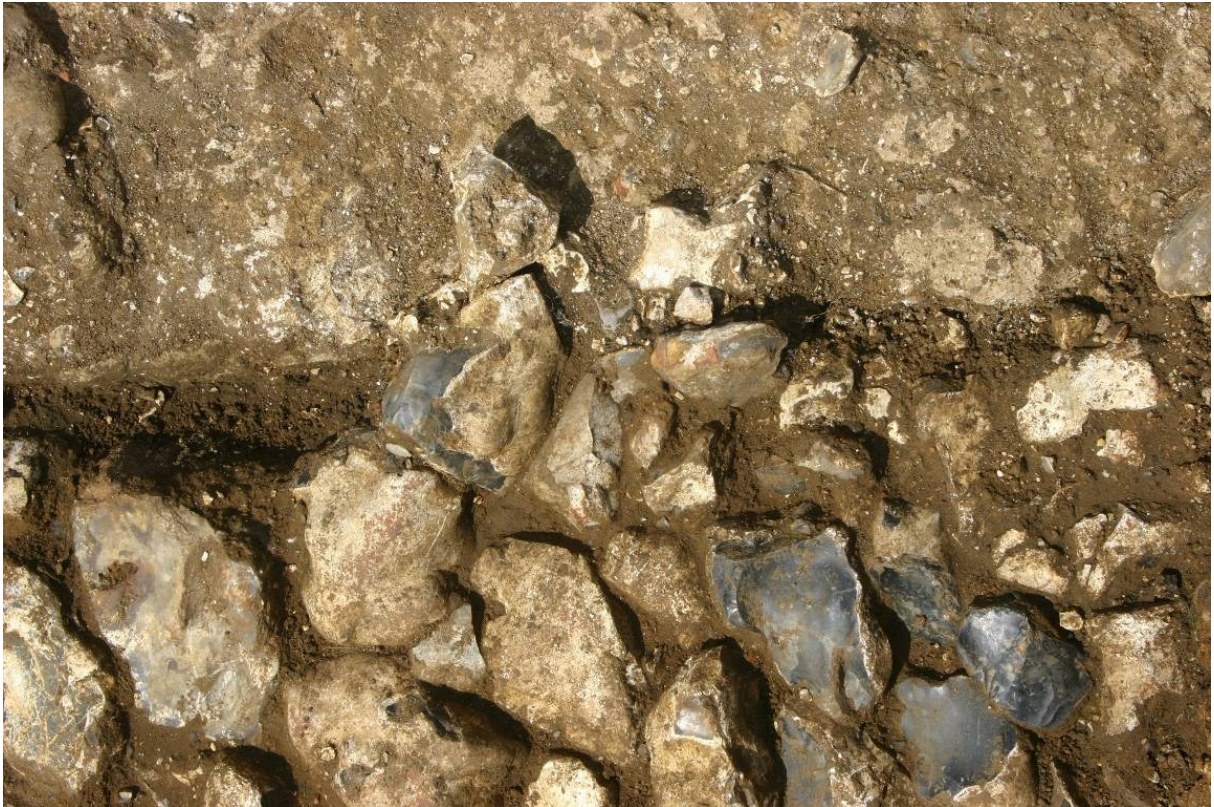
Figure 90. The cobbled surface [CEZ18] lapping over the eastern edge of the abutment.

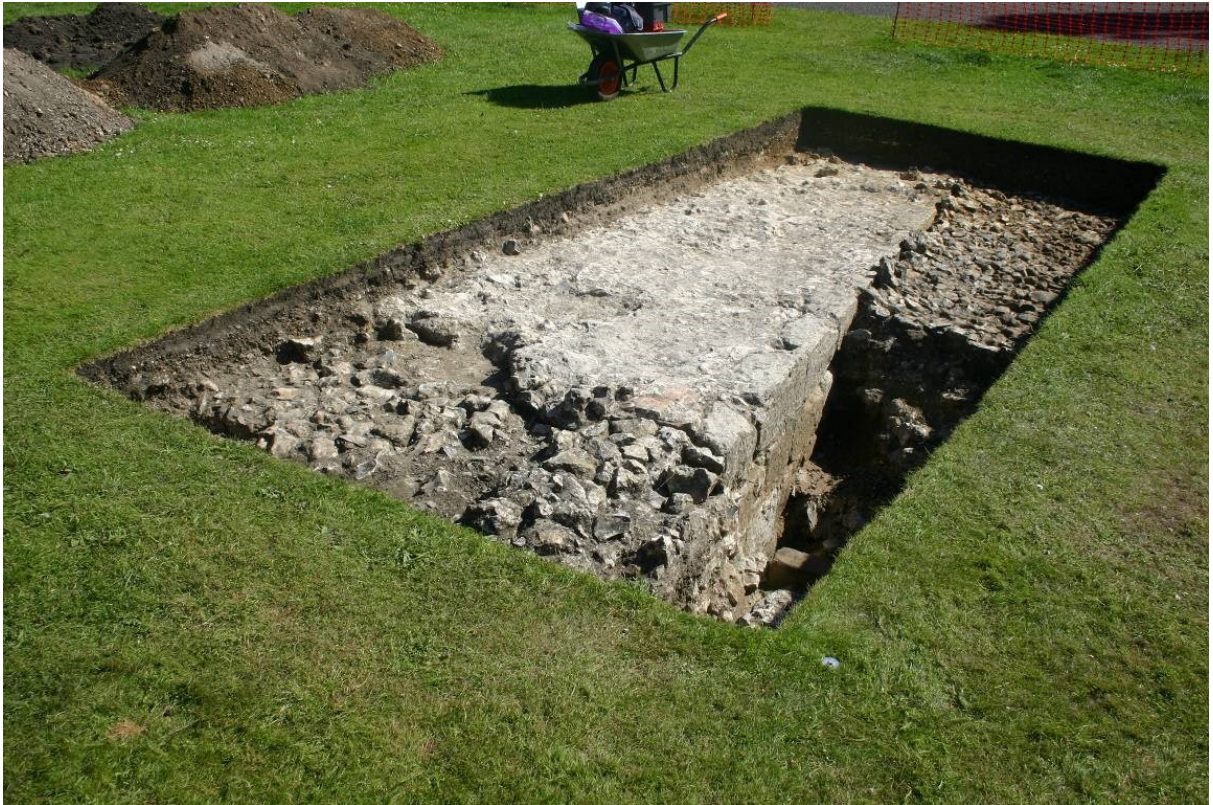
Figure 92. The bridge abutment in trench CEZ looking northeast.

A second wall [CEZ24] projected from the south face of the abutment and was clearly bonded into it (see section 9.3.5 below).

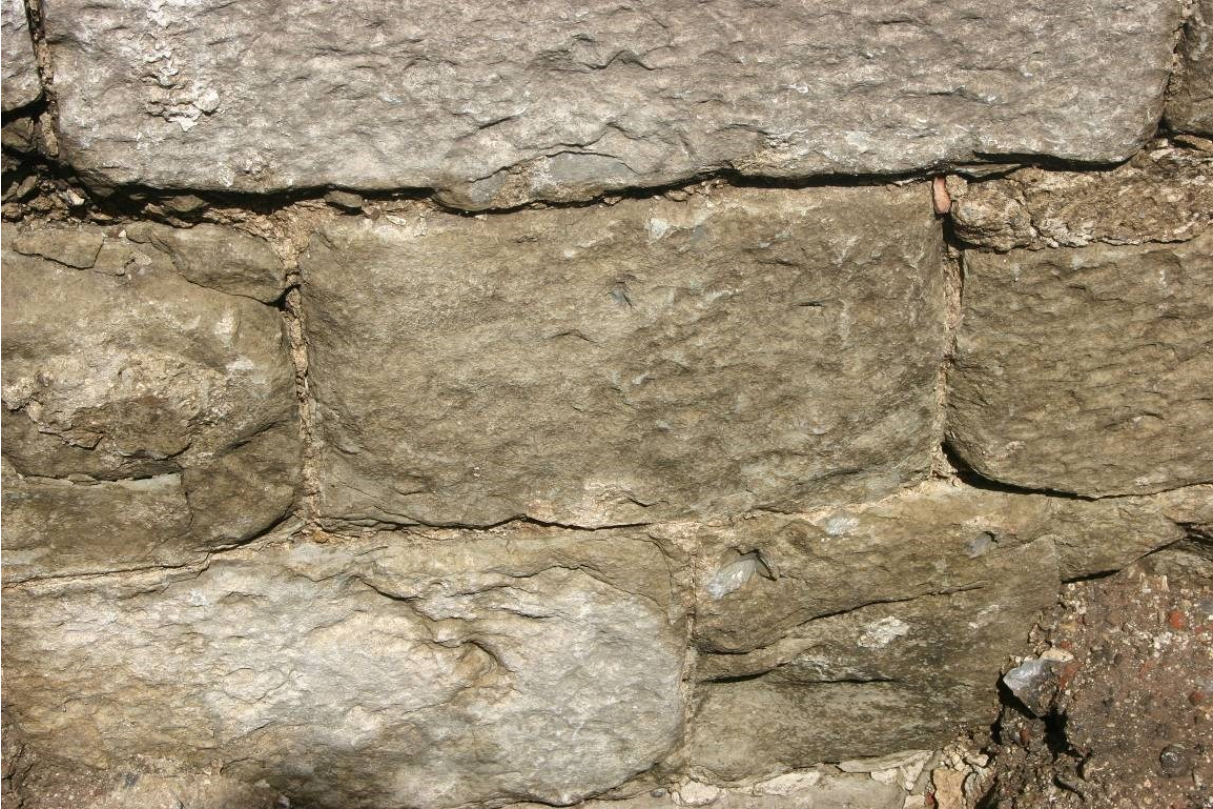
Figure 94. The stone blocks on the side of the abutment in trench CEZ.

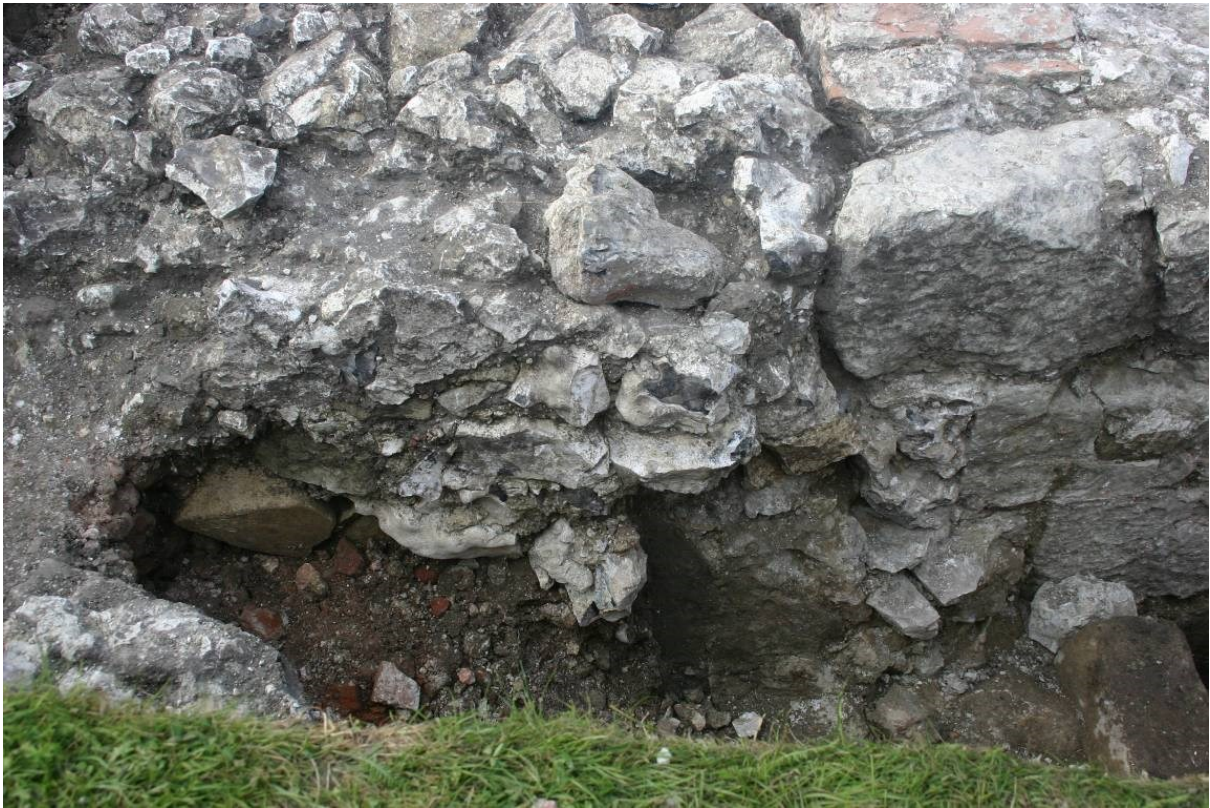
Figure 96. The wall [CEZ33] with [CEZ23] the right and the top of the southward running wall [CEZ24] just visible bottom right.

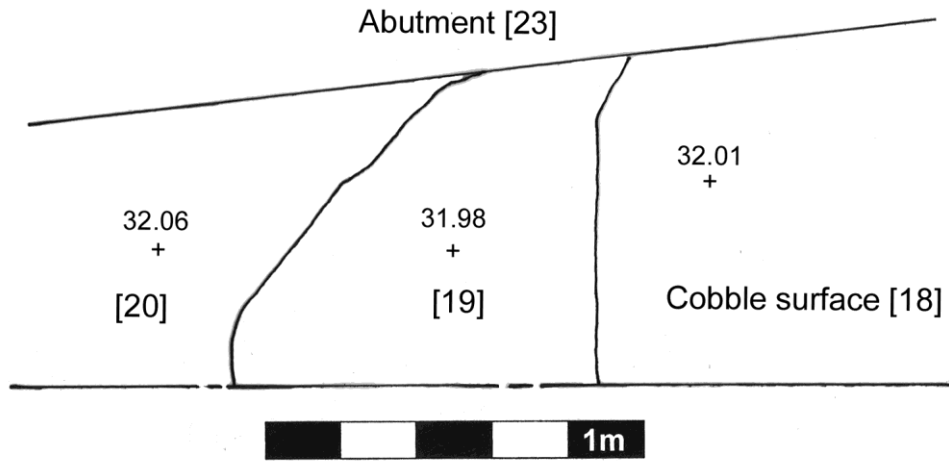
Figure 97. The top of layers [CEZ19] and [CEZ20] to the west of the cobble surface.

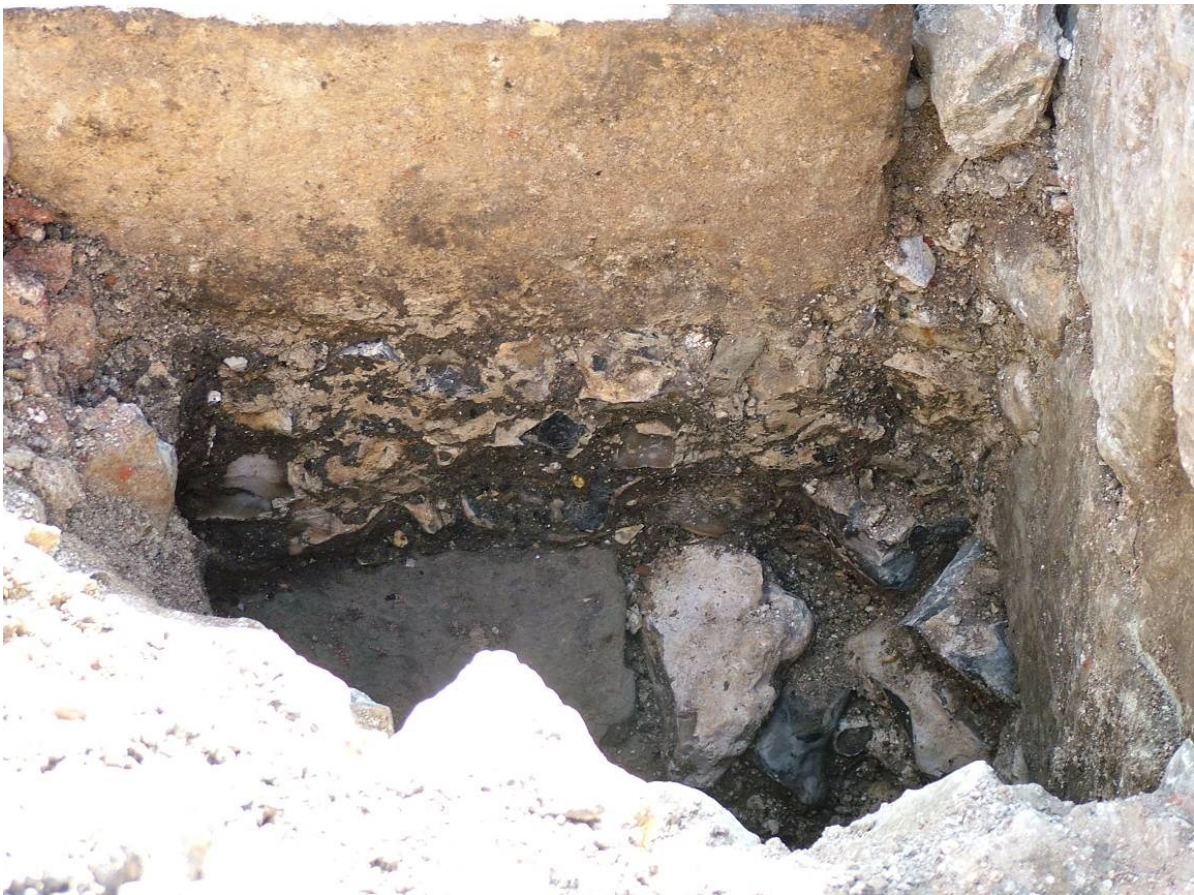
Figure 101. The south side of the moat wall [CEZ24] showing the flint bonded into the abutment wall [CEZ23].

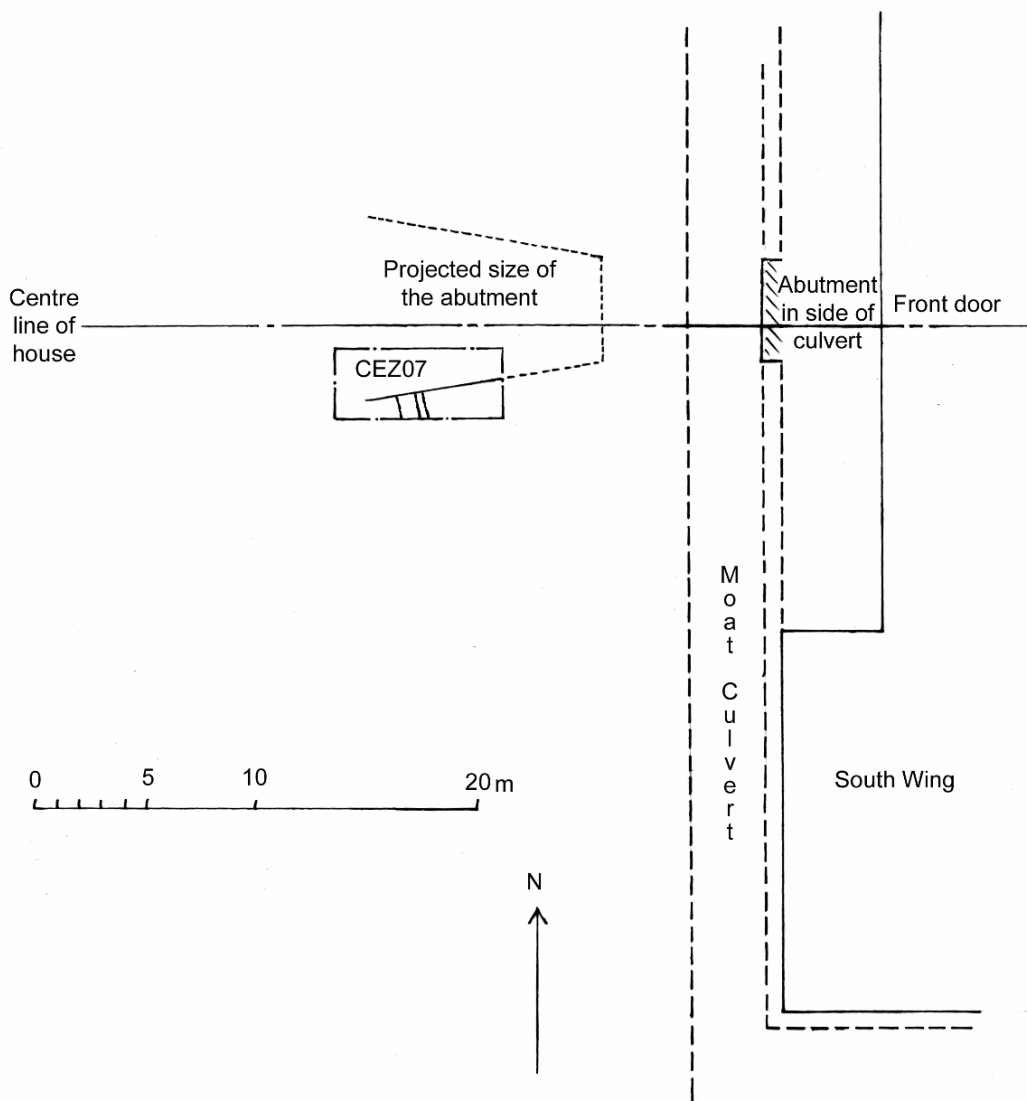
Figure 103. Plan of the bridge abutment extrapolated from the excavation and the features in the moat culvert.
