Beddington Park and The Grange

A report on observations and documentary research during the
Heritage Fund and Community Fund project 2015-2020

Carshalton & District History & Archaeology Society
Occasional Paper 17

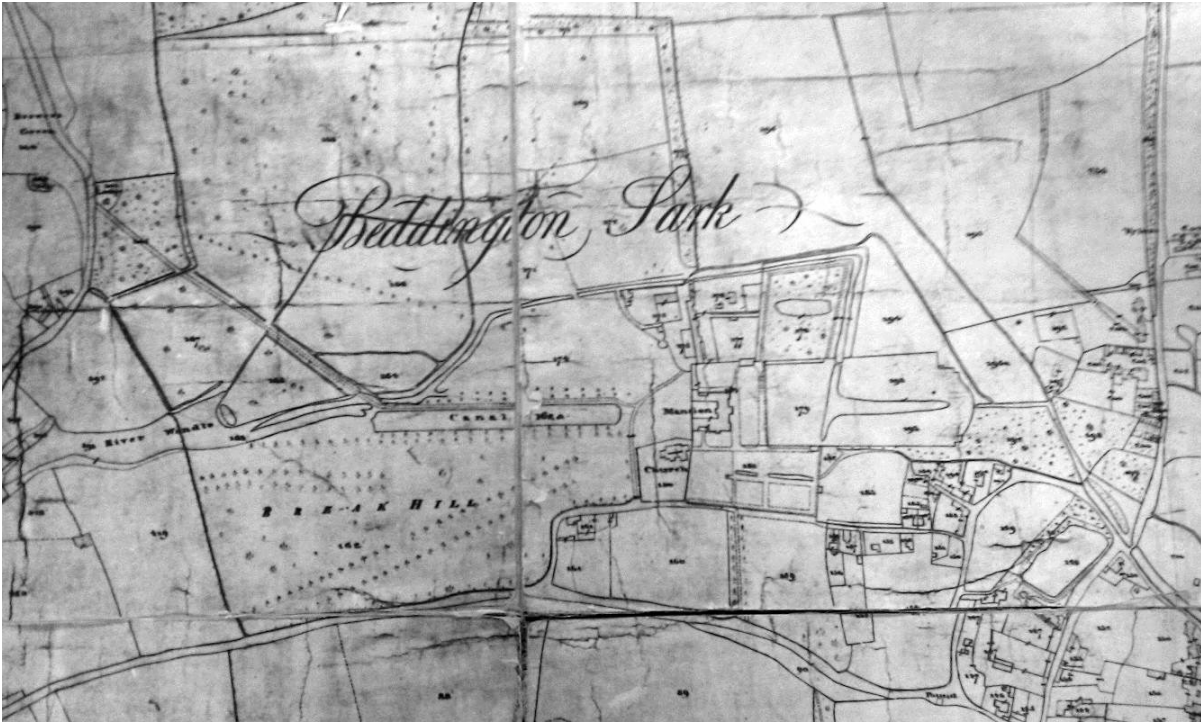
Figure 8. The park from Beddington and Bandon Enclosure award map of 1820.

The 1820 map provides the first detailed plan of the park and throws light on the changes in the preceding half century or so (figure 8). The northern end of the Tudor park was still divided into fields as on Rocque (figure 5). The area of woodland which Rocque shows in the northwest corner of the park had been reduced to The Grove which still survives north of The Grange. The clearance of this wood may be connected with the sale of ash trees in January 1784.⁴⁸ The clearance appears to have been connected with changes to the drainage of the western side of the park. The area to the east of The Grove has been ridged so that water flowed into a central ditch which emptied into a water course along the side of the drive to West Lodge (Section 4.14). This connected to a series of channels which supplied water to the bleaching grounds and print works along the side of the Wandle to the west of London Road.⁴⁹

The 1820 map shows a large long building parallel to the river (figure 8). This had been partly demolished by 1868 and had completely gone by 1896. Excavations in 2015 and 2016 showed that it was a large barn, probably dating from the mid-18th century. The foundations were covered by a demolition deposit which, from the shape of the ground surface, may extend almost to the road to Canon Bridges' Bridge.¹³⁹

The enclosure award map of 1820 shows a stream along the south side of the area close to the avenue along the west lake (figure 8). At the western end this turned north, and two short stubby channels are shown running east. The latter can still be seen as green lines when the grass is parched in dry weather. The southern stub may have connected to a small culvert which seems to have been laid along the line of a river channel which flowed through the north arm of the moat around Carew Manor.¹⁴⁰

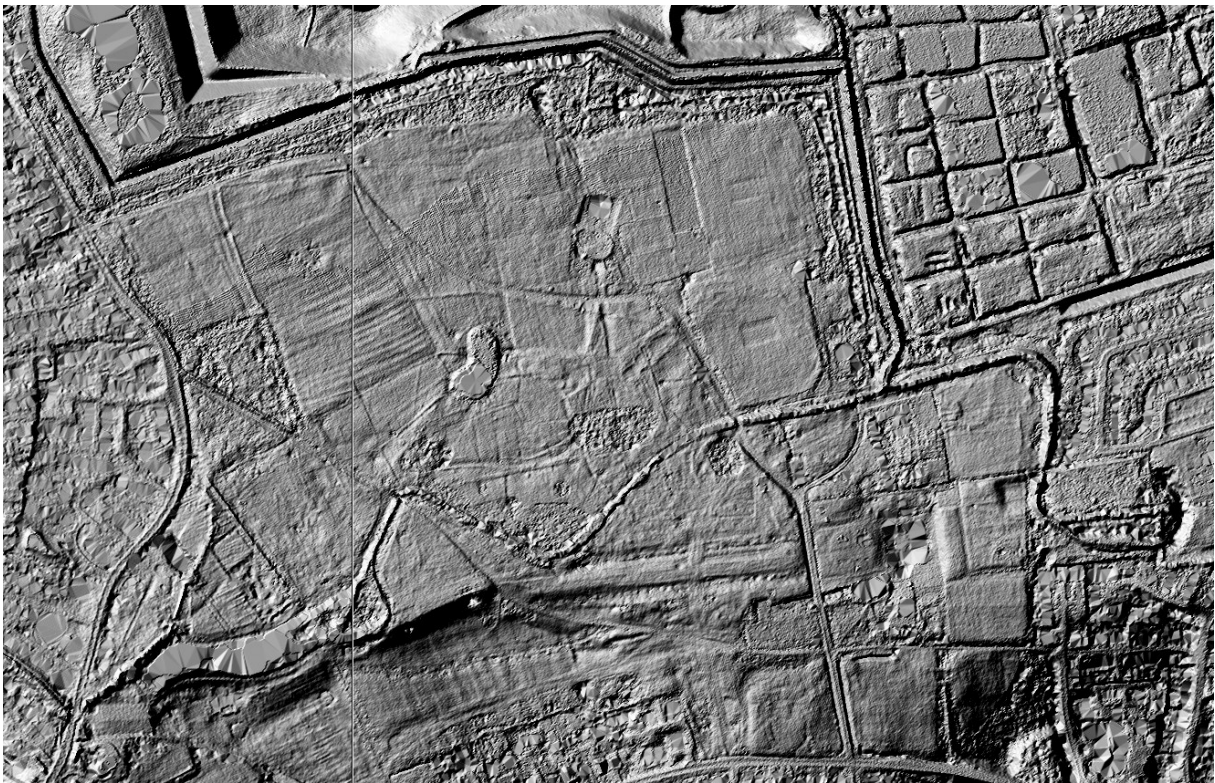
Figure 19. Lidar scan of the park. Azimuth 120, height 35.

The park is covered by the Environment Agency's lidar scans which are available through the data.gov.uk website. The data has been processed into images using the Relief Visualisation Toolbox produced by the Institute of Anthropological and Spatial Studies, which is a Research Centre of the Slovenian Academy of Sciences and Arts.¹⁰⁵ The Environment Agency's data is in effect a table of spot heights at 1m interval. The Toolbox software turns this into a relief image with the trees and buildings removed so that areas are not lost in shadow. The altitude and angle of the light can be altered to produce the most useful result. This is expressed as the azimuth or position on the horizon expressed as degrees from north and the height or number of degrees elevation above the horizon. This allows the landscape to be lit with the 'sun' in artificial positions which could not occur naturally. The technique is very effective and is able to reveal slight gulleys, banks and other undulations, which are discussed below.

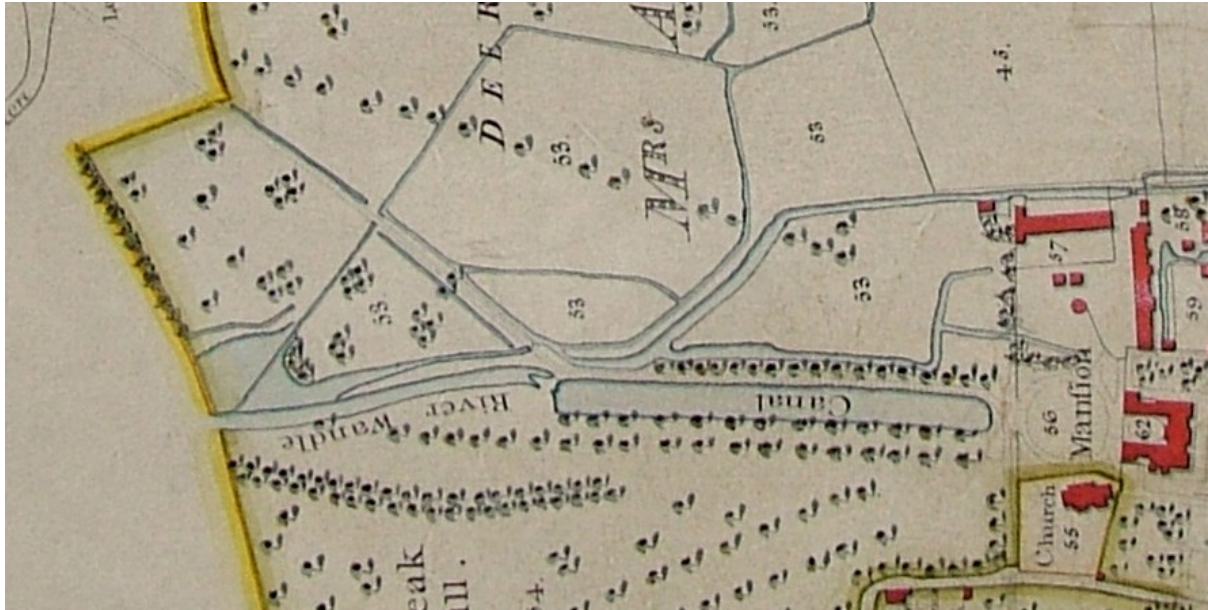
Figure 22. The river from the enclosure award map of 1820.

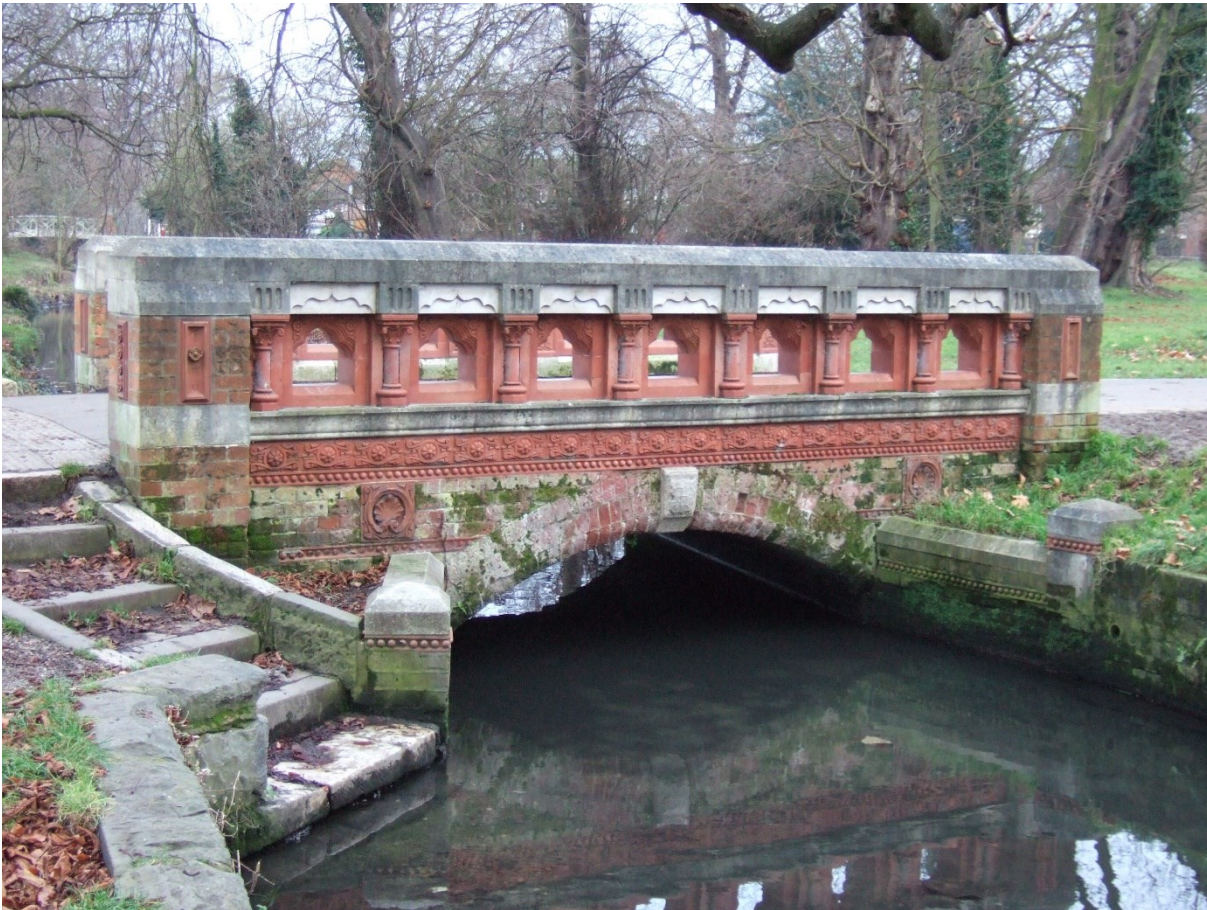
Figure 27. The downstream side of Canon Bridges' Bridge in 2006. Much of the terracotta is restoration following damage in the 1987 gale.

This small bridge spans the Wandle to the northwest of the dovecote. It is of brick and moulded terracotta with Portland stone dressings. The west side of the bridge was demolished by a falling tree in the great gale of 1987. Examination of the shattered remains showed that the terracotta was made by the Watcombe Pottery at Torquay and that the bricks were made by R. Allen of Ballingdon near Sudbury in Suffolk. The bridge was made for Canon Bridges as the design includes his initials. He had family connections with the Sudbury area. The bridge was restored with components custom made by the Shaw Hereford Tile Company of Darwen, Lancashire. The bridge was re-opened in May 1990.

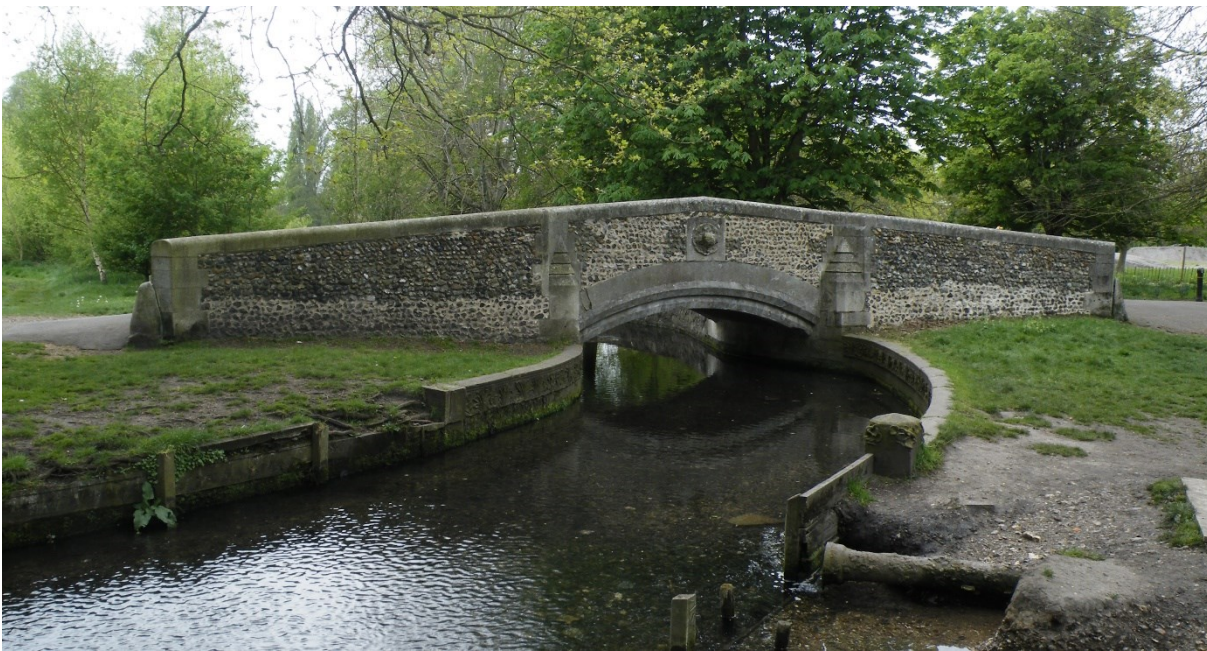
Figure 29. The upstream side of the flint bridge in 2019.

This crosses the Wandle towards the west side of the park. The bridge is faced with flint and limestone in ‘gothic’ style. There were ‘gothic’ gargoyles in the centre of the parapets. The one on the upstream side is now badly eroded while the downstream one is broken. The river channel bends as it approaches the bridge, and is lined with a low retaining wall which is decorated with plants and small aquatic animals such as frogs and newts. The bridge is illustrated in Smee’s *My Garden* and, in the list of illustrations it is described as ‘New Bridge over the Wandle (1871) in Beddington Park’.¹²⁰ The foundations of an earlier bridge can sometimes be seen in the riverbed.

The lower part of the side walls and most of the arch over the river were repointed as part of the Lottery funded project.

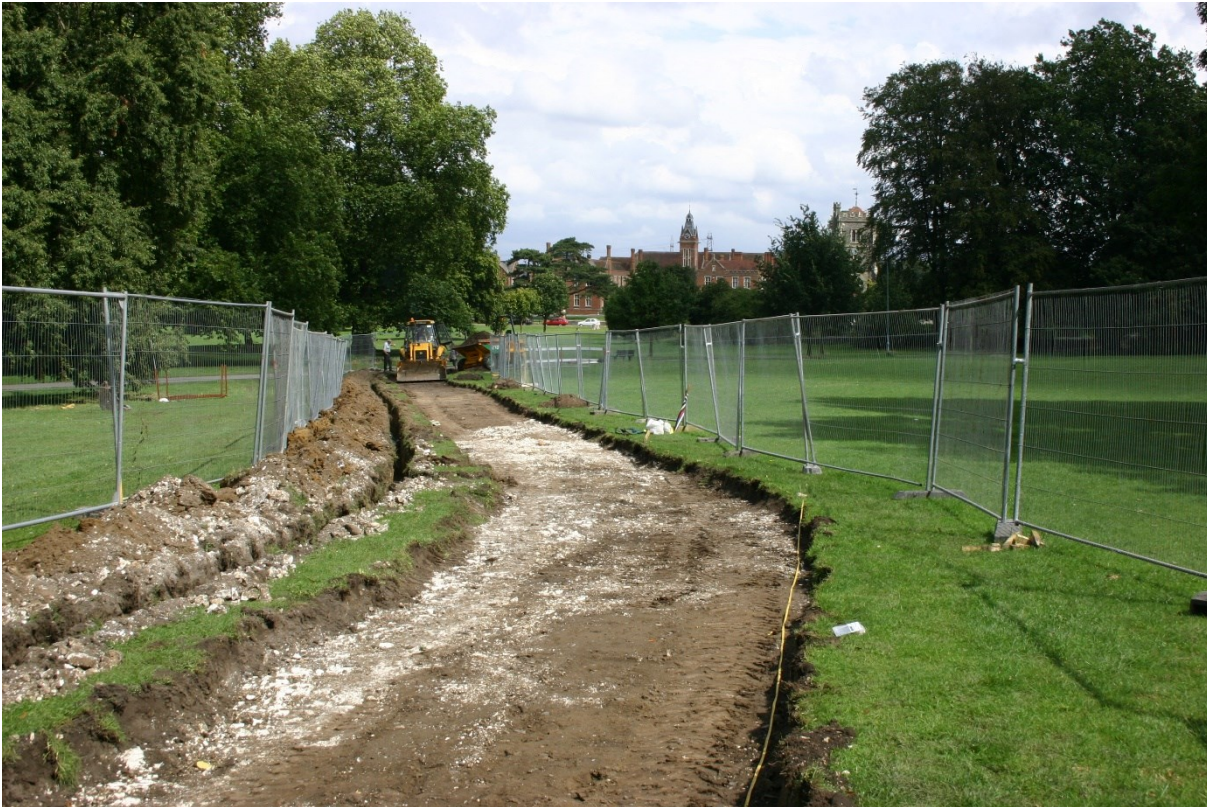
Figure 42. The chalk foundation exposed during the construction of the cycle track in 2004.

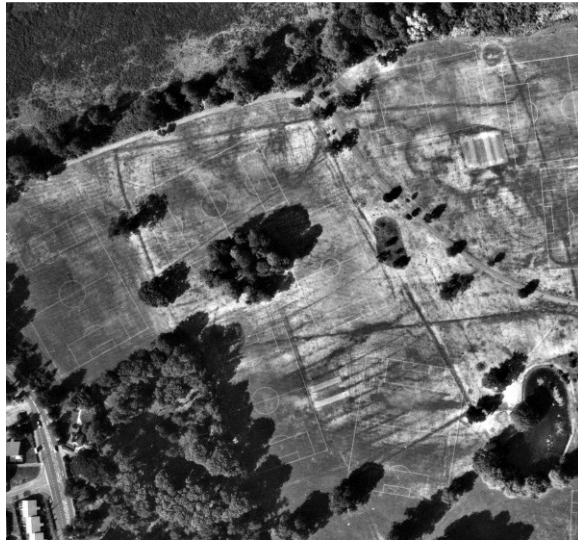
Figure 46. The northwest corner of the park. Note the field boundaries defined by the silt-filled ditches which appear as dark lines. The area to the east of the plantation has been drained by a series of closely spaced parallel ditches which feed into a central north-south ditch.

The horizontal line running from the northeast corner of the plantation is the cut for a modern sewer.

The southern part of field C is covered with ridges aligned approximately east-west and joined by a central north south ditch (figure 46). These are probably not ploughing ridges as they run right to the boundary ditch leaving no headland for the plough to turn, and were more likely made for drainage.

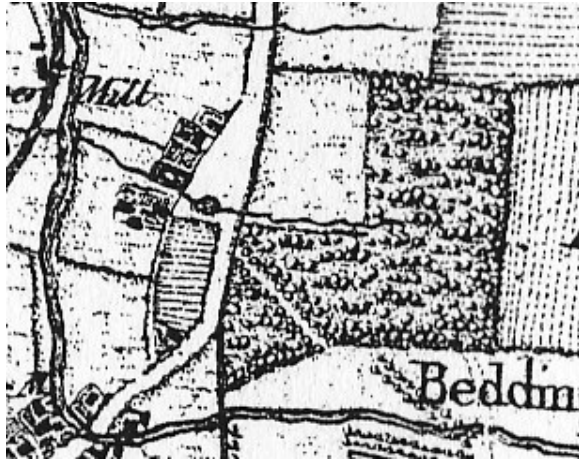
Figure 48. The area on Rocque's map of Surrey about 1760. Lodge plantation and the fields to the east and northeast of it are woodland. Note the drainage channel running along the north edge of Lodge Plantation and continuing westward to the Wandle.

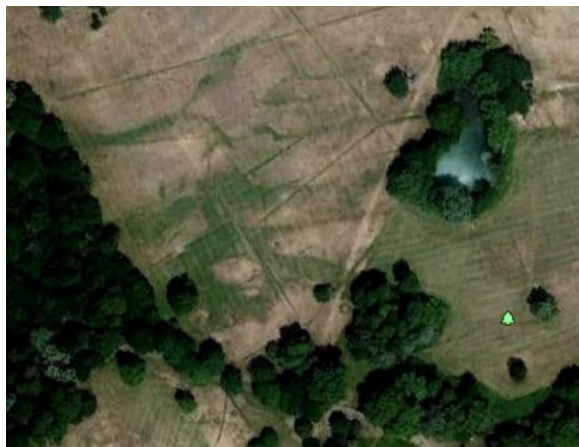
Figure 50. A 2010 air photo from Google Earth. The drainage ditches are not very visible but the green areas suggest silt-filled channels which probably drained west towards the Wandle.

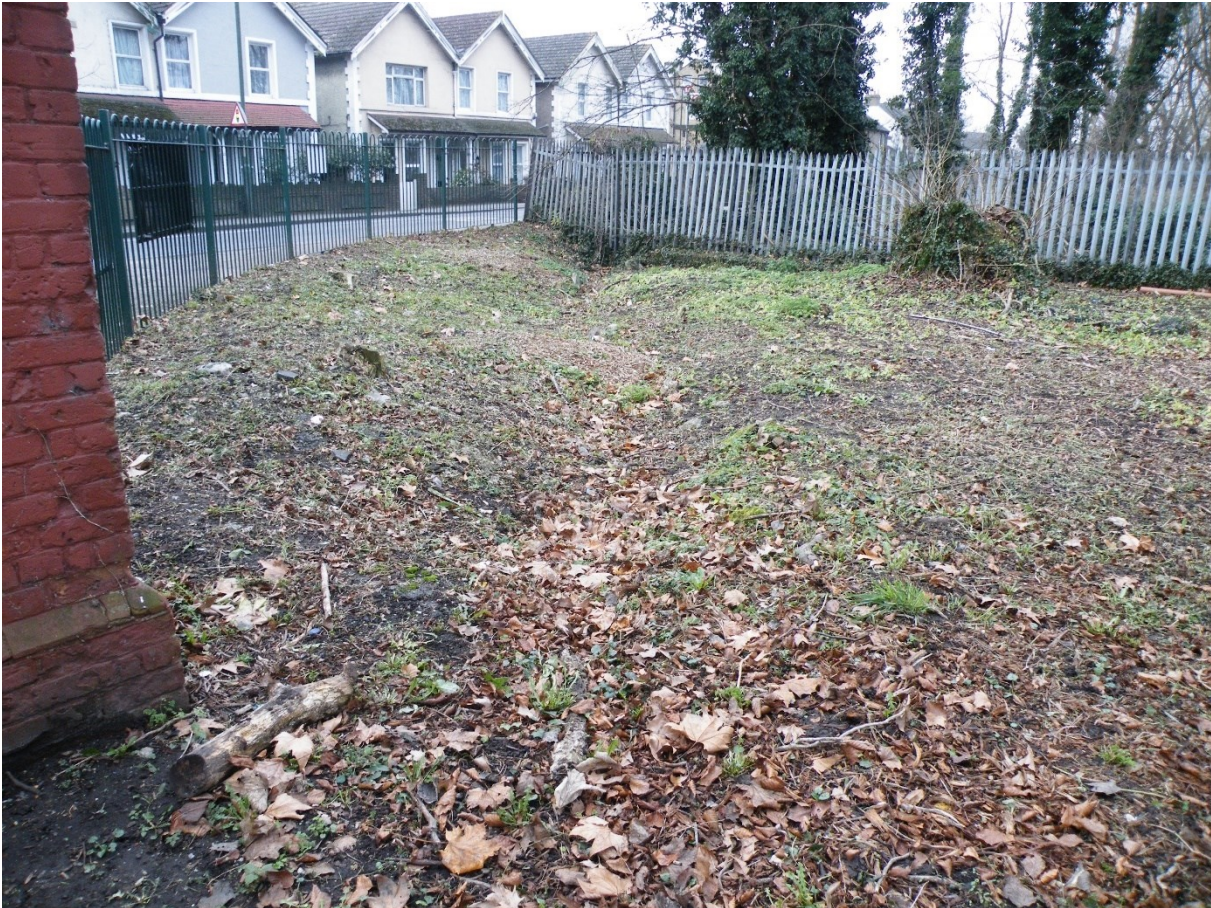
Figure 51. A hollow marking the site of the former channel on the north side of the Hackbridge gate on 14 Jan 2018. This area was levelled in the Lottery funded project so the hollow is no longer visible.

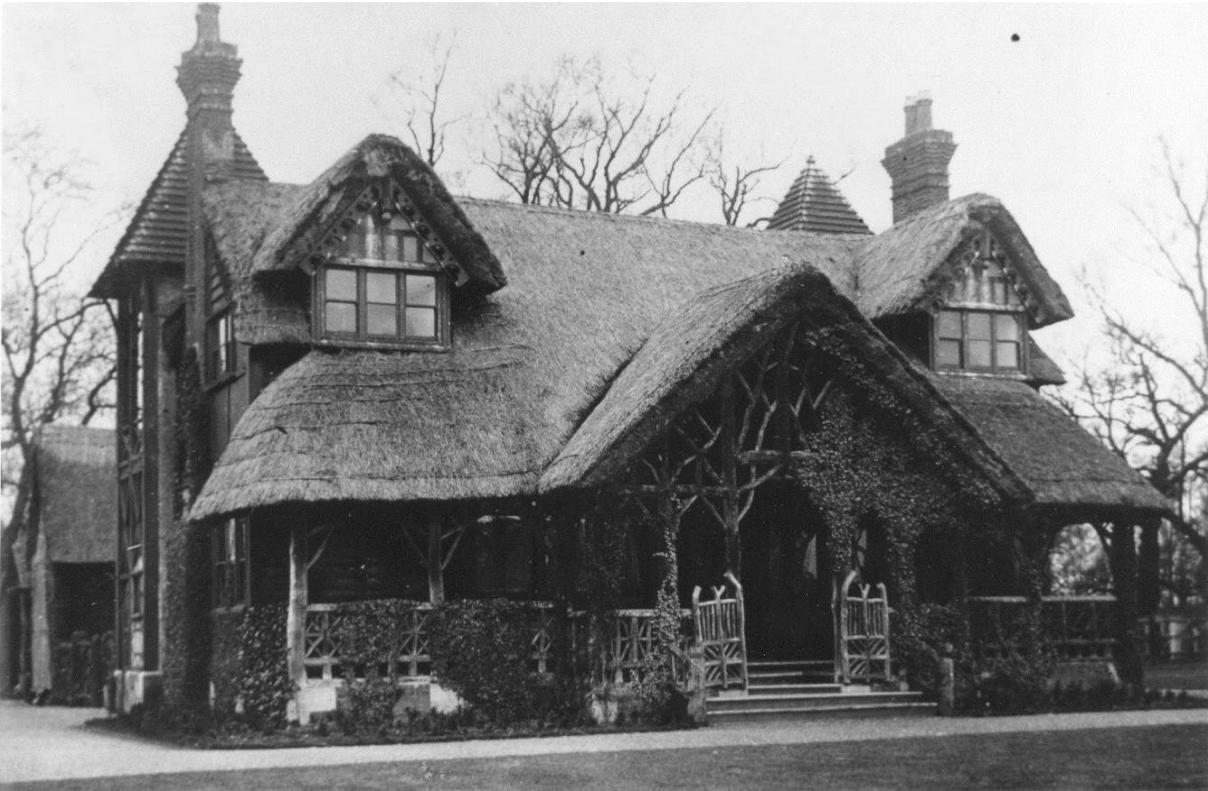
Figure 59. The east front of the pavilion on the archery ground. Designed by Joseph Clark for Canon Bridges and now demolished.

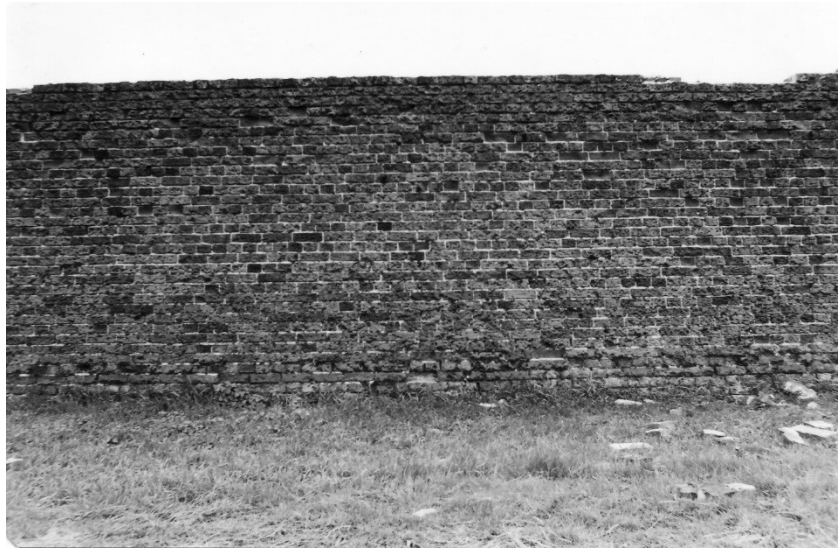
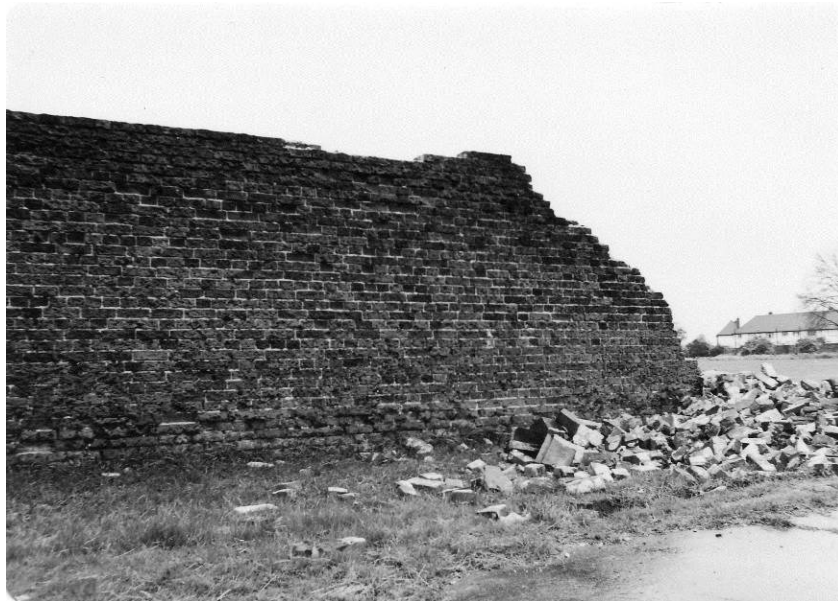
Figure 64. The remains of the wall between the north gate and river on 3 May 1981. Note the bond break adjacent to the gate pier. The wall has now been replaced by a hedge.

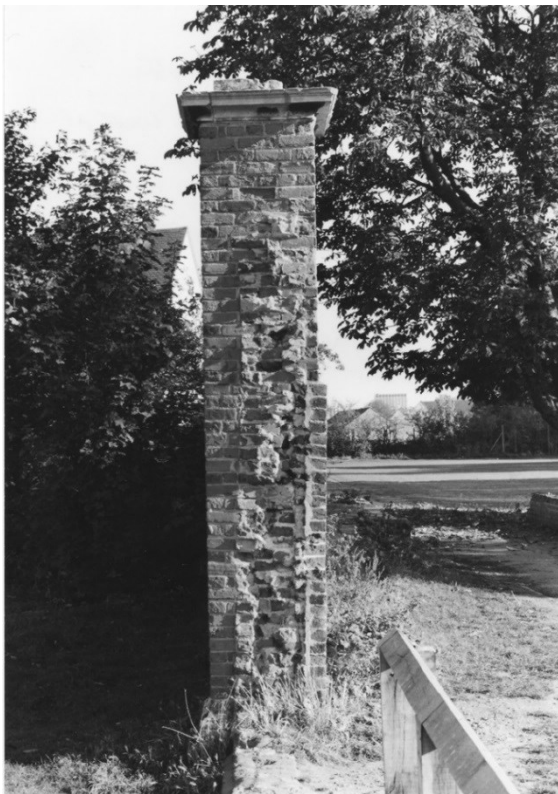
Figure 66. The pillar by the Wandle. Left: west side of the pillar with the scar from the missing wall. Top right: sketch of the moulding on the pillar top. Bottom right: sketch plan of the pillar top. This does not show the correct angles of the corners.

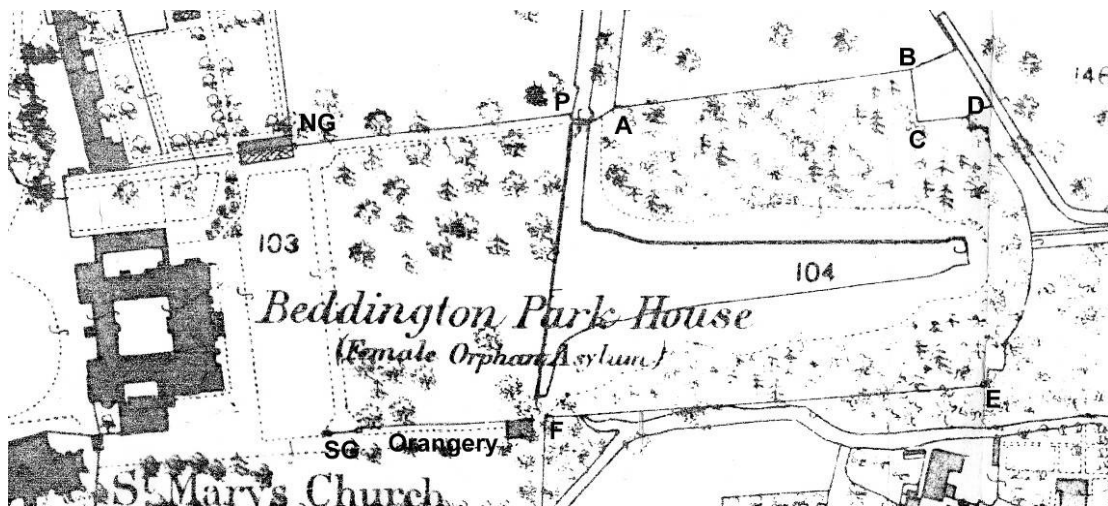
Figure 67. The central garden area and its boundary walls from the 1st edition 25 inch Ordnance Survey map, 1868. NG North gate; SG South gate; P Pillar by Wandle

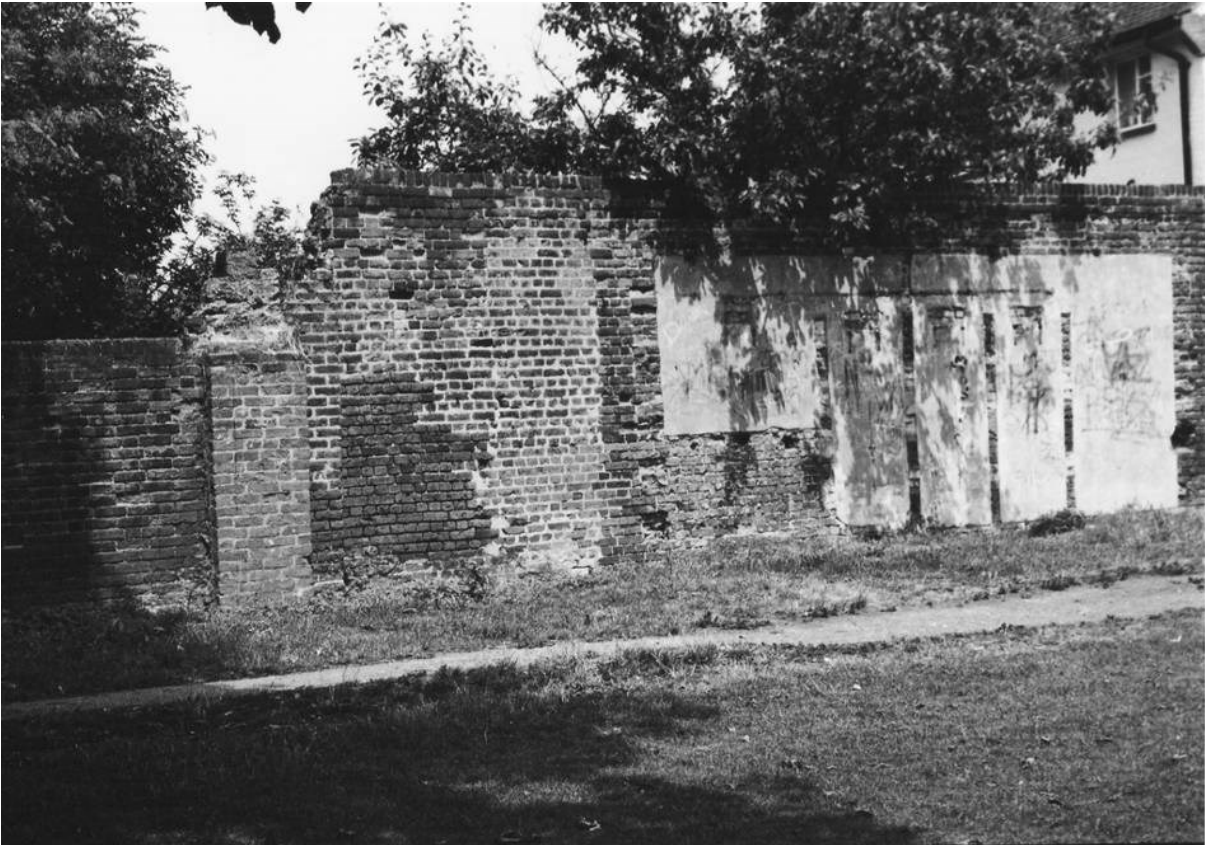
Figure 68. The west end of the north wall in 1986 showing the remains of a pillar of uncertain date and the scars from the demolished swimming pool changing cubicles.

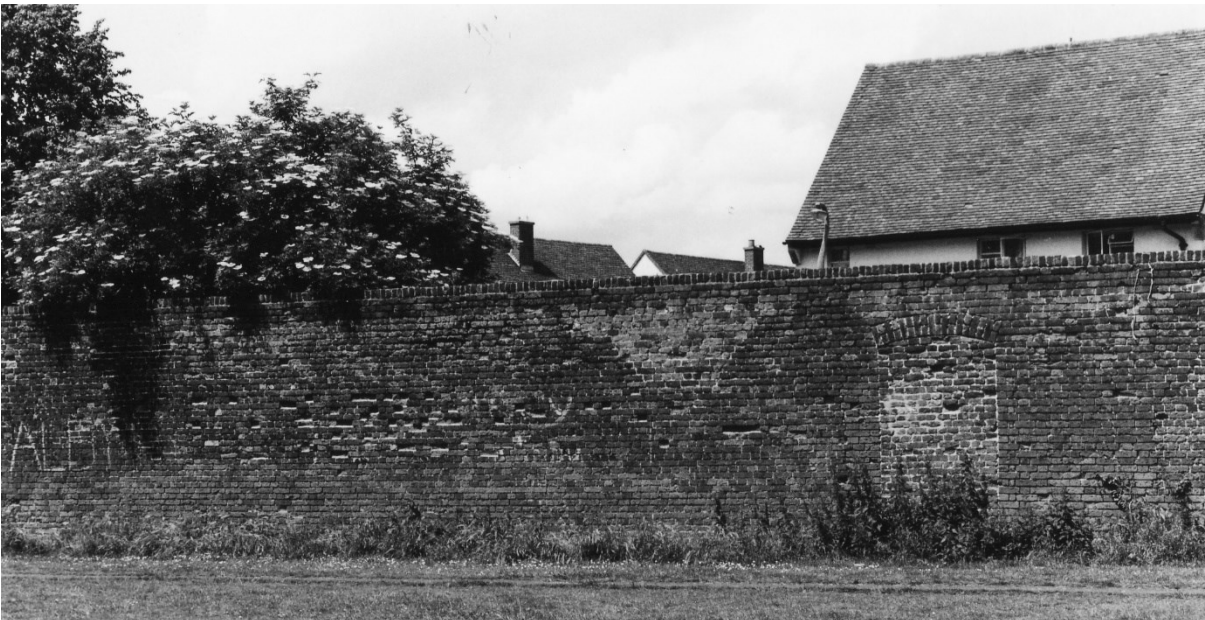
Figure 69. The north wall of the eastern end of the central garden in 1986 showing the blocked door.

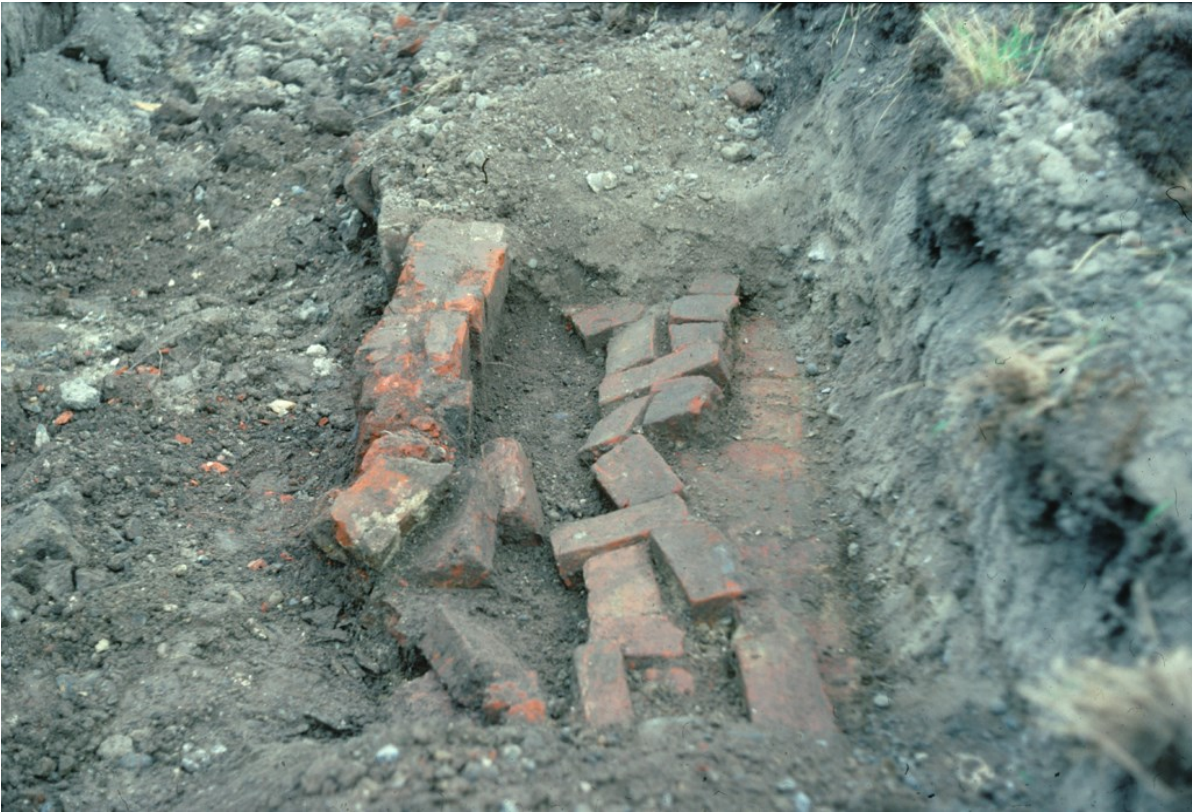
Figure 71. The southern lakeside wall exposed during flood alleviation work in 1990.

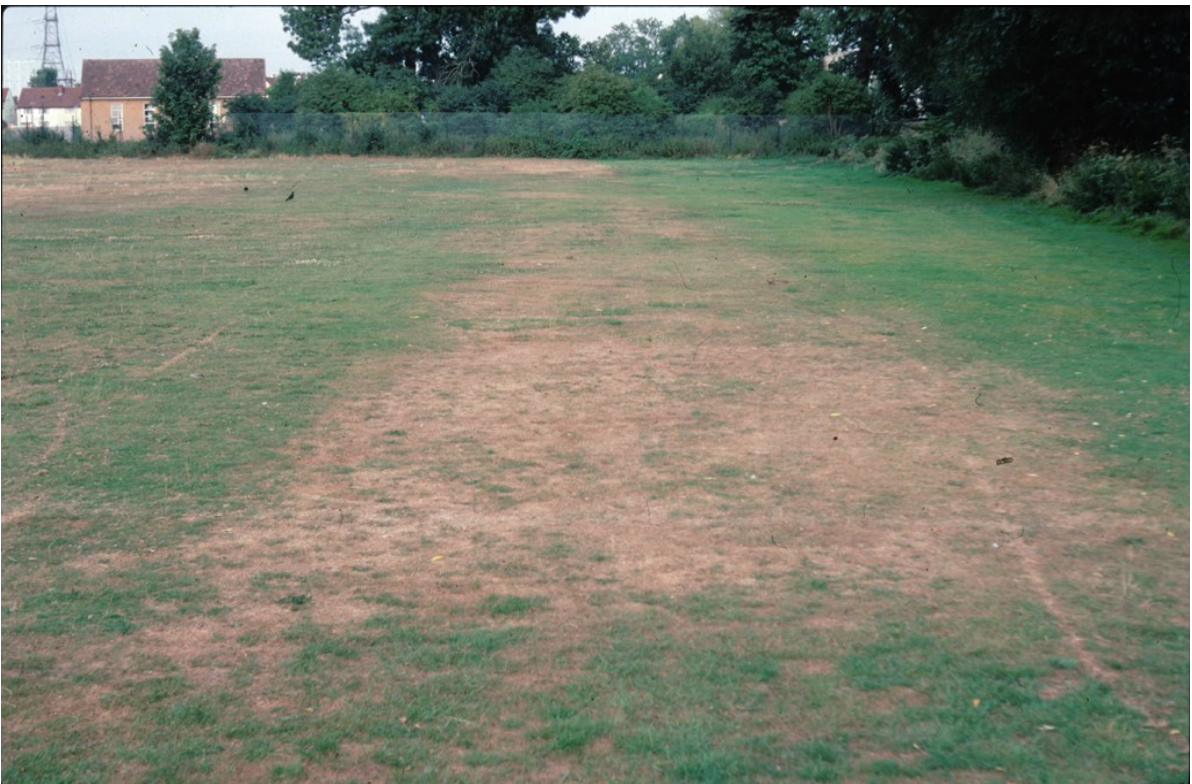
Figure 72. Parch-mark on the grass on the north side of the river probably marking the walk along the north side of the east lake, June 1989.

There was a cascade at the eastern end of the lake. If it is assumed that the lake was symmetrical about the cascade the parch-mark would be a few metres south of the projected northern lake edge. It is therefore likely that the mark represents the northern edge of the lake with a gravelled walk similar to the south side. The lake would have been about 44m wide.

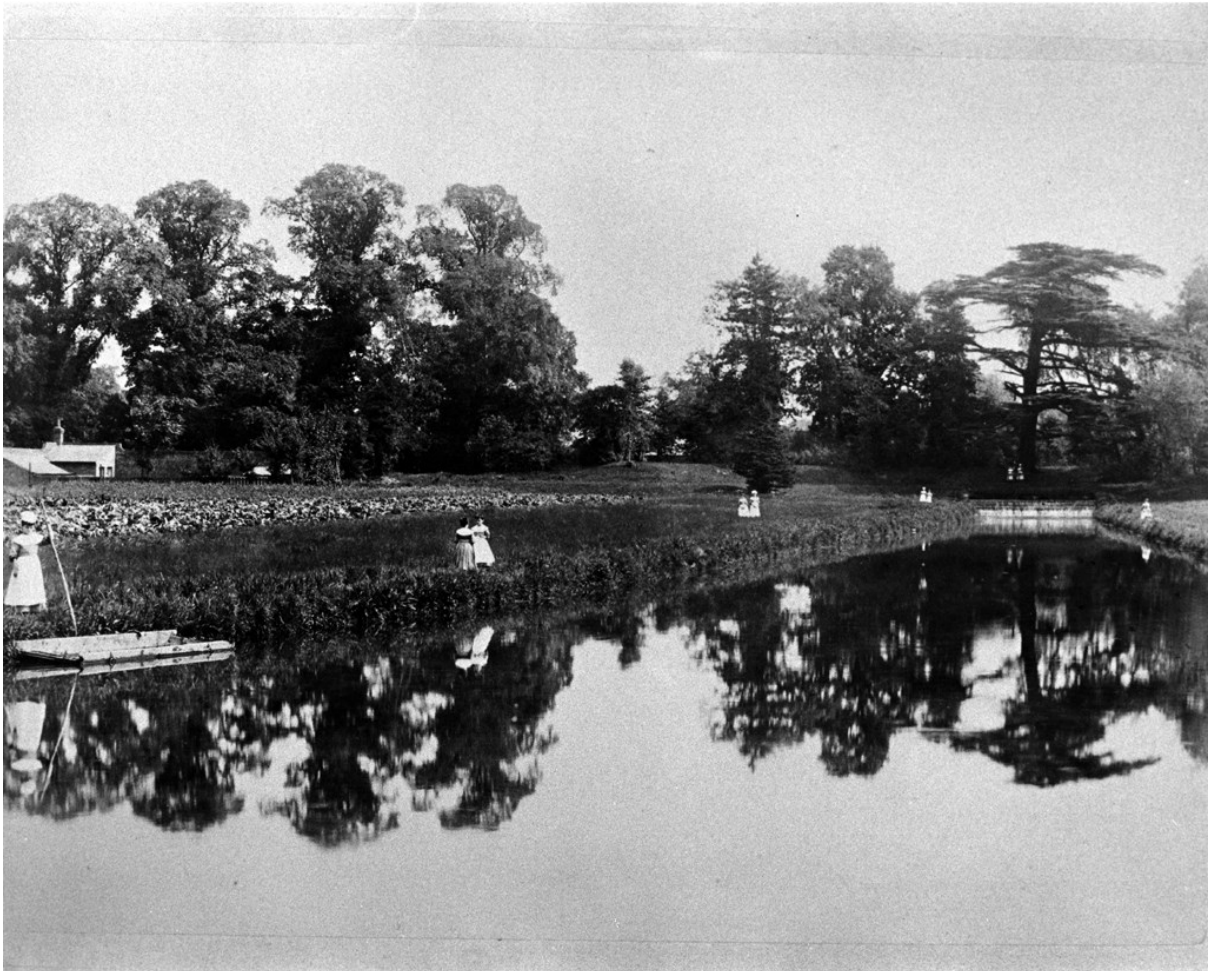
Figure 73. The cascade around 1900.

The east end of the garden was closed by a curved gravel bank. The river entered the garden by two brick culverts through the centre of the bank and then flowed over a cascade. Each culvert was 1.25m wide and about 0.78m high. Photos from about 1900 show that the cascade was a fairly simple structure with two short drops followed by a higher one (figures 73 and 74).

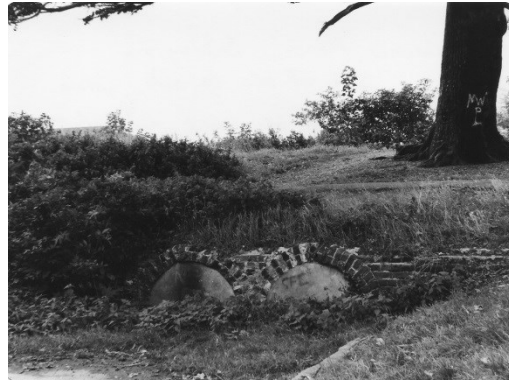
Figure 75. The cascade culverts in 1987.

The culvert exits and part of the northern side of the cascade channel survive (figures 75 and 76) although they are overrun with brambles.. The north wall was 4.45m from the centre line between the two culverts suggesting that the original width of the cascade was about 8.9m.

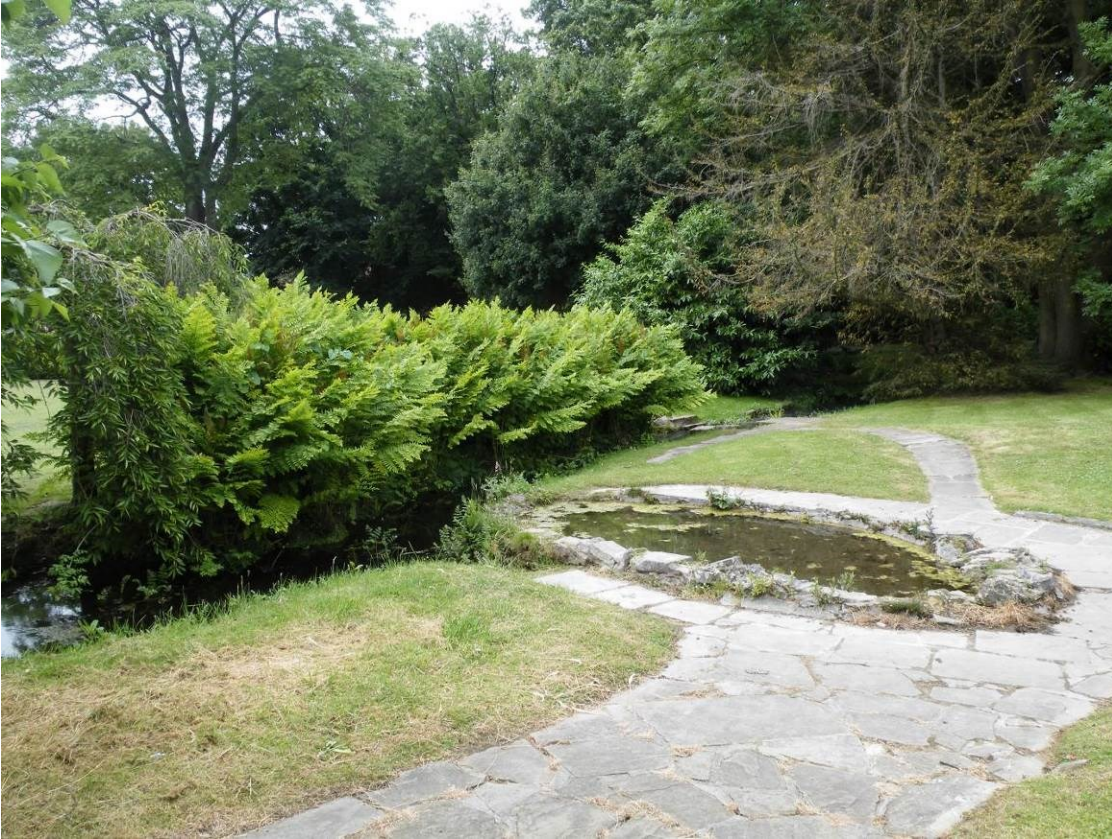
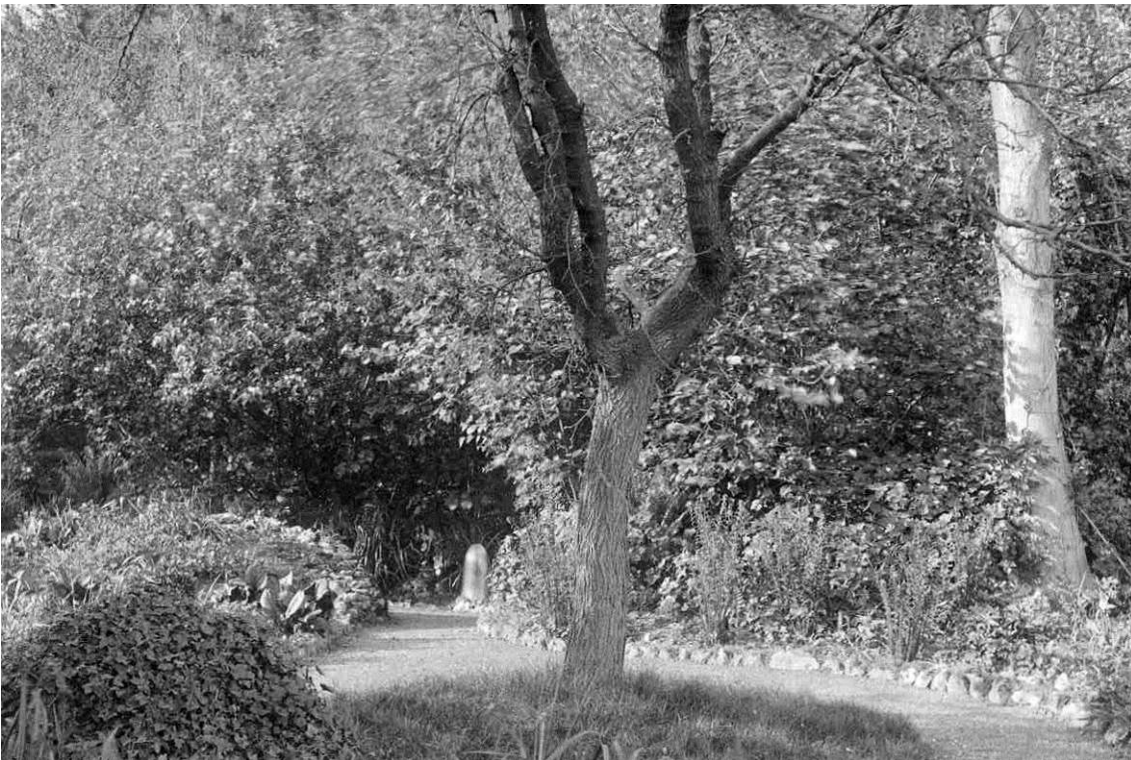
Figure 109. The artesian well looking north in 2013.

Figure 110. The artesian well photographed on 24 June 1903 by JH Baldock for the Photographic Survey of Surrey. Looking north. The mulberry in the centre is still standing although it has lost some branches, has tipped over and has become hollowed out.

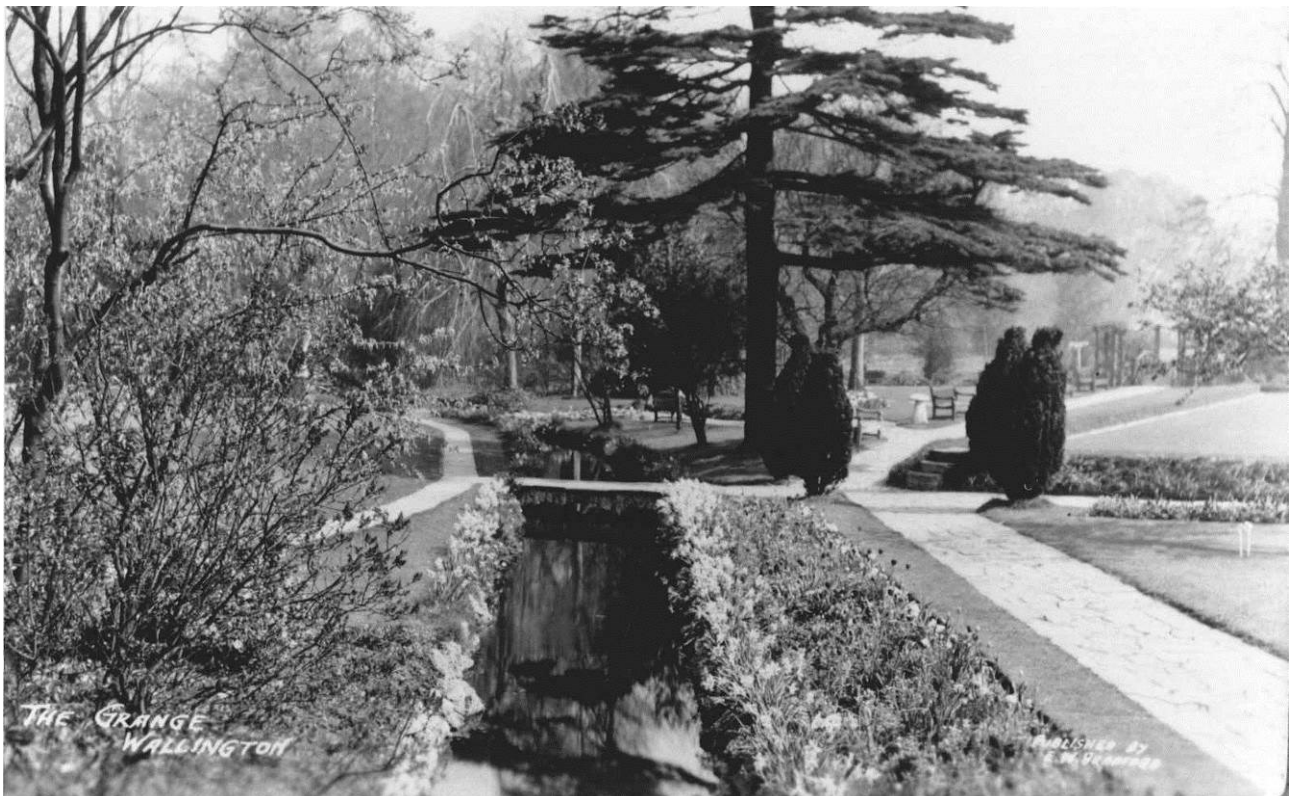
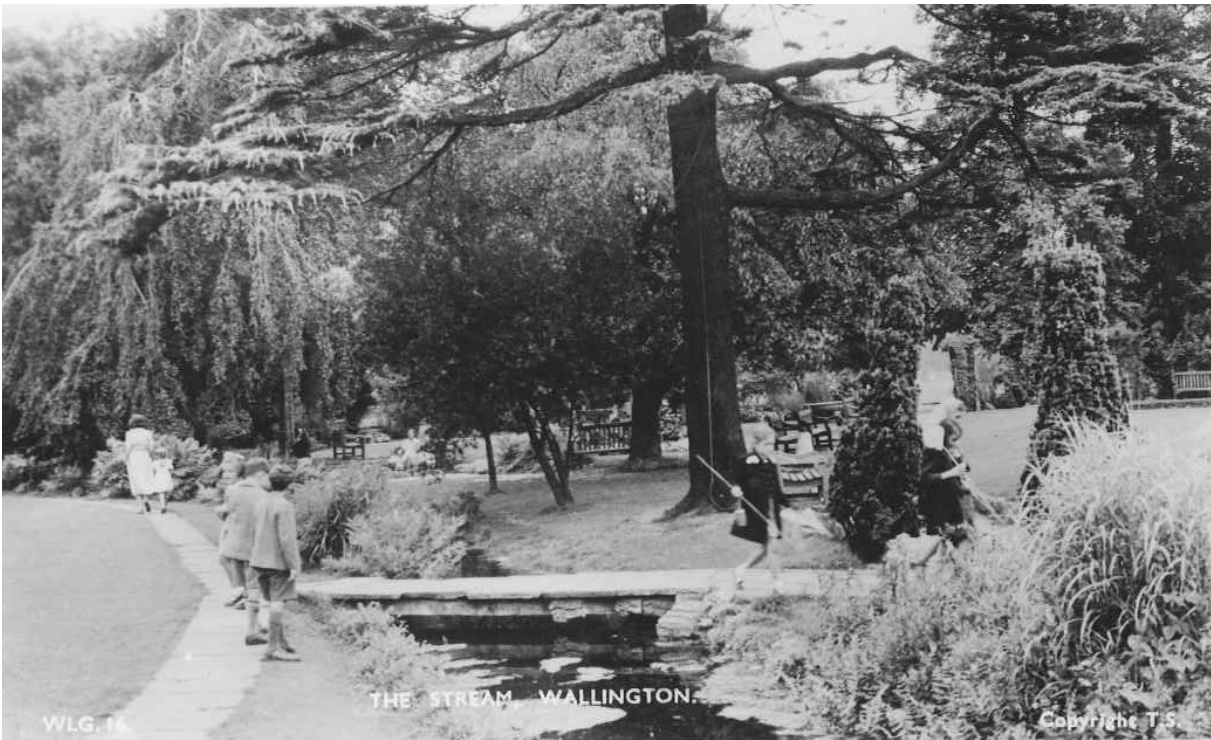
Figure 111. The central stream looking north towards bridge E. The photo was probably taken in the early years of the public park.

Figure 112. The central stream looking north towards bridge E. The photo was probably taken in the early years of the public park.

The Local Studies Collection includes two photos which were probably taken in the early years of the public park which show the channel looking north towards bridge E (figure 111 and 112). The earliest – judging by the size of the trees to the right of the bridge – shows flowers along the riverbank with a proper border on the east side.

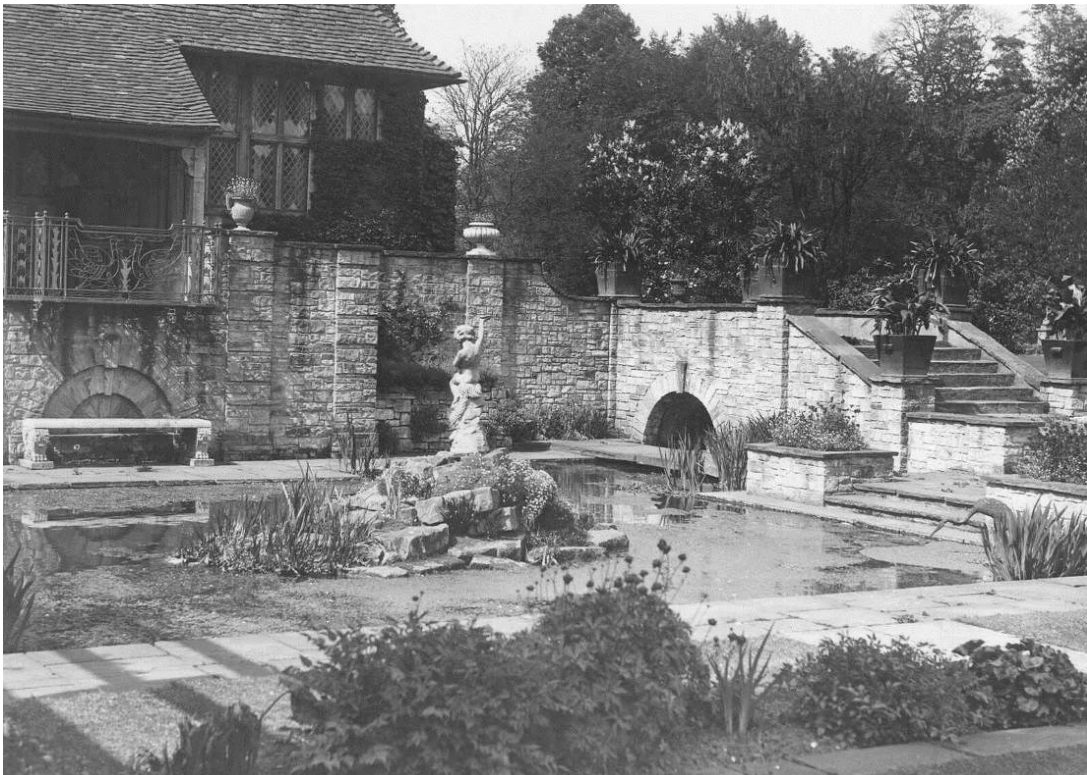
Figure 115. The pond probably taken around the time the Council acquired The Grange.²⁷³

The stream then flows over a weir with a drop of 0.4m, and under a bridge into a stone-lined pond in a paved area at the foot of the terrace at the south end of the house. The terrace has art deco railings and this, and the squared random stonework, suggest a date in the 1920s. On the northeast side of the pond steps lead up to a bridge with a French burr mill stone set in the pavement. On the southwest side of the pond there is a pergola supported by stone columns on either side of the bridge over the stream. The pond, bridges, and pergola and art deco railings are very much of a piece and appear to be a single build. A photo, which was probably taken when the Council bought the park, shows a small rock and statue in the centre of the pond, and Italianate stone bench below the railings and an assortment of plant pots on the wall (figure 115).

²⁷³ This is one of a group of photos in the Local Studies collection marked with newspaper editing instructions and marked T. Booth. (figures 115, 118 and 129) T. Booth was the Town Clerk of Beddington and Wallington, and it seems likely that the pictures were taken for the Council around the time they acquired The Grange.
