Beddington Park and The Grange

A report on observations and documentary research during the
Heritage Fund and Community Fund project 2015-2020

Carshalton & District History & Archaeology Society
Occasional Paper 17

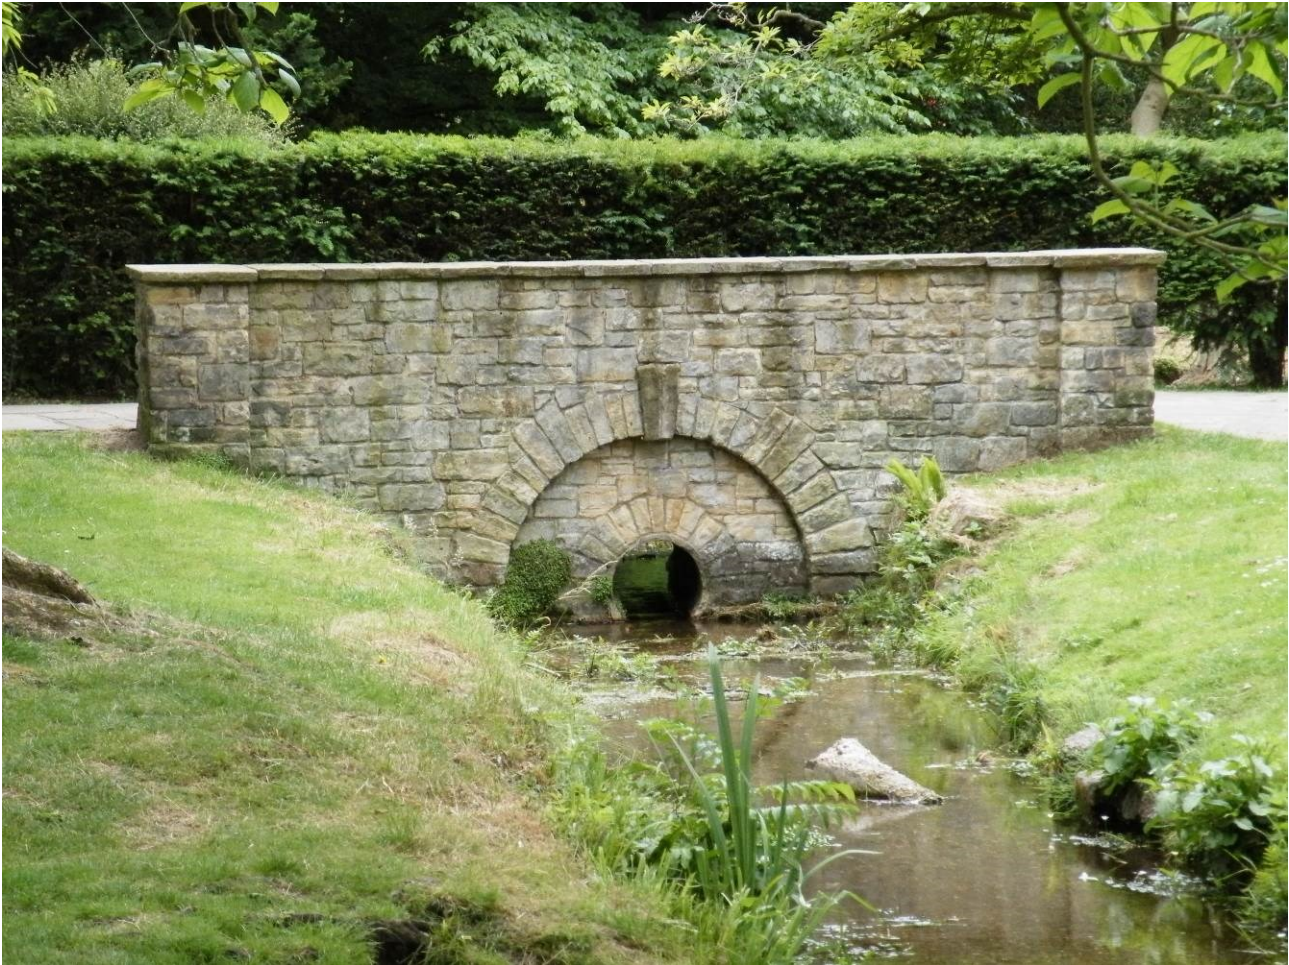
Figure 116. The upstream side of bridge F looking south in 2013.

The banks downstream of the pond contain a good deal of concrete rubble. The stream then flows under bridge F which consists of a pipe set in concrete. The upstream side has a random block stone parapet very similar to the work around the pond. The stream then emerges into the rockery from beneath a hedge. The streams here are described in section 8.5.

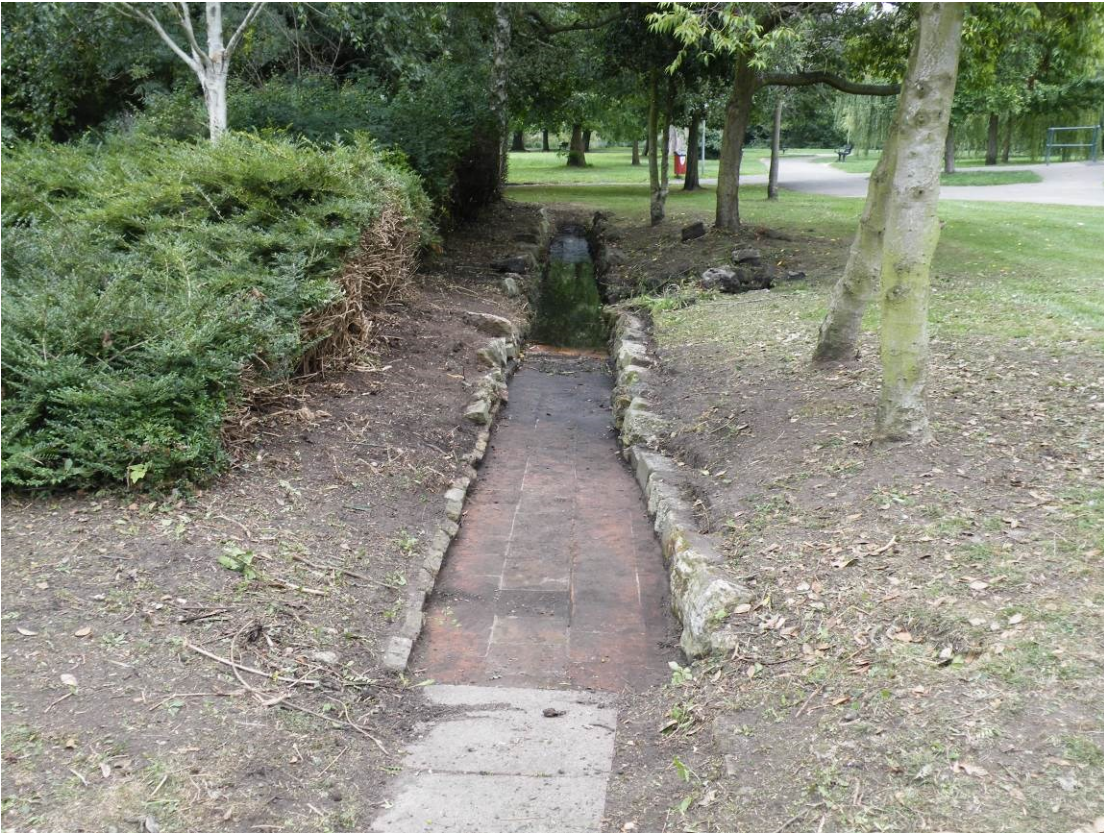
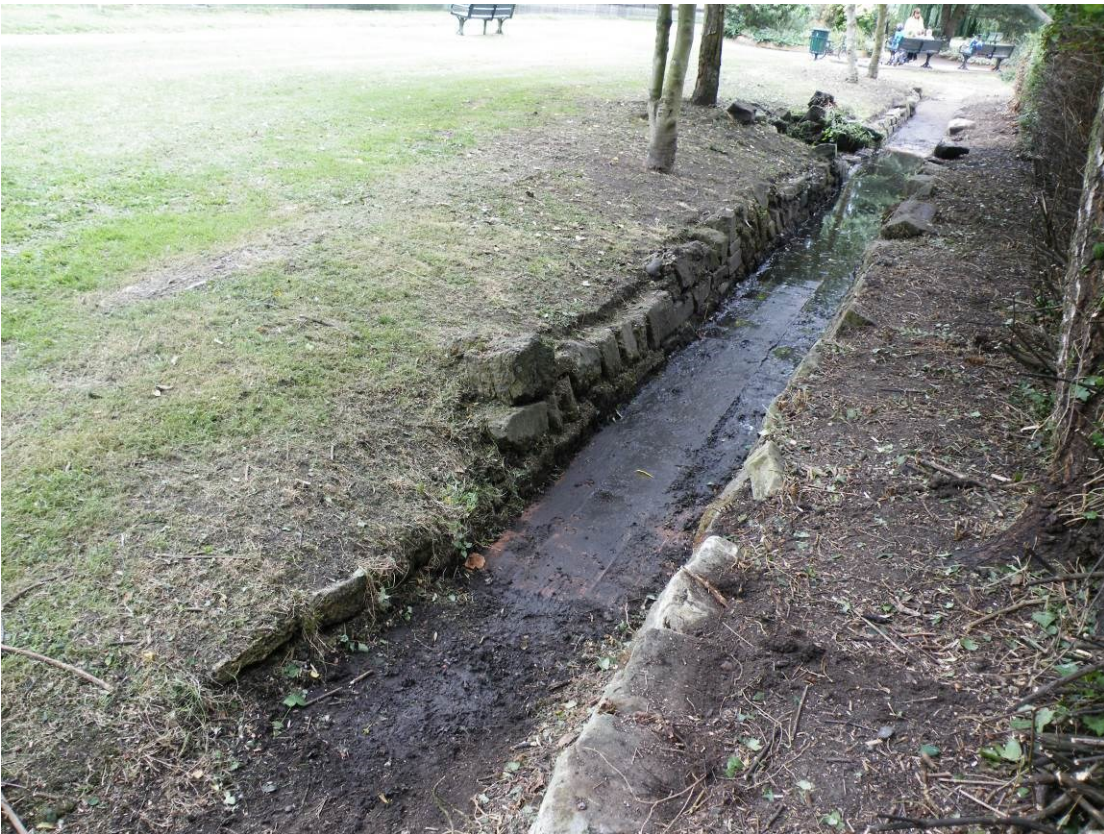
Figure 119. The remains of the fernery looking east in 2015.

Figure 120. The remains of the fernery looking west in 2015.

The remains of the fernery were cleared and investigated in the summer of 2015. They consist of an east-west aligned walkway set into the ground and edged with low walls. There is a small heavily silted pool in the centre of the south side and some lengths of concrete foundation visible to the south of the walkway (figures 119 to 127).

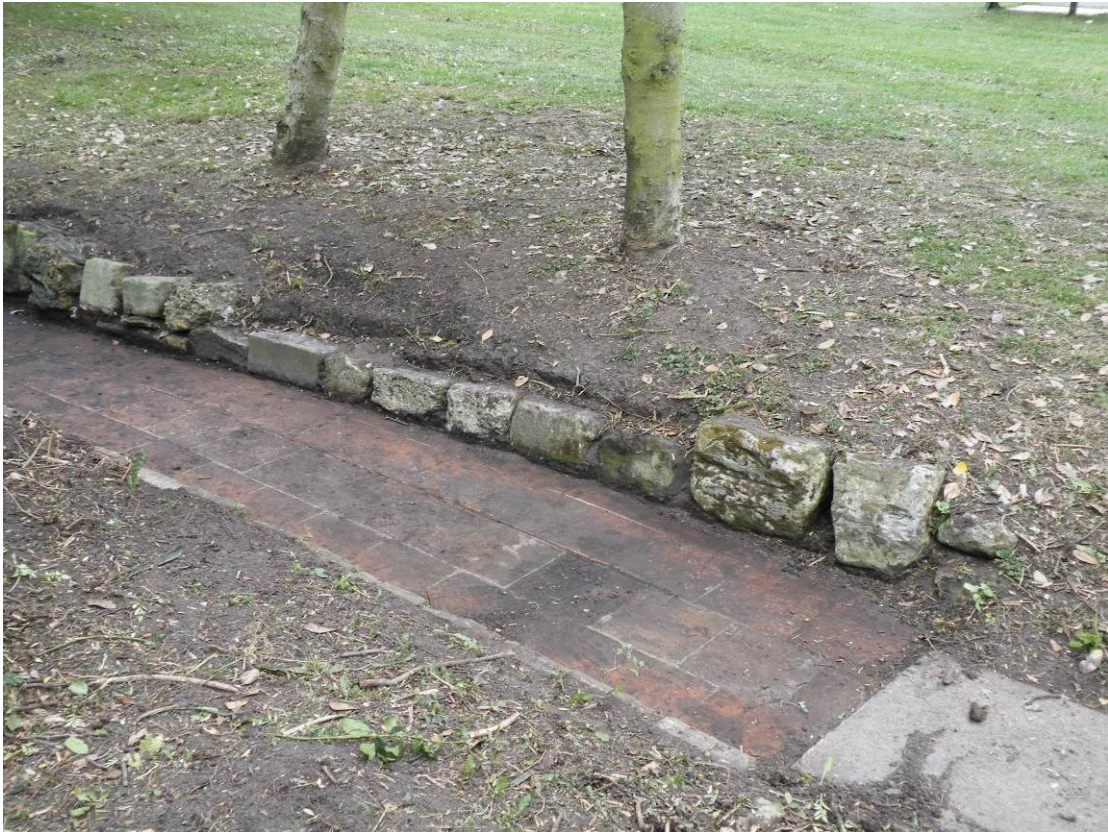
Figure 121. The western end of the fernery in 2015 showing the south wall overlying the floor tiles.

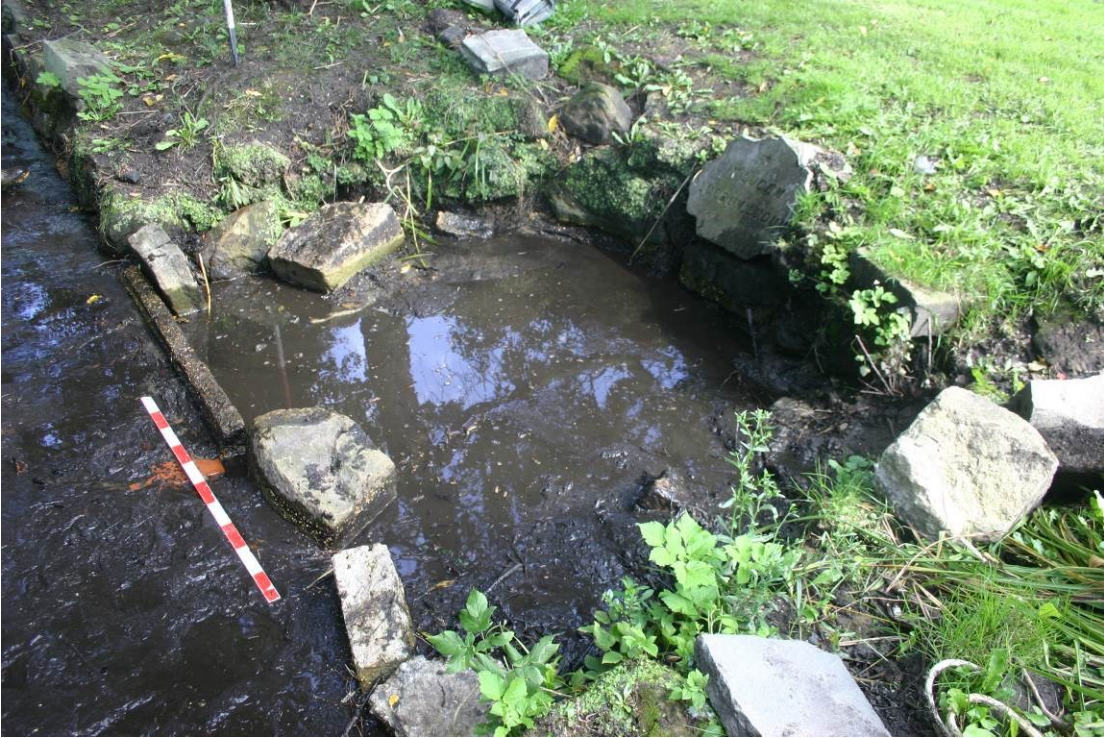
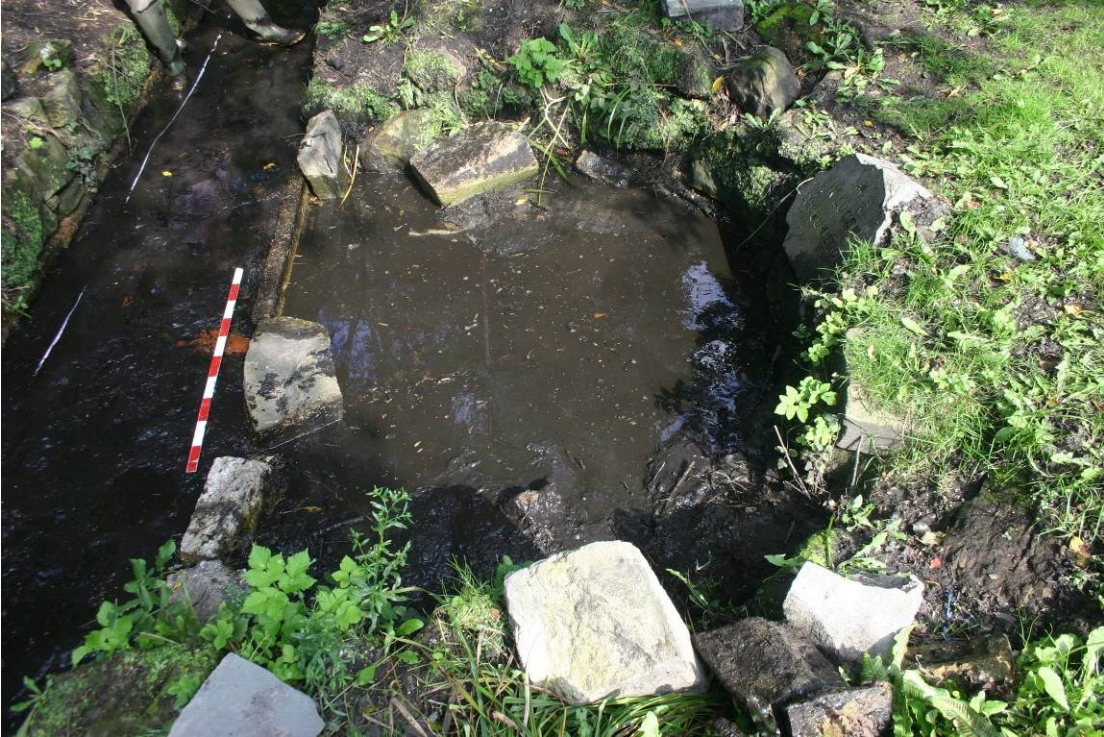
Figure 123. The pool looking east in 2015.

Figure 124. The pool looking west in 2015.

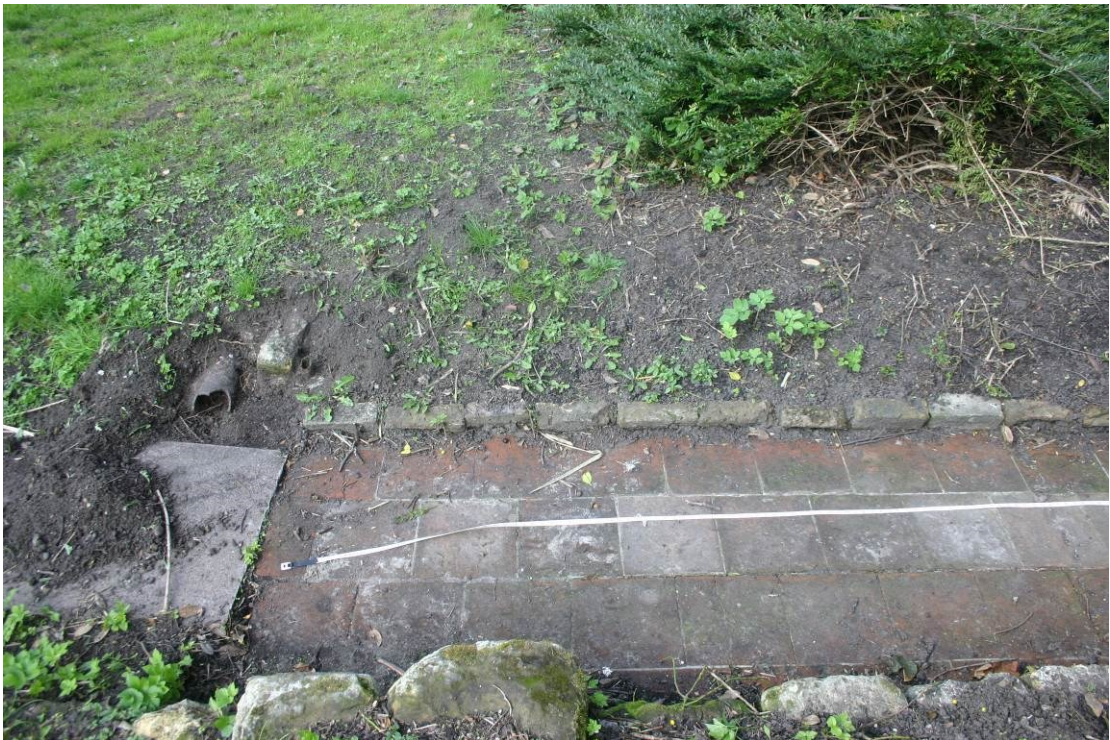
Figure 126. The western end showing a fragment of a north-running wall with a pipe to the left of it in 2015.

There is a northward-running line of yellow stock brick just beyond the west end of the tiles. This rests on a cement foundation. There is a vertical iron pipe set in cement just inside the brick. There is also a horizontal cast iron pipe with an internal diameter of about 100mm (4in) just outside the foundation (figures 126 and 127).

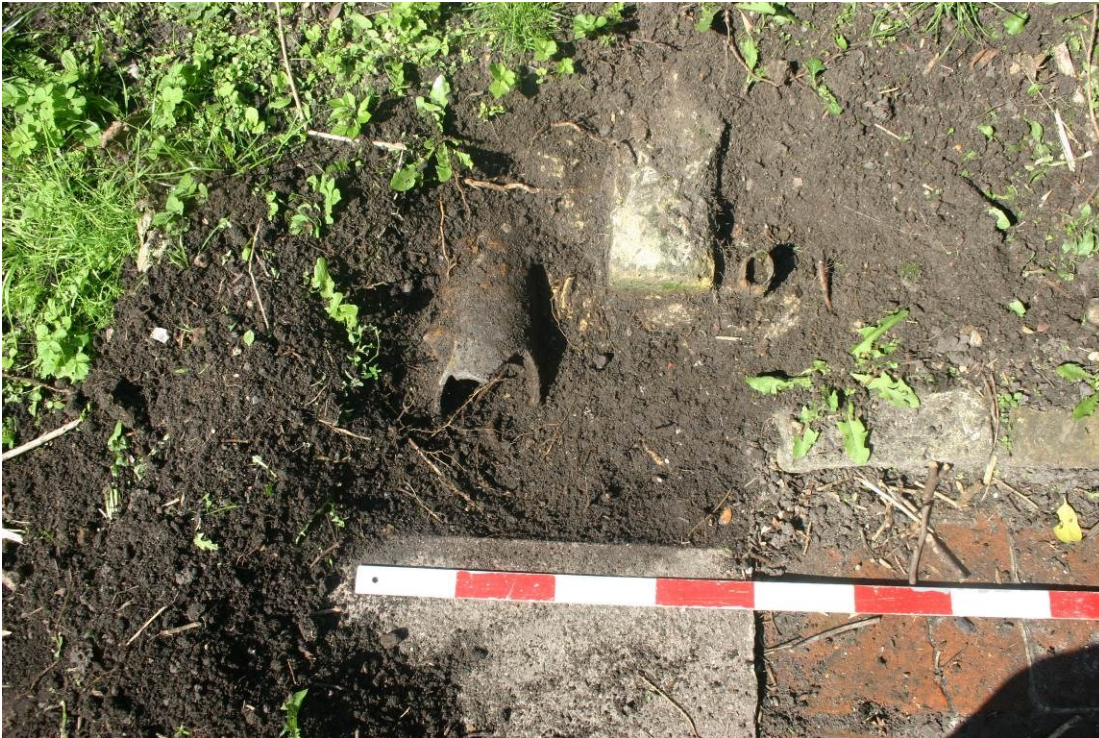
Figure 127. East end. Detail of the pipe and the northward-running foundation in 2015.

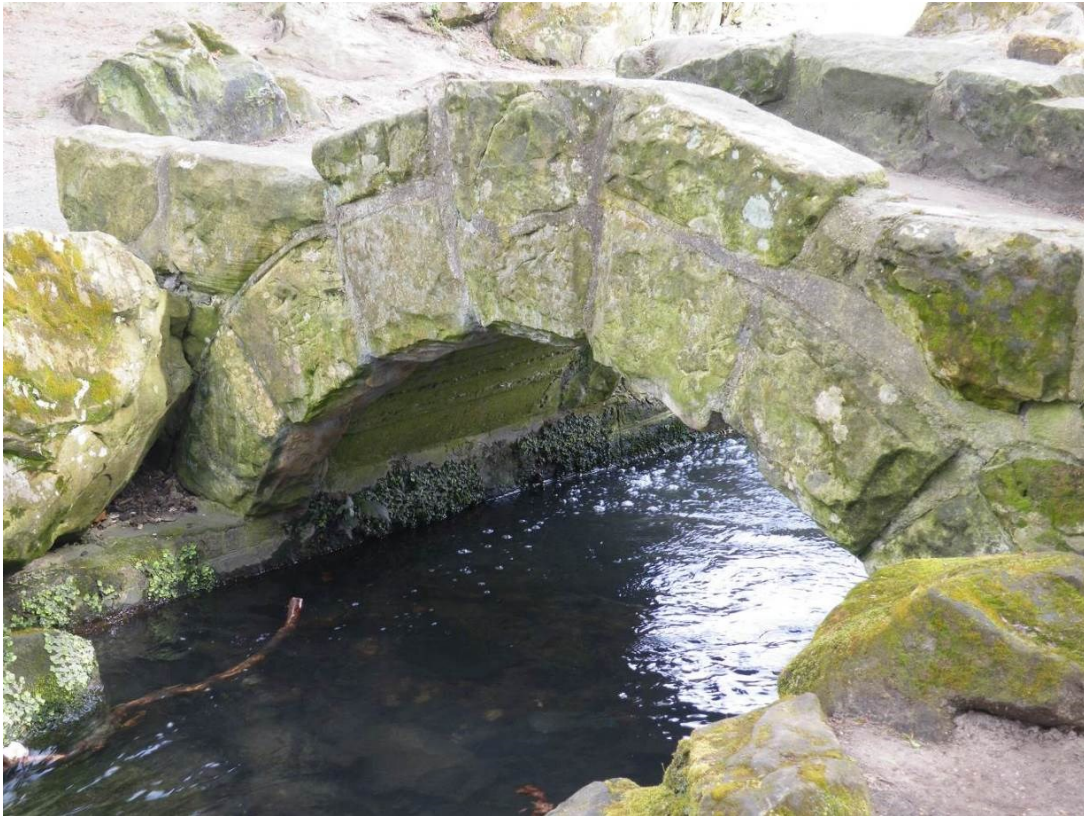
Figure 133. The bridge over the spillway in the rockery in 2013. Note the concrete arch.

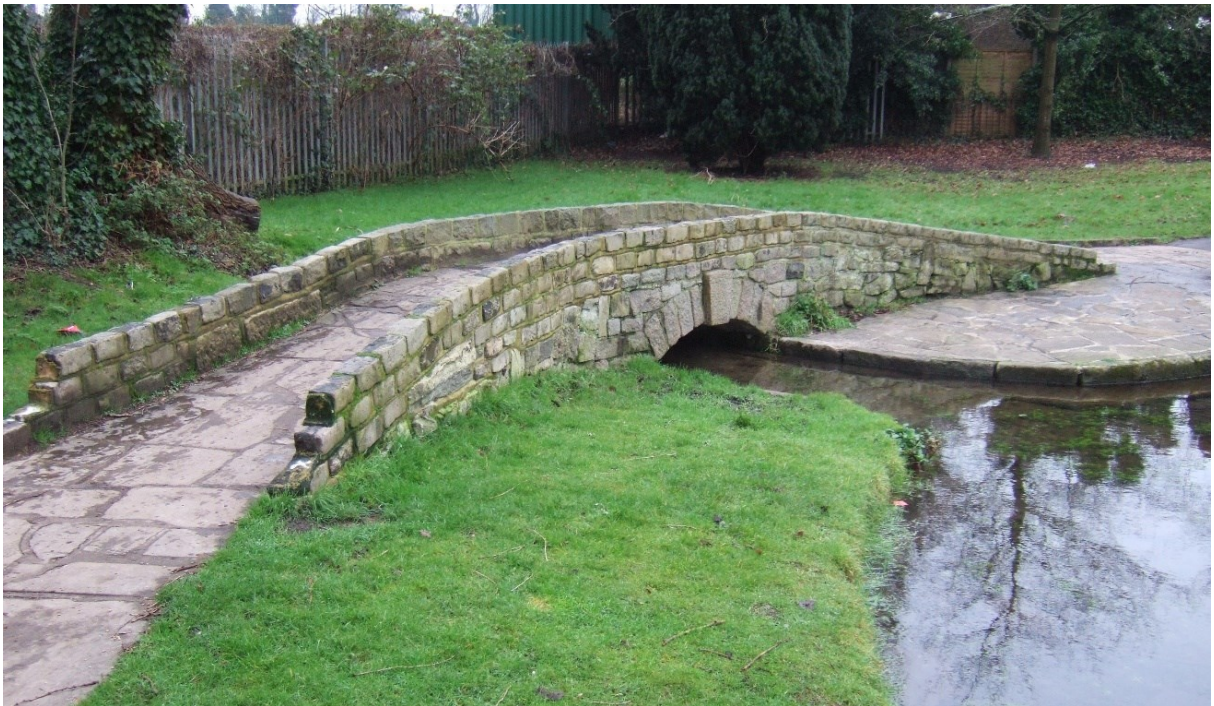
Figure 140. The bridge on the east side of the pond in Manor Garden.

The spring pond survives and continues to flow except in very dry weather. A small short channel runs into the east side of the pond. It is crossed by a bridge with low parapets made of grey ‘granite’ blocks. The Lodge is now a private house.
