Carshalton & District History & Archaeology Society

Local History Note 20

The history of Sutton Lodge, Brighton Road, Sutton

March 2025

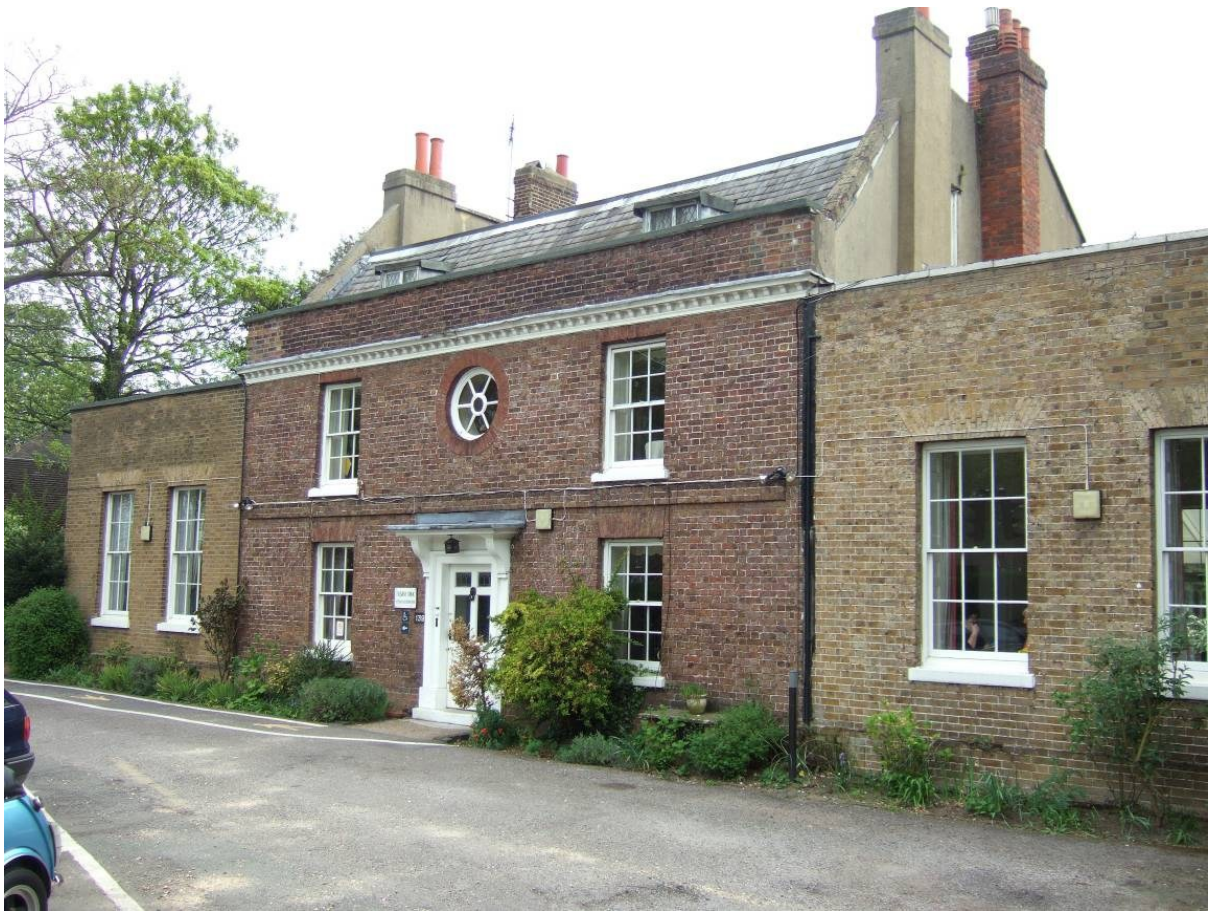
Figure 1. The front looking north.

The front of the central block is of yellow to red brick laid in Flemish bond. It is two storeys high and three bays wide (figure 1). There is a door in the centre with a circular window above it and sash windows to either side. The windows have straight tops of cut and rubbed brick and stone sills. There is a cornice and a parapet above it.

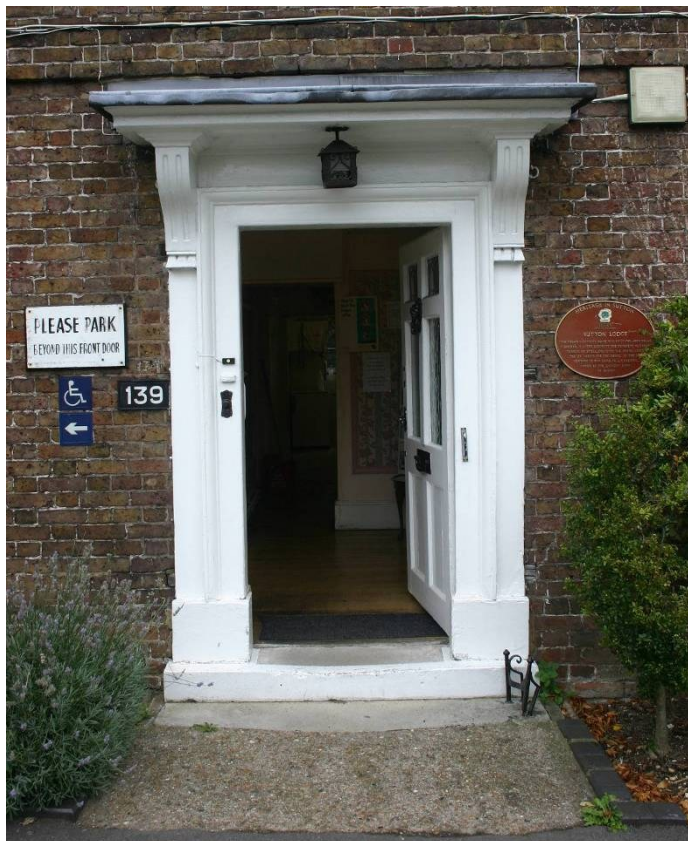
Figure 2. The front door.

The door frame appears to be original. It has a hood or porch supported by brackets with guttae at the bottom. The door itself is divided into six panels. The woodwork appears to be original but the upper four panels have been replaced with glass (figure 2).

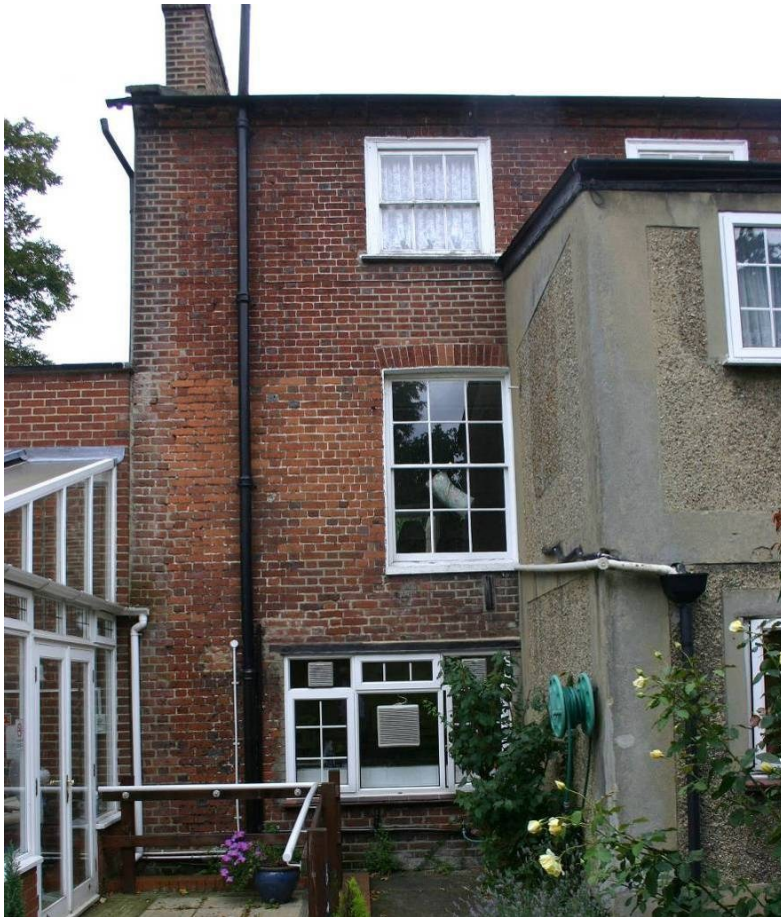
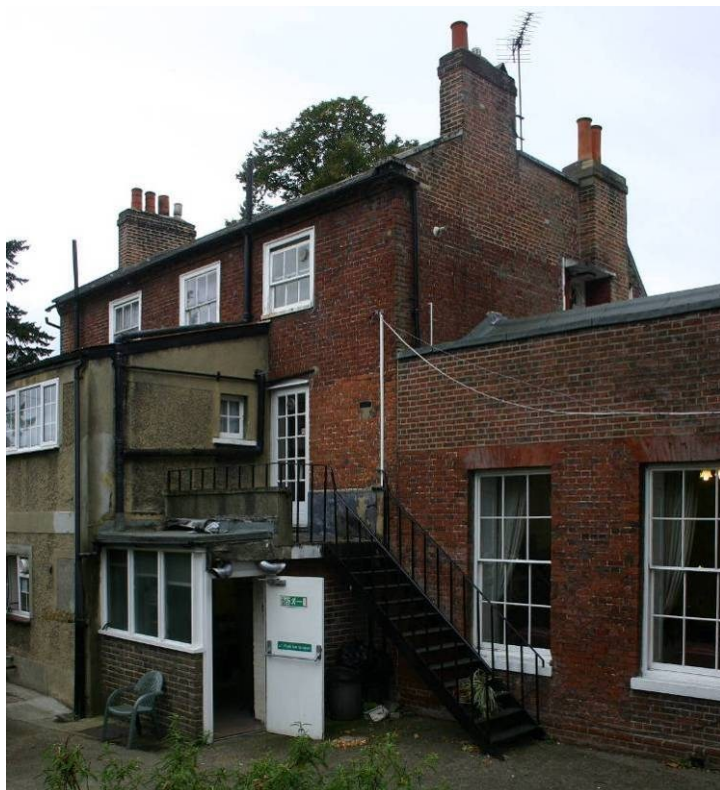
Here, the central block is a three bay, three storey structure, in soft red brick laid in Flemish bond (figures 3 and 4). There is a two storey cement rendered extension in the centre and a small single story extension to the north of it with a fire escape over it. The latter looks very modern – perhaps from the 1970s. These extensions mean that there is only one surviving window on the ground floor which has been widened and replaced in UPVC.

There are two windows on the first floor. One, at the northern end of the elevation has a segmental head, while the southern one is wider with only a slight curve at the top.⁵

There are three square windows on the top floor which are wider than the northern first floor window. These have a soldier course along the top and there is then a line of dentilation along the eaves.

The brick of the top floor is slightly darker suggesting that it is an addition, perhaps of the same date as the wide southern first floor window although there is no associated bonding break in the north wall.

Figure 3. Central block, back, south end.

Figure 4. The back of the central block looking southwest.

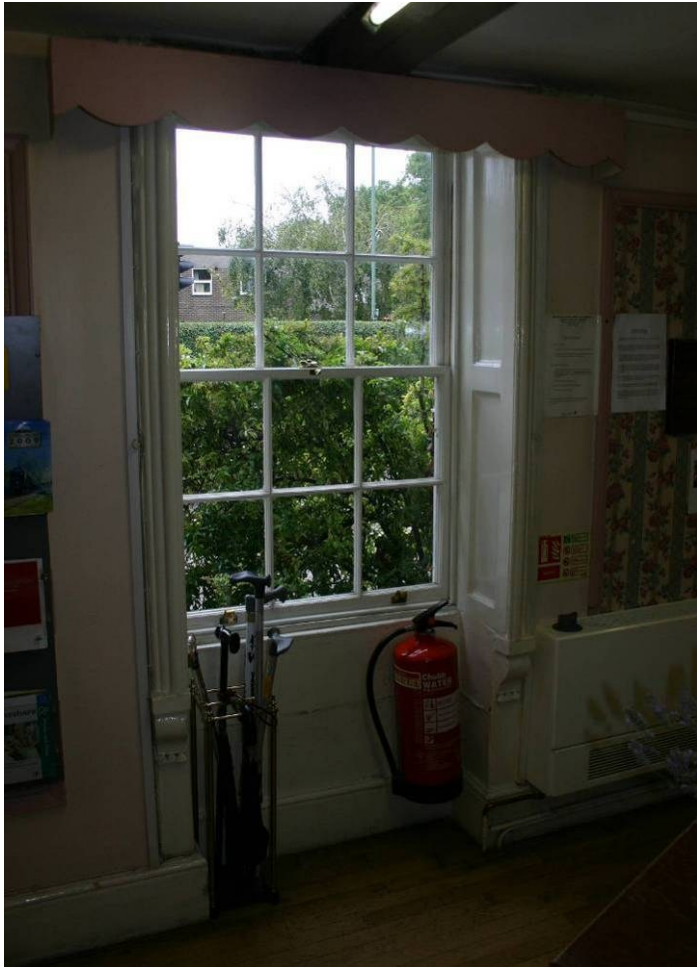
Figure 5. Front window in the central block.

The bottoms of the two front windows are set back into the wall. The window frames end in brackets with guttae at the bottom, similar to the front door (figure 5).

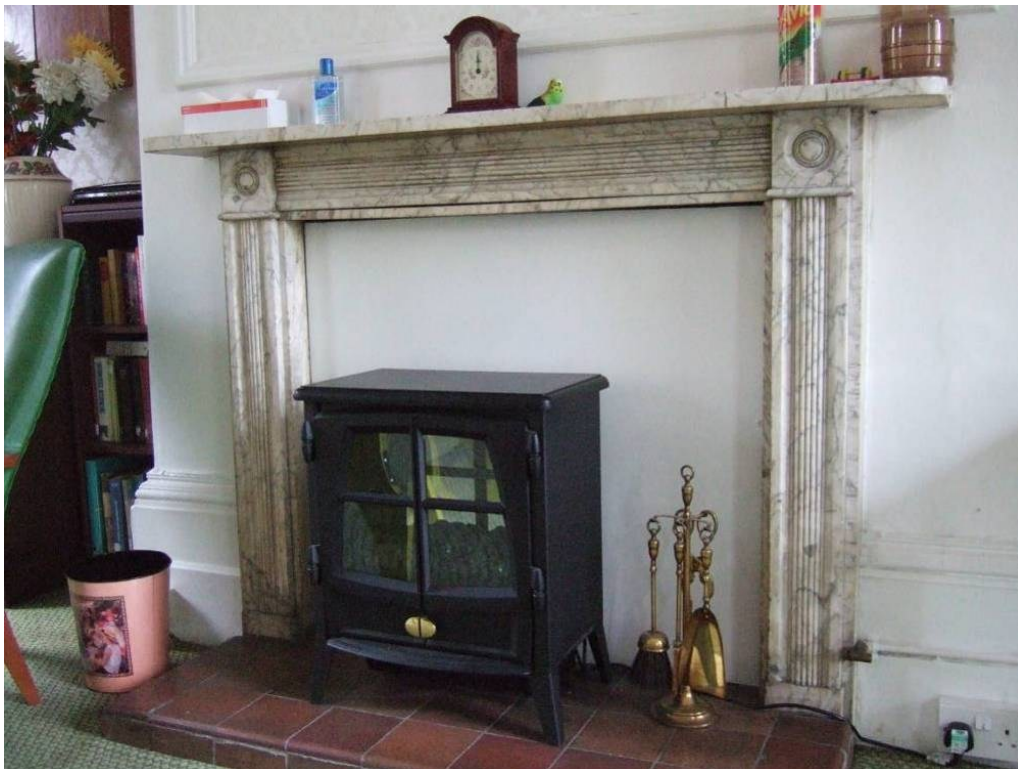
Figure 6. Fireplace in the north wing.

There is a very late 18th or early 19th century fireplace of grey veined white marble connected to a chimney against the wall of the main block (figure 6).

The wings are clearly additions and the variations in construction suggest that they are of different dates. The inventory suggests that only one wing existed in 1812. This is likely to have been the northern one as the fire place in it was fashionable from the 1790s into the early 19th century.⁹ The fireplace in the south wing probably dates from the 1820s or 30s into the mid-19th century.

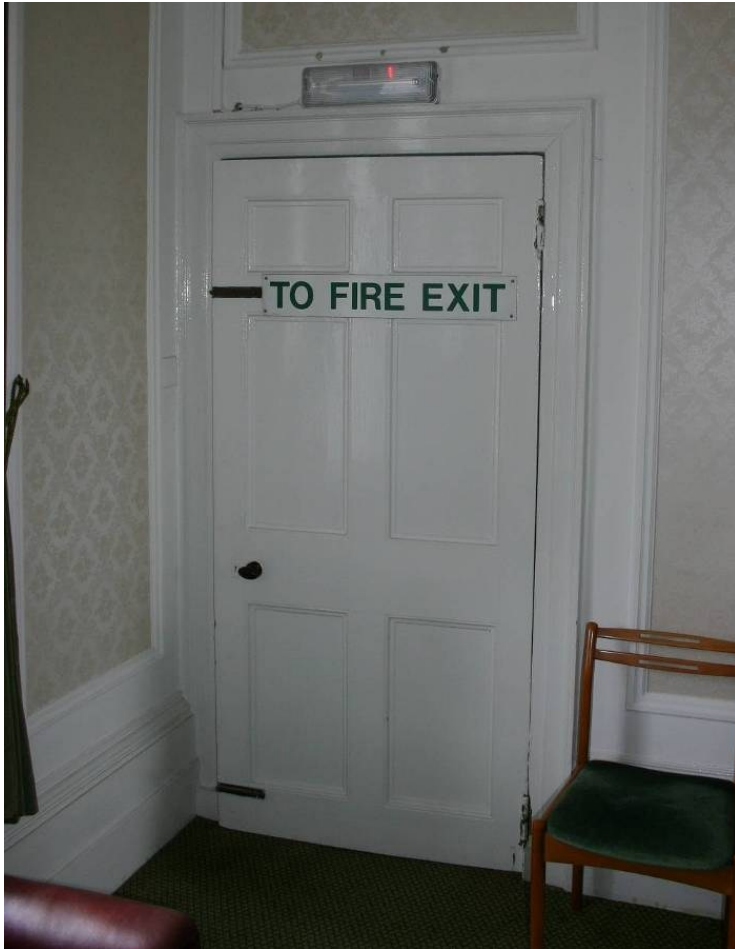
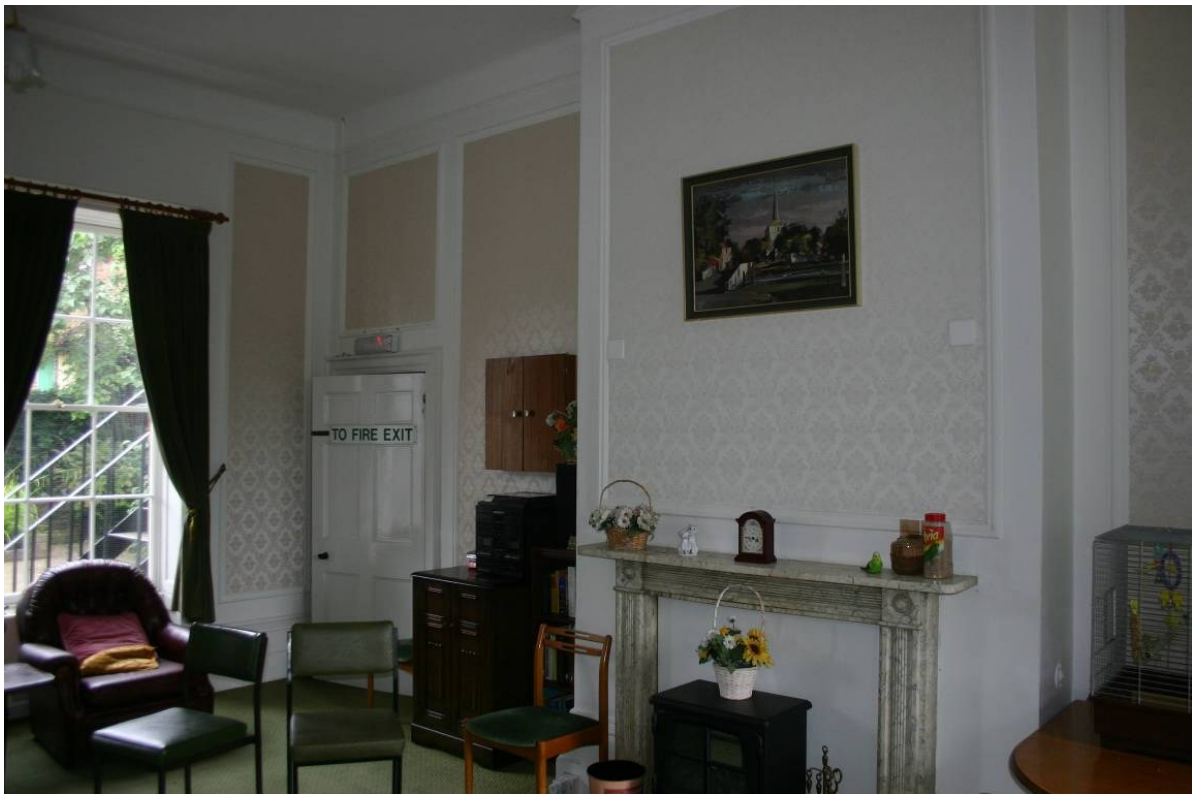
The north wing contains one large room. The floor level is above that of the main block to which the room is connected by two doors, one at the east end and one at the west. The doors are divided into six panels with two small ones at the top, similar to each other, and to the front door (figures 7 and 8).

Figure 7. Door between the north wing and the central block.

Figure 8. The north wing.

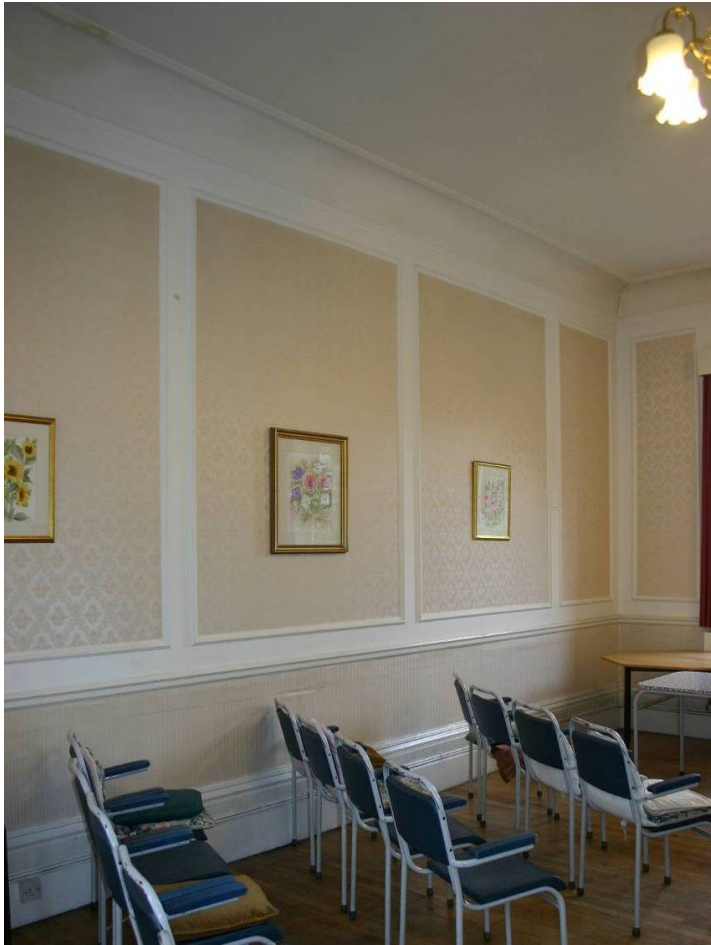
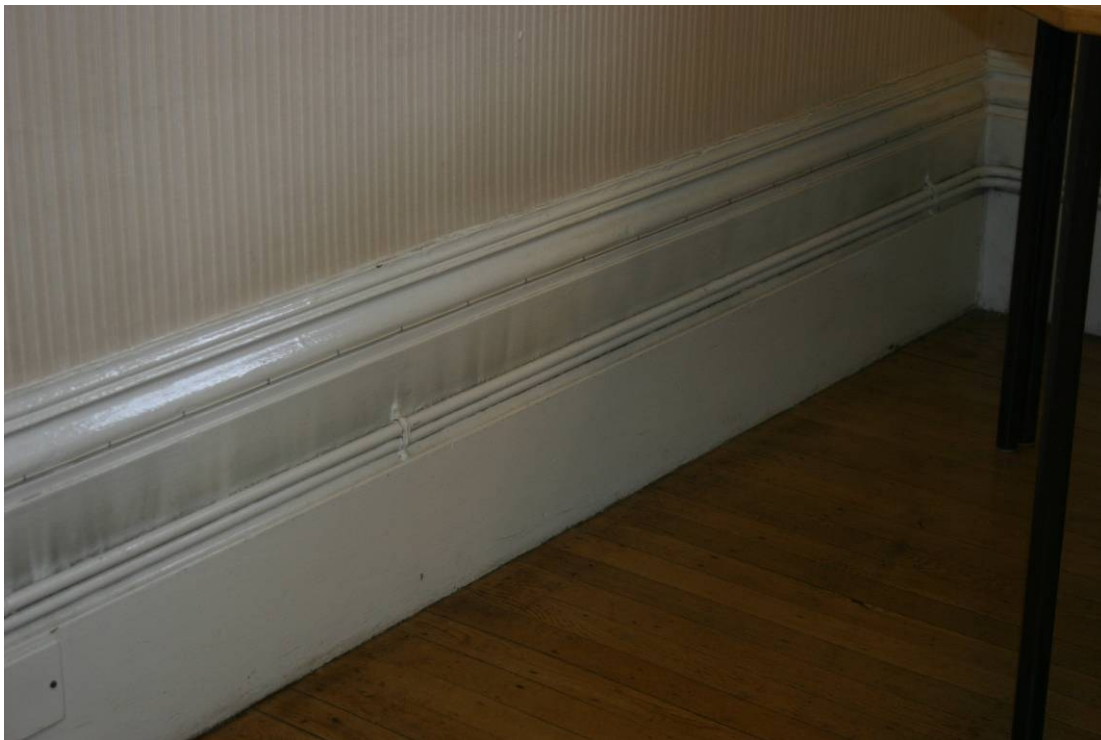
The walls have a high skirting and dado rail with decorative panels above (figures 9 and 10).

Figure 9. The south wing south wall.

Figure 10. Detail of the skirting on south wall of the south wing.

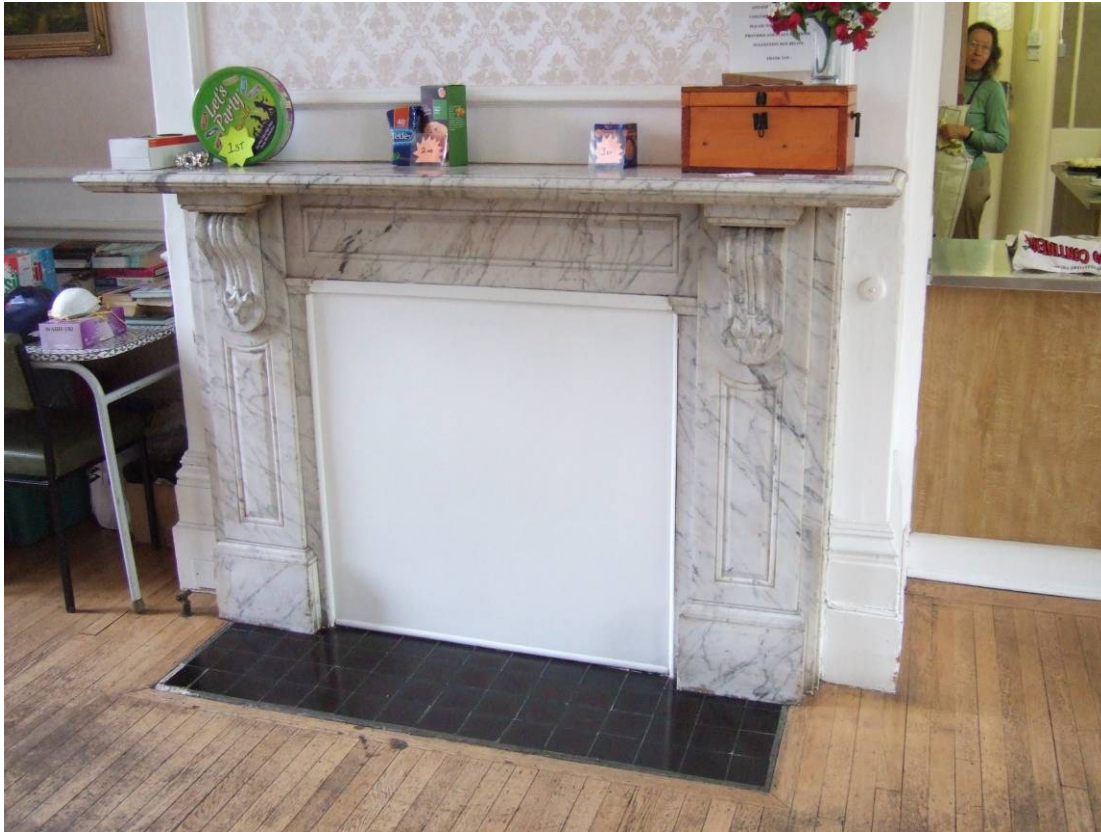
Figure 11. Fireplace in the south wing.

The fireplace is of grey veined white marble. This is probably early to mid-19th century (figure 11).

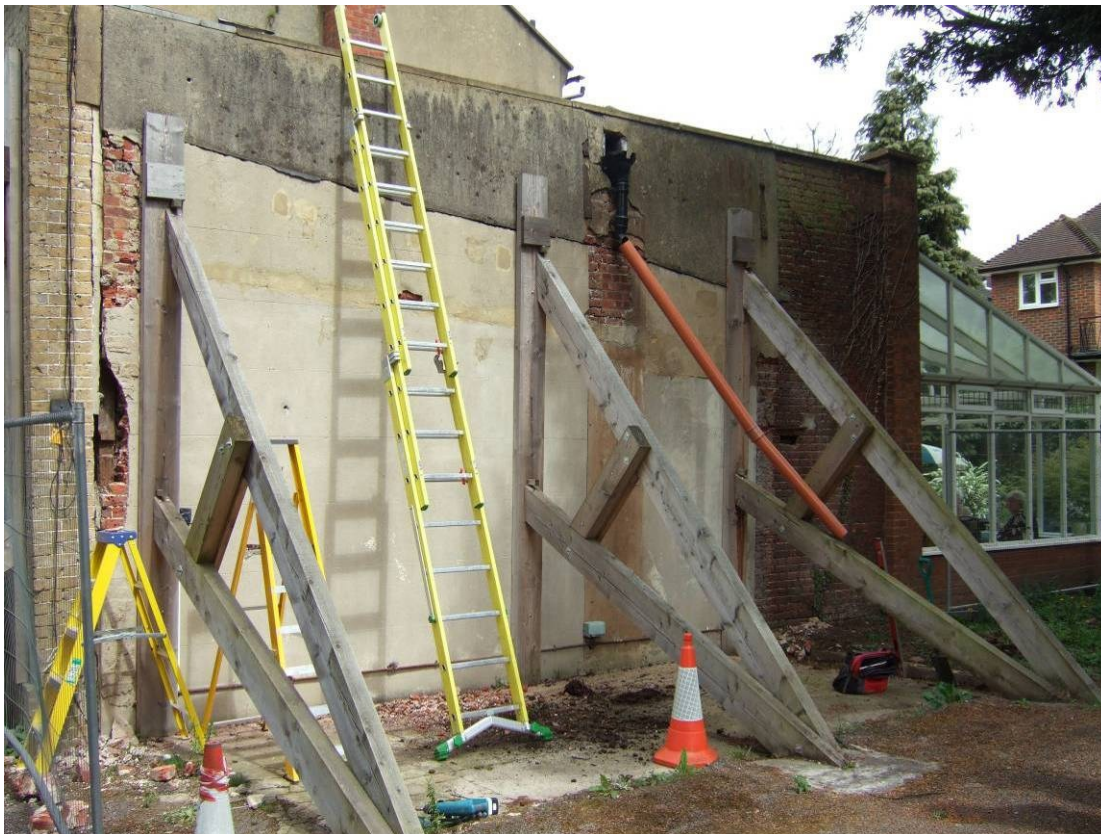
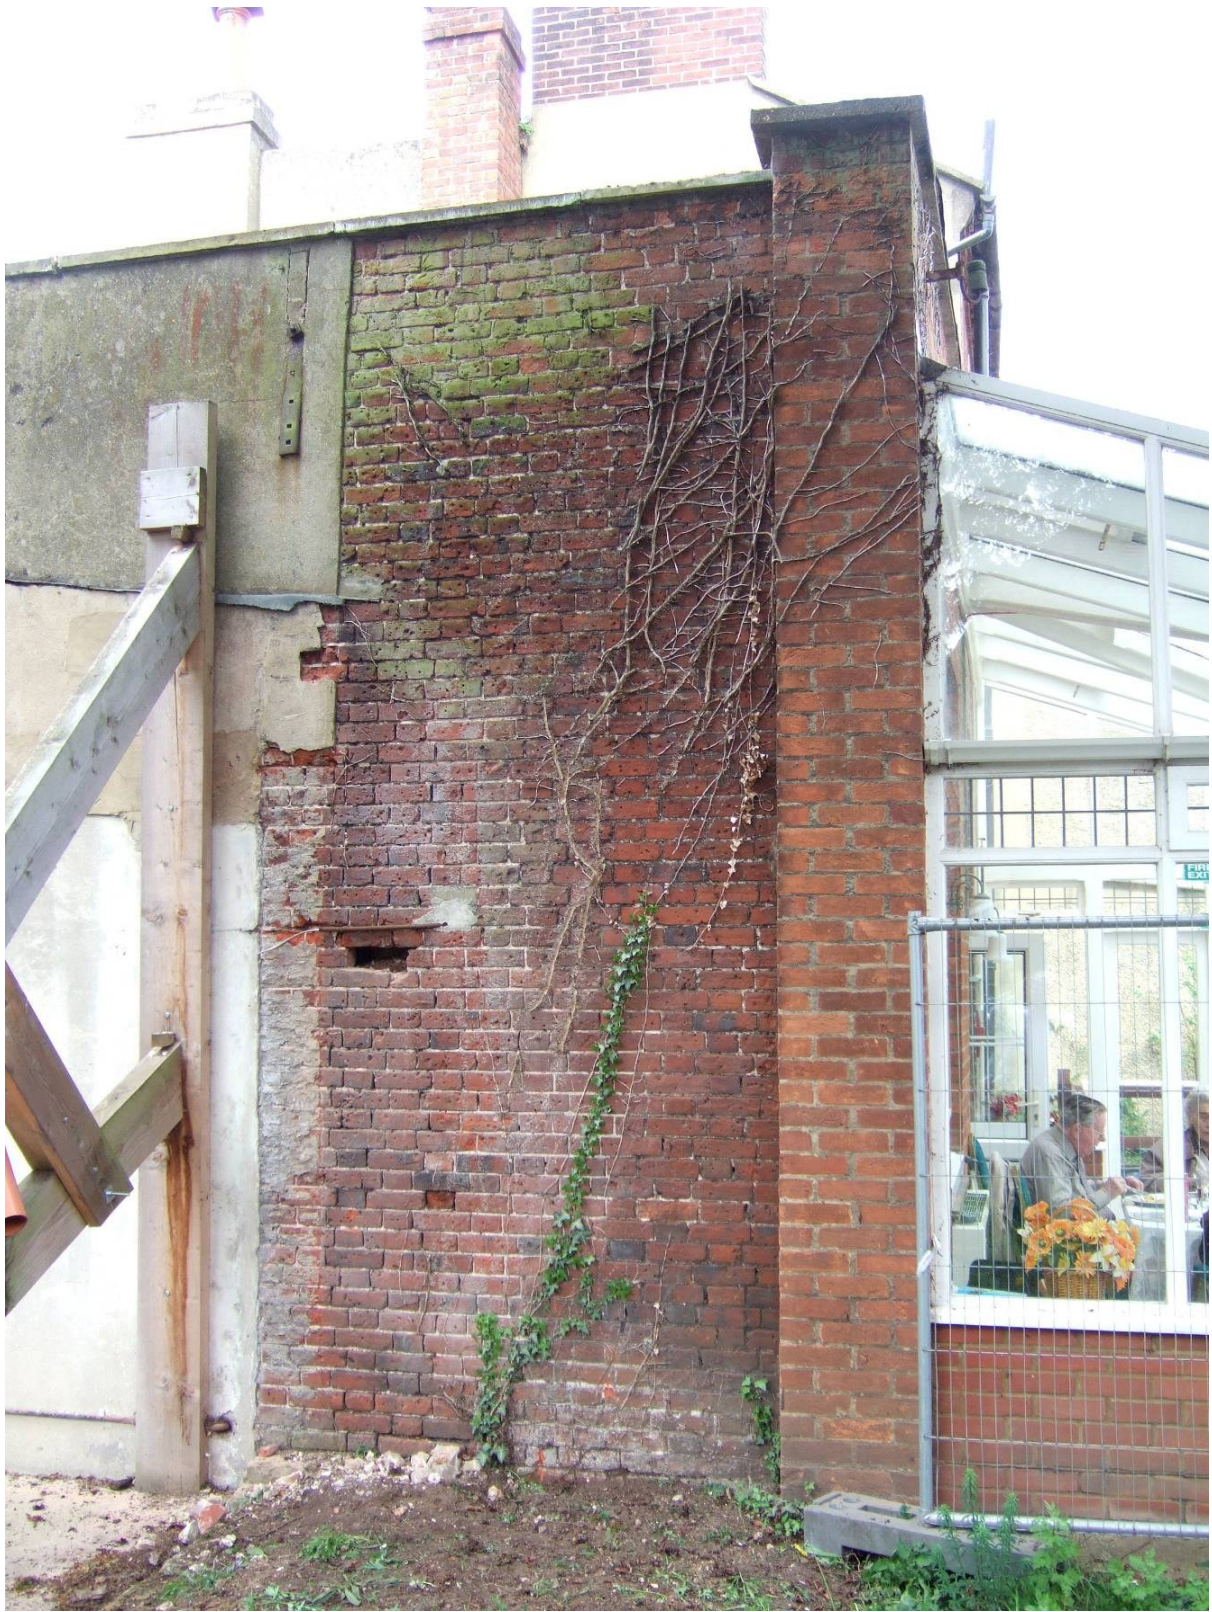
There is a clear bonding break between the yellow brick of the front and the soft red brick of the side. The latter is laid in Flemish bond where it is visible (figures 12 and 15).

Most of the wall face is covered with Portland cement rendering which has been lined out in blocks. The line for an eastward sloping roof cuts through it for an outbuilding which has now gone.

There is a rainwater hopper in the centre of the elevation which appears to have emptied on the roof of the outbuilding. The brick below it has suffered damage and been subjected to a recent poor repair.

There is a very clear and clean bonding break between the front and side wall of the south wing. The timber post exposed at the western end of the side wall and the small fragment of rail at the eastern end suggest that this wall was originally timber framed and was presumably covered with either peg tiles or mathematical tiles. This timber work appears to be backed by a brick wall which must carry the 19th century decoration on the inside of the wing. It seems that an underlying brick structure was originally faced with tiles. The most likely explanation for this curious arrangement was to increase the water resistance of a wall which was exposed to the southwest winds and not directly visible from

Figure 12. The south wall of the south wing.

Figure 15. The eastern end of the south wall of the south wing.

Much of the elevation is now covered with concrete render. This has no architectural merit and from the historical point of view there seems little to be lost by re-facing this section of the wall.

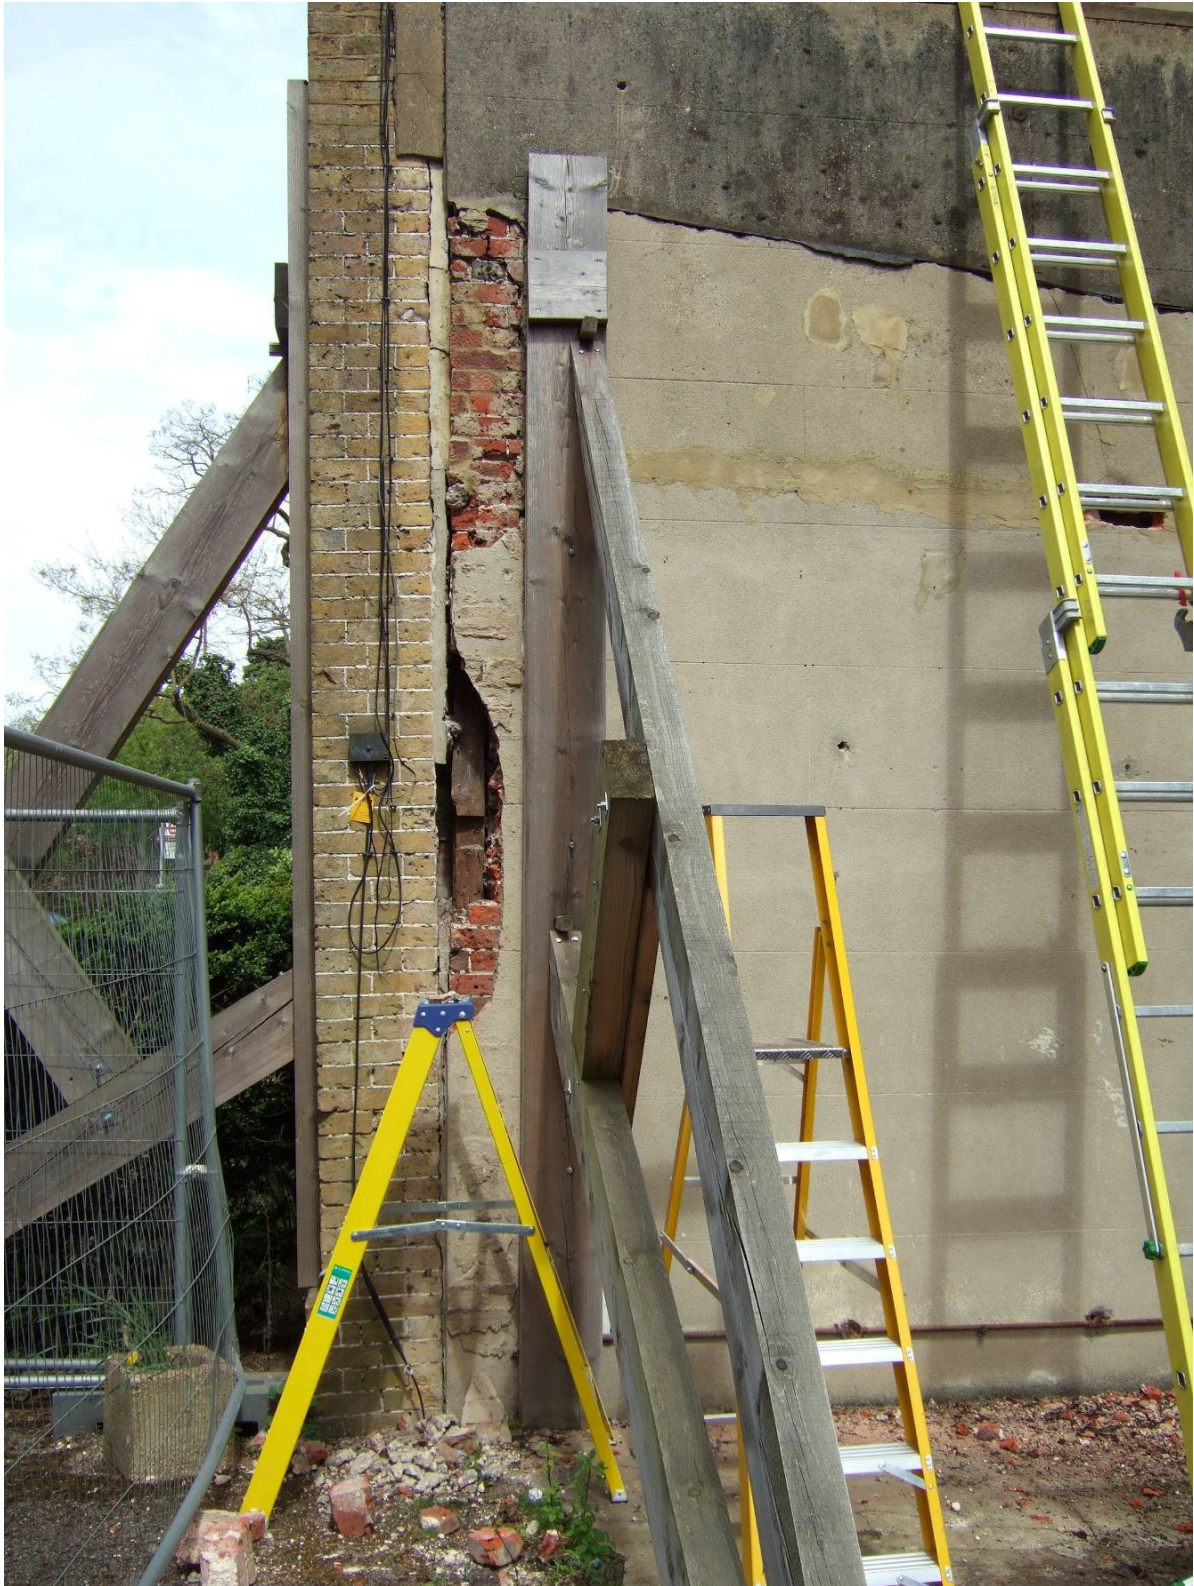
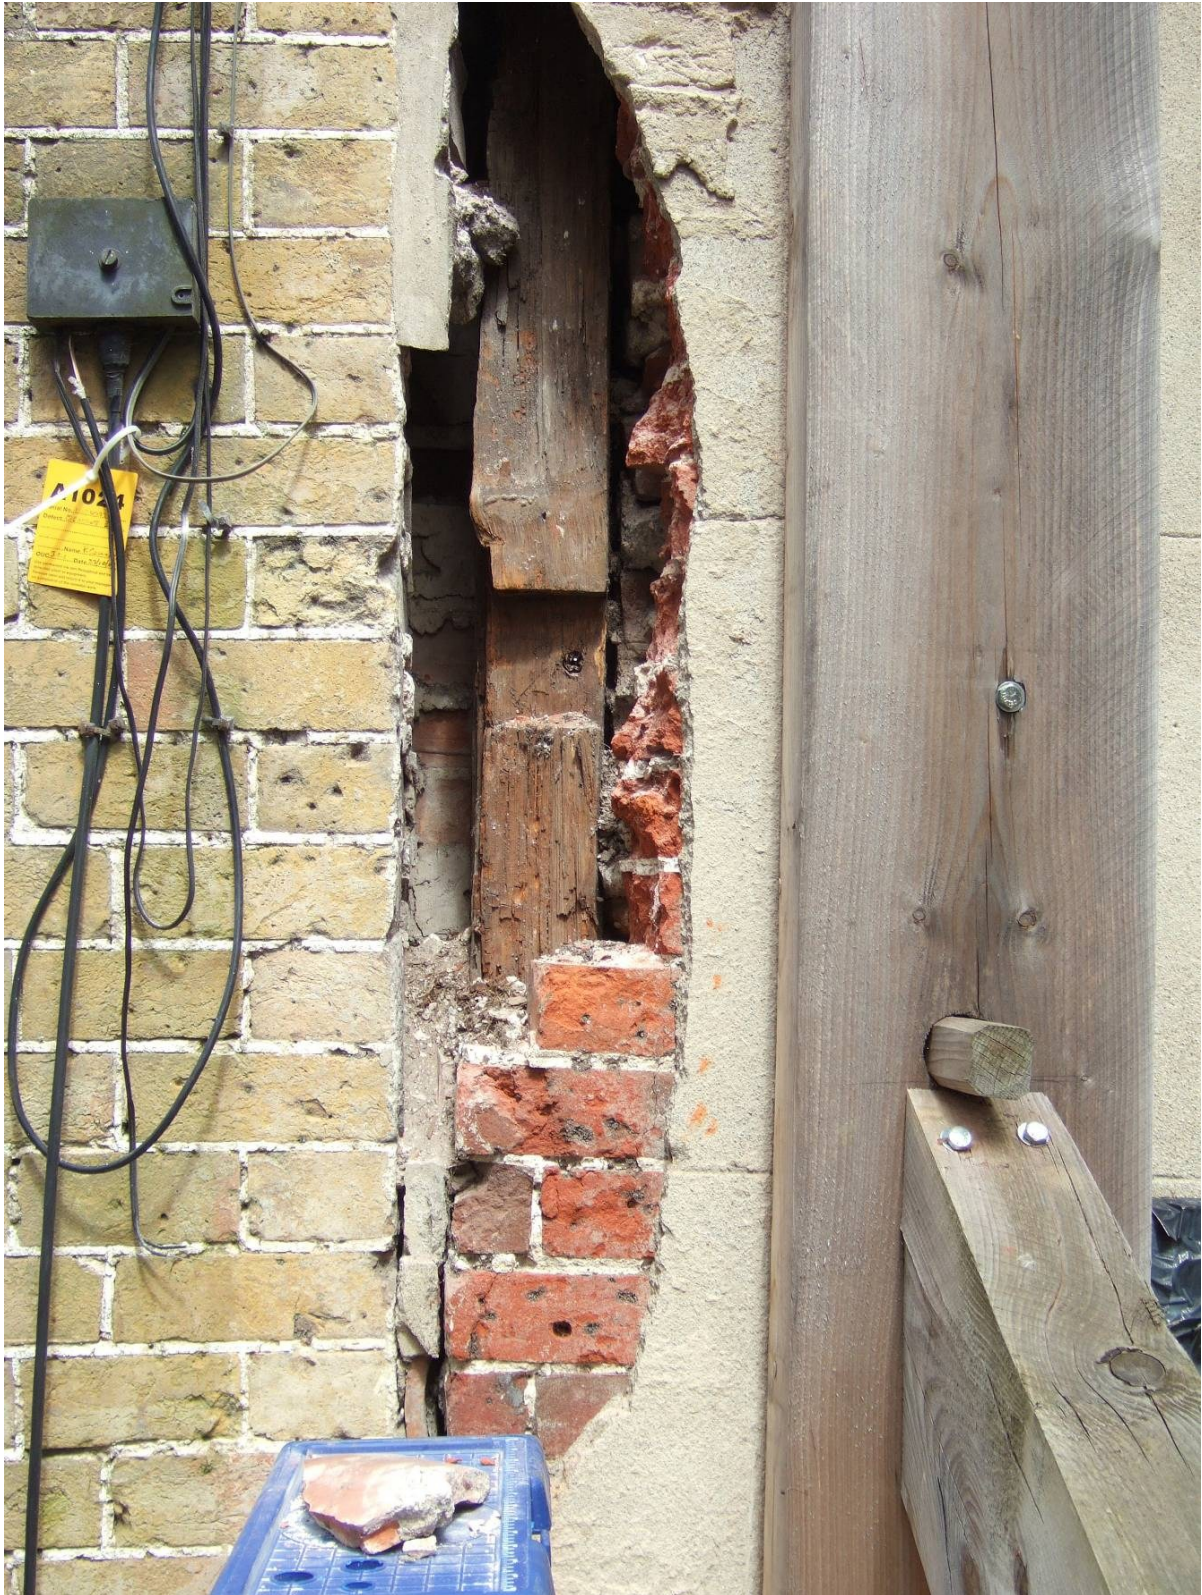
A vertical timber has been exposed at the southwest corner of the building behind the red facing brick (figures 13 and 14). This contains a halving for a horizontal timber which is now missing. A fragment of horizontal timber has been uncovered at the about the height of the halving towards the east end of the elevation.

At the southwest corner there appears to be a brick wall or skin inside the timber, a mass of rough brick work beside it and then the red brick external facing which has bulged outwards.

If the above interpretation is correct the existing brick outer skin must date from the 19th or perhaps the very early 20th century although the brickwork looks older.

Figure 13. The western end of the south wall of the south wing.

Figure 14. Detail of the western end of the south wall of the south wing showing the timber post with the halving and the brickwork behind it.
