Beddington Park Cottages

**Investigations before and during building work,
1982 - 1987**

John Phillips

Carshalton & District History & Archaeology Society
Occasional Paper 6

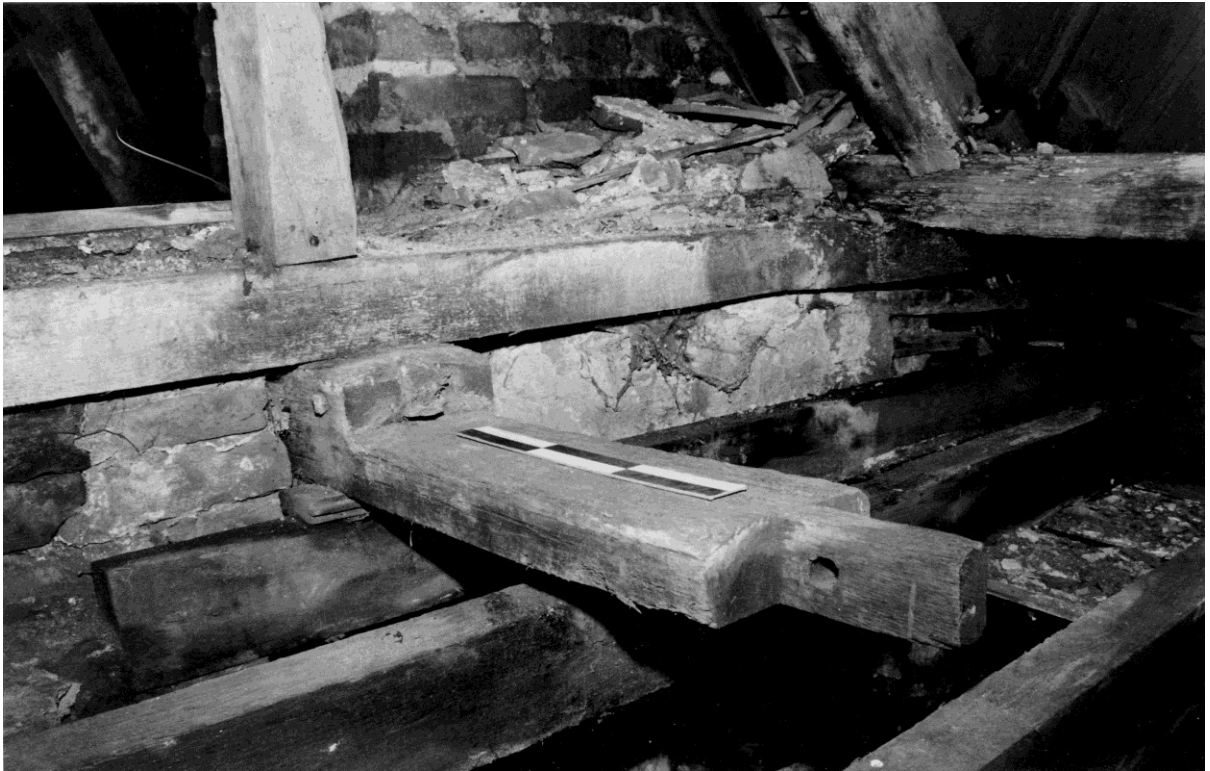
There was an edge-halved scarf at the south end of the surviving length of collar purlin above room 1A-7 close to the north wall of the room (figure 5).

Figure 5. The scarf at the south end of the surviving length of collar purlin looking roughly northeast. The joint was located above room 1A-7 close to the north wall of the room. Scale in 30cm long.

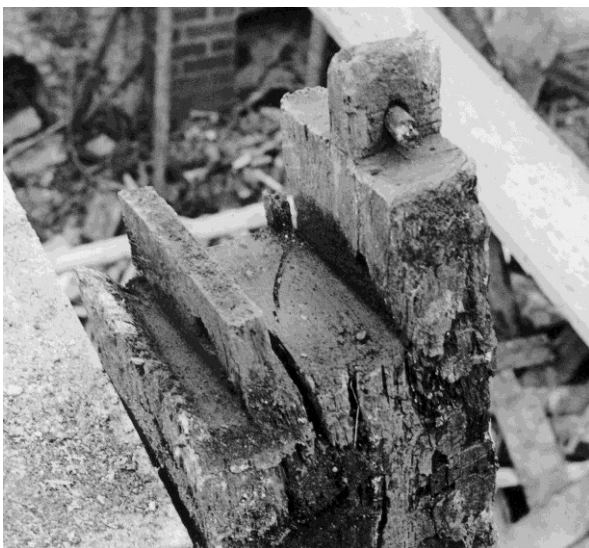
Figure 13. The head of post 2E during conversion.

The joint between the wall post 3W, the wall-plate and the tie-beam were examined in detail while the head of post 2E was exposed during reconstruction work (figures 13 and 14). The joints were of a fairly conventional form with an upstand linking the post and tie-beam, a dovetail lap joint with entrant shoulders between the tie and the top of the wall-plate and a simple mortise and tenon between the post and the bottom of the wall-plate. On the eastern post there was a small upstanding ledge along the outer edge of the post to hold the wall-plate in place. It is not known if this was present on the western post as the area was not visible. The joint at the western end of truss 3 was similar except that the wall-plate was scarfed where it passed through the joint.

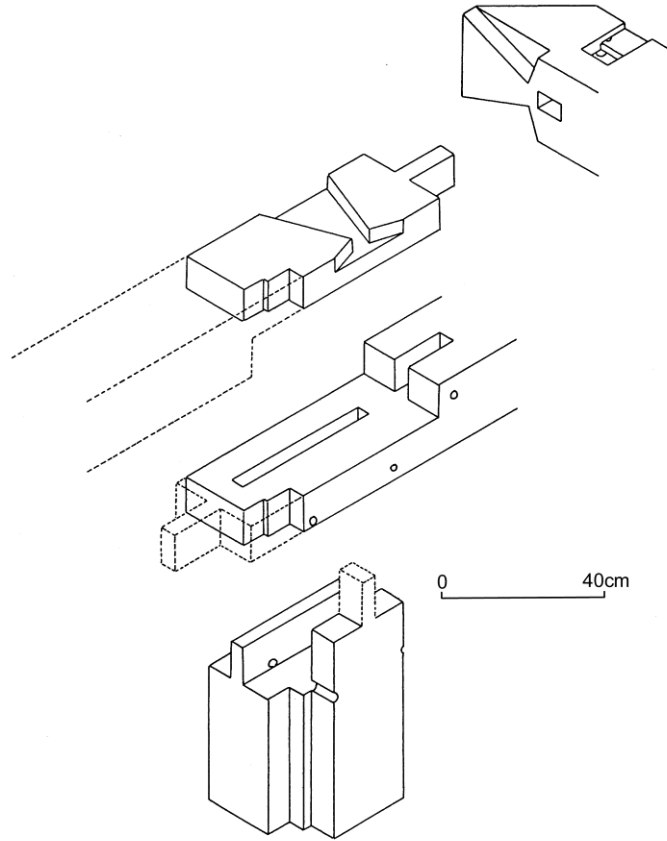
Figure 14. The joint at the head of post 3W.

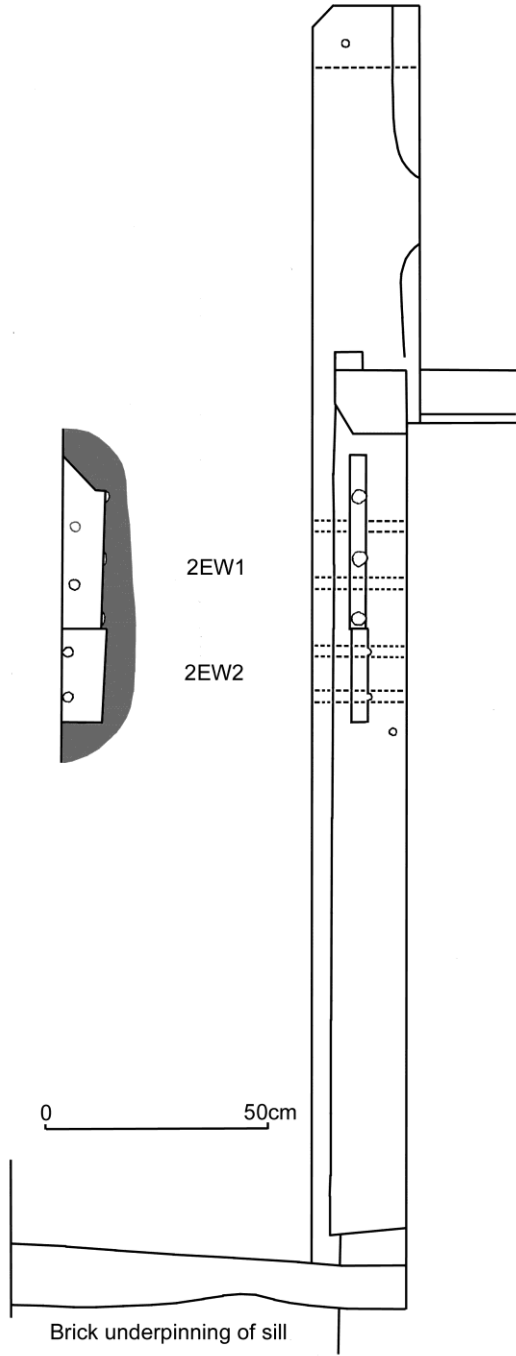
The sill beam, on which the wall posts would have rested, was very poorly preserved. The only section in good condition was located beneath post 2E (figures 16 and 17). Here the post had a height of 2.83m. There were traces of a sill about 2cm below the rotten bottom post 1W which had a surviving height of 3.1m and there was a short length of timber below post 1C which had a height of 2.92m. The bottoms of all the other posts were badly rotted but the wall posts had surviving lengths of 3.1m or more and 3W was 3.19m. The lengths of posts 2E and 1C are therefore anomalously short. It seems likely that the ground sill below post 2E was a later piece of under pinning. It rested on brickwork rather than chalk.

Figure 16. The west side of post 2E.

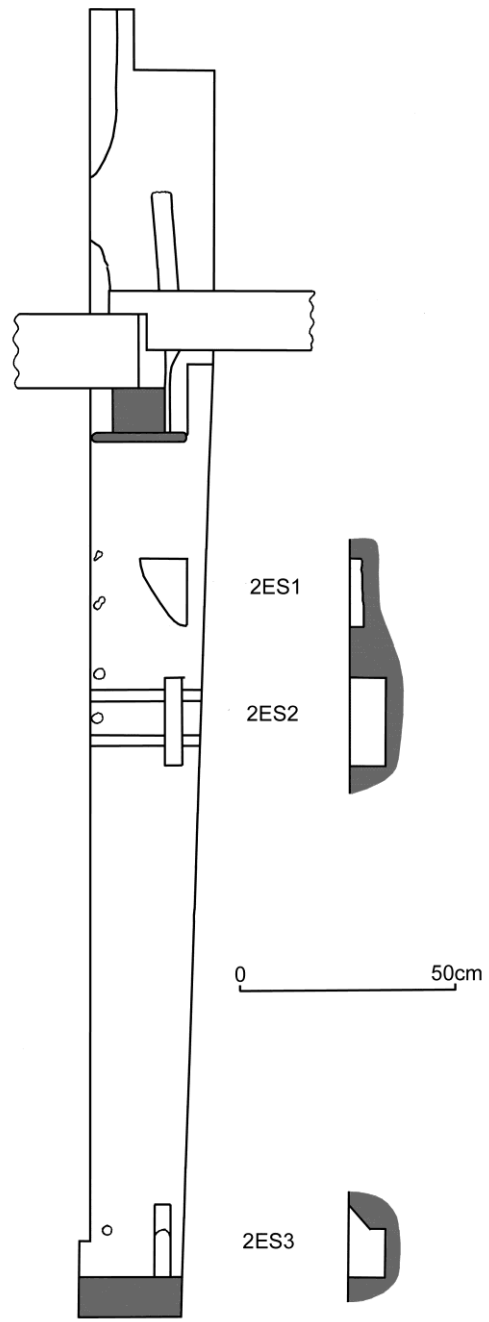
Figure 17. The south side of post 2E.

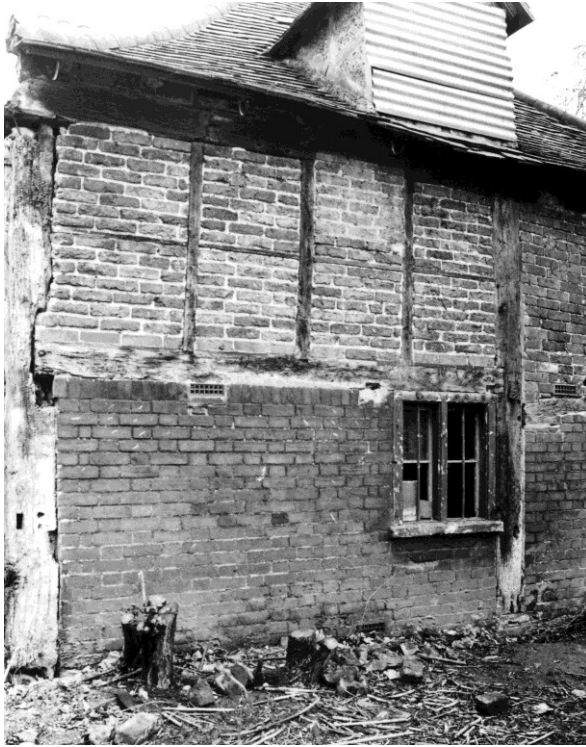
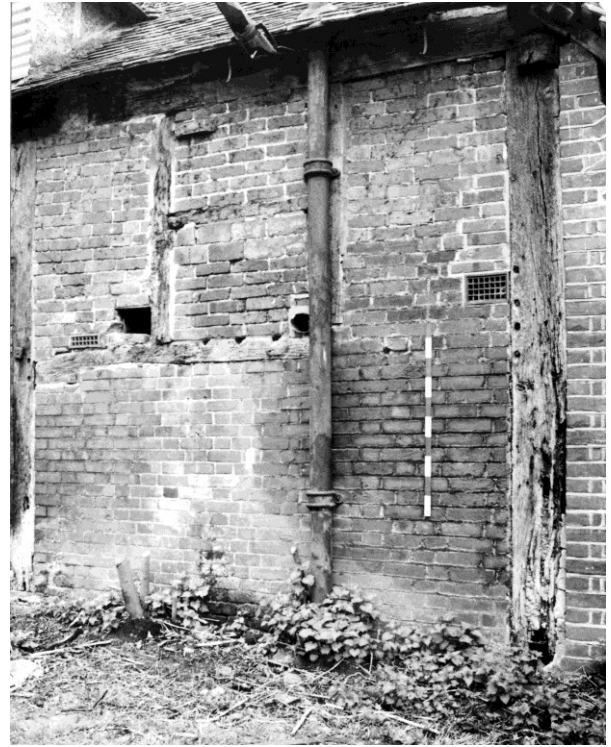
The area between the timbers is filled with brick of varying finish and size suggesting haphazard alteration. The oldest appear to be on the east side above the wall-rail (figure 23). There most of the bricks had a rather rough finish and a median height of 60.5mm. Comparison with other bricks on the site suggests that they may date from the early eighteenth century although reuse is of course possible.⁴ There was a line of later looking bricks – possibly a repair – along the top of the mid-height rail and also blocking the window which cut the underside of the tie-beam. The other bricks appear to have been comparatively recent. Two groups were measured, both in the lower part of the wall, one to the east of the centre-post and one to the west. The median sizes differed suggesting that they may not have been placed in a single building episode.⁵

Figure 23. The north wall. East side to the left, west to the right.

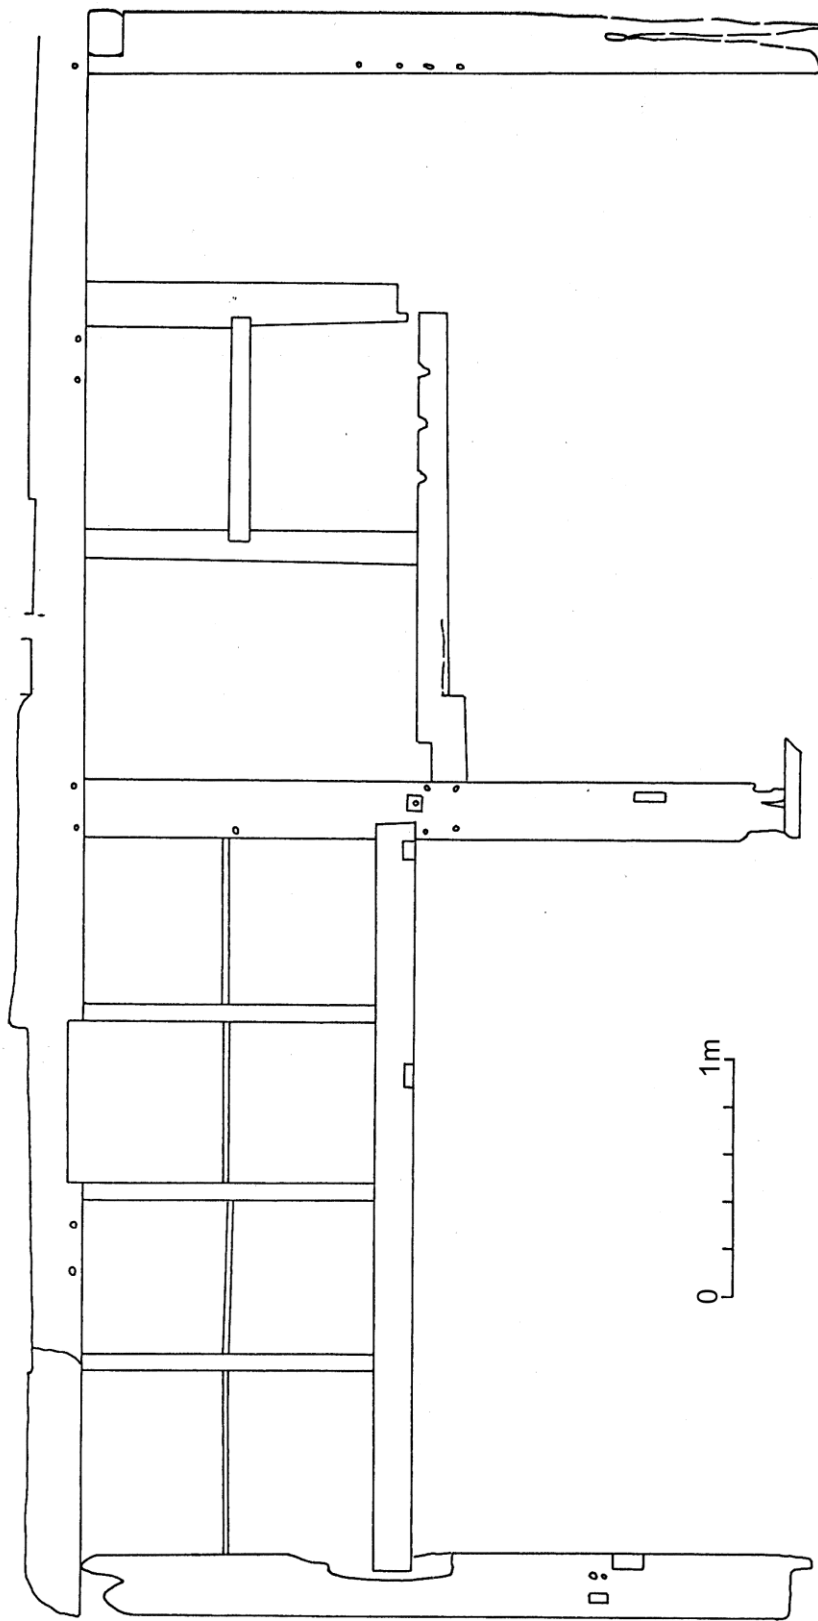
The north wall (figures 23, 23 and 25) was 6.75m wide. The three posts remained although the lower parts of them were rotten. The joint between the tie and the eastern post had completely rotted and the two timbers were held together with two iron bars. The eastern end of the tie also appears to have rotted and had been replaced with a new section of timber connected to the original by a very rough plain vertical scarf. The tie of the second truss (figure 11) had been cut between posts 2C and 2E to make a door leaving two sections about 3.3m long to the west and 1.5m to the east. The eastern end of the western section of the tie had clearly dropped and had twisted and split the joint at the head of post 2E. The width of the truss at tie level was just over 6.84m but the cut had clearly allowed the truss to spread. The eastern post (2E) was 2.83m high and survived down to a ground sill. The bottom of the western post (2W) was rotten and the lower part and the ground sill was missing. The centre-post (2E) was severely damaged by fire before it was recorded. Its original length and the nature of its footings are unknown. Two sections of the tie-beam of the third truss survived (figure 12). One of these ran from the head of the western post (3W) for about 1.8m where it had been cut away to accommodate a brick chimney-stack. The stack was 1.2m wide and the second section of truss survived to the east of it. This was 1.54m long and ended well short of the projected position of the eastern post which had gone. The western and centre-posts survived although in both cases the bottoms had gone.

There was a rail running across the wall at about mid-height from the centre-post towards post 1W. It had been cut off 1.02m short of 1W but there are peg holes in the post for a mortise to secure it immediately below the brace mortise (figure 25). A similar rail appears to have existed on the eastern side of the wall as there are peg holes for it in the centre-post. The relevant part of the eastern post had been cut away.

Figure 25. The north wall of the cottages with the timbers of truss 1. Modern windows omitted.

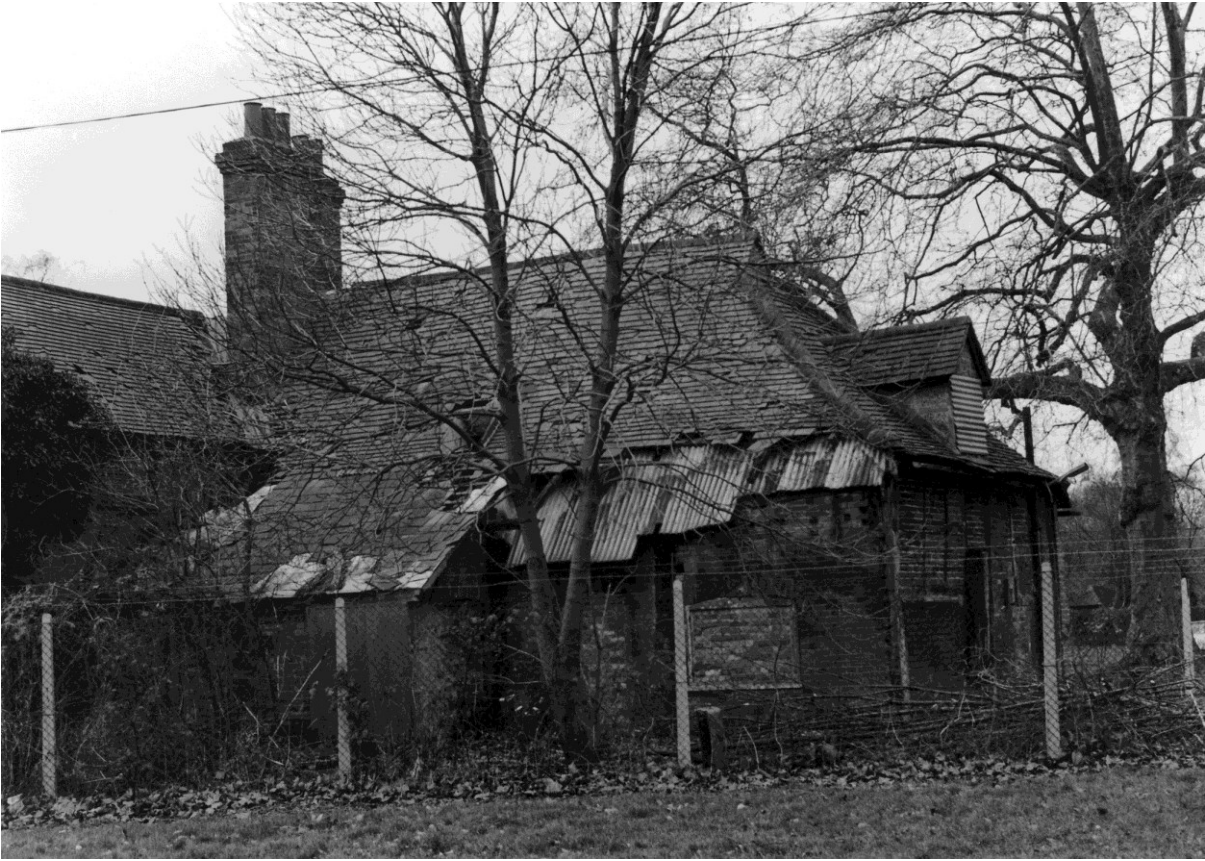
On the eastern side of the roof alterations had been made to cover extensions built against the side of the building. In bay one a few thin rafters survived which were laid on top of the earlier rafters and projected out to cover an extension. At the time of the survey the extension and roof had gone and only a few unsupported rafters remained with corrugated iron inserted below to protect the head of the wall (figures 29, 30, 32 and 33).

Figure 29. The east side of cottage 1 showing the lean-to extensions. 9 January 1983.

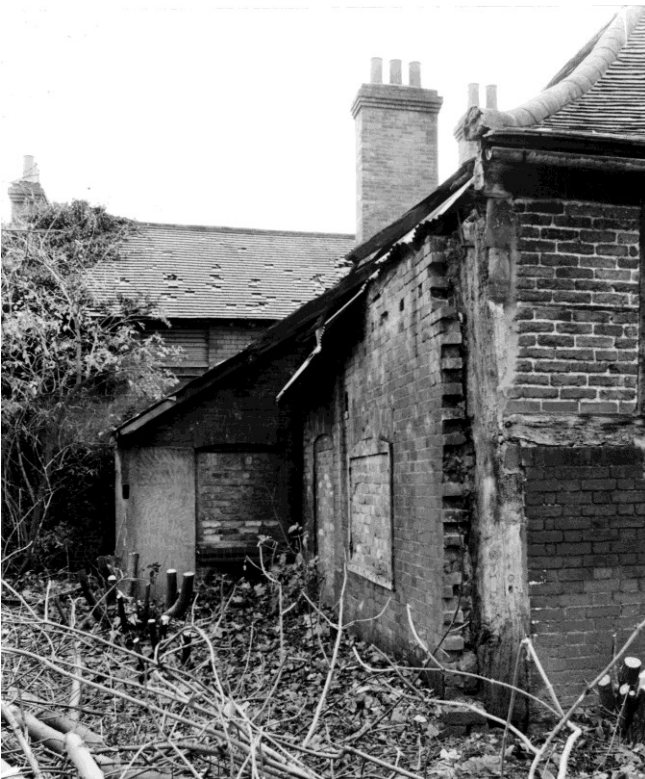
The wall was one stretcher thick, was laid in Flemish bond and appeared to be fairly uniform suggesting that it was of one date (figures 30, 31 and 32). There was a window at the north end and a door at the south, both with segmental heads and both bricked up. The door blocking included a rustic Fletton brick which were first produced in 1922.⁶ Both door and window blockings also contained some plain Flettons. The wall-plate rested on the wall and sloped down considerably to the south. The north end of the wall was a ragged break suggesting that it originally extended north beyond the northeast corner of the existing building.

- Secondary rafters had been laid on top of the main rafters and extended beyond the main wall (figures 30, 32 and 33).
- There was a line of notches cut in the brickwork below the wall-plate presumably to hold the ends of joists to support a ceiling (figures 31 and 32).
- The ground by the wall was covered with concrete and planking probably to form the floor of the extension although they could have surfaced an outside yard. At least part of the concrete was underlain by heavily broken red floor tiles. These were partly excavated (figures 33 to 35) but the eastern wall of the extension was not exposed.

Figure 30. The northeast corner of the building looking south.

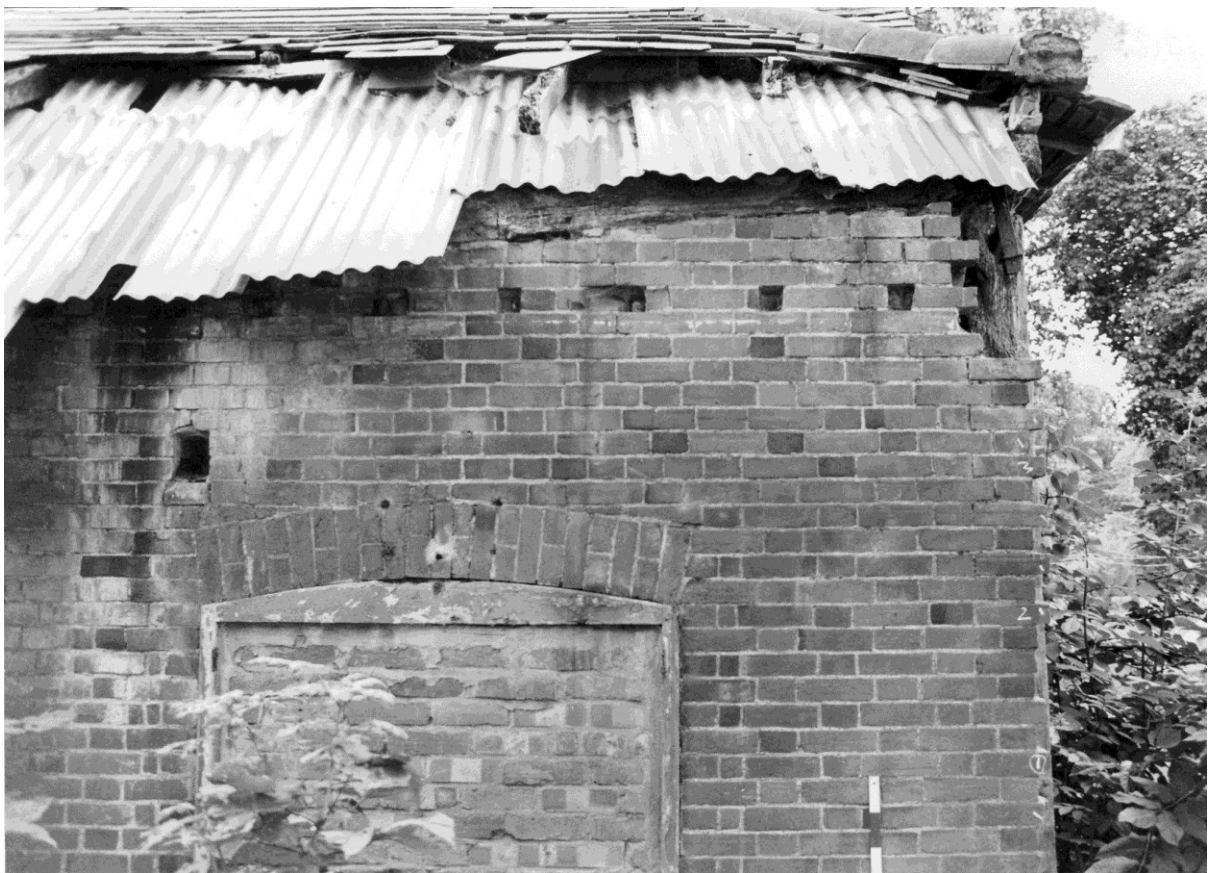
Figure 32. The upper part of the east wall at the northeast corner.

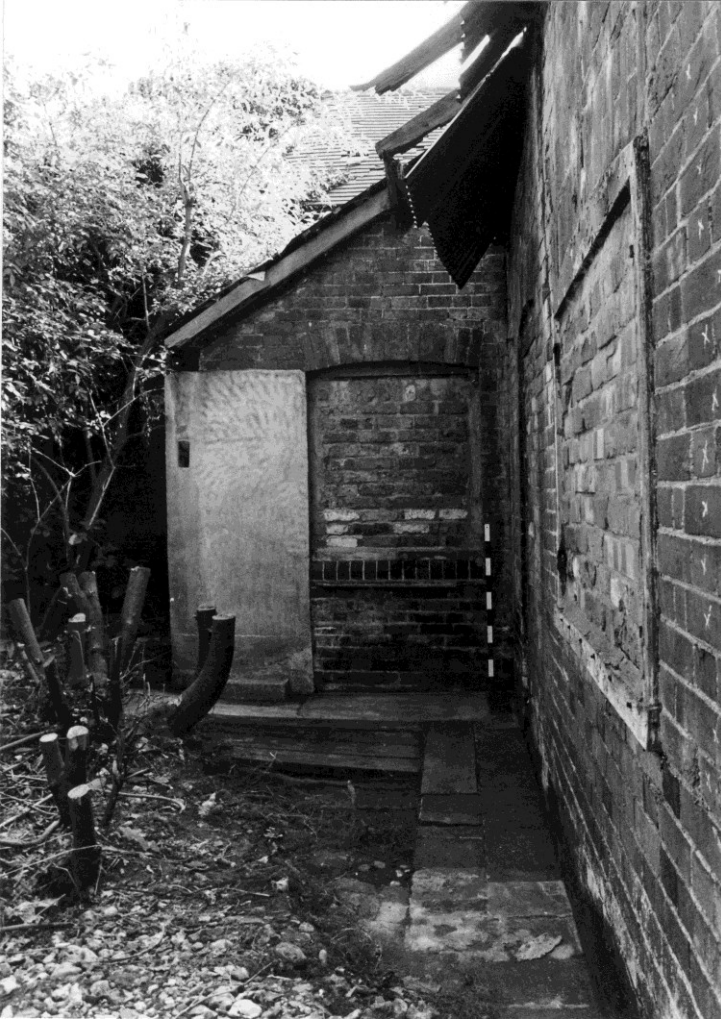
Figure 33. The east side of the cottages looking south from the northeast corner towards the extension of room 1-5. The foundations of the structure built against the east wall of room 1-4 are in the foreground.

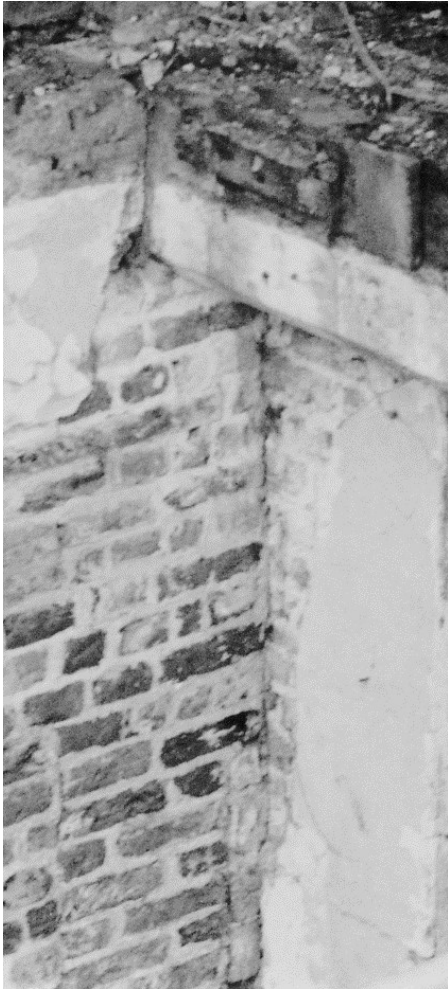
The west side the eastern stack was built around the bridging joist which ran down the centre of bay 2 and supported the first floor. The stack appeared to butt up against a brick wall which ran below the joist separating rooms 1-5 and 1-6 (figure 41).

Figure 41. Detail of figure 40 above showing the butt joint between the chimney-stack (left) and the bridging joist and the wall beneath it.

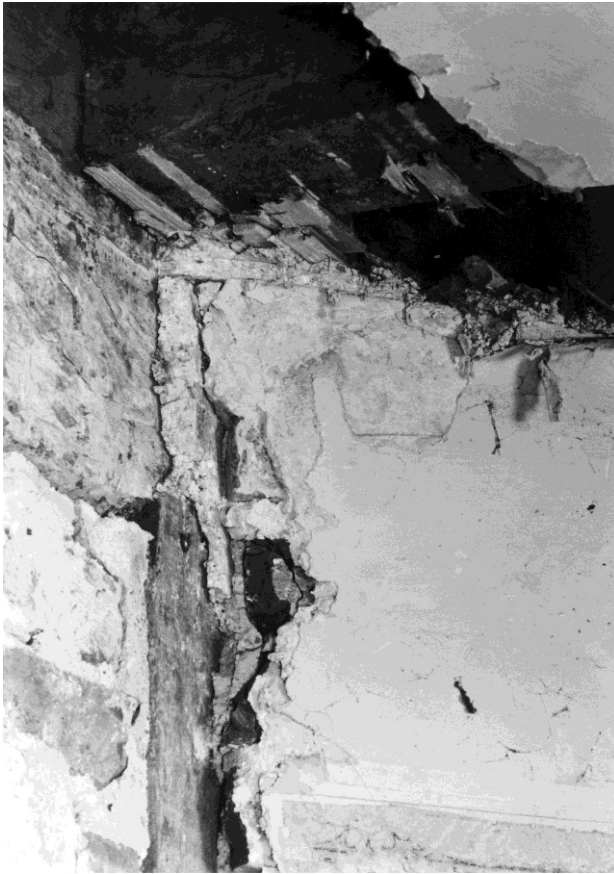
The fireplace in room 1-6 was built into the southeast corner of the room. Its brickwork butted up against plaster on the west side of the bridging joist showing that it was later than the timber (figure 44).

Figure 44. The southeast corner of room 1-6 at ceiling level. The plastered area to the right is the edge of the fireplace which was built into the corner of the room. The timber to the left is the bridging joist which supported the first floor in bay 2. The brickwork under it is the wall between rooms 1-6 and 1-5. Note the plaster on the side of the bridging joist showing that it and the wall were earlier than the fireplace.

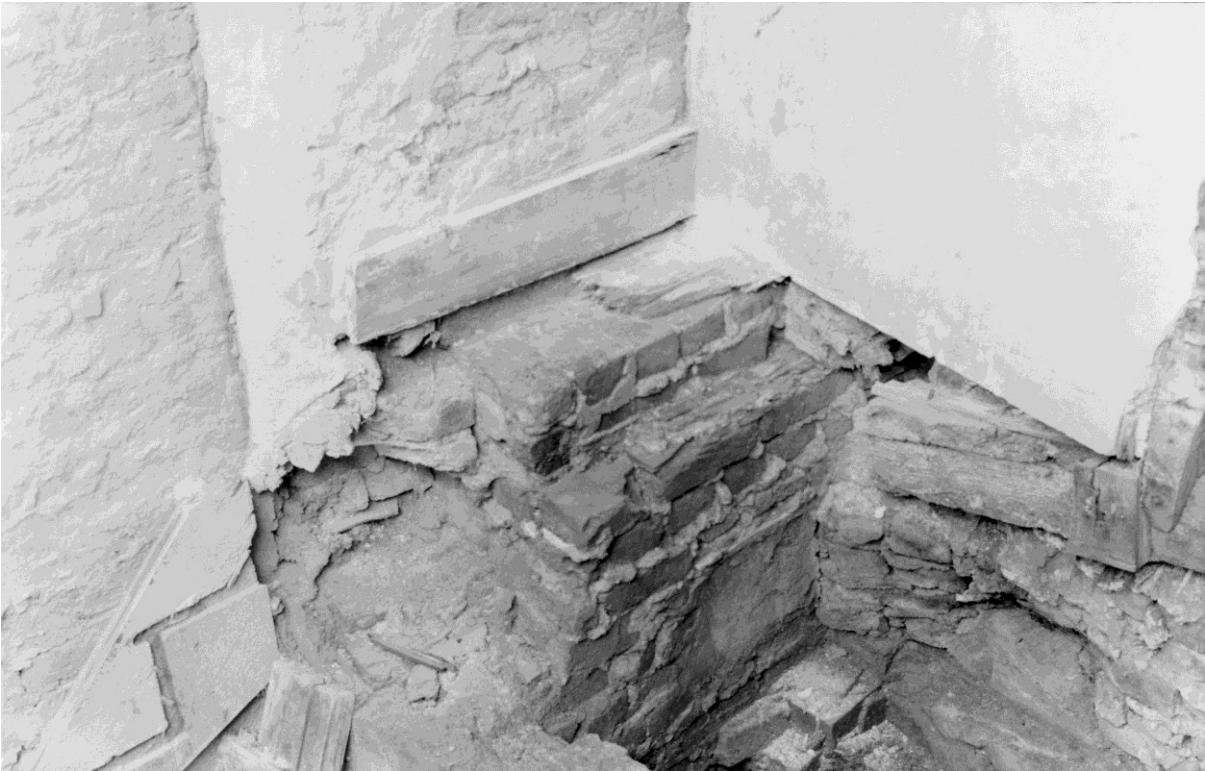
The first floor was supported by a ledge on the side of the chimney-stack. This ledge had been built up under an existing floor as the ceiling plaster was still in place on the ledge and roof tiles had been used to pack a gap between the plaster and the top of the brickwork (figures 45, 46 and 47).

Figure 46. The north side of the chimney-stack above the oven. Note the lath, plaster and tile packing on the lower ledge which originally supported the first floor. The skirting and floorboard on the upper ledge appear to relate to a staircase which was constructed over the oven probably after it had gone out of use.

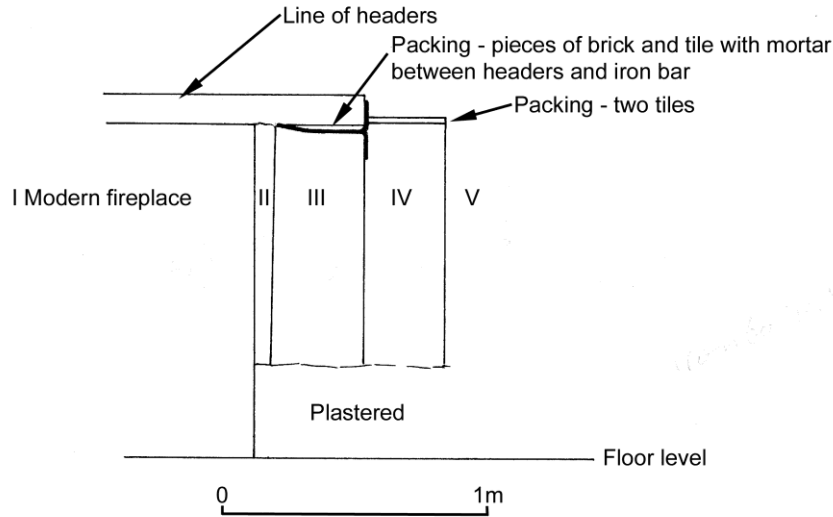
The western side of the fireplace in room 1-5 had been narrowed. The earliest filling (area IV on figure 48) narrowed the fireplace by 0.3m. The second filling (area III) narrowed the opening by a further 0.36m. The third filling II appeared to be for the modern fireplace I. An iron bar ran across the top of fill III and presumably ran behind the modern structure and then continued into stone work around the oven door on the east side of the fireplace. The western end of this was split up and down and inserted into the gap between areas III and IV. This was presumably contemporary with fill III and supported the top of the fireplace. The chalky mortar bonding area III was likely to be eighteenth century or earlier.

Figure 48. The western side of the fireplace in room 1-5.

- I Modern fireplace.
- II Hard purplish bricks separated from of the fireplace by a straight joint. Bonded with orange mortar similar to area I.
- III Bricks bonded with white mortar with pieces of chalk, some tiny fragments of flint and possibly some coal. The bricks were fairly well moulded. The joint between II and III was filled with red mortar.
- IV Bricks and mortar with traces if smoke blackening on some edges. The top of the section is packed with tiles.
- V Brickwork of the chimney-stack.

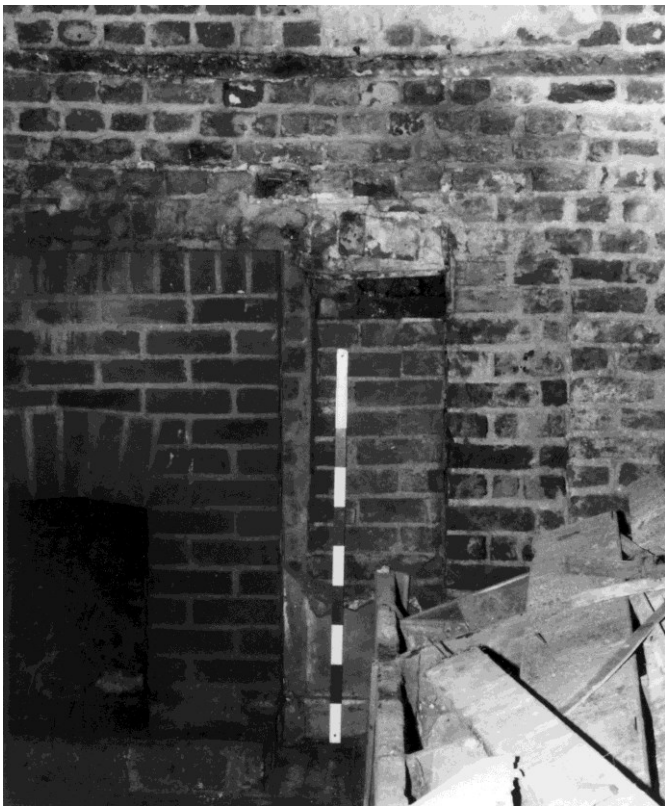
The fireplace in room 1-11 on the first floor had a cast iron grate which may have dated from the early nineteenth century (figure 49). The brickwork around it was covered with plaster until the reconstruction took place. A photo taken during the reconstruction (figure 40) suggests that the, apart from the grate, the opening had not been much altered.

Figure 49 (above). The fireplace and grate in room 1-11.

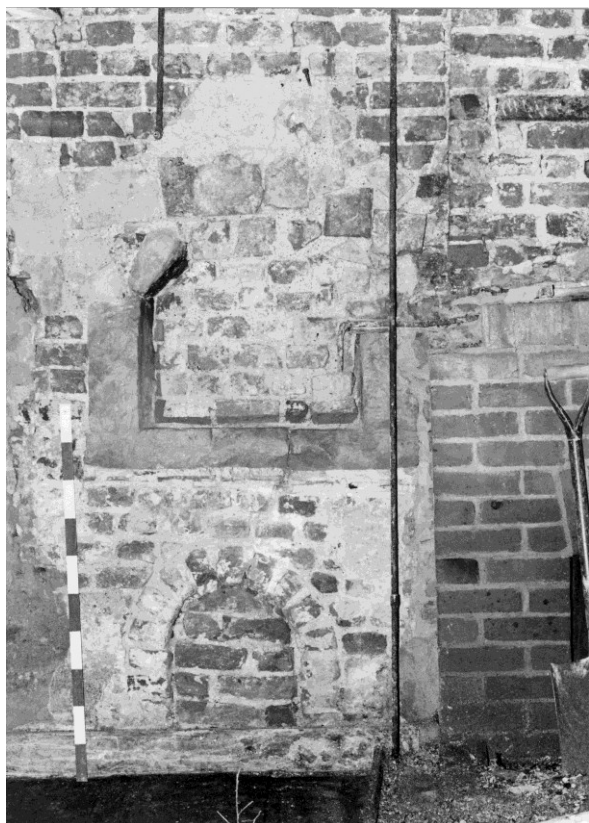
Figure 51. The blocked door and ash pit for the earliest oven in the south wall of room 1-5.

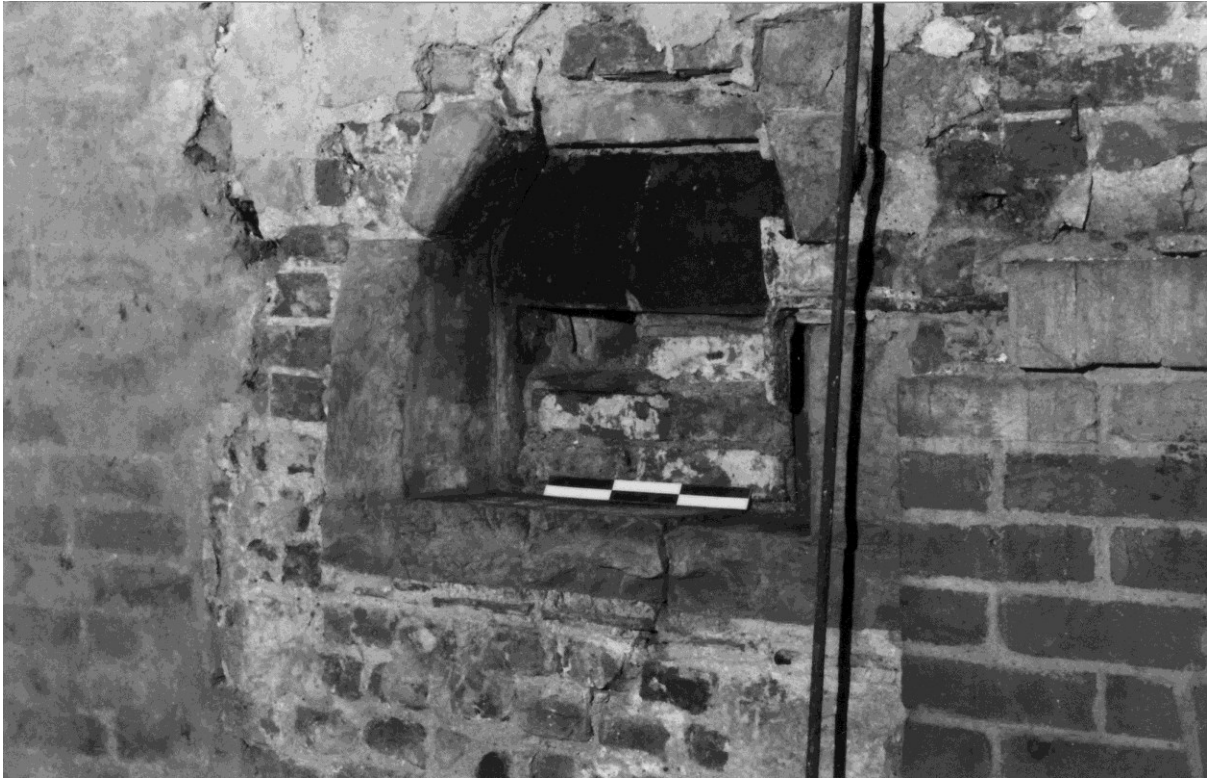
Figure 52. The door of the earliest oven with the blocking partly removed.

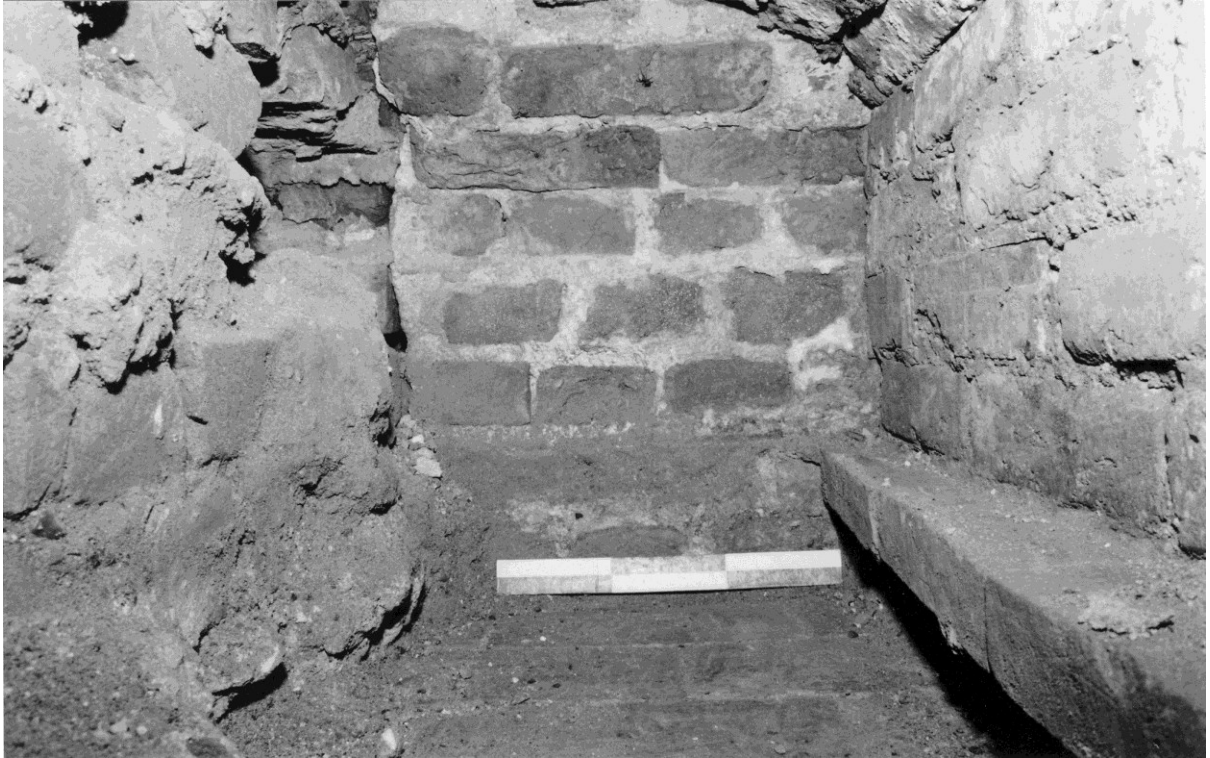
Figure 56. The remains of the ash pit of the second oven looking west. The back curved inwards towards the top and had formed the west side of the ash pit of the first oven.

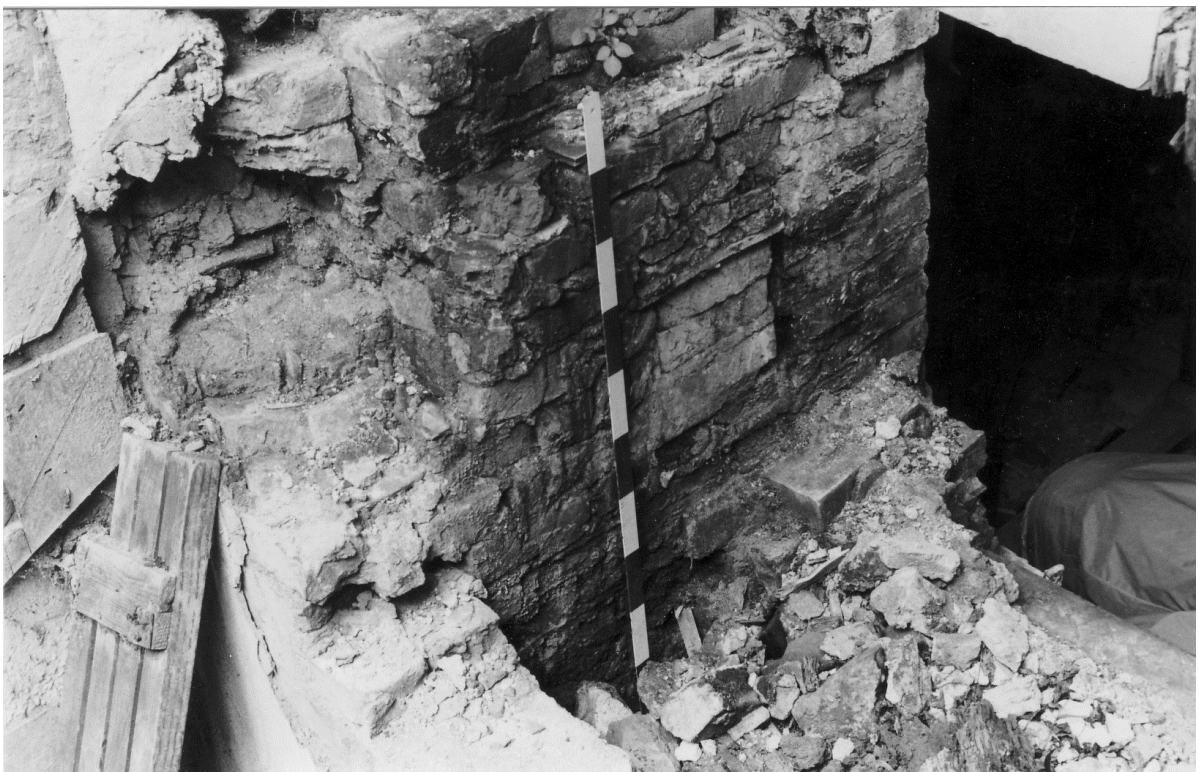
There was an opening for a flue in the east side of the east chimney-stack (figures 57 and 58). It was not clear whether this served the first or second oven or both.

Figure 57. The east side of the east chimney-stack by the ovens. Note the blocked flue to the right of the scale.

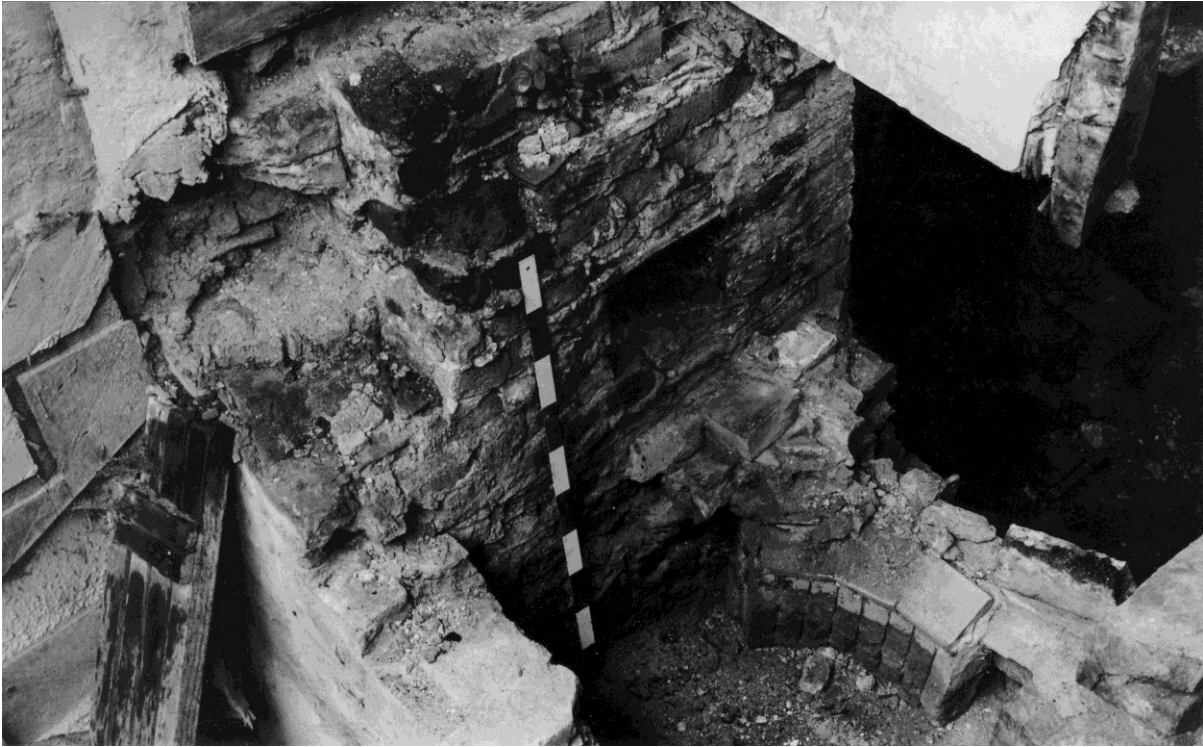
Figure 58. The east side of the east chimney-stack by the ovens. Note the unblocked flue to the right of the scale.

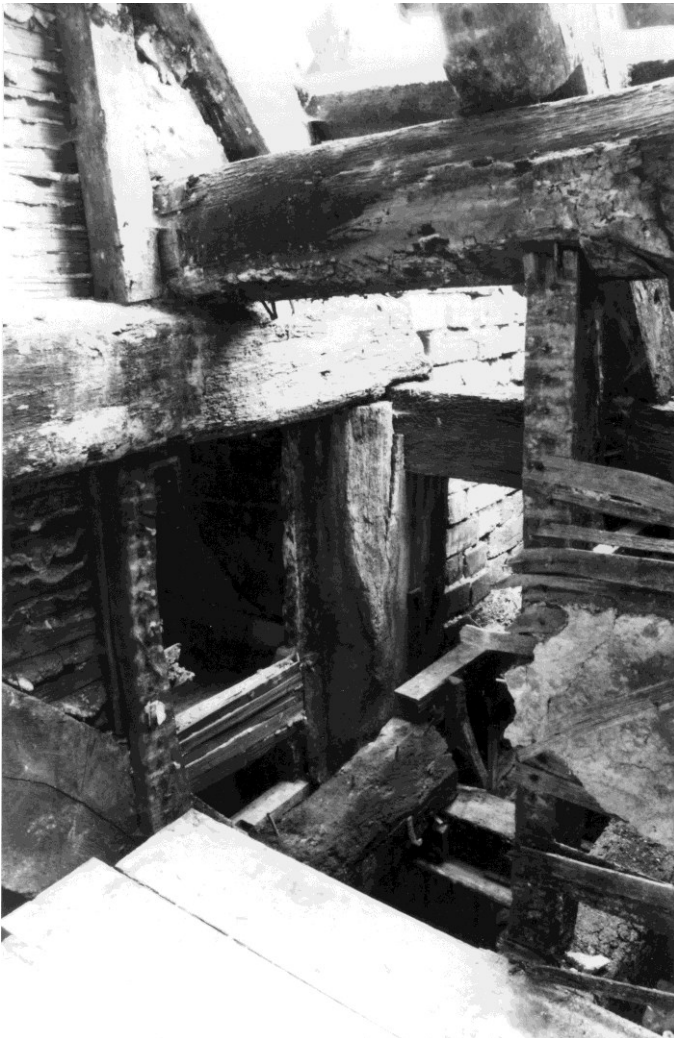
On the east side of the building, the joists rested on a beam which ran between post 2E and the site of 3E (figure 73).

Figure 73. Head of post 2E with the tie-beam of truss 2 to the left. The beam added to support the roof extension of room 1-5 can be seen at the top. The floor room 1-10 at the bottom. Looking northeast. March 1983.

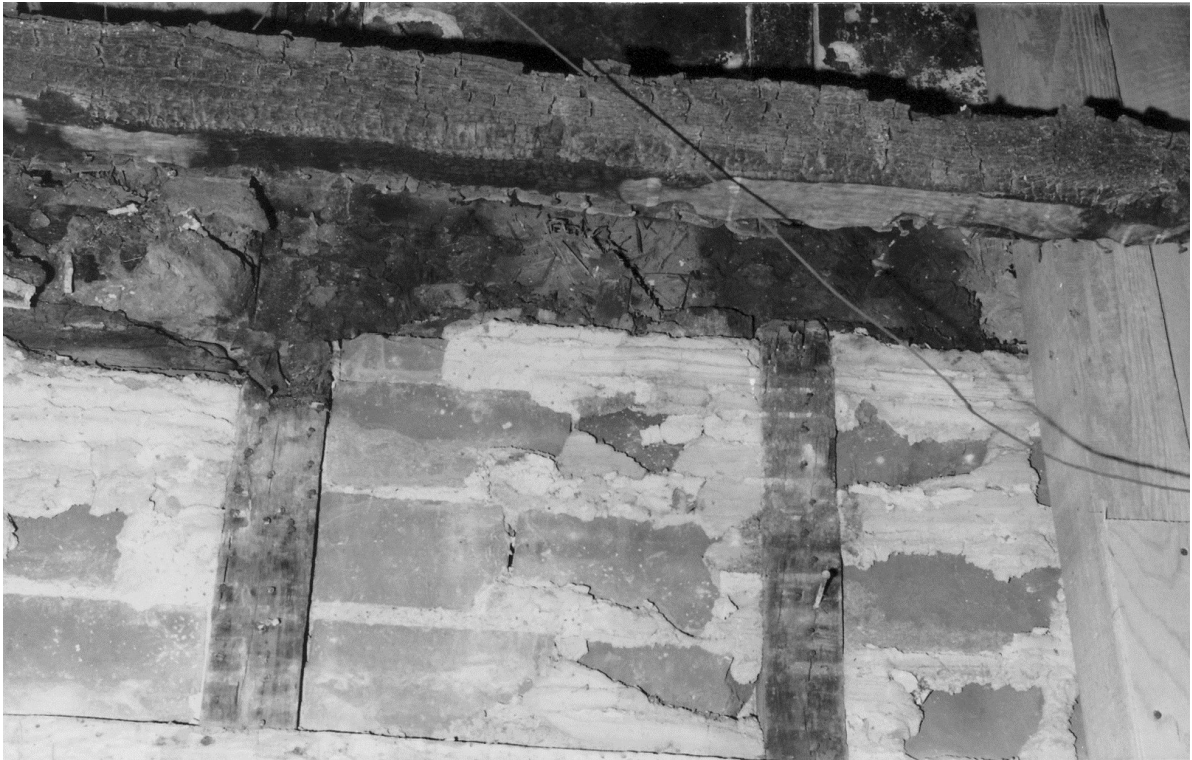
Figure 75. The upper part of the north wall of room 1-1 showing the boundary between the wattle and daub above and the timber framed brick work below. The timber across the top was one of the floor joists for room 1-11. The wattle and daub continued upwards to form the north wall of 1-11 which was part of truss 2.

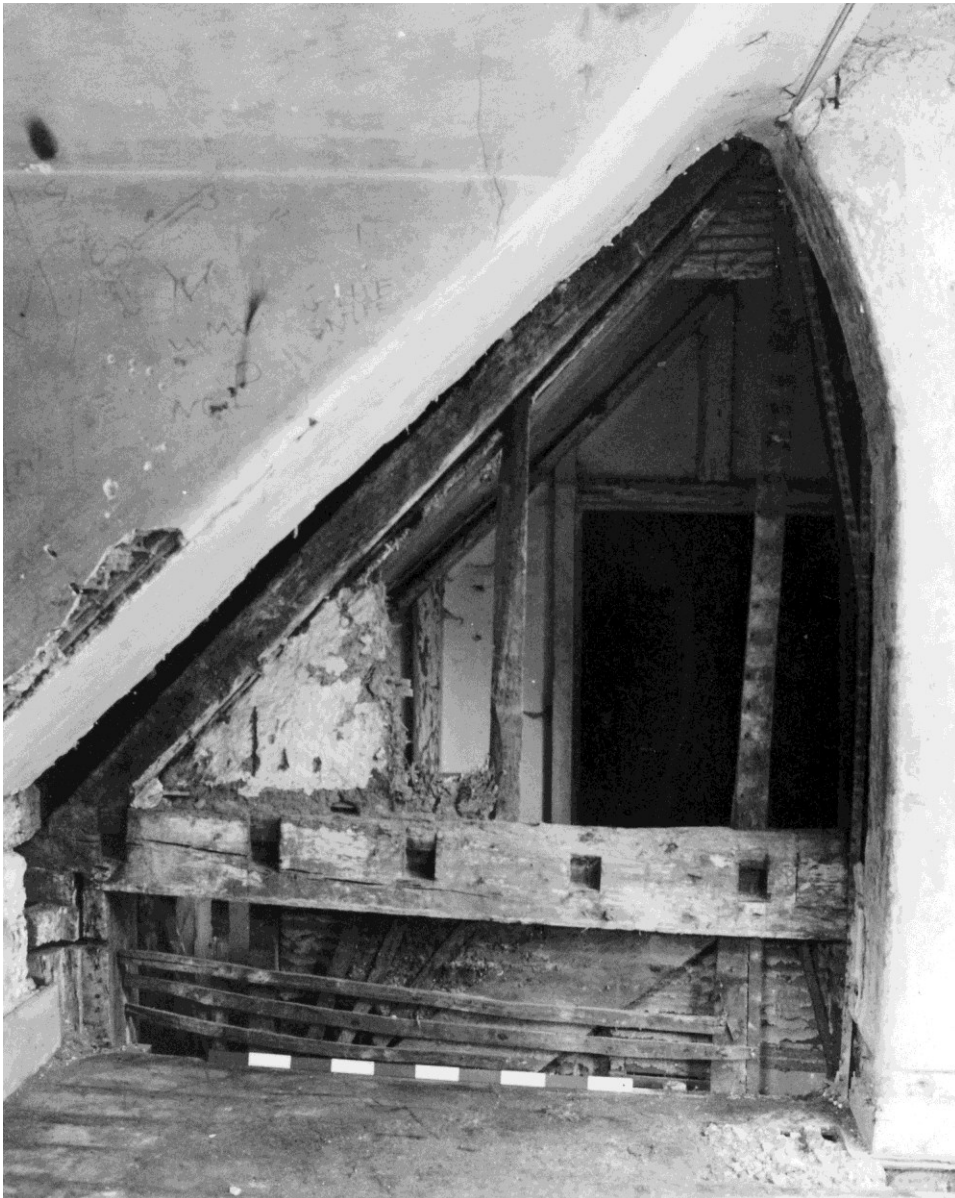
The south side of the tie-beam 3 of cottage 1 had been mortised to support an attic floor in 1A (figure 80). The roof looked fairly recent.

Figure 80. The west end of the south side of truss 3 in room 1A-7. Note the lath and daub and the mortises for floor joists at attic level.

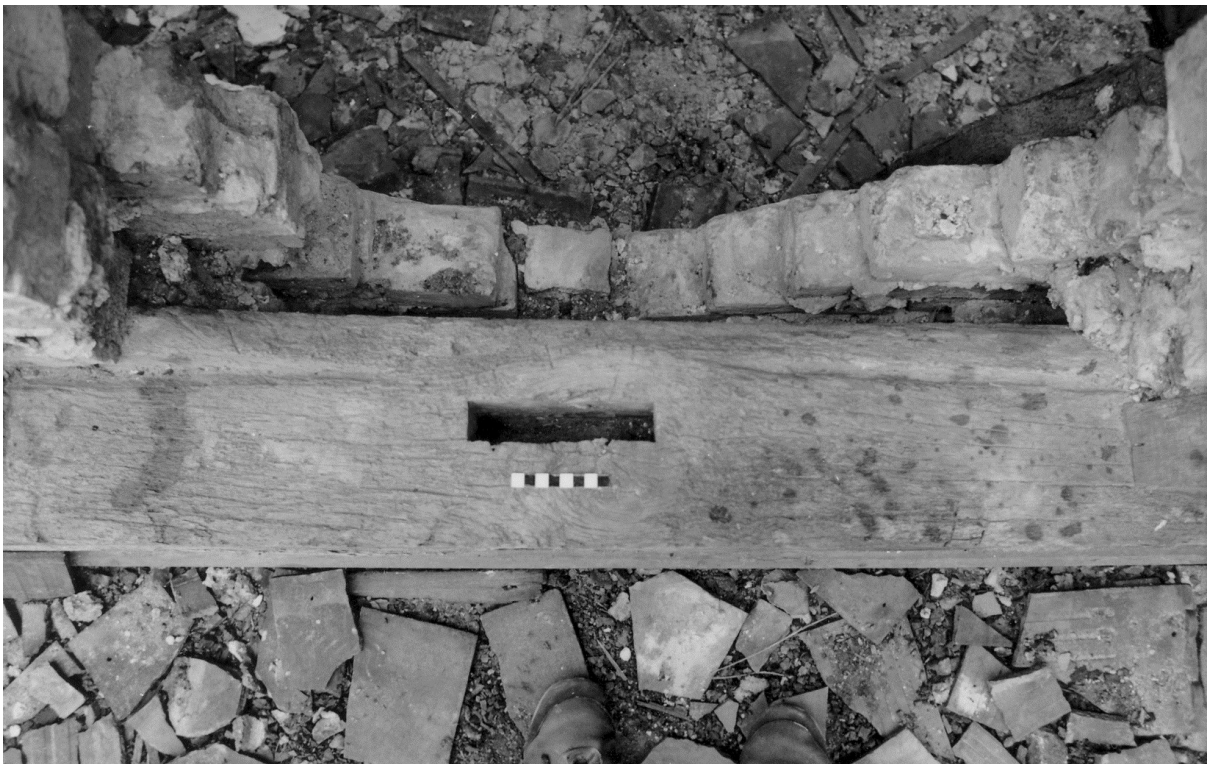
Figure 83. The centre of north truss in cottage 1B. Seen from above showing the mortise for a crown post or king post. Scale 8cm. 30 August 1982.
