Beddington Park Cottages

**Investigations before and during building work,
1982 - 1987**

John Phillips

Carshalton & District History & Archaeology Society
Occasional Paper 6

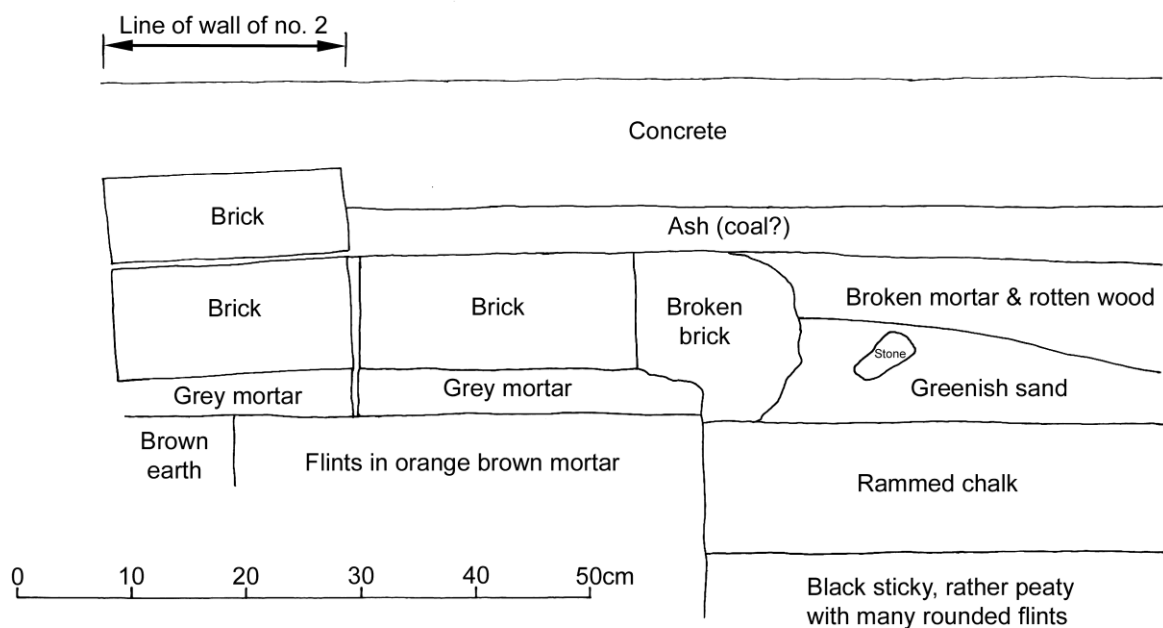
A section across the foundations of the western wall of Cottage number 2 was examined on 22 September 1986 (figure 89). Some of the black sticky layer (bottom right in figure 89) was excavated to a depth of about 25cm below the chalk without finding the bottom. The upper part of the layer contained many sub-angular flints in black sticky clay-like soil. The flints seemed to be less common at the bottom of the layer although this was only seen in a small area at the bottom of a rough irregular hole. There were no finds but the volume of material examined was small. The deposit was probably natural and was similar to [AH2] except that the back material there was soily and not sticky and clayey.

Figure 89. Section through the foundations of the west wall of cottage 2 looking north.
