The Dovecote at Carew Manor, Beddington

John Phillips

**Carshalton & District History & Archaeology Society
Occasional Paper 13**

Site address: Church Road, Wallington, Surrey
Grid reference: TQ 29544 65371
London Borough: Sutton
Listed building number: 1002017
Revised: 17 April 2020

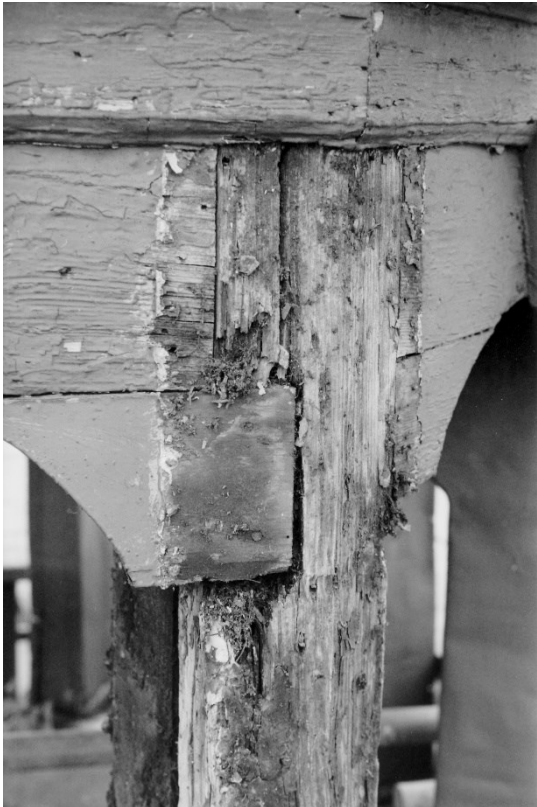
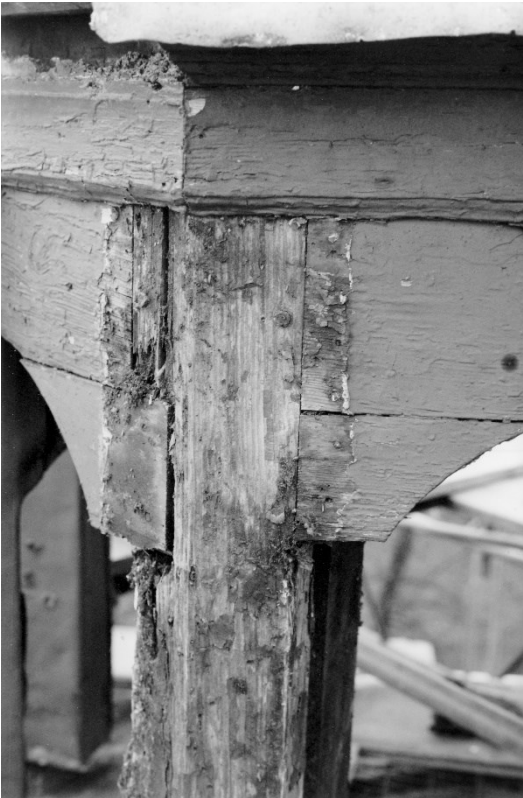
The open sides of the turret had vertical posts at each corner. The semi-circular heads of the openings were made of boards with the prominent wooden ‘key stones’. The boards and ‘key stones’ are mostly fixed with modern round nails. In at least one case (figure 9) the boards forming the arch were tenoned into the front column and secured with wooden pegs. The mortise was 58mm deep and 15mm wide. It probably extended the full height of the boards.

Figures 7 (left) and 8 (right). The top of the turret showing the junction between the columns and the boards forming the arch. Note the use of nails.

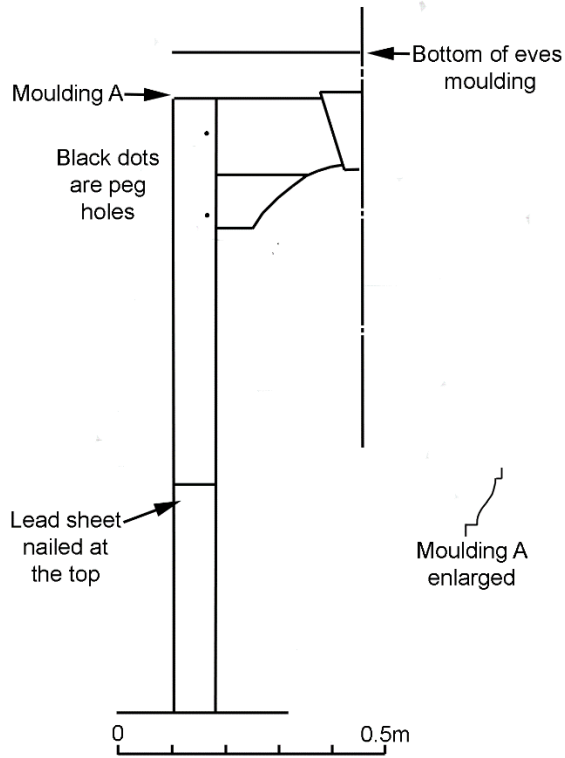
Figure 9. The northeast face of the turret.

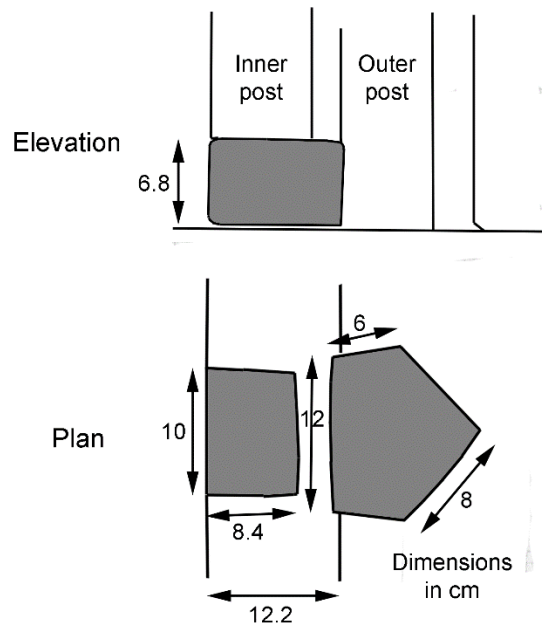
The columns consisted of two posts with a gap between them (figures 11 and 12). The outer face of the outer timber was cut at an angle to form the corners of the octagon. The tops of alternate inner column timbers were connected by two tie-beams which were reinforced by braces. The bottoms of the inner columns rested on a rough hexagonal ring beam which overlay the lead covering the top of the main roof. It seems likely that the inner columns and the

Figure 12. Plan and elevation of the post base at the east / northeast corner of the turret.

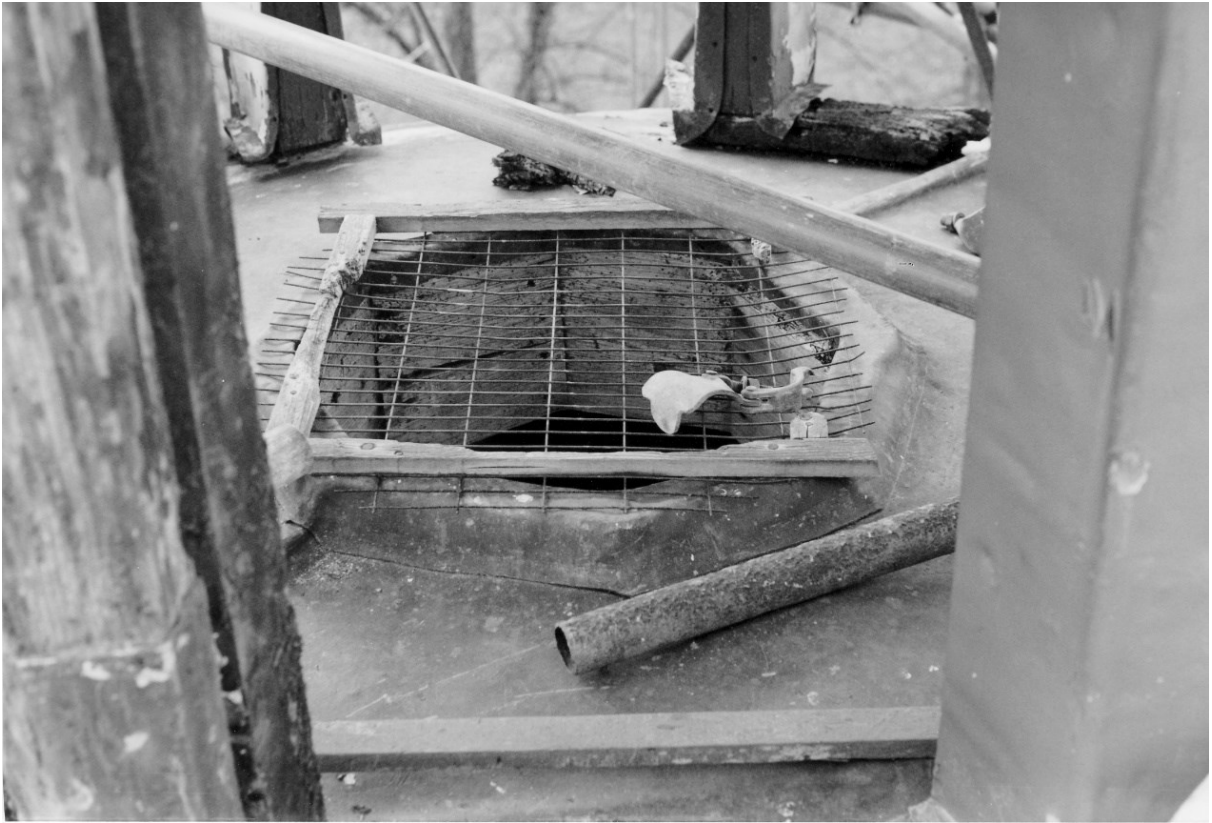
Figure 13. The floor of the turret showing the wired-off entrance where the birds came in and out

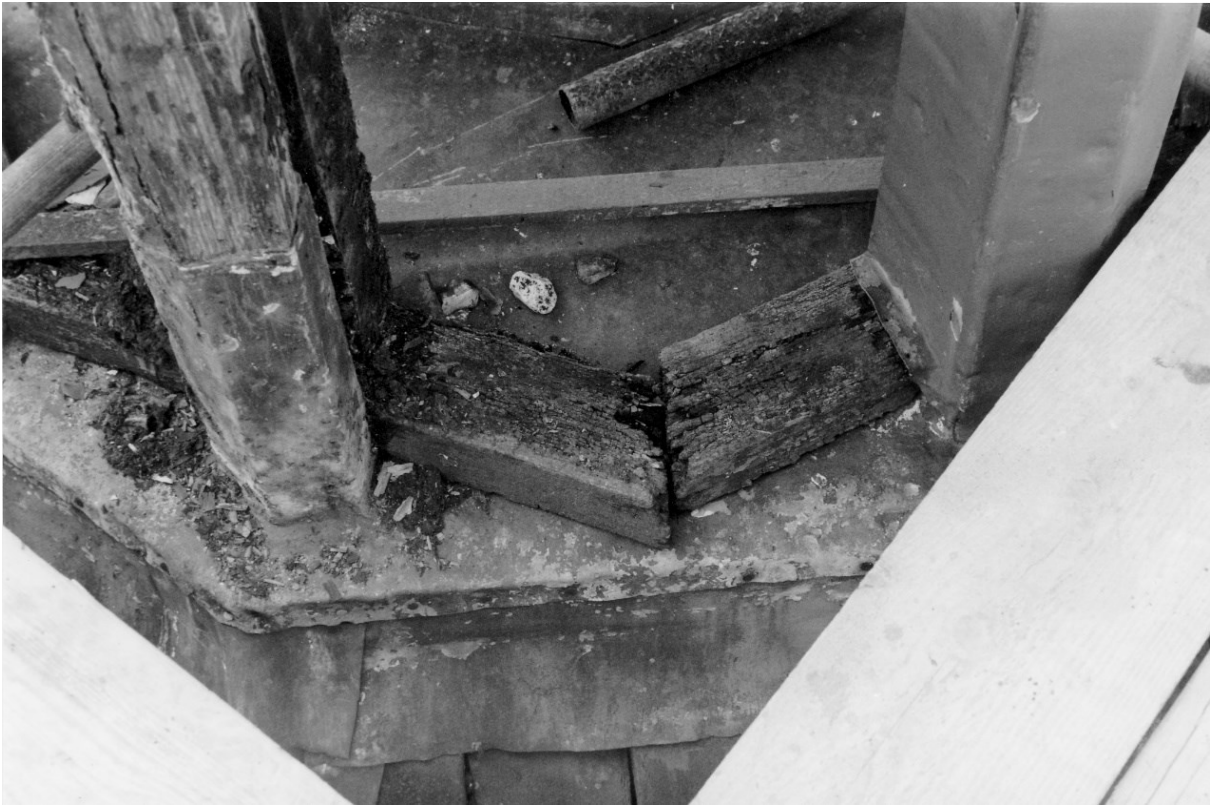
Figure 15. A further view of the base of the turret showing the inner and outer timbers of the column on the left. The inner one rested on the ring beam.

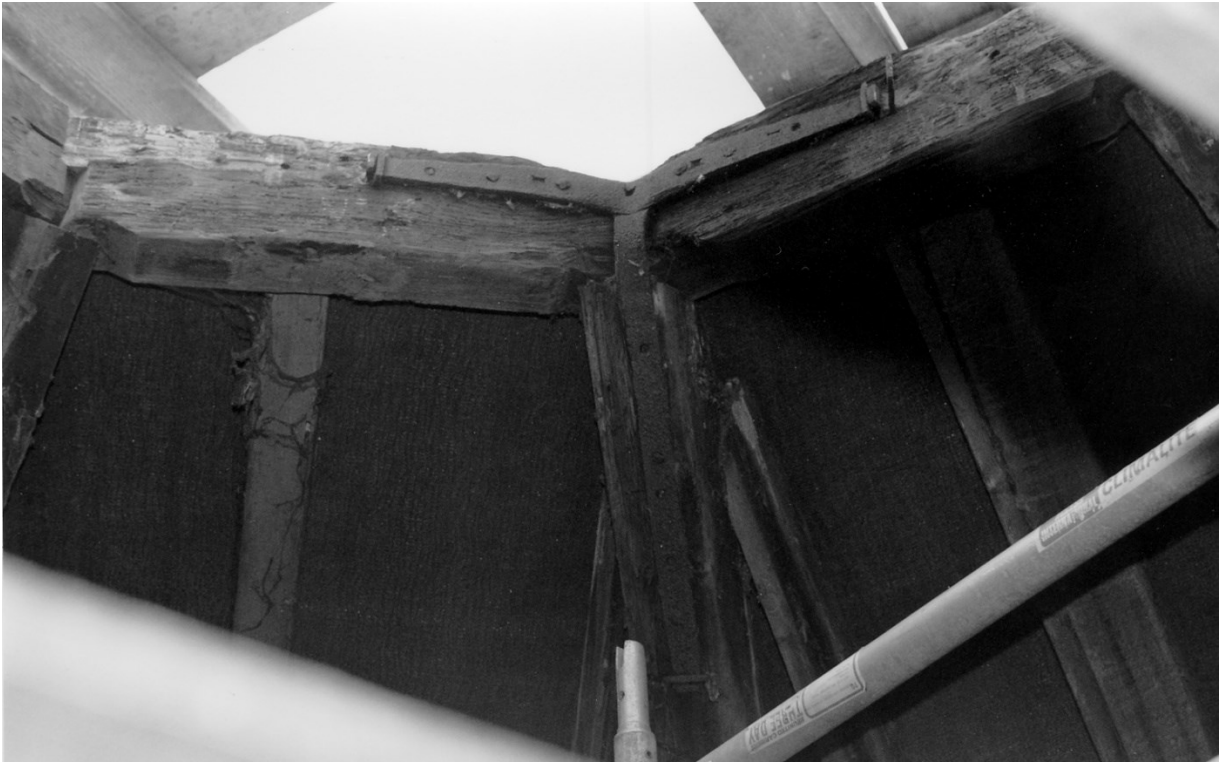
Figure 23. The underside of the roof apex showing the ring beam and the iron ties joining it together and linking it to the top of the principal rafters.

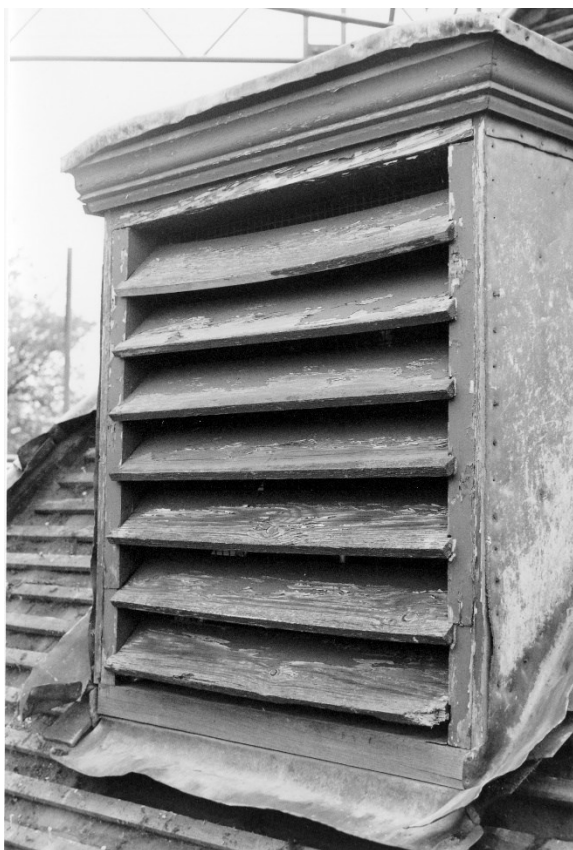
Charles Marshall's letter to SPAB of 19 September 1928 says that the workmen had renewed a good deal of the woodwork on three of the dormers. The Council had replaced the louvres with glass. SPAB objected to this but it is not clear if they were successful.¹⁸

By 1953 the dormers appear to have been open to the elements without either glass or louvres.¹⁹ The latter appear to have been reinstated in the roof repairs carried out in 1977.

Figure 25. The front of the southeast ventilator.

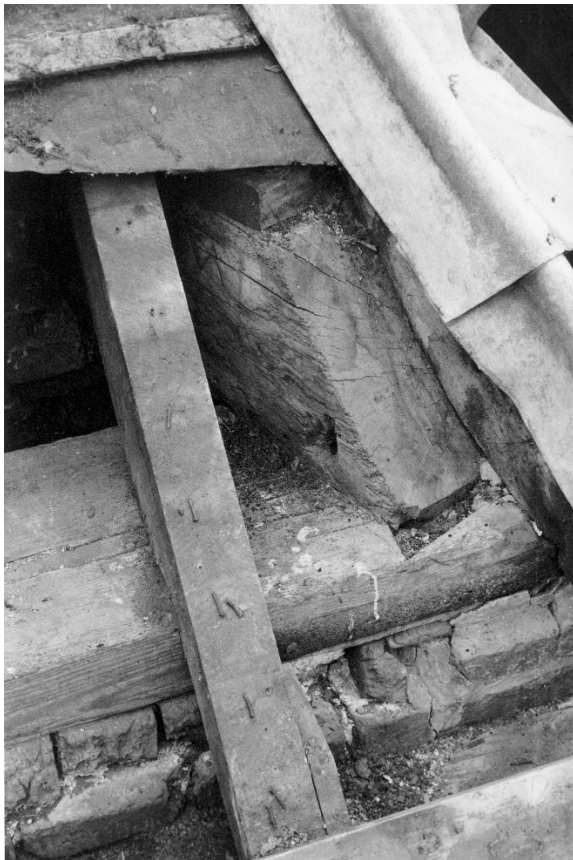
The original tie is 32.8cm wide by 29cm high. It has a waney edge on the bottom corner on the south side, but not on the north. The top is rather eroded and rotten. There is a neatly cut carpenter's mark on the north face (figure 33). The tie fits into a dovetail in the top of the wall plate (figures 30 to 32). The tie has pulled out by 3cm. The present principal rafter ends on a block of wood on top of the tie and a sprocket continues the line down to the cornice (figures 30 and 31).

Figure 30. The north side of corner 6.

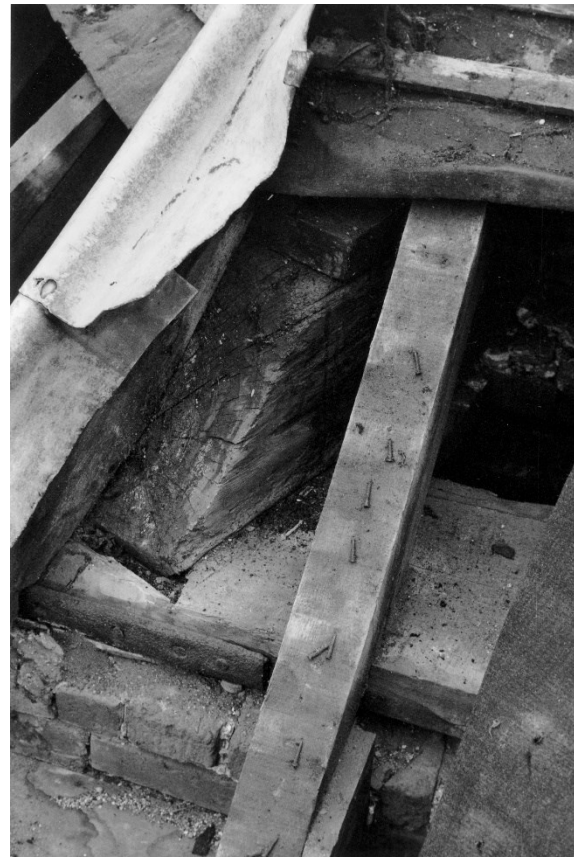
Figure 31. The south side of corner 6.

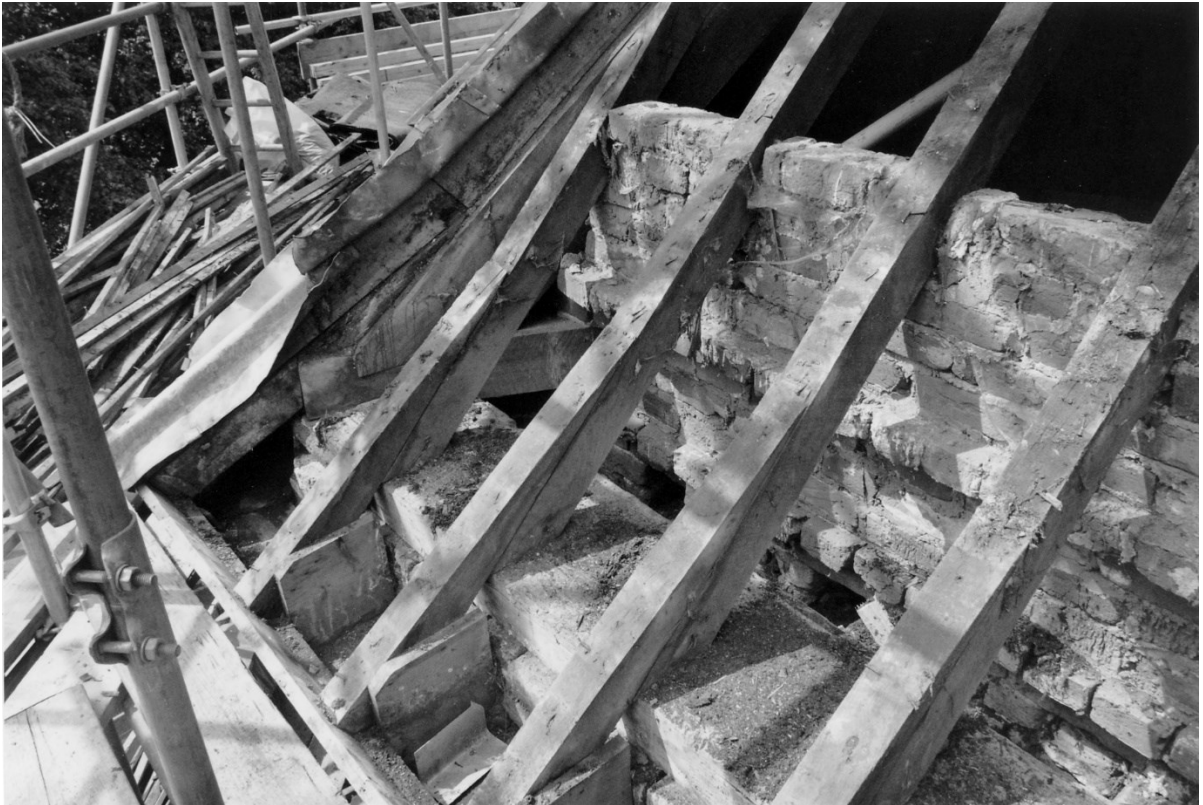
The removal of the lower part of the roof covering in the 1997 repair work exposed the top of the boxes so the structural details could be seen. The wall was in two parts: the outer wall on which the wall plate rested and the nesting boxes which built against the inside of it as shown in figures 42 and 43. The lack of bonding between the two parts and caused at least parts of the nesting boxes to move inwards leaving a gap of 30 to 35mm.

Figure 42. The top of the wall showing the common rafters and the sprockets which support the roof above the eaves and end against the board forming the top of the cornice. The common rafters end on the wall plate which rests on the brick outer wall. The inner wall which forms the front of the nesting boxes rises up to meet the underside of the rafters.

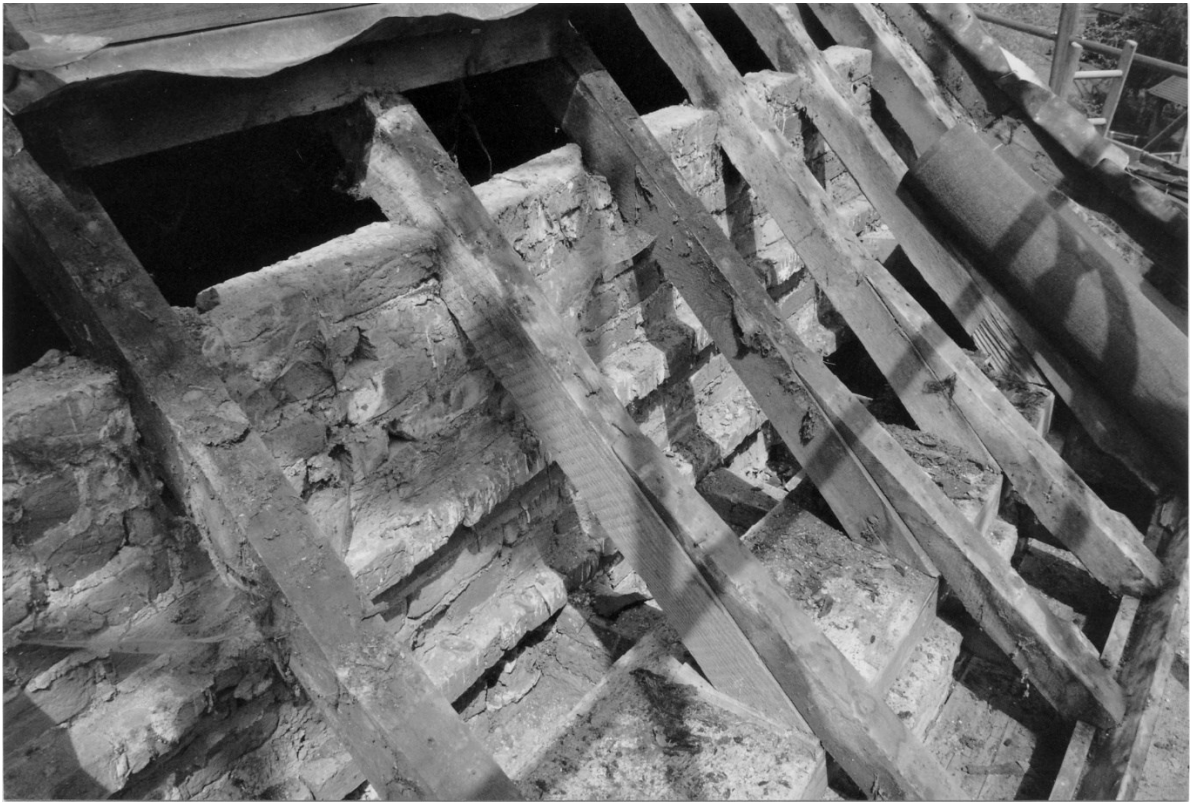
Figure 43. The back of the front wall of the nesting boxes.

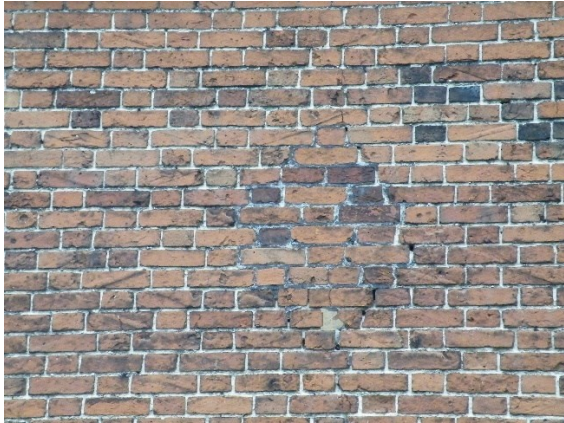
The first floor and potence are supported by a large bridging beam which runs across the building from above the door. The western end has been inserted into the wall leaving a clear scar in the external brickwork (figure 45). The upper edge of the beam has lines of bare-faced soffit tenons with spurred face shoulders on both sides. These look as if they were for floor rafters but there is no seating for the other ends in the dovecote wall. This suggests that the timber was reused. Hewett says that examples of this joint are known in the early 18th century²². The centre of the bridging beam is supported by a vertical post which is mentioned in EE Boden's 1927 survey.

Figure 45. The scar on the west wall where the first-floor bridging beam was inserted.

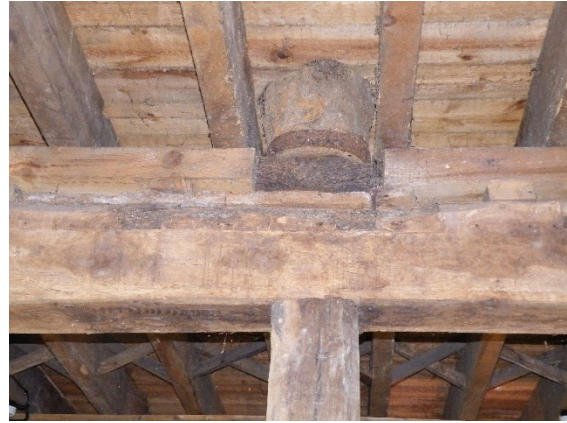
The octagonal post of the potence rests on a pivot at the centre of the bridging joist (figure 46). There are two pieces of packing between it and the joist. The bottom of the potence is slightly tapered and there is an iron band to stop the wood splitting.

Figure 46. The bridging beam with the base of the potence and the top of the central post.

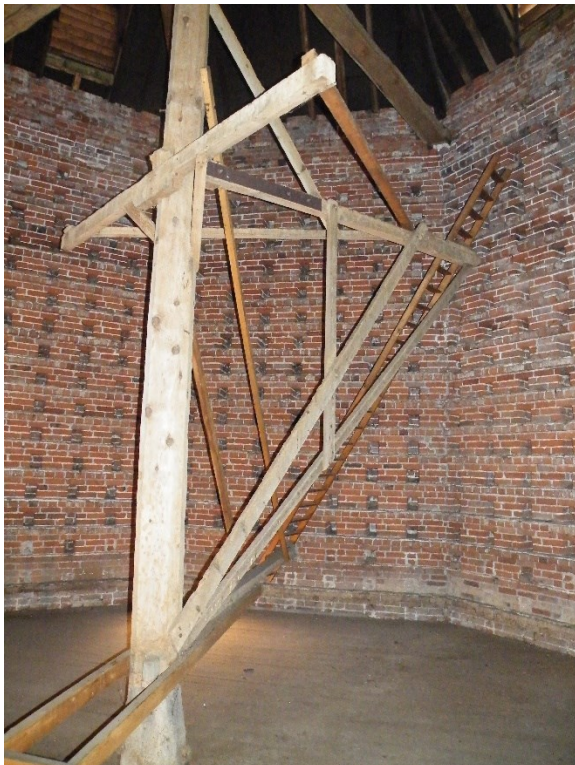
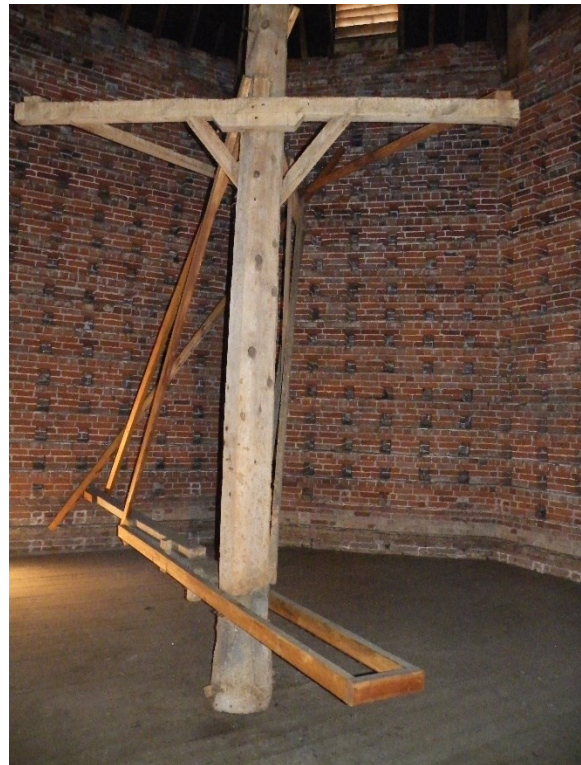
The potence consists of a mixture of old and replacement wood, some obviously modern. Photos taken in 1953 show that the ladder and the other obviously modern timbers are recent

replacements.²³ This was done when the dovecote was being prepared for public opening. The 1953 photos show that the then existing ladder was cruder consisting only of treads nailed to the top of the two side timbers.

Figure 47. Two views of the potence.

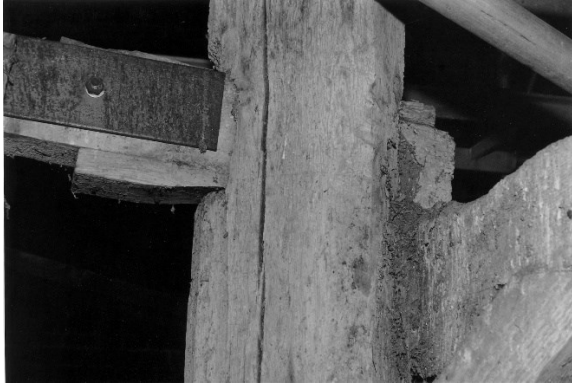
Figure 48. The joint between the potence post and the horizontal timber which supports the upper end of the ladder.

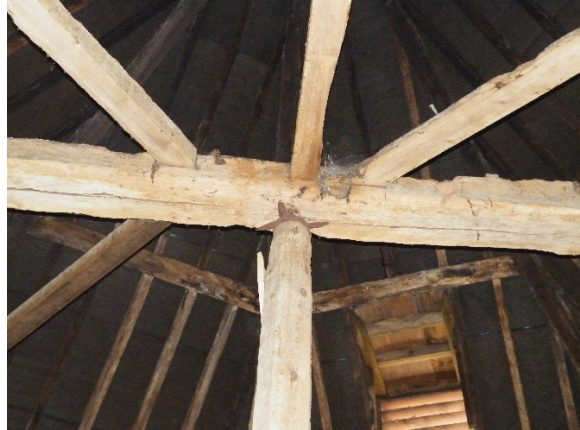
Figure 49. The main tie-beam and the top of the potence.

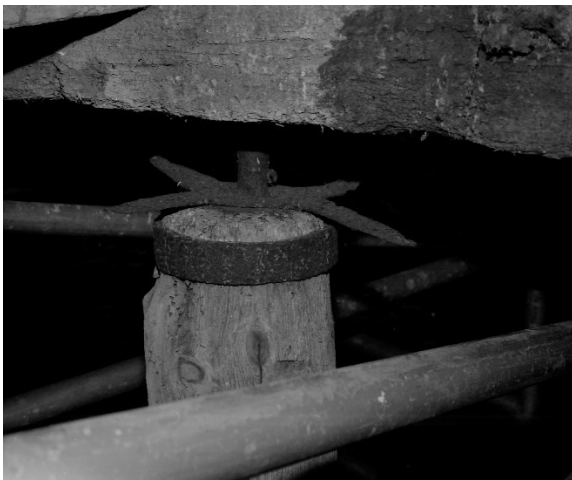
The top of the potence is connected to the underside of the tie by a metal pin to allow rotation. There is an x-shaped iron fitting loose on top of the post (figures 50 and 51). This was probably originally fixed to the underside of the tie-beam to prevent the pin eroding the wood.

Figure 50. The top of the potence.

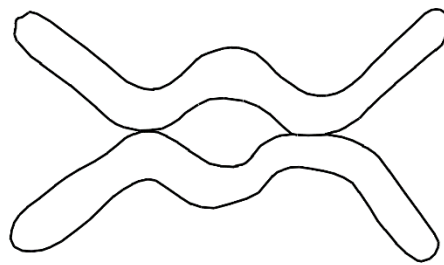
Figure 51. Rough sketch showing the shape of the iron fitting at the top of the potence. Each arm is about 20cm long with three nail holes in it. The iron was 7 to 8mm thick.
