Carshalton & District History & Archaeology Society

Local History Note 21

The Carshalton House springhead and the structures in the bed of the lake

Site code CAL84

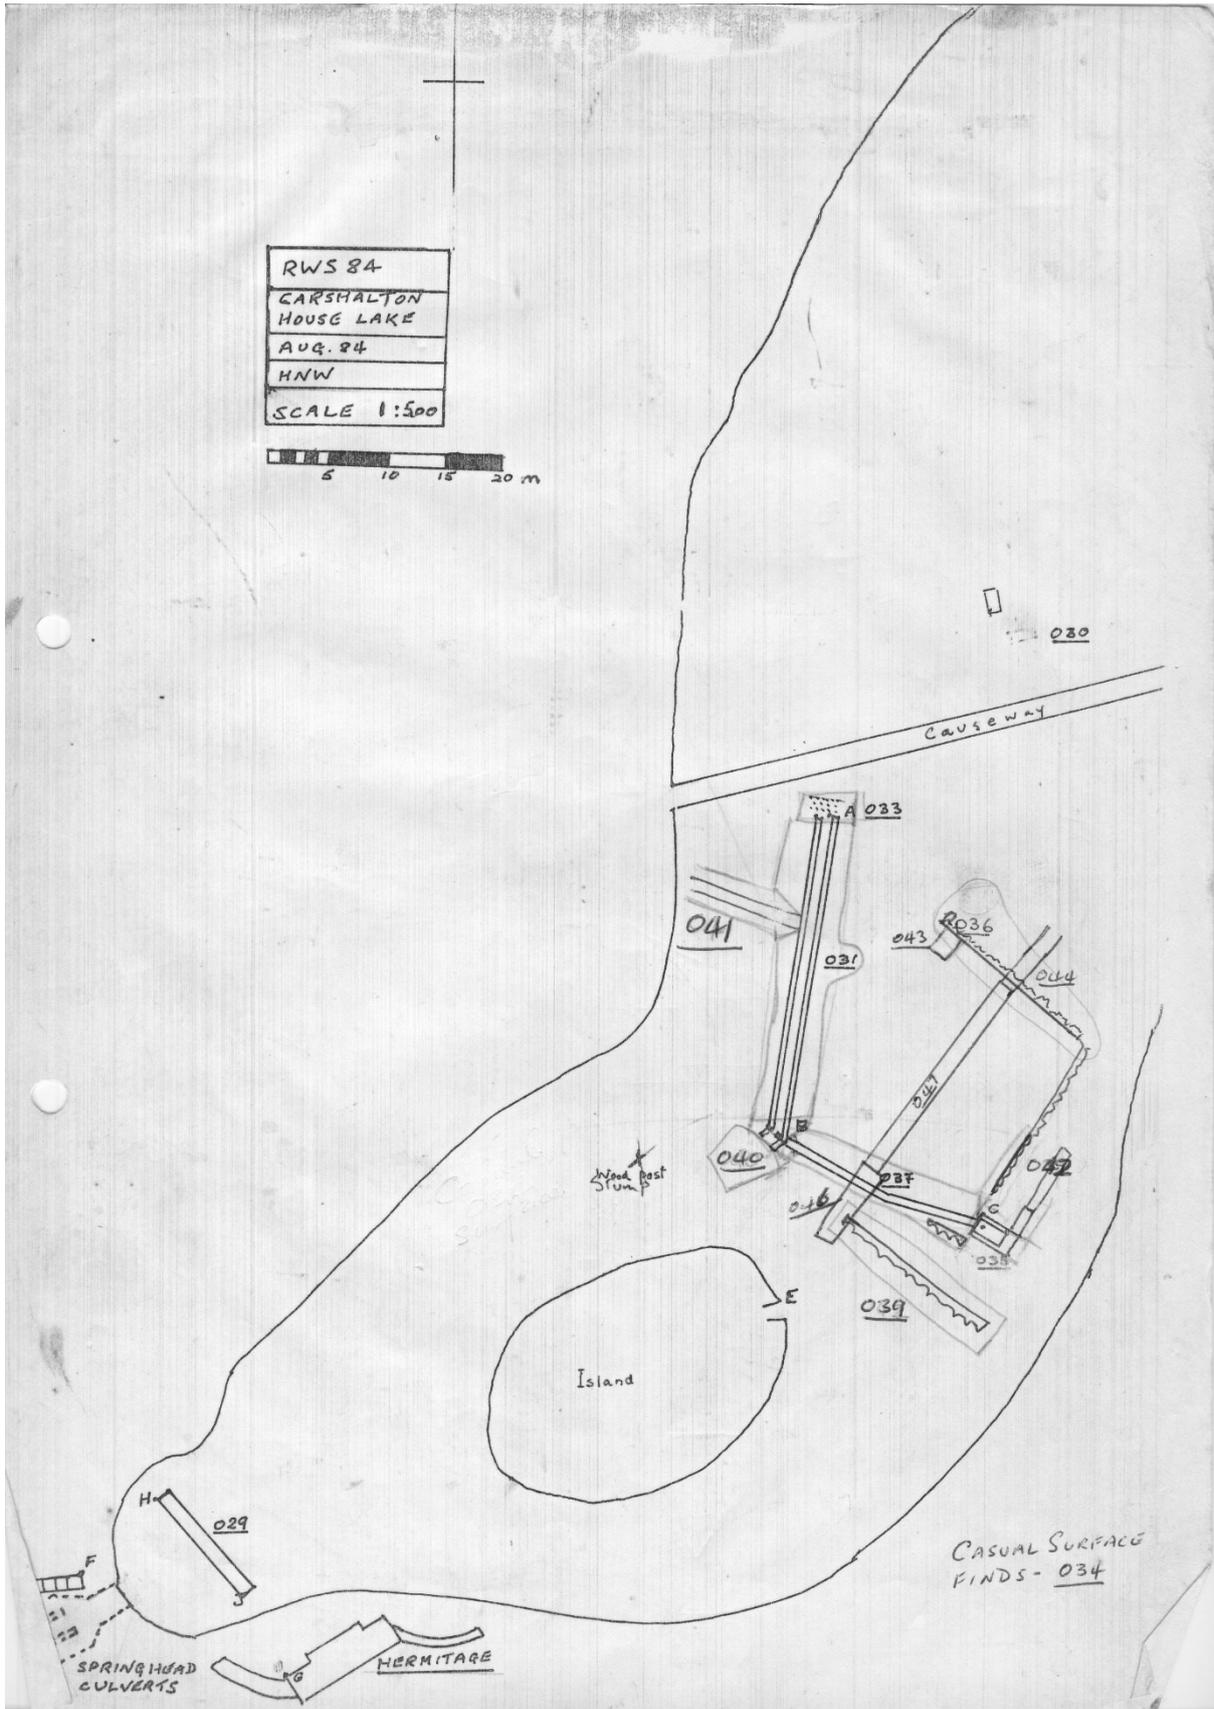
Figure 1. Site plan from file of context sheets. This is on paper and is referred to as the Paper Plan.

Each feature was given a three-figure number and the deposits within it were given context numbers which were in circles. I have changed these to square brackets. This summarises the information on the two series of context sheets. On one set of context sheets the layers are numbered +, 2, 3 etc. I have changed + to 1. The numbering of the features on the drawings is sometimes inconsistent. I have in general followed the numbering on the Paper Plan (figure 1).

This was also described as trench A. It was 1m wide and about 10.8m long and was dug across the head of the lake as shown on figure 1. It contained three layers:

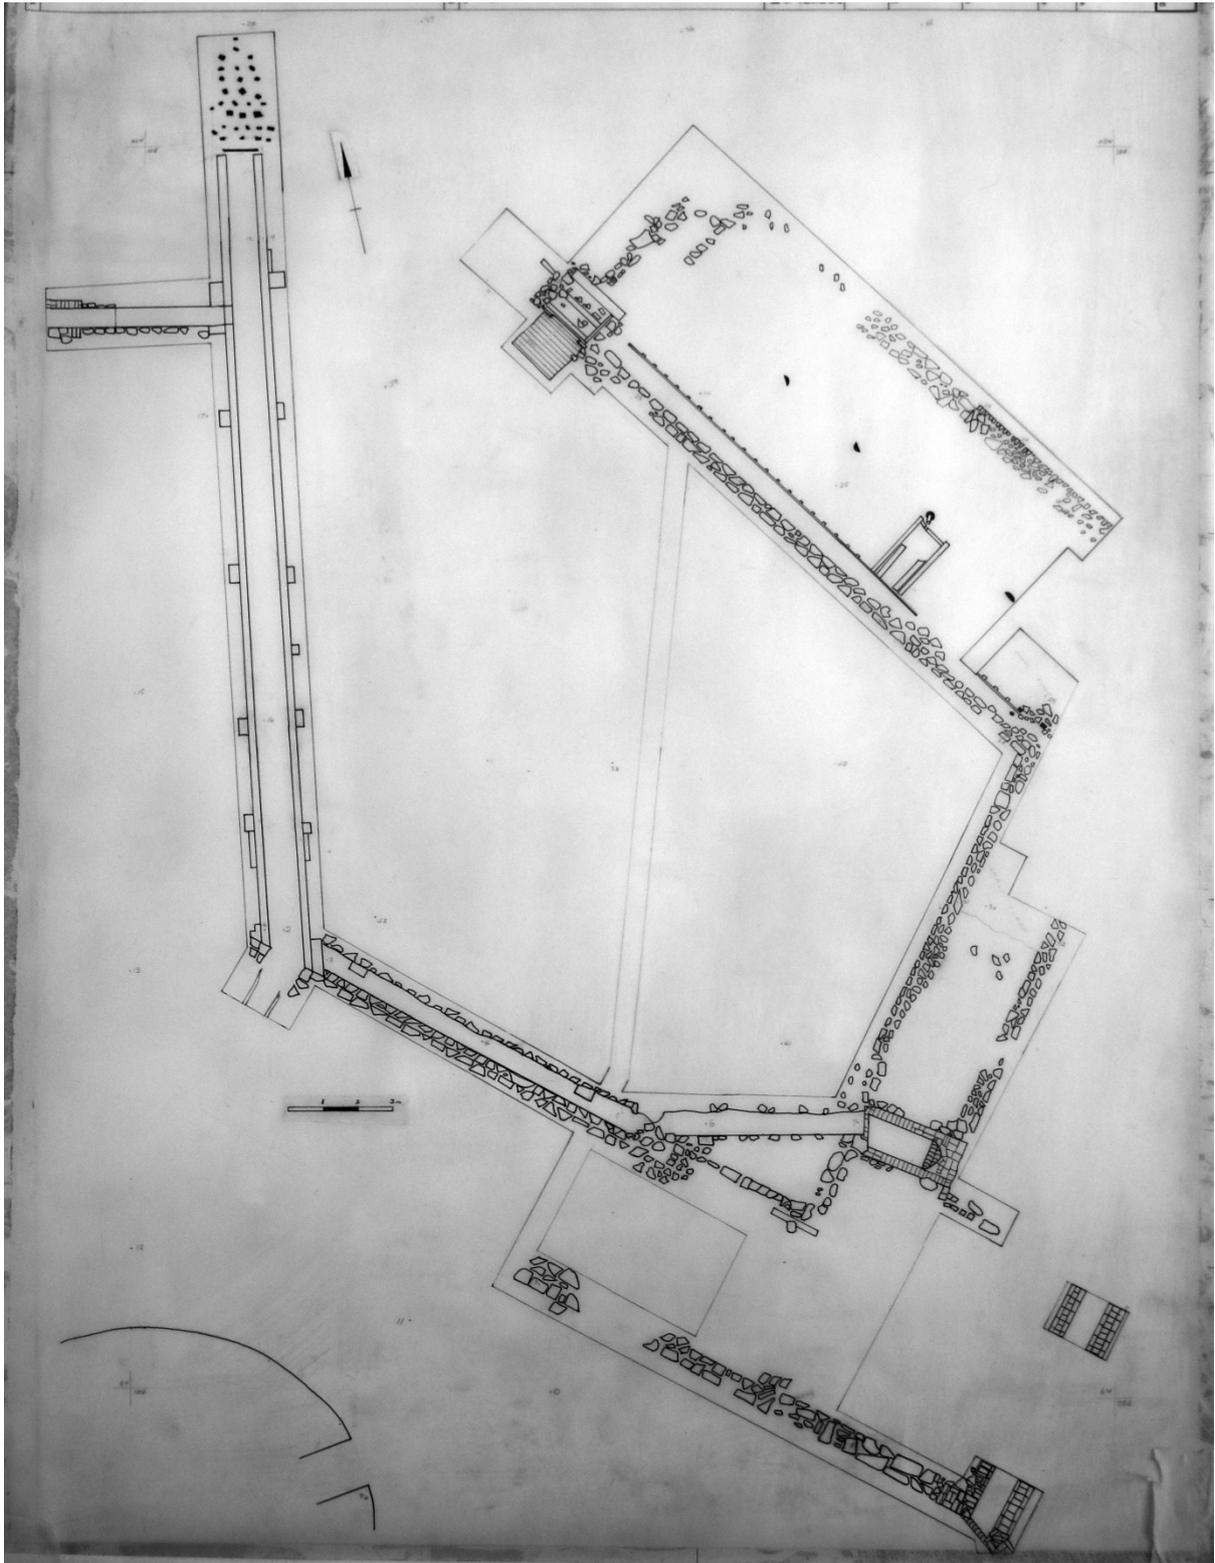
Figure 2. Photograph of a site plan on plastic drawing film which is referred to as the Film Plan.

The film plan (figure 2) shows two parallel walls in the eastern area forming a structure with an external width of 3.5m. The length of the western side was 11m. The east side was only partly excavated as the foundation passed into the bank forming the edge of the present lake. The eastern side was numbered 042. I have not found a context number for the western one.

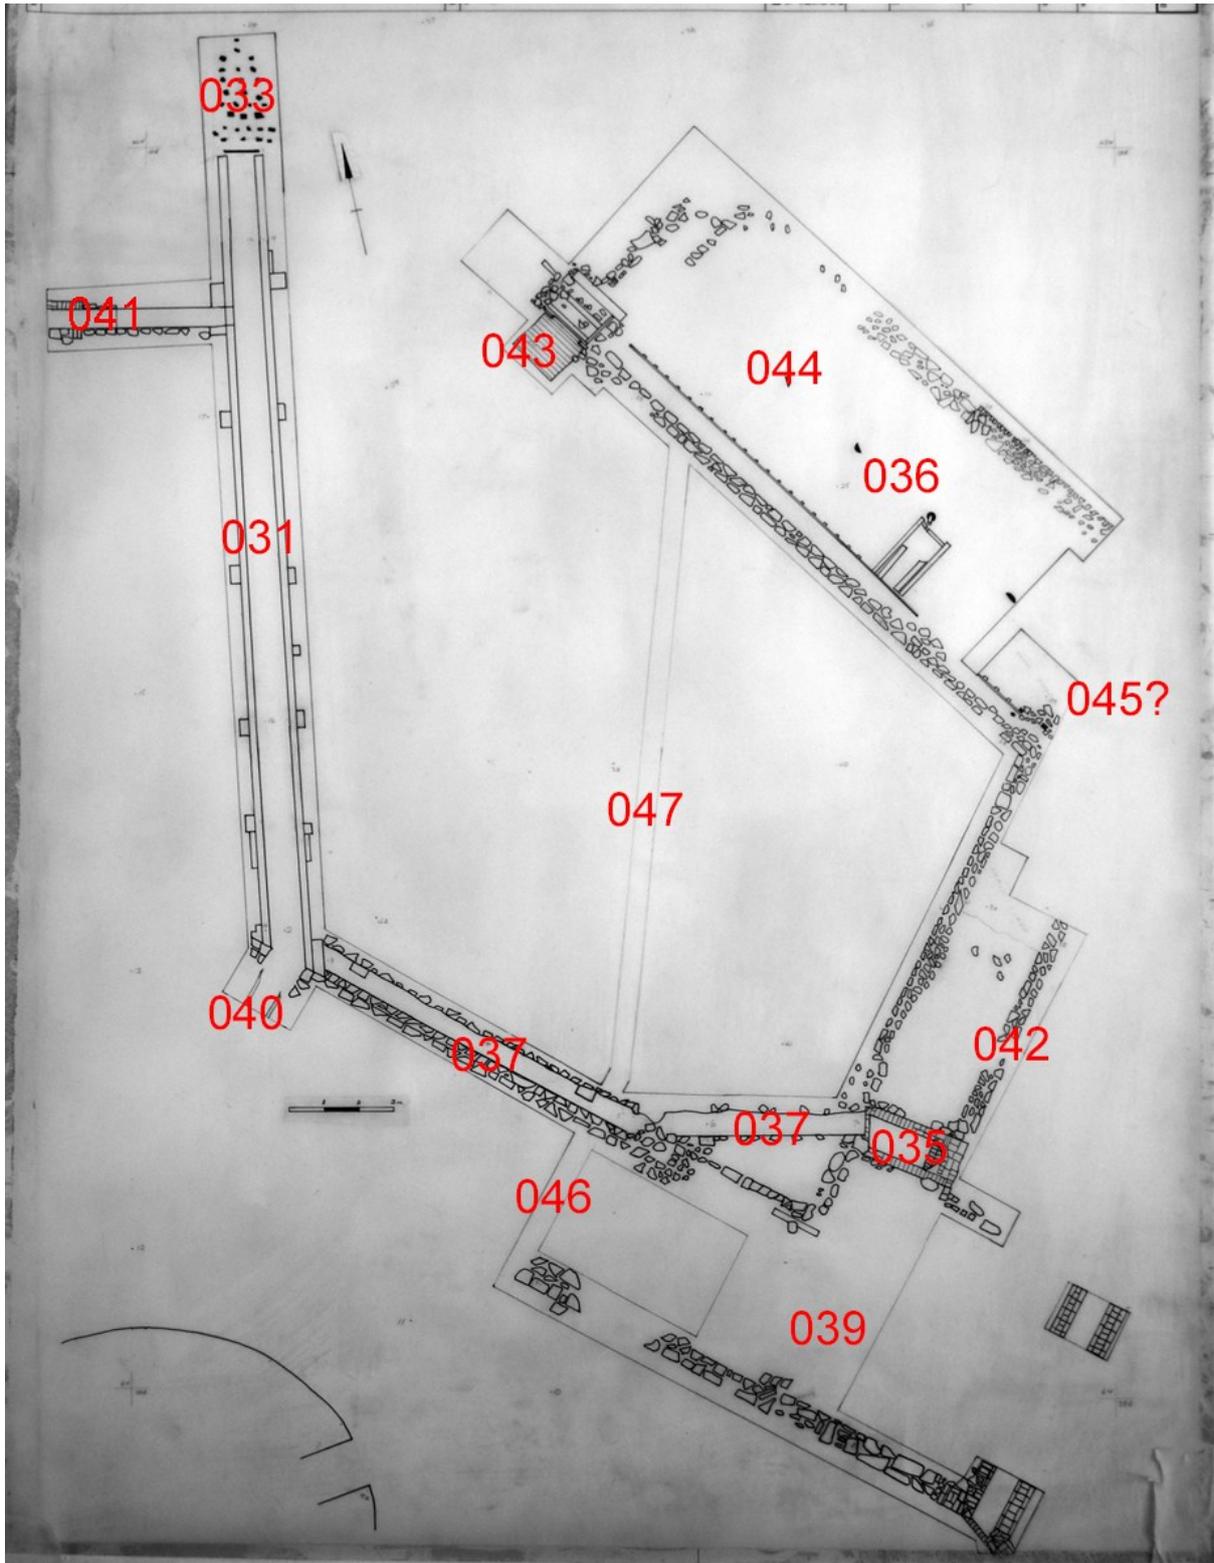
Figure 3. The film plan with added feature numbers.

The main features in the southern area were a culvert (037) which ran from a brick structure (035) more or less west to the south end of culvert 031 (figure 3). There were the chalk foundations of a rectangular structure numbered 039 on the south side of culvert 037. A section (046) was cut through both culvert and foundation.

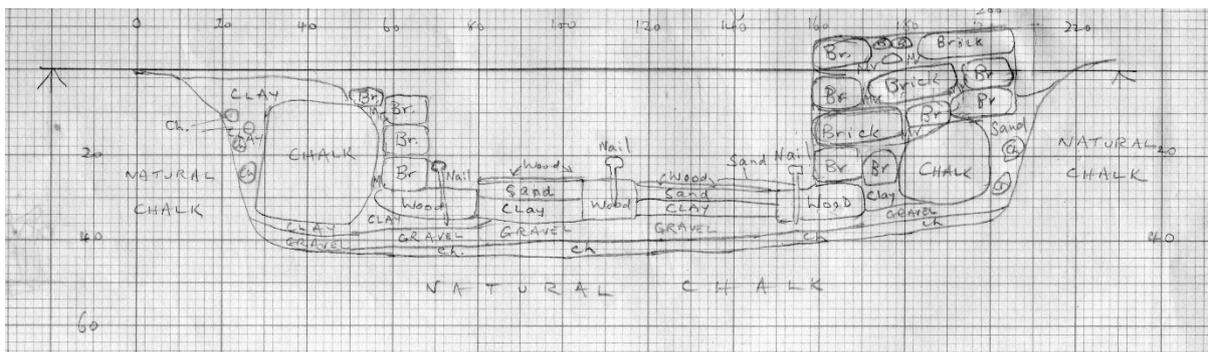
The site archive contains an unlabelled section drawing which is probably of this channel. It shows that the channel was cut into the natural chalk and that side walls were constructed of chalk blocks faced and covered with brick. There were three longitudinal timbers, one in the centre of the channel and the others partly under each side wall. These appear to have supported a plank floor which was held in place with iron nails. The areas between the longitudinal timbers were filled with sand resting on clay. There was a thin gravel deposit below the clay and then chalk.

Figure 4. An unlabelled section drawing probably of channel 031.

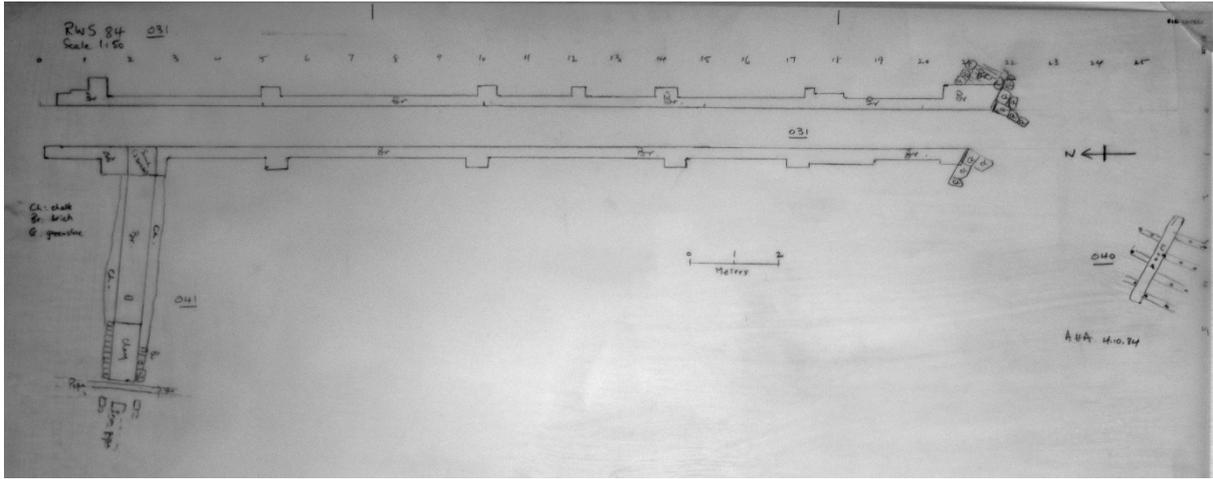
Figure 5. Culvert 031 with north to the left.

The main feature here was a culvert (031) which was aligned roughly north-south. The channel was 92cm wide. The sides consisted of four courses of brick with mortar on the top suggesting that they had once been higher. The tops were 12cm below the bed of the lake. The bricks were red, without frogs and were 22.5cm long, 6cm high and 10cm wide.

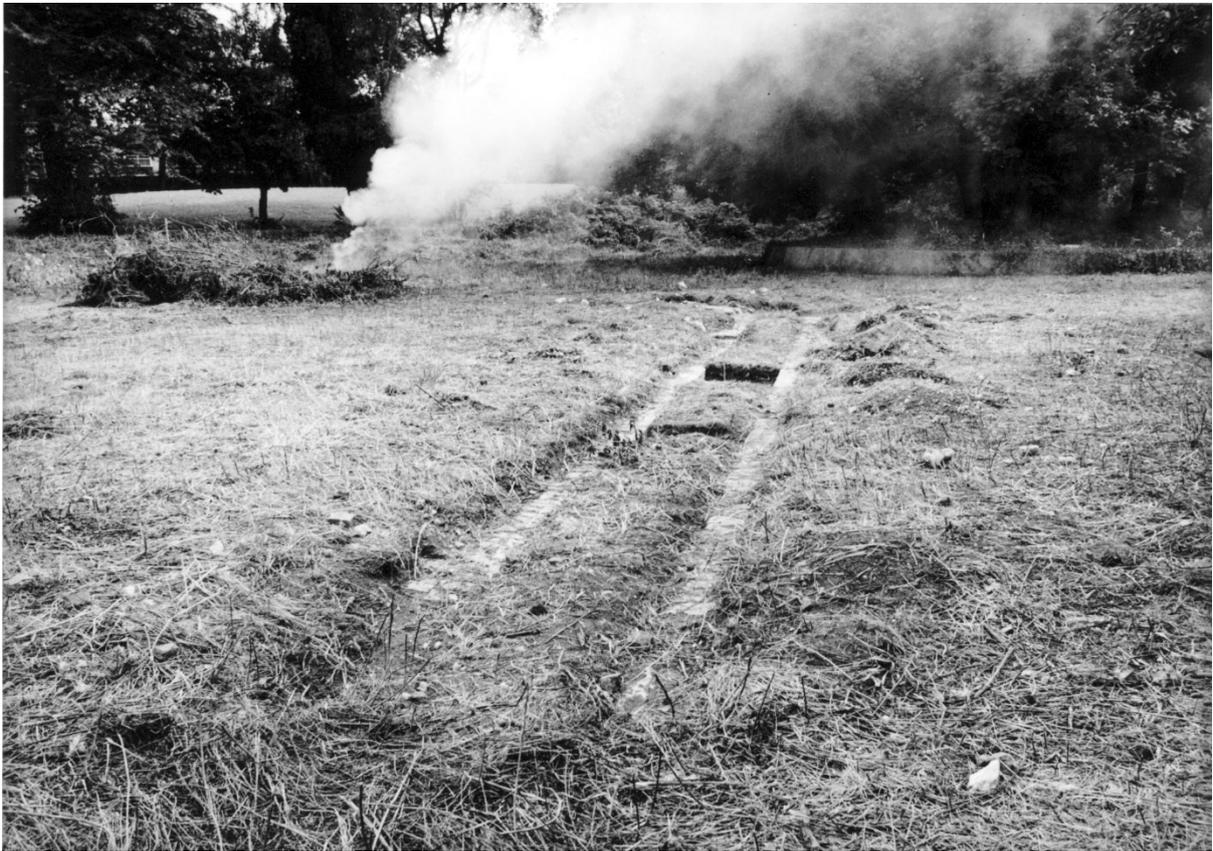
Figure 6. Culvert 031 looking approximately south.

At the north end of 031 there was an area of wooden posts set in chalk (033). There are two photos of the area (figures 6 and 7) and two plans. The former appear to have been taken before the excavation of the stakes was complete and only show part of the area. One drawing (figure 8) shows the end of culvert 031 with four rows of posts of variable size and shape and uneven distribution. Some were split logs without bark. A second drawing (figure 9) shows a more extensive area of posts and was presumably made after further excavation. The posts were set in chalk and extended up into black silt or soil.

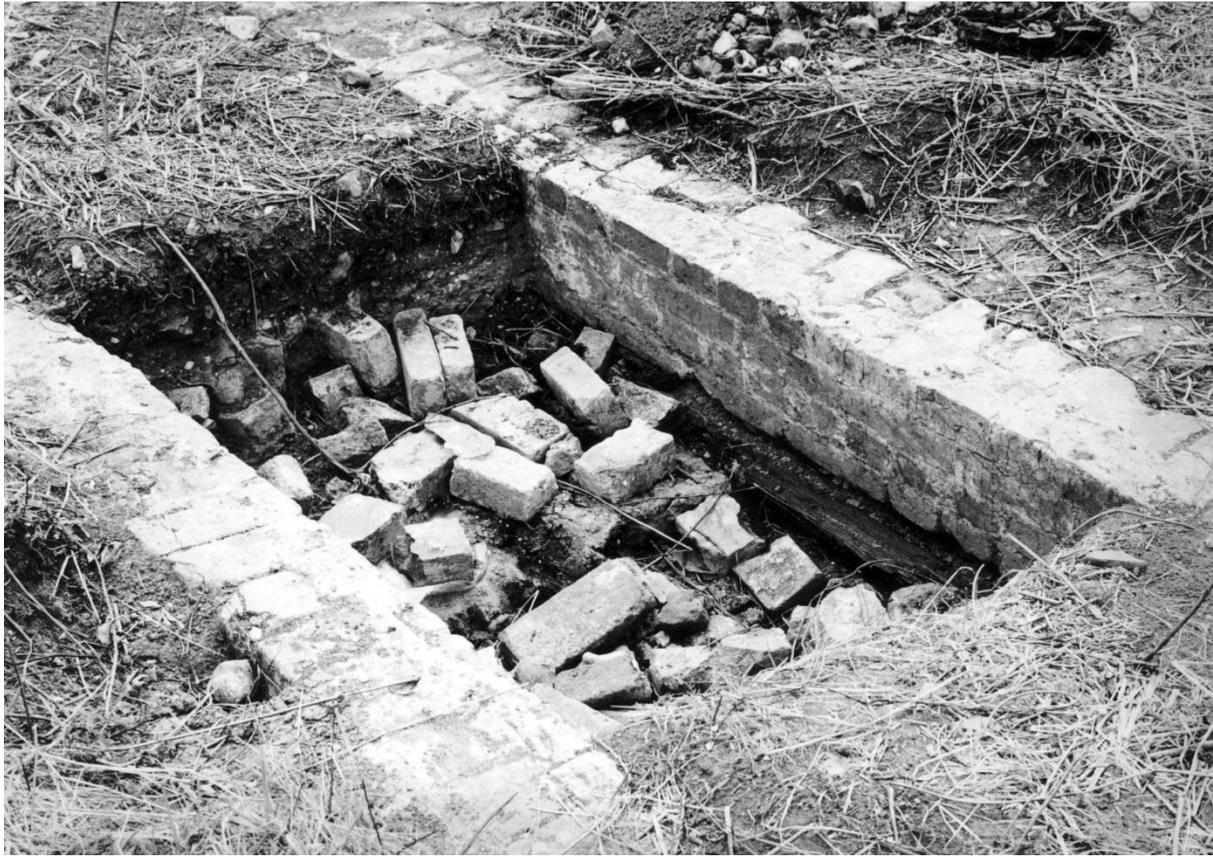
Figure 7. An excavated section of 031.

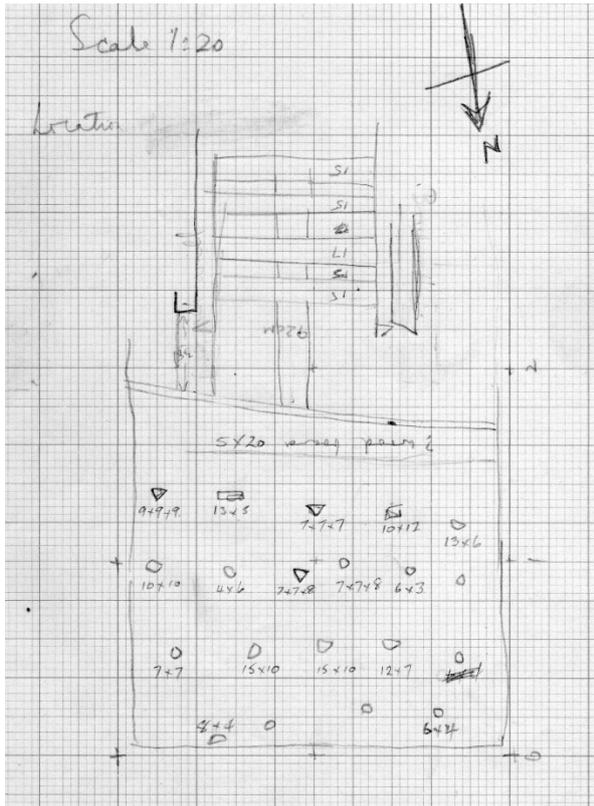
Figure 8. The north end of culvert 031 and the posts 033.

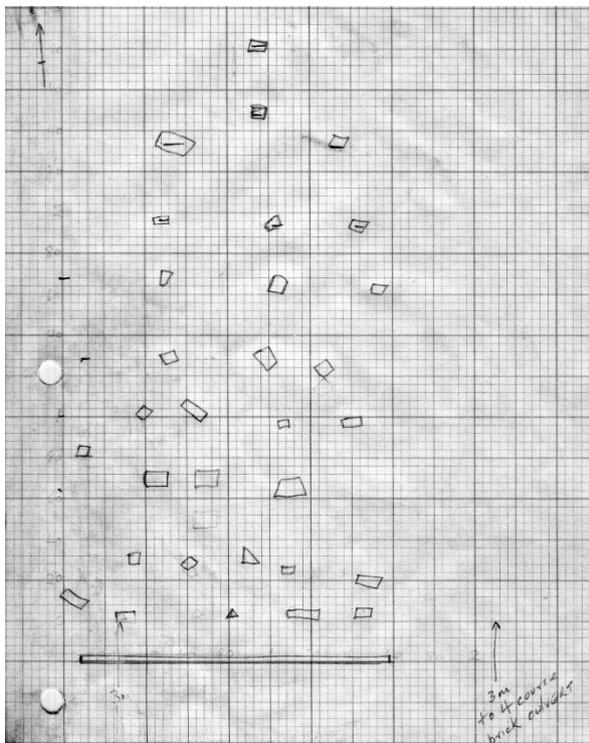
Figure 9. The posts 033. Note that north is at the top of this drawing, the reverse of figure 8.

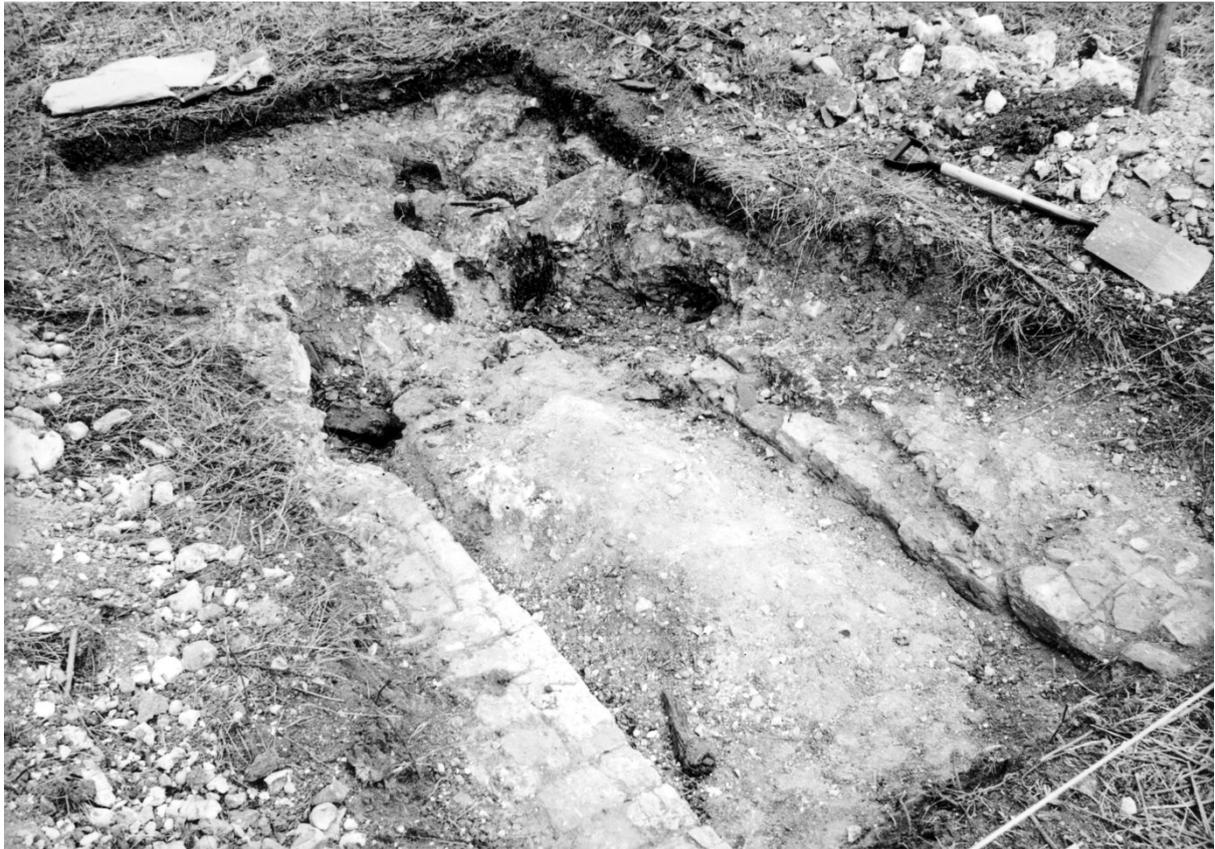
Figure 10. The north end of culvert 031 with the wooden stakes 033. The drawings suggest that the trench was subsequently enlarged, exposing more stakes.

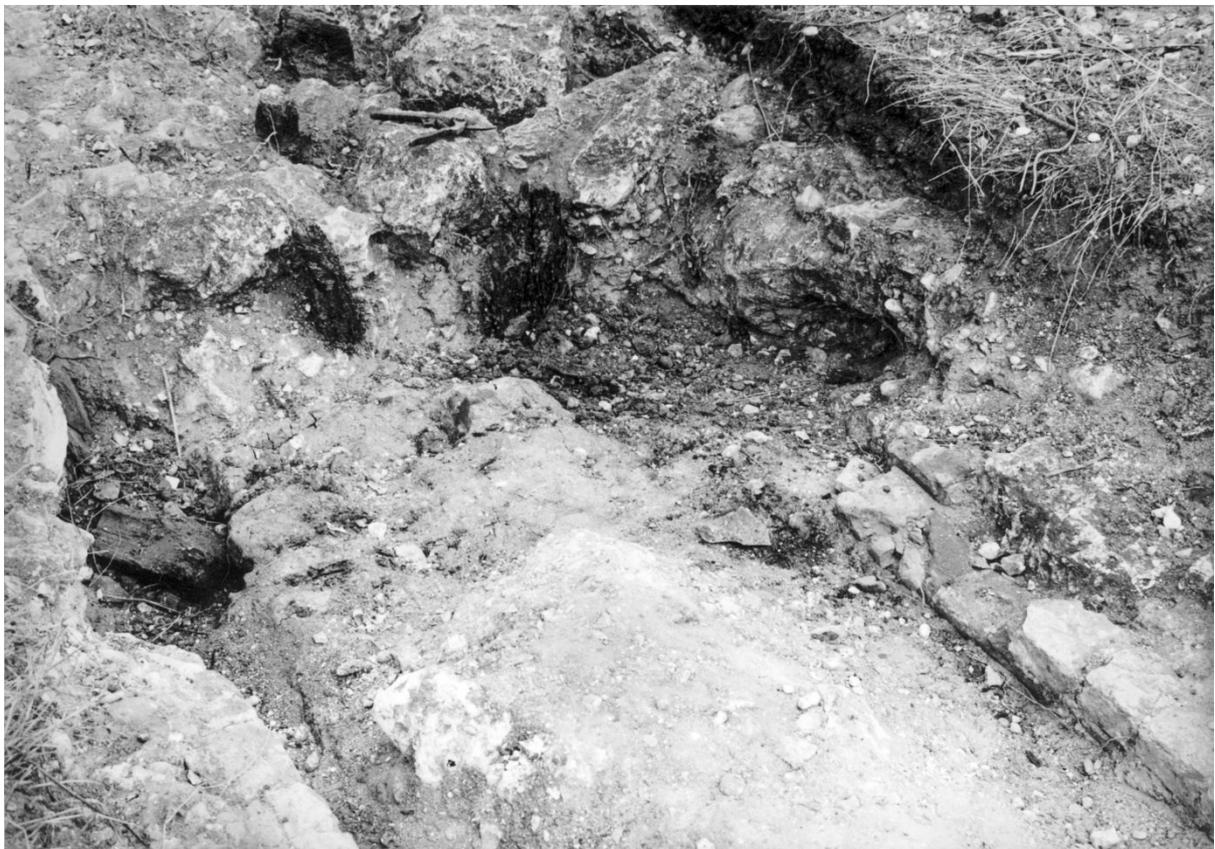
Figure 11. Detail of the north end of culvert 031 with stakes 033.

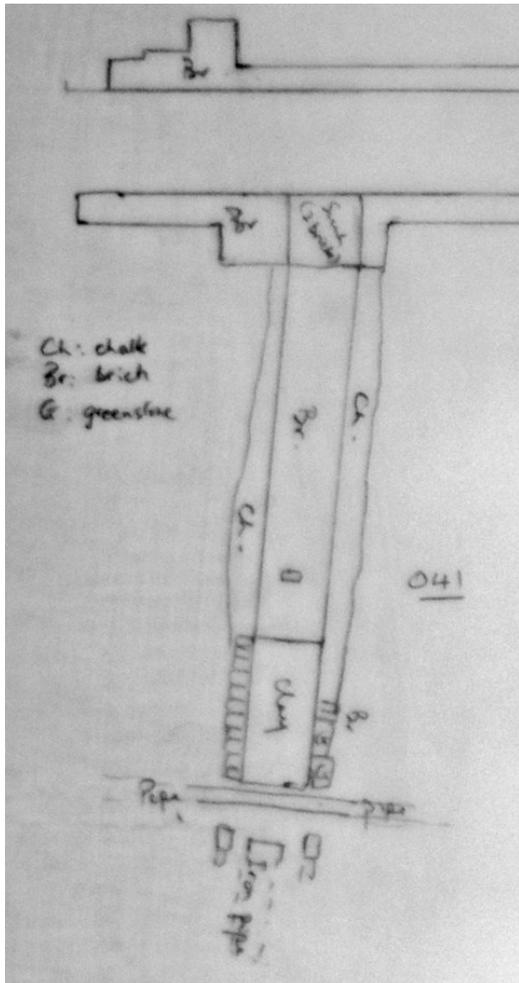
Figure 12. Detail of figure 5 showing culvert 041. North to the left. Culvert 031 at the top.

A culvert (041) joined the west side of 031 towards the north end. It came from the direction of the house. The junction with culvert 031 was of brick. Upstream it was brick-floored, with chalk side walls. The floor then became clay, and an iron pipe discharged into the end. The context sheet says that it was the outlet of a water overflow conduit running from house basement under the lawn, but the source of this information is not given.

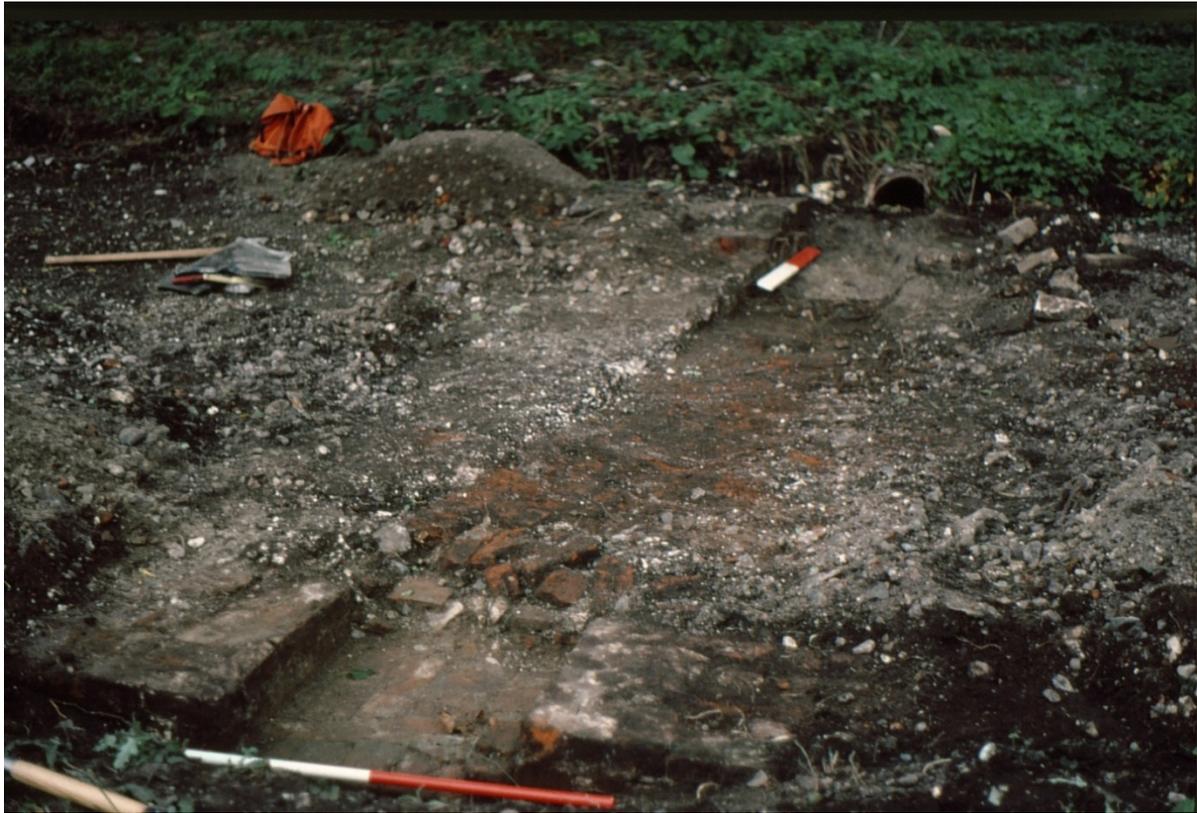
Figure 13. Channel 041 with the edge of 031 in the foreground. Looking west.

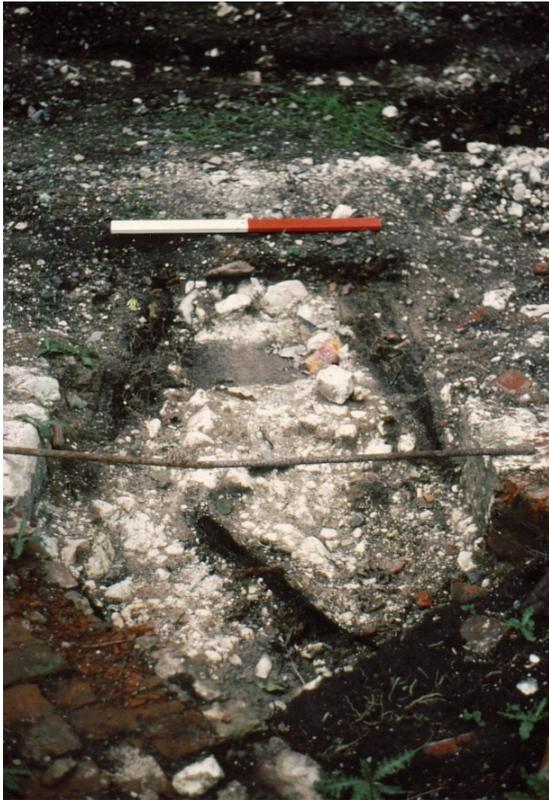
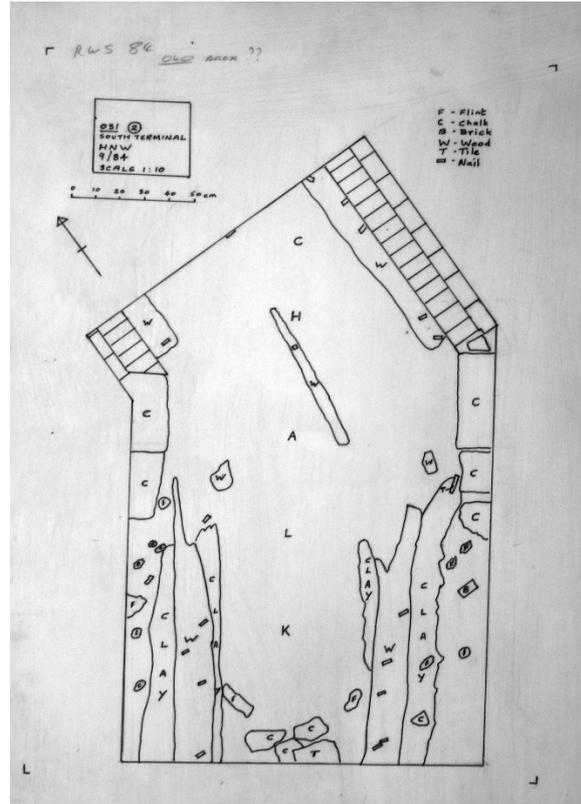
Figures 14 and 15. Channel 040 looking south from the end of 031 and in plan with north at the top.

Two channels flowed into the south end of 031. One (040) came from the direction of the spring head. It joined 031 at an angle. Only a short length was excavated but it seems to have been similar to 031 with brick side walls and a wooden floor with clay puddling. The other channel (037) is described in the southern area.

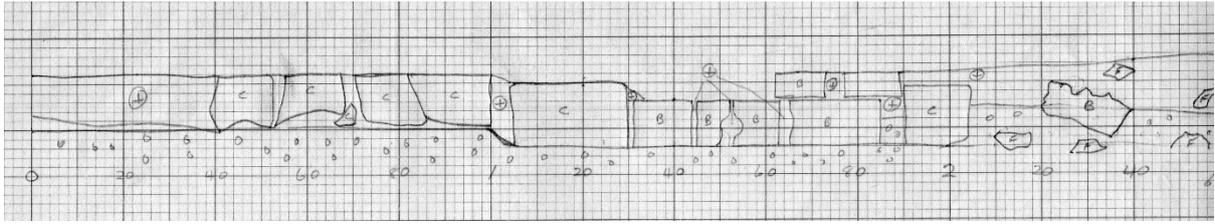
Figure 16. The west side of trench 046 which cut through the floor of 039 to the left, and then the south chalk block wall of culvert 037, its brick floor and chalk block north wall. Drawn at 1:10 on 2mm graph paper.

Culvert 037 had a floor of bricks set on edge, and chalk side walls. It was 0.6m wide. The excavator noticed mortar on the floor of the culvert, and in two places there was a second layer of brick. Hugh Waterhouse suggested that the second layer of brick had originally covered the whole of the culvert floor. However, the surviving bits of the second course are small and do not look convincingly *in situ*, while the mortar could be limescale deposited on the culvert floor.

For much of its length the south wall of culvert 037 butted up against the chalk foundation of a rectangular structure (039). When exposed in 1984 it was in a very fragmentary state, but two photos taken by Dr Peatling in the early 1920s show that the structure originally extended westwards to culvert 040. It had an external width of 5m. The Film Plan (figure 2) shows it extending south beyond culvert 035 to end against another unnumbered culvert aligned southwest to northeast. The structure was about 23m long. The greater part of the interior was unexcavated so there may have been undetected cross walls dividing it into smaller units. The section 046 (figure 16) shows that it had a floor of large chalk blocks.

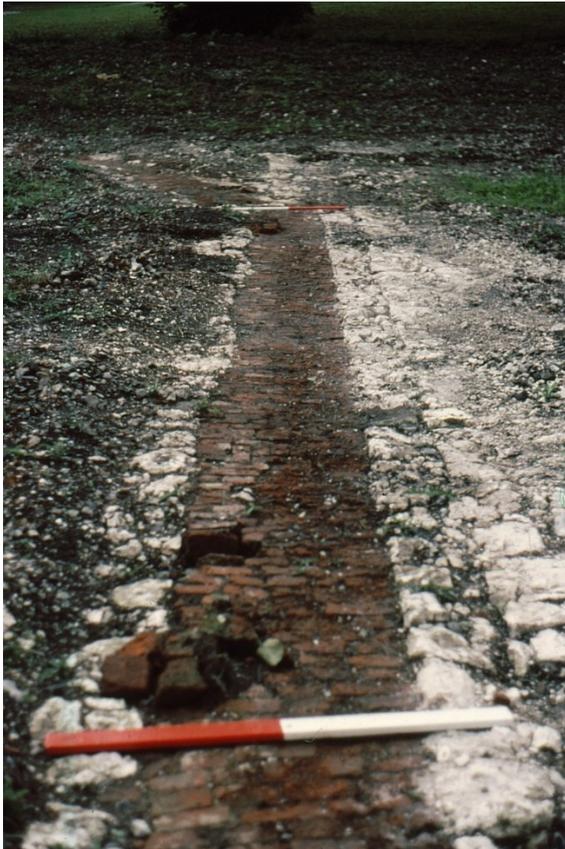
Figure 17. Culvert 037 looking east. Note that the south side wall is straight while the north is irregular.

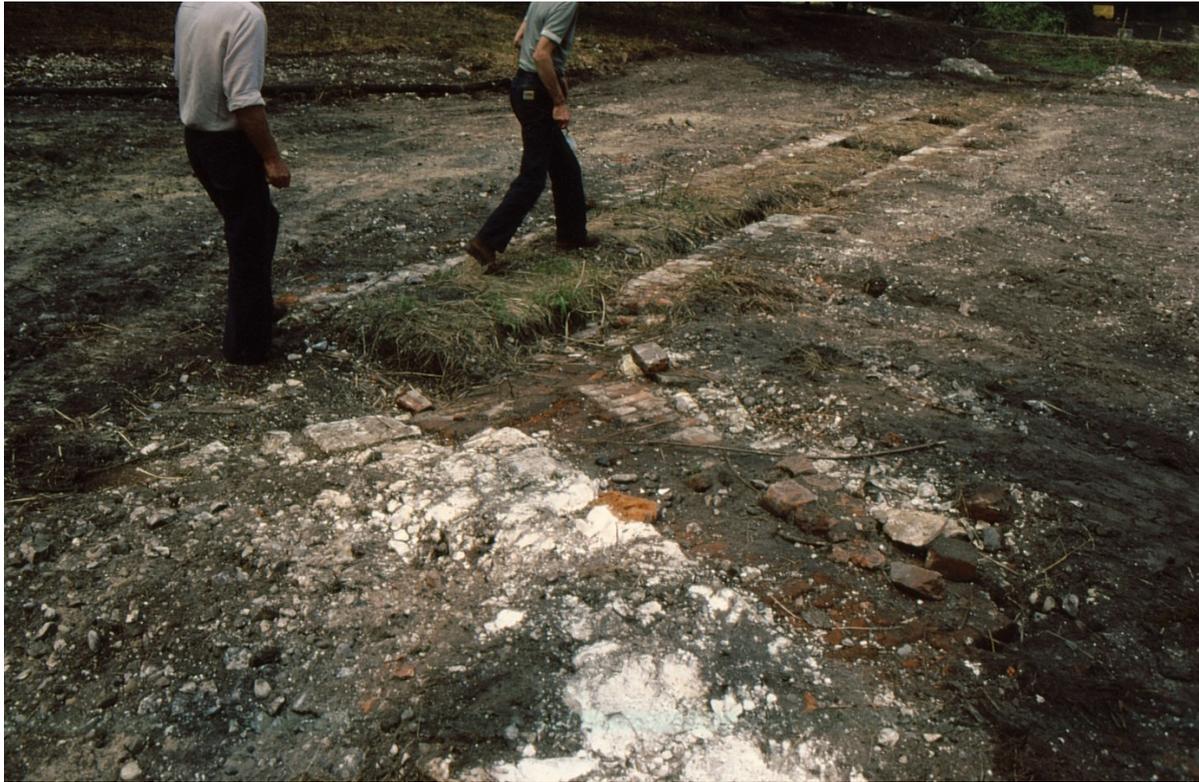
Figure 18. The junction of culvert 037 (foreground) with 031 (background).

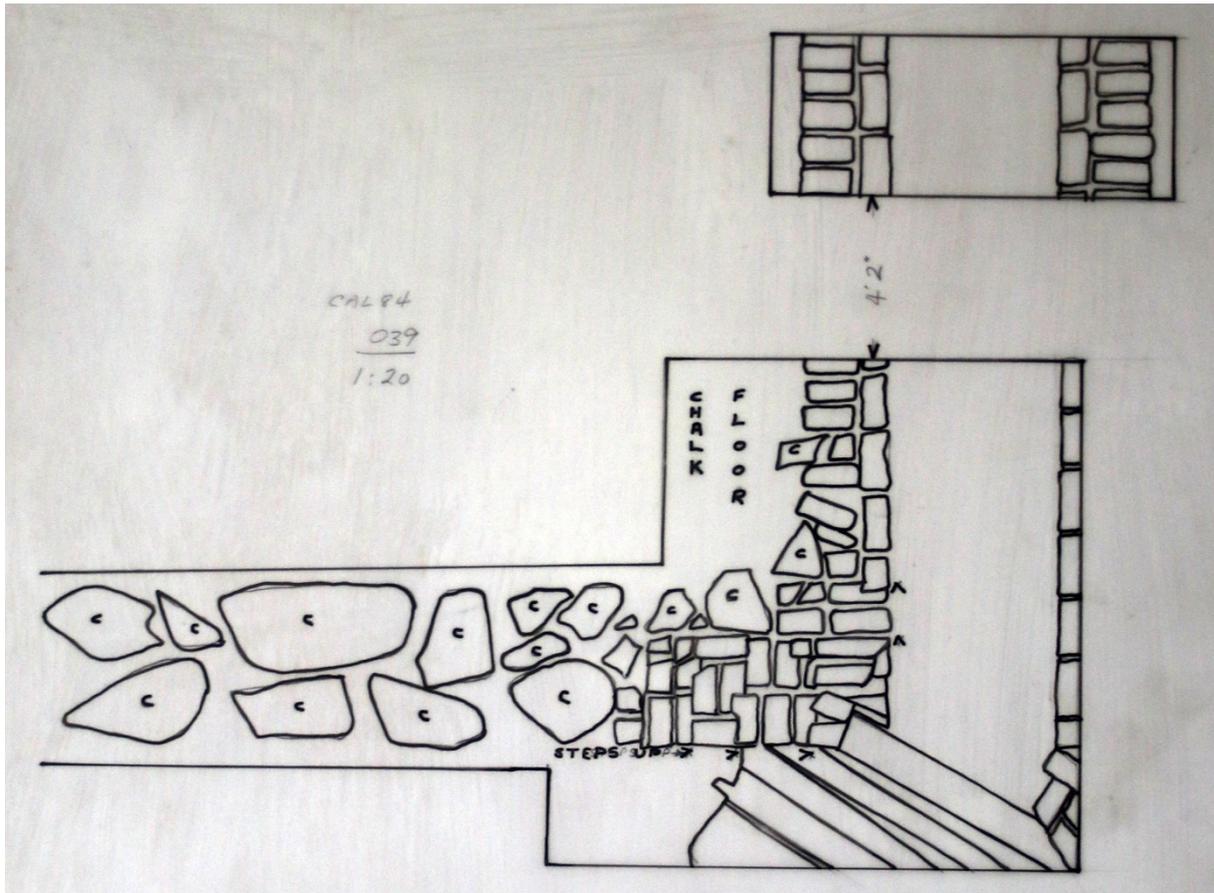
Figure 19. The southeast corner of 039 showing the culvert running across the end wall.

The Film Plan shows two sections of culvert which ran along the east wall of 039. They were about 0.7m wide and appear to have had brick sides. A plan (figure 19) appears to show some timber at the southeast corner of structure 039 but its nature and purpose is unclear.

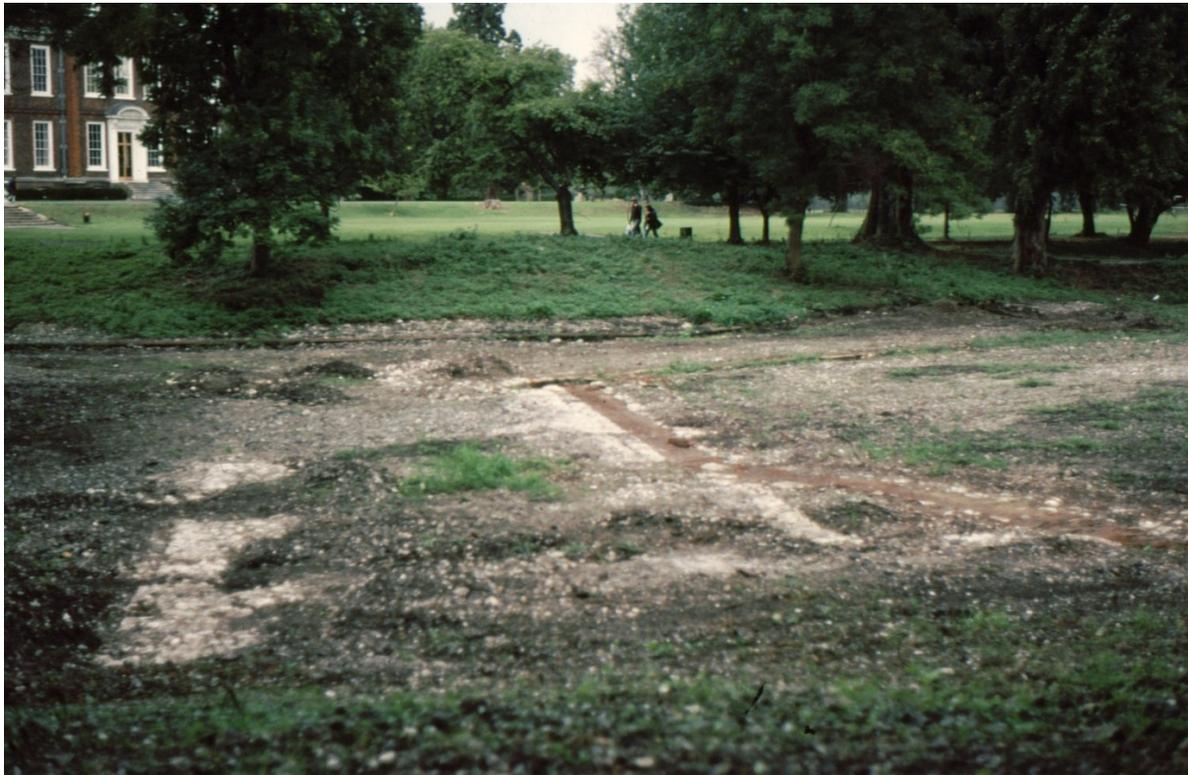
Figure 20. The southern part of 039 with the brick floor of culvert 037 to the right.

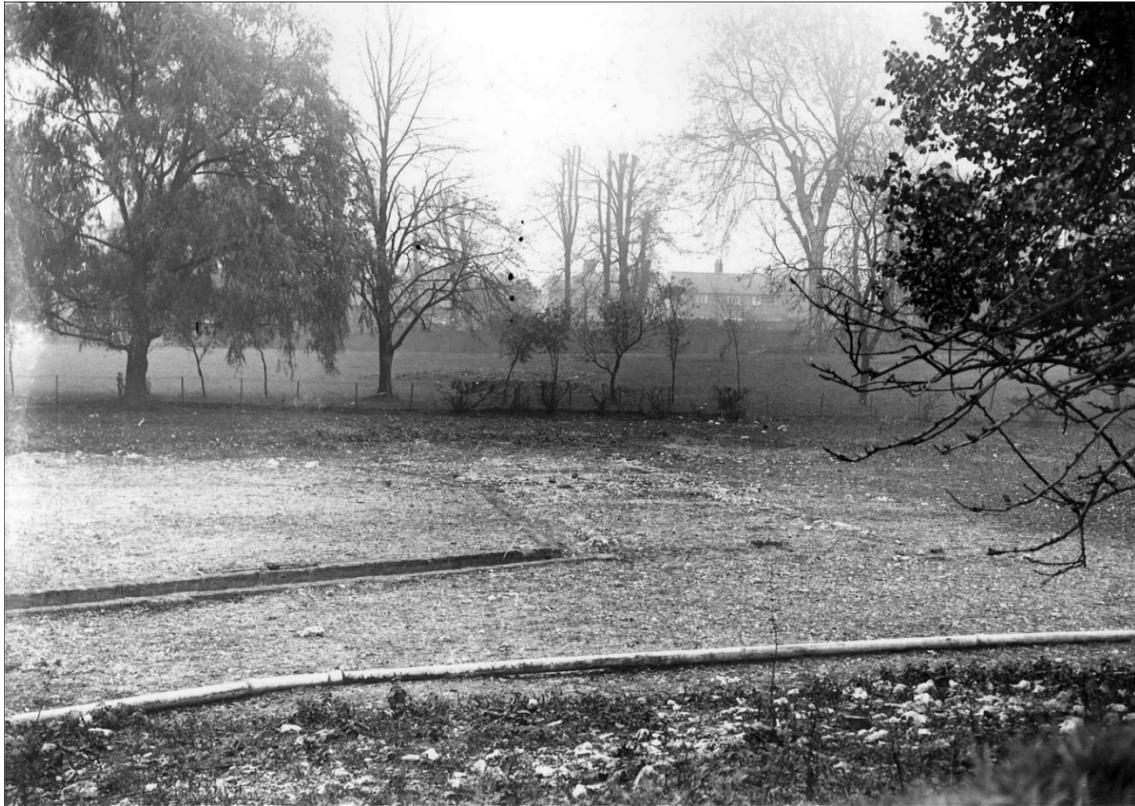
Figure 21. Photo taken by Dr Peatling in the early 20th century. Looking east. Culvert 031 is visible on the left with culvert 037 running eastwards from the end of it. The chalk foundation 039 can be seen to the right of it extending from the end of 040 which continues the line of 031.

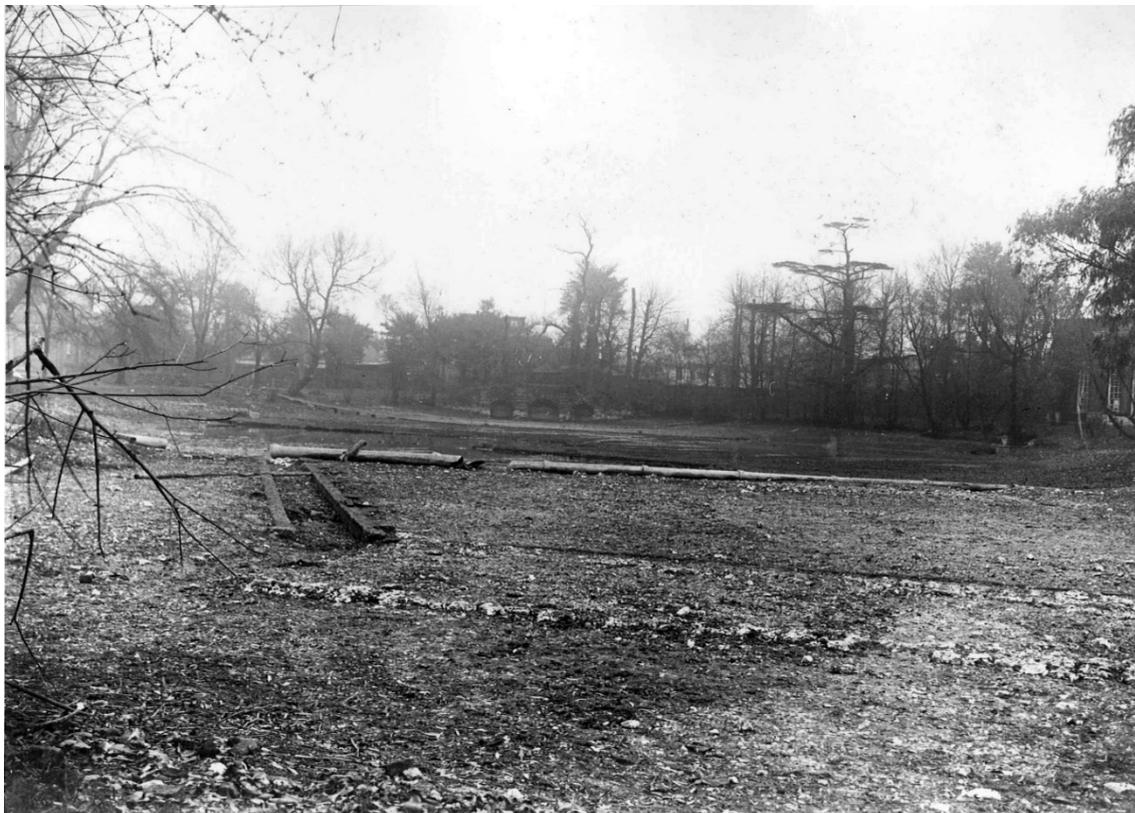
Figure 22. Another view by Dr Peatling looking north along culvert 031 with foundation 039 to the right.

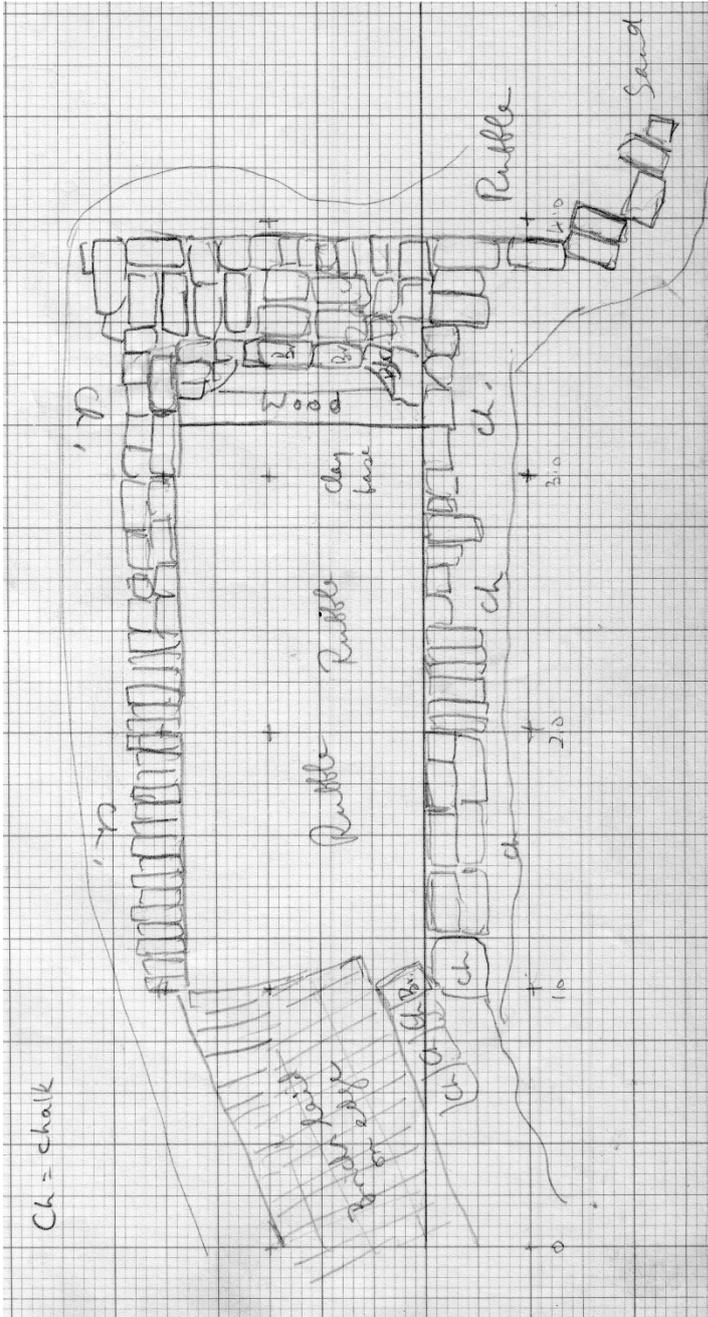
Figure 23. Plan of culvert 035 drawn at 1:20 on 2mm graph paper. North is to the left.

The eastern end of culvert 037 turned away from foundation 039 and connected to a short brick, walled culvert 035 which it joined at an angle. The plan of this (figure 23) suggests that it had brick sides probably with a wood floor over clay. It had a length of about 2.4m and width of 0.92m. The context sheet says the walls were constructed on chalk blocks. It ended against a brick wall.
