Carshalton & District History & Archaeology Society

Local History Note 21

The Carshalton House springhead and the structures in the bed of the lake

Site code CAL84

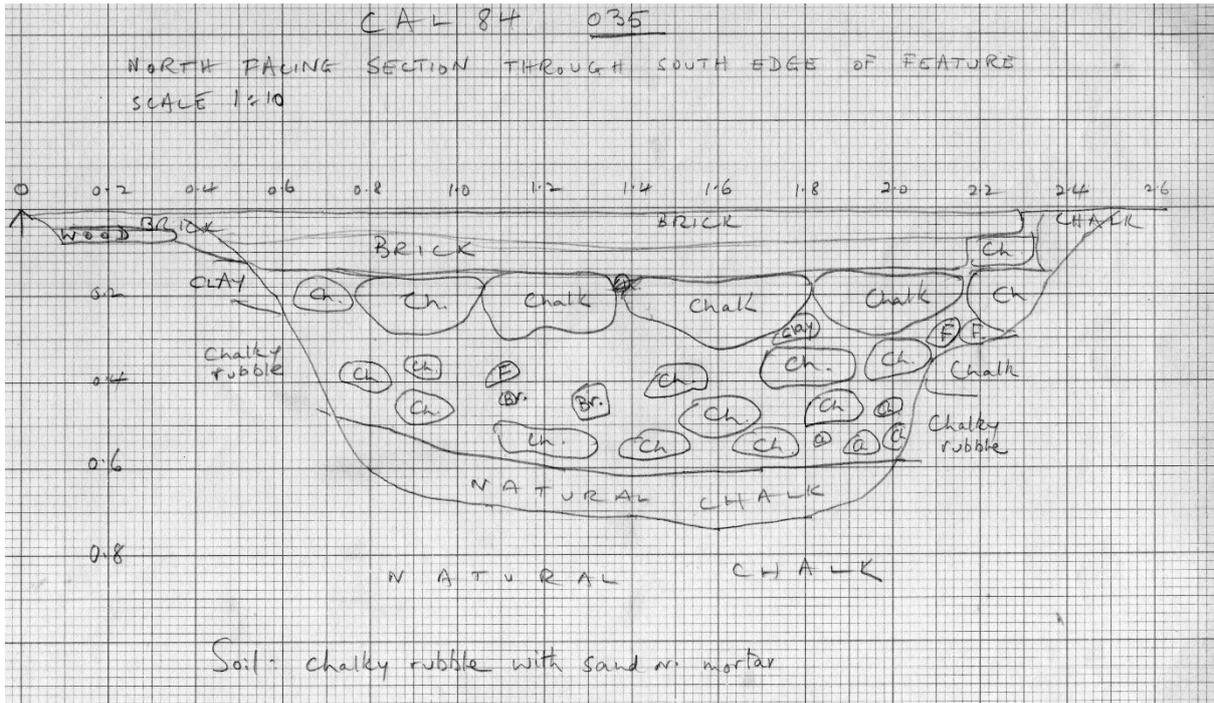
Figure 24. North facing section through south edge of culvert 035. Drawn at 1:10 on 2mm graph paper.

There are two section drawings of a pit or channel which are labelled 035. One is described as 'North facing section through the south edge of the feature' and the other as 'South facing section through the centre of the feature' (figures 24 and 25). They show an irregular pit or channel dug into the natural chalk and overlying deposits. The fill is chalk with some flint and brick in a matrix described on one drawing as "chalky rubble with sand or mortar" and on the other as "sandy loam with chalk and brick and some (?) mortar". The pits do not appear on the plan (figure 23) but were presumably in the bed of the channel. The section drawings might be consistent with the pit being an artifact of the excavation. It may be significant that a note on the context sheets says that feature was partly excavated by unauthorised persons whose results are not available.

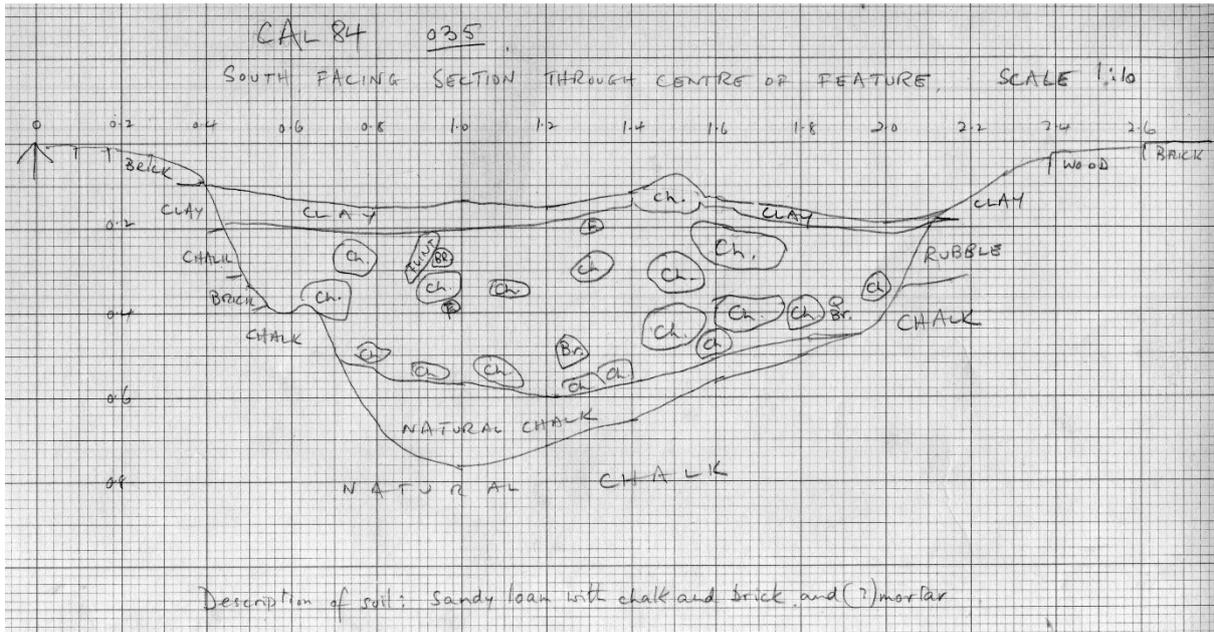
Figure 25. South facing section through centre of culvert 035. Drawn at 1:10 on 2mm graph paper. Ch = chalk, Br = brick, F = flint.

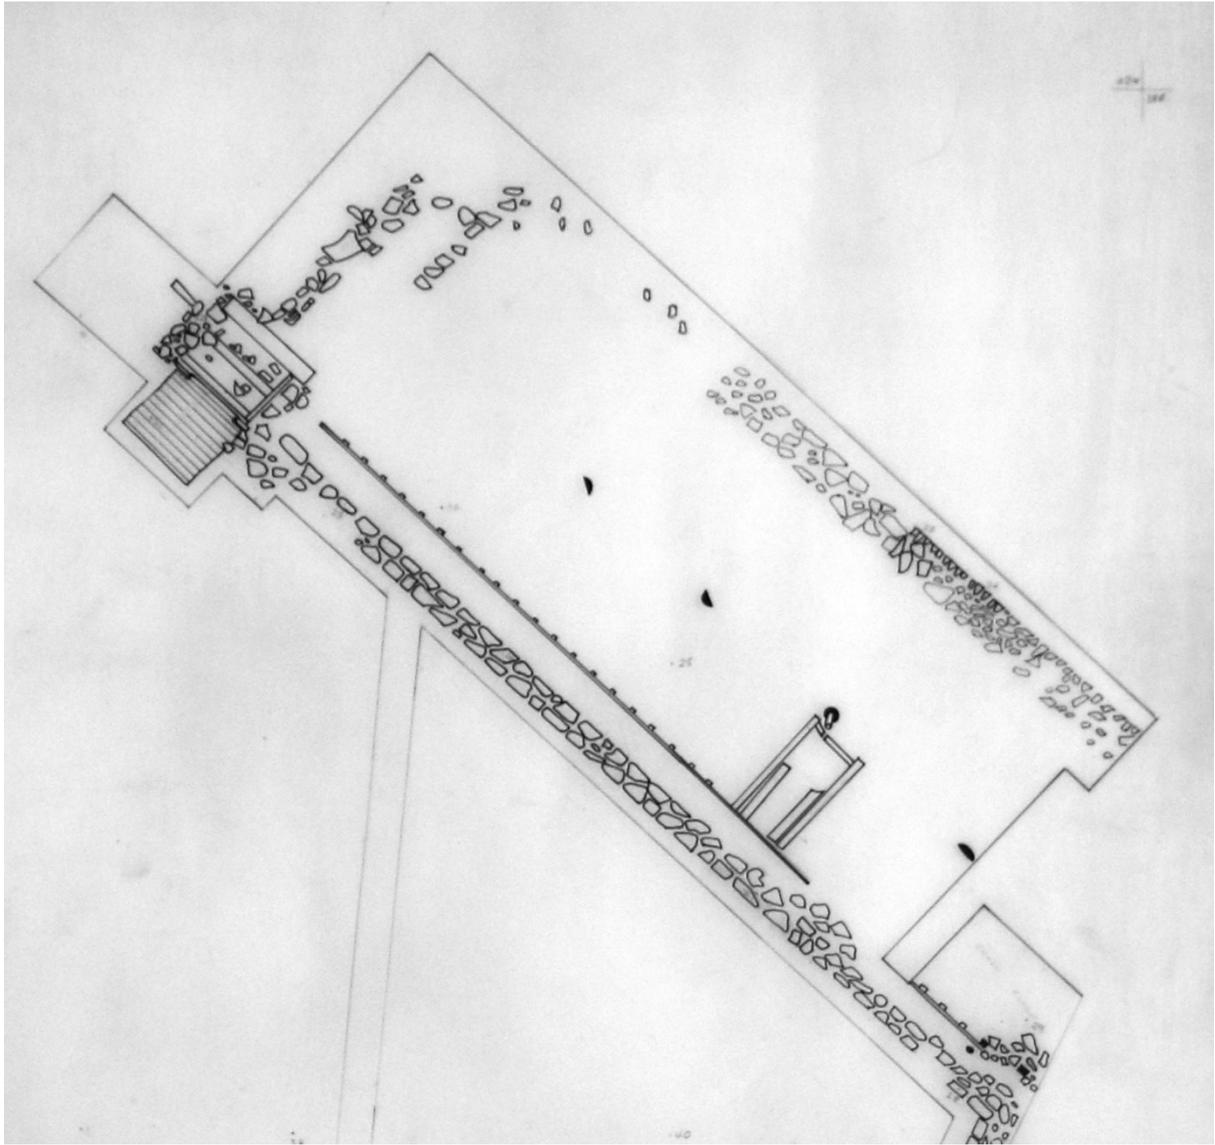
Figure 26. Detail from the Film Plan showing foundation 036 with the wooden floor at the southwest corner.

At the southwest corner of the building there was a timber structure (043). This consisted of a framework within it, and over the foundations, and a timber floor outside and adjacent to it. The floor was about 1.4m north-south by 1.6m east-west and consisted of east-west aligned boards secured by three lines of nails suggesting that it rested on three beams. The framework may originally have been similar but there is not enough remaining to be certain.

There was a second wooden structure in the eastern end of the building but there are no details other than the plans (figures 26 and 27).

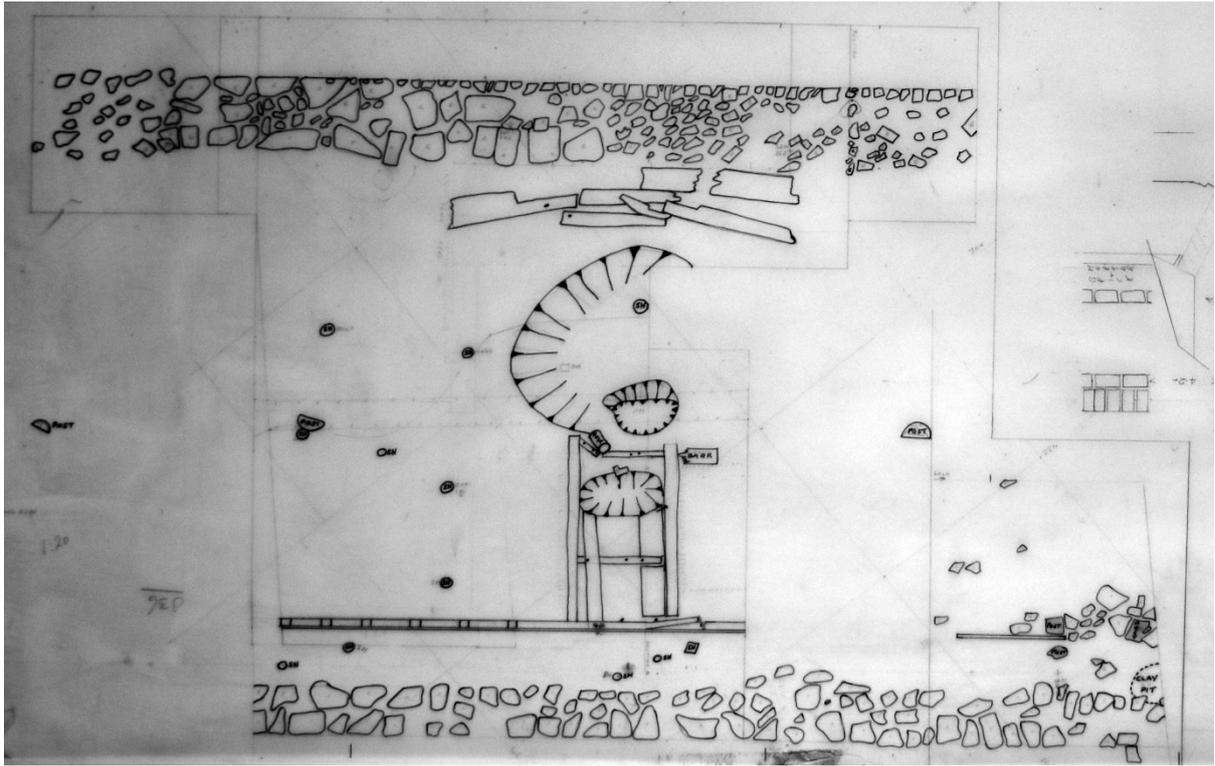
Figure 27. The eastern end of 036.

Feature 045 is described as a depression in rubble area at the east end of 036. It was filled with black earth which contained broken brick, flints and chalk. At the base was an east-west aligned wooden beam set in clay. The location of this is not clear. The coordinates of the pipe bowl do not fit with the pit to the north of the timberwork on figure 27. There was only one context:

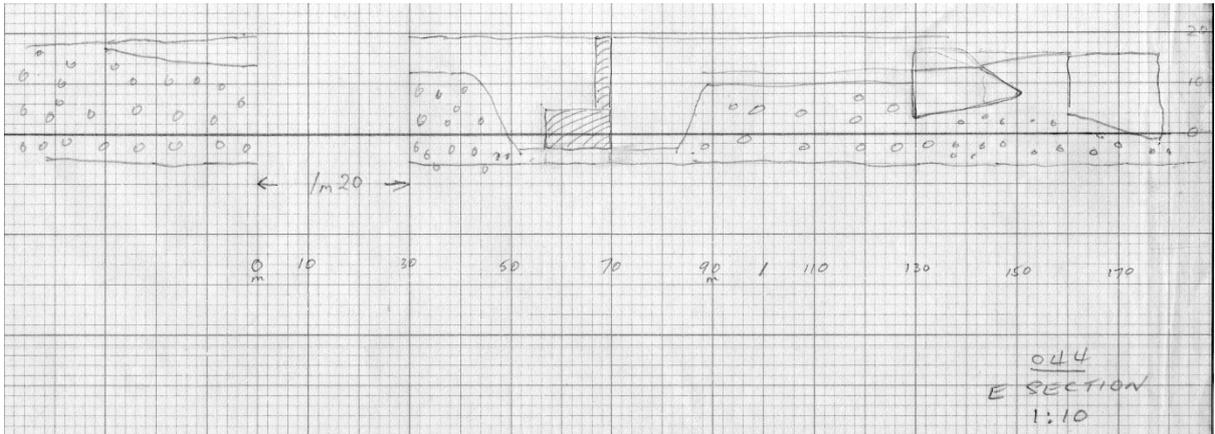
Figure 28. The east side of trench 044 which cut through the foundation of 036. Drawn at 1:10 on 2mm graph paper.

The foundations were sectioned by trench 044 (figures 28 and 29). This showed that the floor consisted of crushed chalk resting on sandy gravel. There was a cut in the gravel which

contained a timber beam, which ran parallel to the south wall about 0.7m from it. The beam supported a plank which rose from its south edge and was supported by posts at about half-metre intervals. The cut was filled with the crushed chalk that formed the floor. The chalk floor thinned to the north and graduated into the sandy gravel that it rested on. The photo (figure 30) suggests that the floor between the plank and the south wall was slightly lower than that to the north.

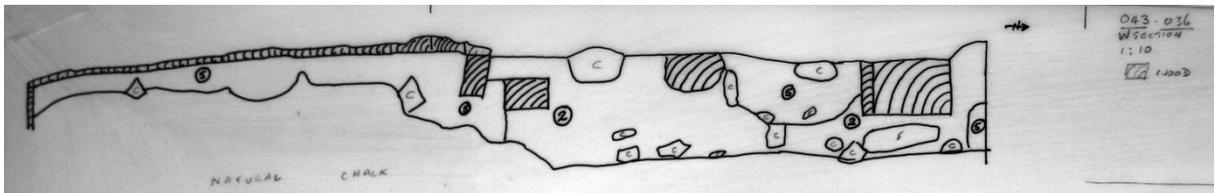
Figure 29. The west side of trench 044 which cut through the foundations of 036.

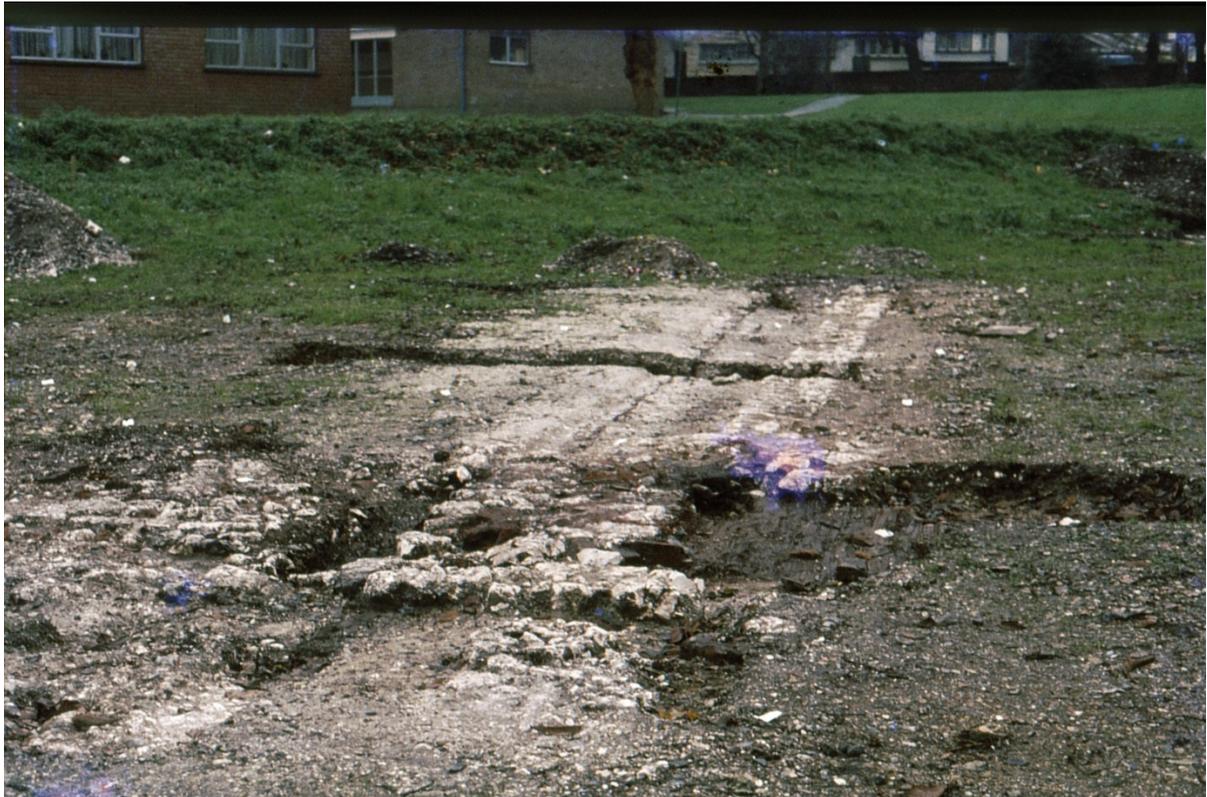
Figure 30. Feature 036 looking southeast.

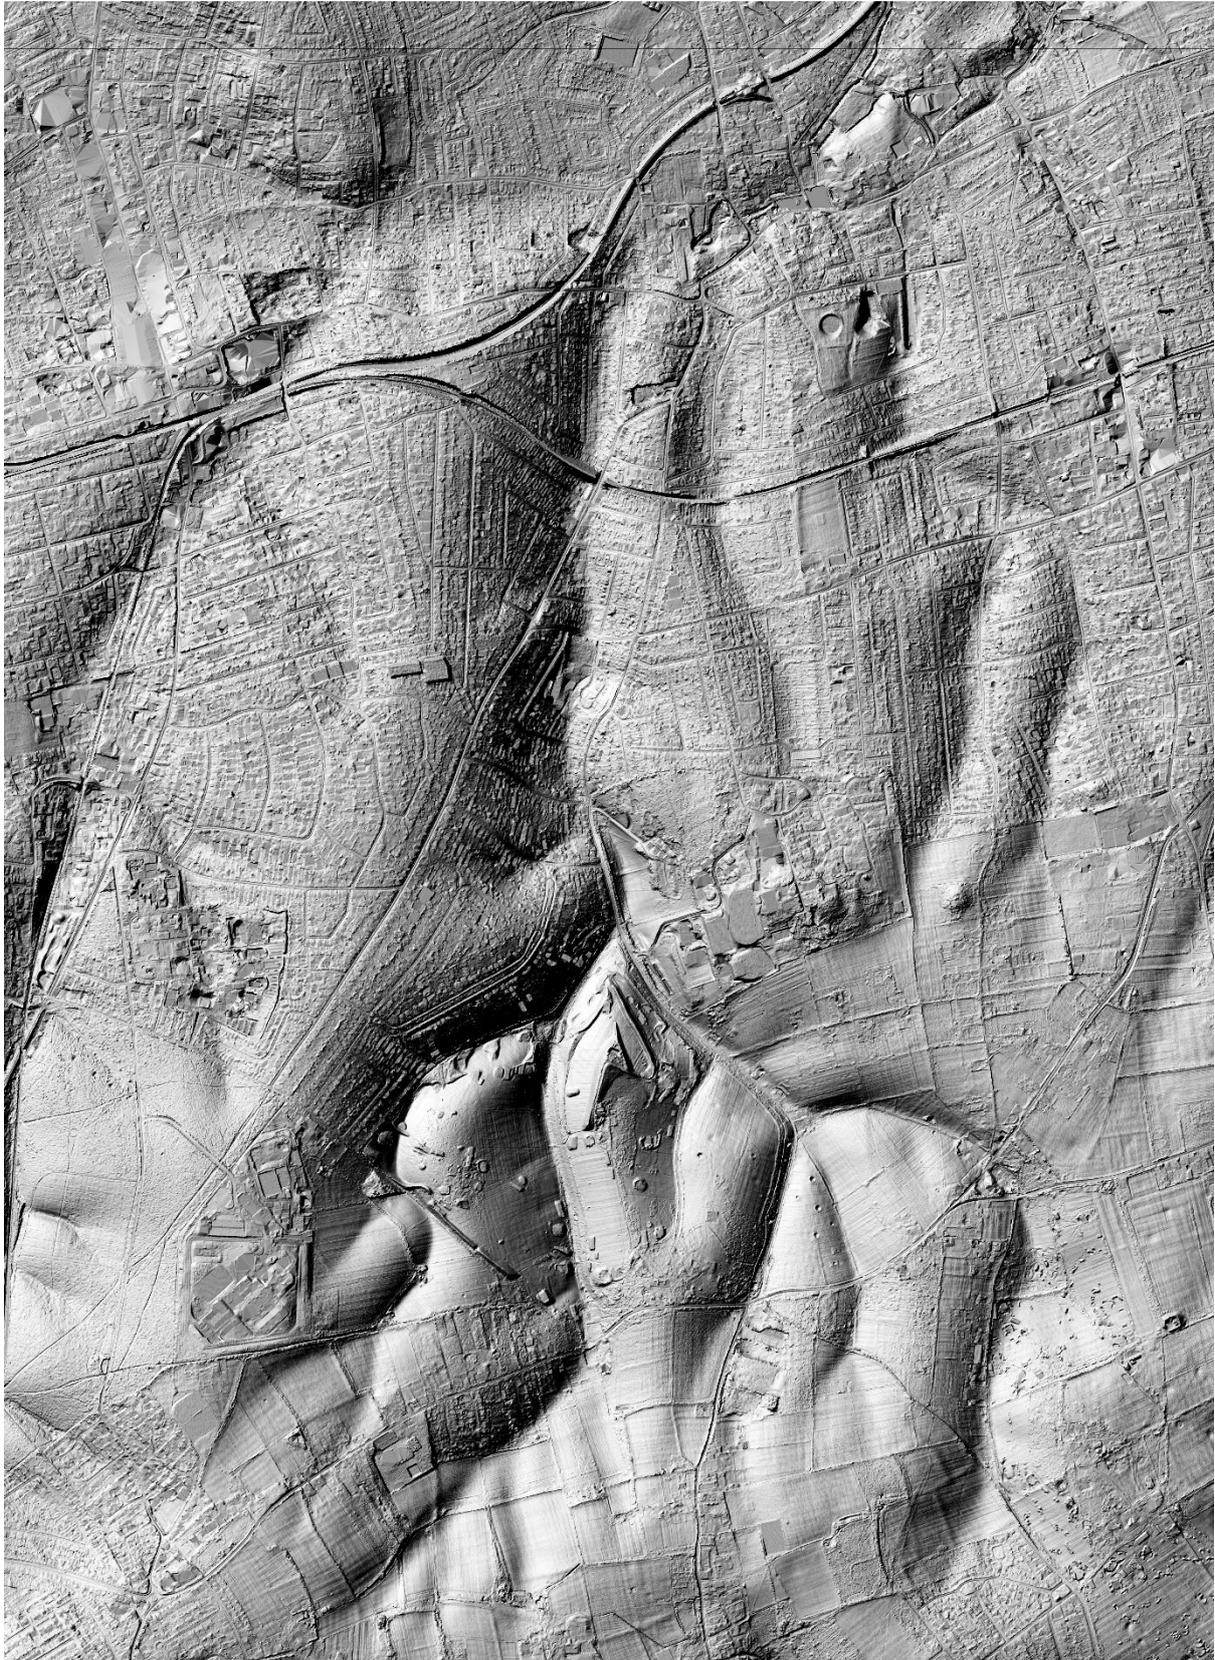
Figure 31. Lidar scan showing the dry valleys to the south of Carshalton. Vertical exaggeration 10x.

If the structures were fishponds how did they fit into the springhead? Three dry valley networks run down to Carshalton (figure 31). The westernmost, and by far the largest, runs from The Oaks along the western side of Carshalton House grounds to the vicinity of the Shorts Road railway bridge. The second is a single shallow valley which runs from the vicinity of the former Queen Mary's Hospital down to the spring head at Carshalton House Lake. The third and east-most starts as two valleys which merge and then descend to the grotto spring head in Carshalton Park. In the past the springs at the last two of these flowed more or less permanently and were the source of the Carshalton Wandle. The largest valley coming from The Oaks is not known to have fed a permanent spring. I have not heard of a bourne in it although it is possible that one used to emerge at Spring Field in the valley bottom near the north end of Oaks Park.

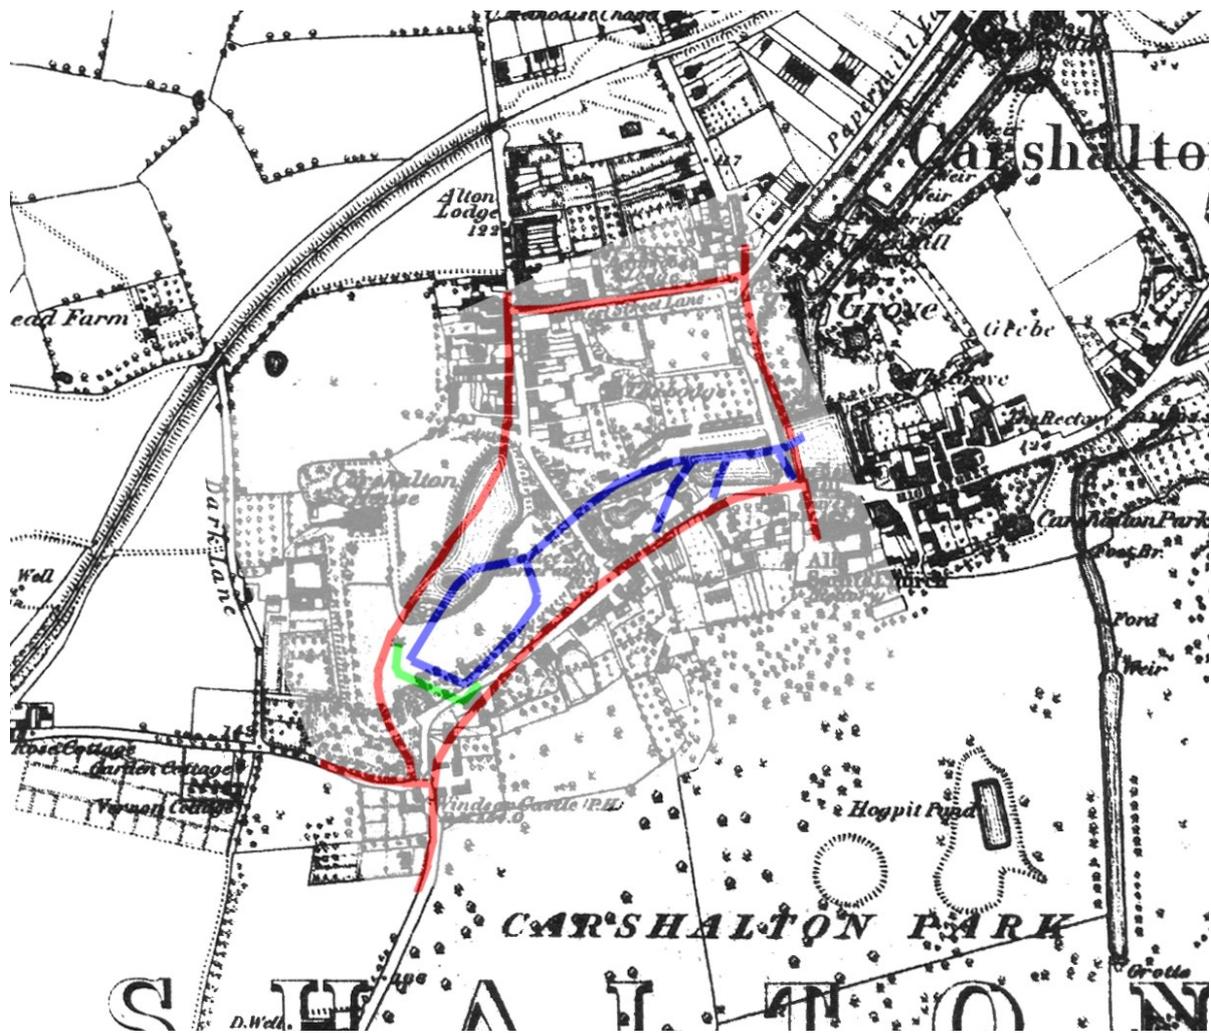
Figure 32. The outline of the springhead lake, watercourses and roads from the Arundel map on the first 6in OS map.

reached about 41m OD and was probably still in made ground.¹⁶ This was 3.7m above the estimated water level in the 19th century lake. The present springhead appears to be just beyond the north end of the one shown on the Arundel Map (figure 32). It is not clear why it was moved. It may have been to facilitate the construction of the Hermitage in a position set by the design of the wider landscape, or it might have been to improve the water supply. The water would have flowed into the springhead through various cracks some of which may have been larger and more productive than others.

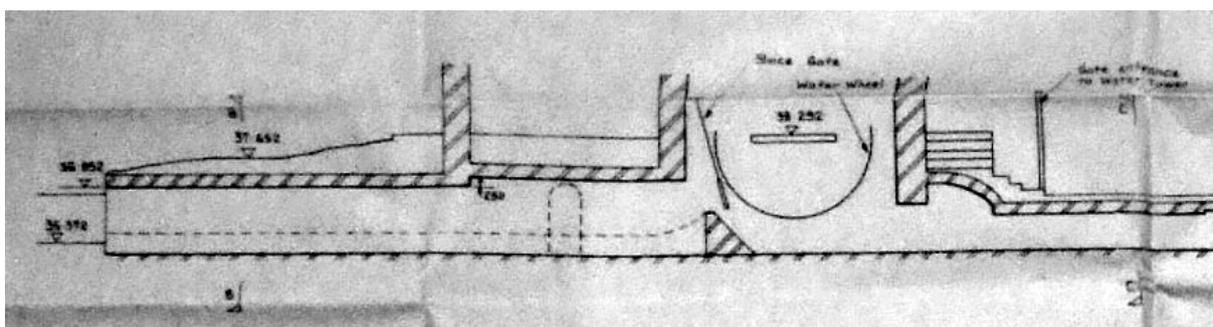
Figure 33. Section along the Water Tower wheel pit and culverts. From a plan by the London Borough of Sutton.¹³

A section drawing through the mill race and wheel (figure 33) shows that the back of the wheel pit rises from the floor of the headrace. This and the bonding breaks between it and

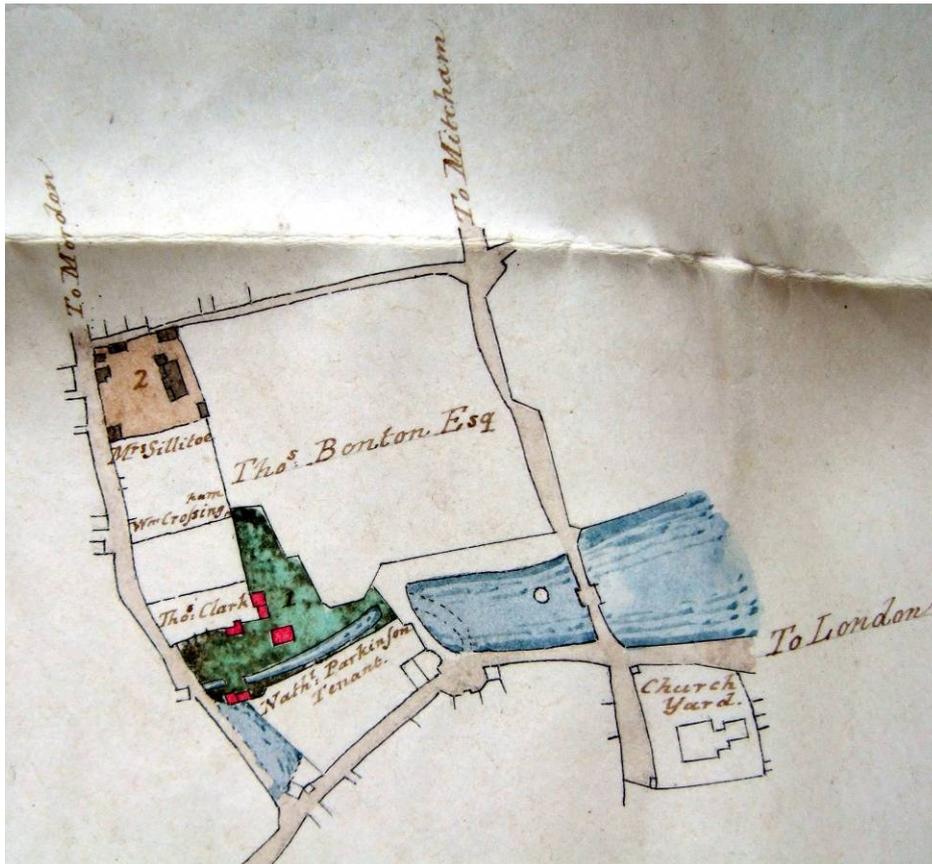
Figure 36. Enhanced detail from a plan made for a faculty relating to an exchange of land involving the rector, 1832.¹⁴

A map of 1832 shows the ford reduced to a short water splash close to the junction with Pound Street (figure 36). It is not clear whether this was the normal state at that date, or that the map was made at a time of low water. It suggests that there may have been a culvert flowing from Carshalton House grounds close to Pound Street. This might be the predecessor of the spring fed drain which still runs into the southwest corner of Margaret's Pool. The ford was finally removed in 1844 reducing the pond to the form shown on the tithe award map of 1847.¹²
